HISTORIC SITE FORM - HISTORIC SITES INVENTORY

PARK CITY MUNICIPAL CORPORATION (10-08)

1 IDENTIFICATION					
Name of Property:					
Address: 1135 Norfolk Avenue		Al	KA:		
City, County: Park City, Summit	County, Utah	Ta.	Tax Number: SA-183		
Current Owner Name: James S	teinmetz	Pa	Parent Parcel(s):		
Current Owner Address: PO BC	X 843, Park City, U		, ,		
Legal Description (include acrea CITY; 0.10 ACRES.	age): ALL LOTS 8 8	≩ 9 AND S ½ LOT 10), BLK 17, SNYDERS AD	DITION TO PARK	
2 STATUS/USE					
Property Category ☑ building(s), main □ building(s), attached □ building(s), detached □ building(s), public □ building(s), accessory □ structure(s)	Evaluation* □ Landmark Site ☑ Significant Site □ Not Historic *National Register □ listed (date:)	Reconstruction Date: Permit #: □ Full □ Par of Historic Places: ☑	Original Use: Current Use: tial		
3 DOCUMENTATION					
Blaes, Dina & Beatrice Lufkin. "Fina Carter, Thomas and Goss, Peter. University of Utah Graduate So McAlester, Virginia and Lee. A Fie Roberts, Allen. "Final Report." Park	□ abstract □ tax care □ original □ sewer p □ Sanbor □ obituar □ city dire ey □ census □ biograp □ newspa bks, articles, intervie al Report." Park City h Utah's

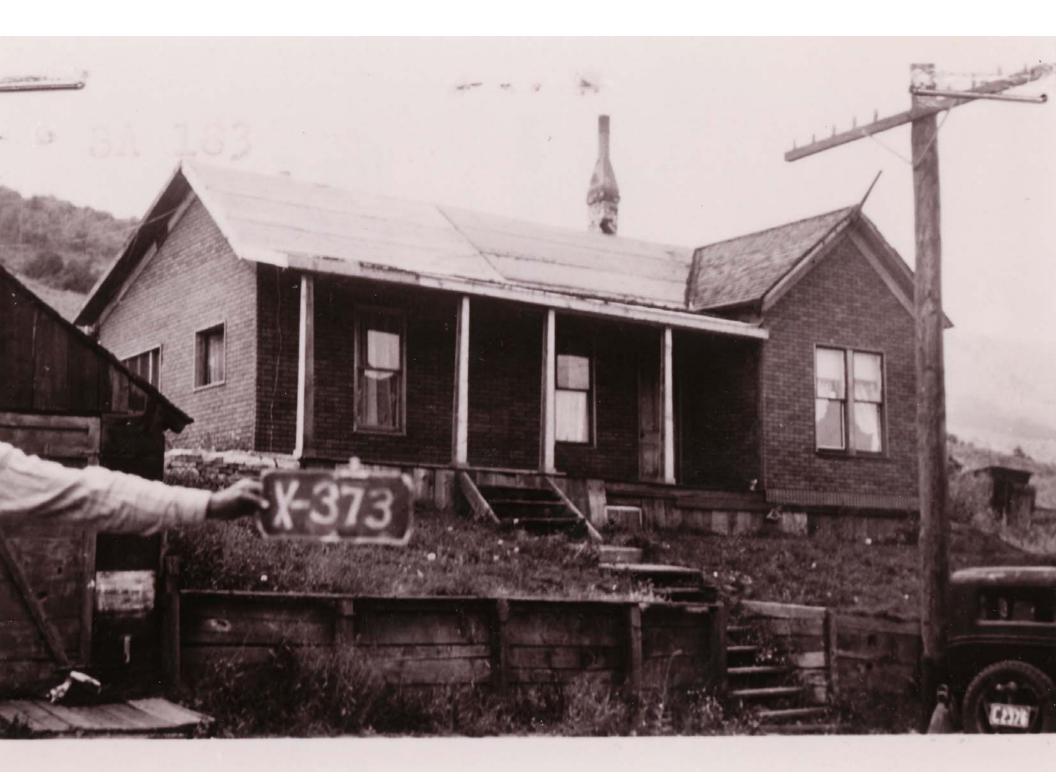
Photo No. 1: Northeast elevation. Camera facing southwest, 2006.

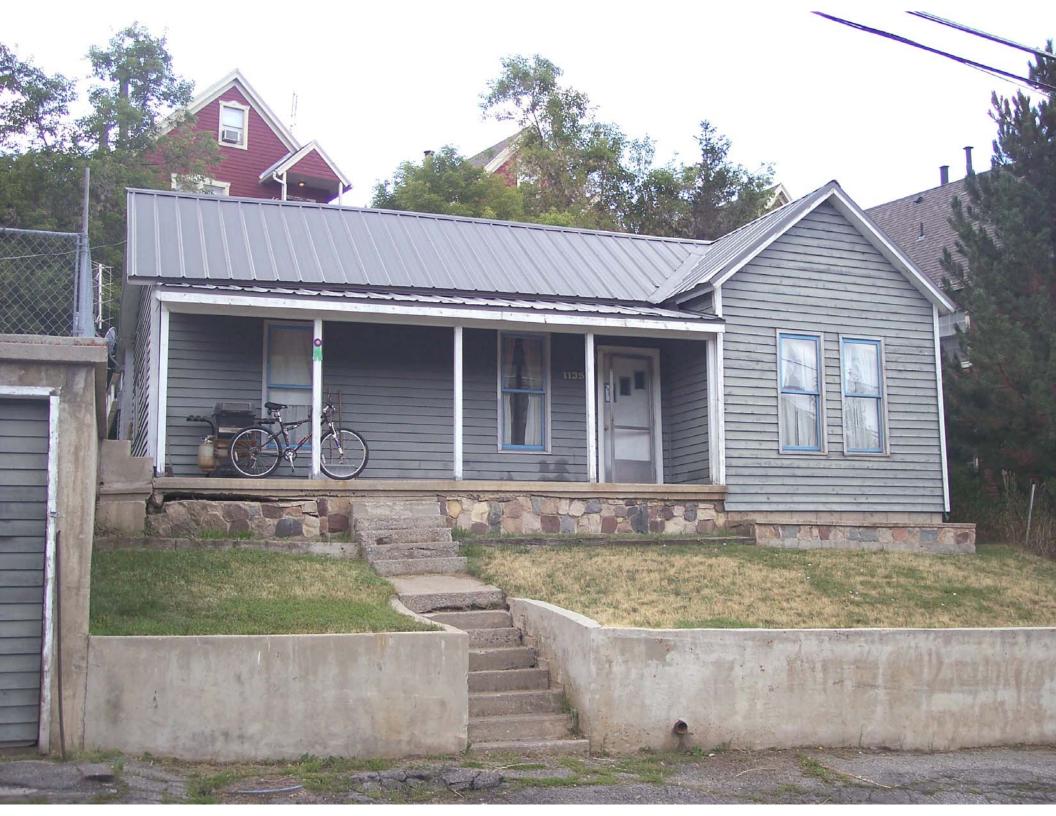
Photo No. 3: Northeast elevation. Camera facing southwest, 1995.

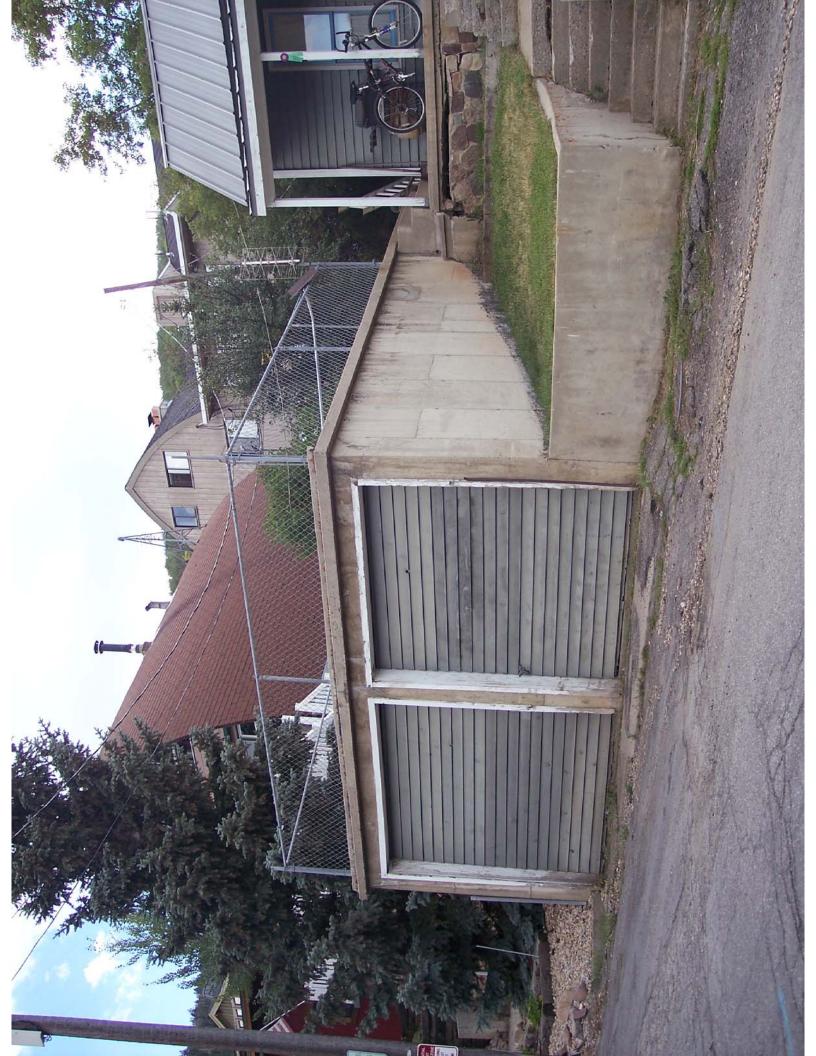
Photo No. 4: East oblique. Camera facing west, tax photo.
