HISTORIC SITE FORM - HISTORIC SITES INVENTORY

PARK CITY MUNICIPAL CORPORATION (10-08)

1 IDENTIFICATION			
Name of Property:			
Address: 1141 PARK AVE		AKA:	
City, County: Park City, Summi	t County, Utah	Tax	Number: KOOR-1
Current Owner Name: SUSAN Current Owner Address: PO Bo Legal Description (include acre KOORING LOT LINE ADJUST	OX 112 PARK CITY, UT age): SUBD: KOORING	84060-0112 LOT LINE ADJUSTME	ercel(s): SA-52
2 STATUS/USE			
Property Category ☑ building(s), main ☐ building(s), attached ☐ building(s), detached ☐ building(s), public ☑ building(s), accessory ☐ structure(s)	Evaluation* ☑ Landmark Site ☐ Significant Site ☐ Not Historic *National Register of H ☐ listed (date:)	Reconstruction Date: Permit #: □ Full □ Partial distoric Places: □ inelig	<u>Use</u> Original Use: Residential Current Use: Residential
3 DOCUMENTATION			
Photos: Dates ☑ tax photo: ☑ prints: 1995 & 2006 ☐ historic: c. Drawings and Plans ☐ measured floor plans ☐ site sketch map ☐ Historic American Bldg. Surv. ☐ original plans: ☐ other: Bibliographical References (bo	□ abstract of t □ tax card □ original buil □ sewer perm □ Sanborn Ma □ obituary ind □ city director vey □ census reco □ biographica □ newspaper

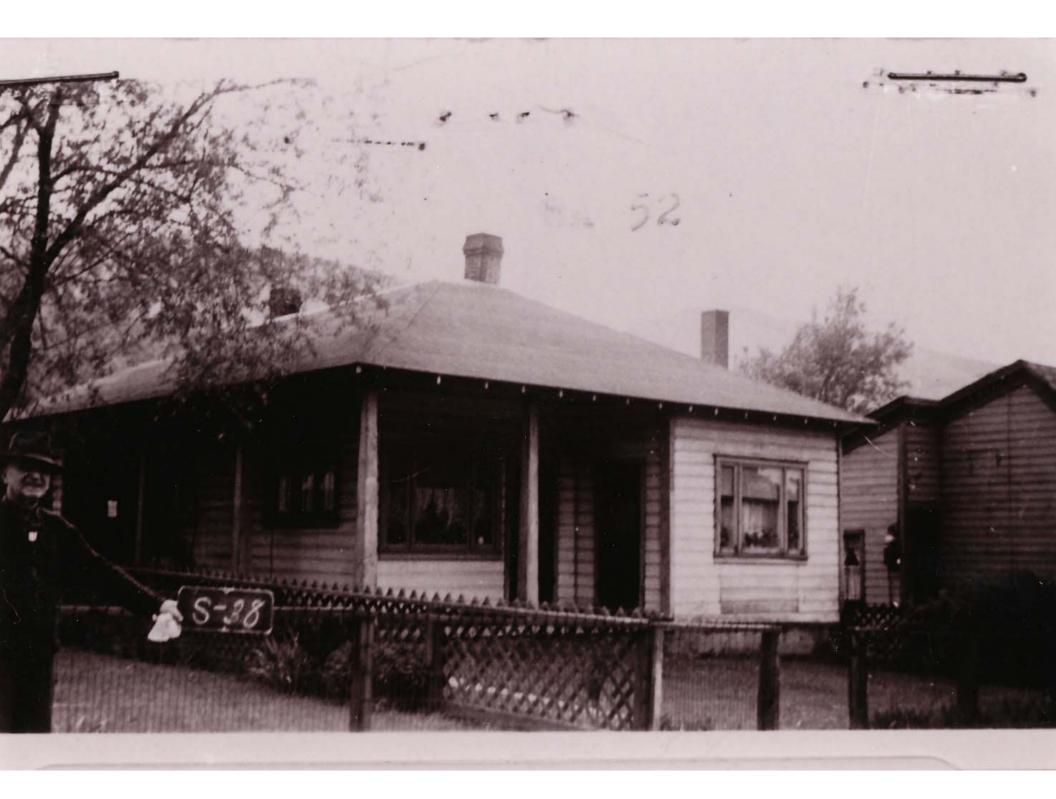
Photo No. 1: East elevation (primary façade). Camera facing west, 2006.

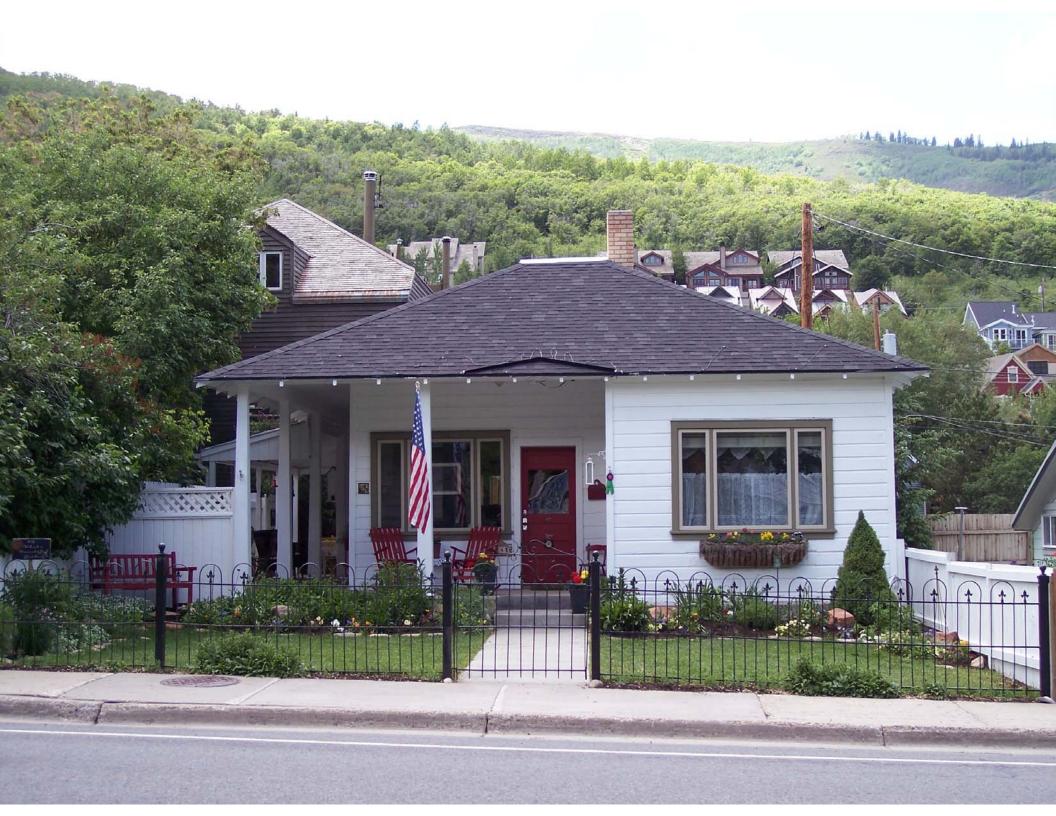
Photo No. 3: East elevation (primary façade). Camera facing west, 1995.
