McPolin Farm Historic Preservation Plan

Prepared for
Park City Municipal Corporation

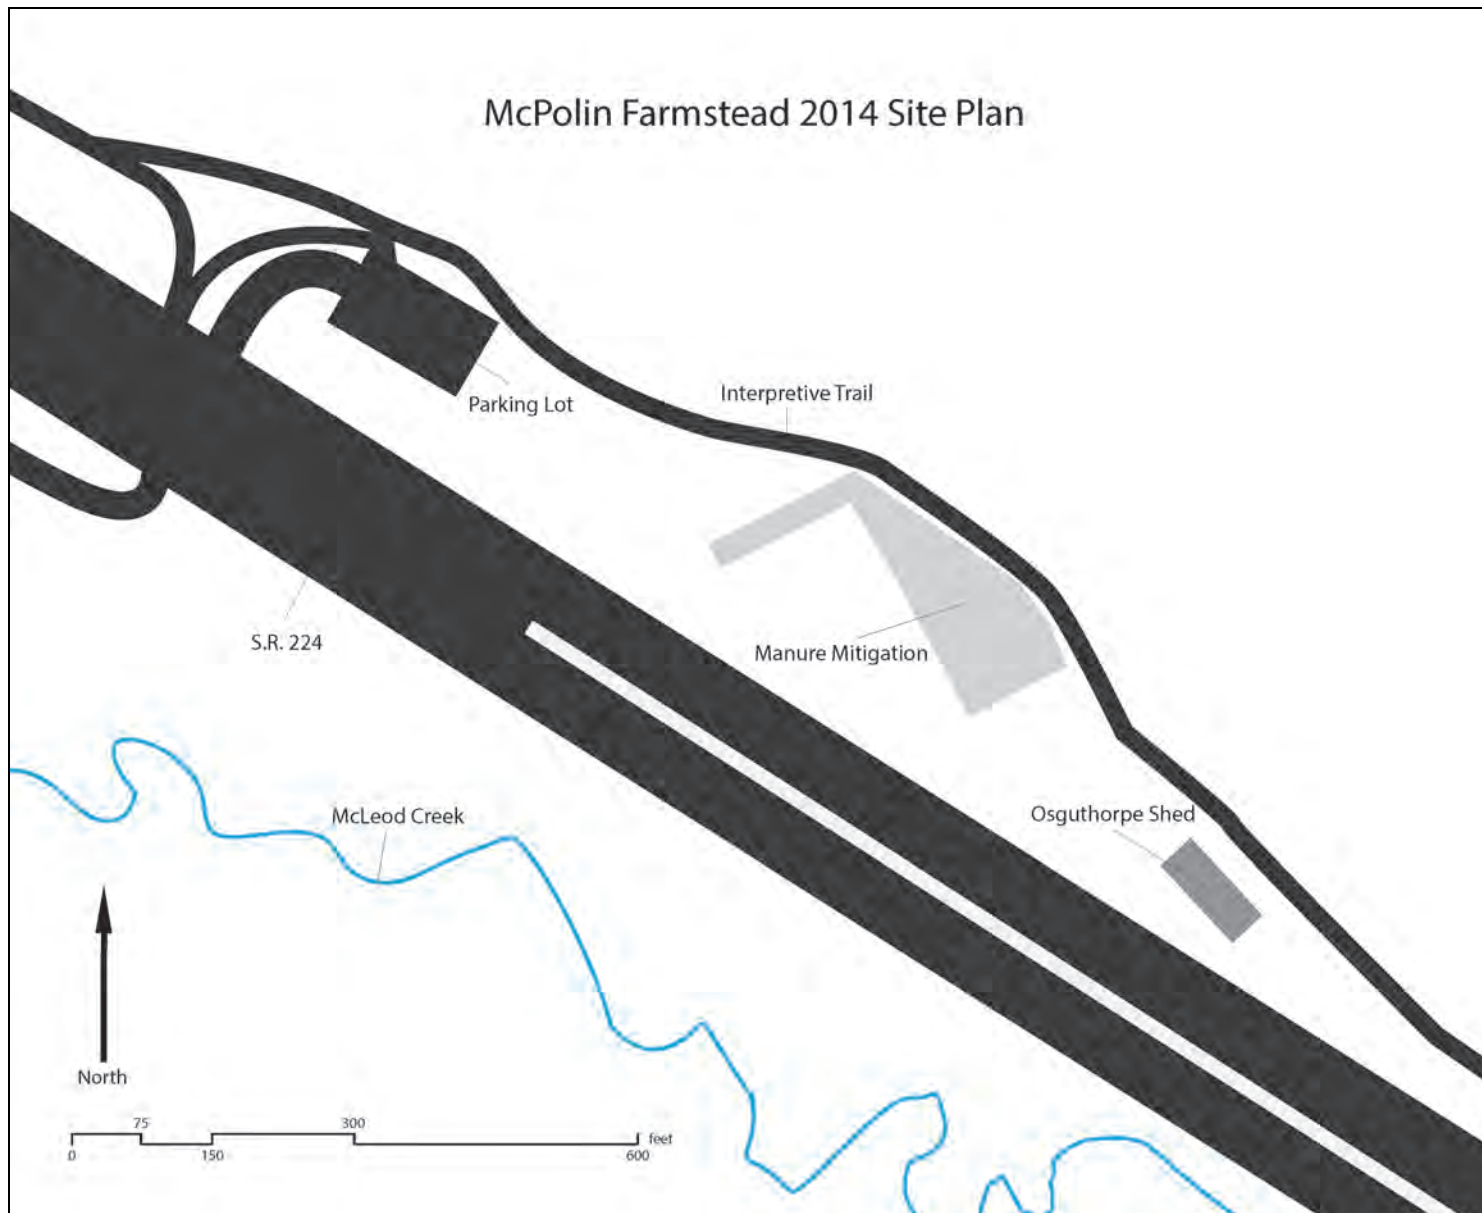
Figure 12c. McPolin Farmstead site plan, detail of Osguthorpe shed area, 2014.

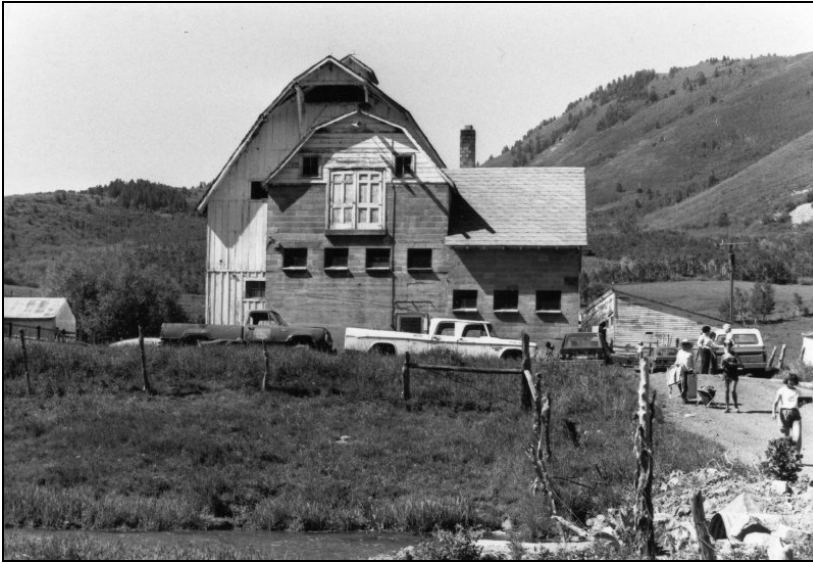
Figure 18. Osguthorpe-era barn with milking parlor addition, ca. 1980, facing southwest. The original machine shed and animal shelter are visible on either side. Image no. 20103016. Courtesy Park City Historical Society and Museum.

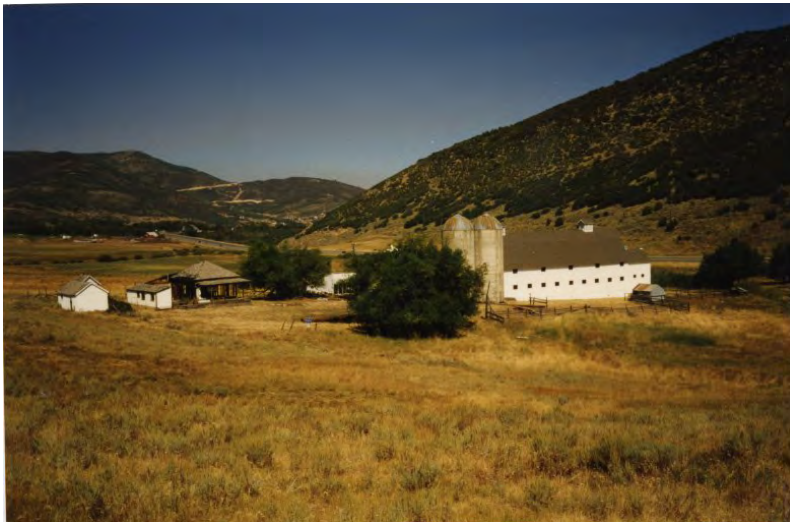
Figure 25. McPolin Farm ca. 1990, facing northwest. Note fire-damaged farmhouse. Image no. 2010305. Courtesy Park City Historical Society and Museum.

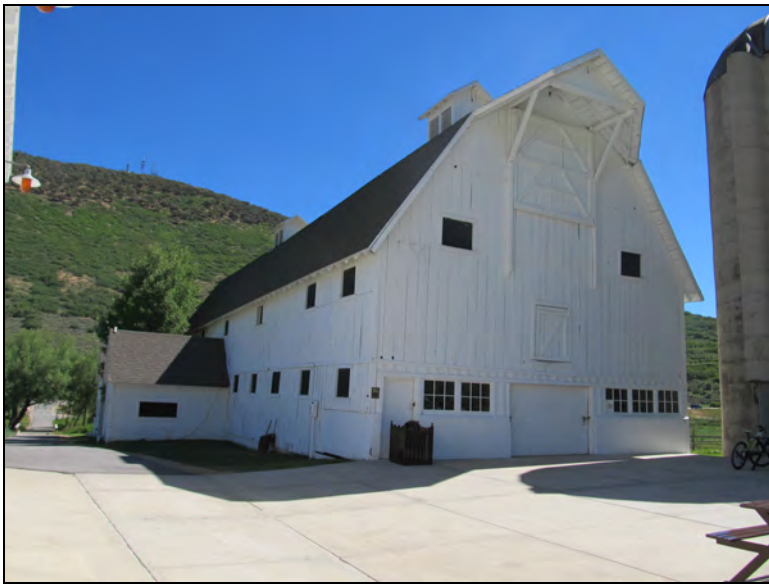
Figure 31. McPolin barn, facing northeast.

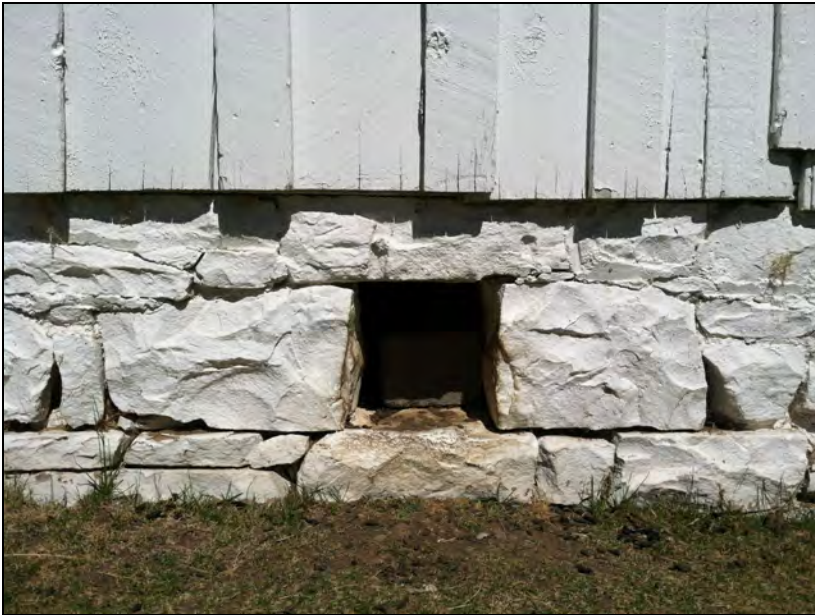
Figure 36. Sandstone foundation, painted white, with opening for basement ventilation.

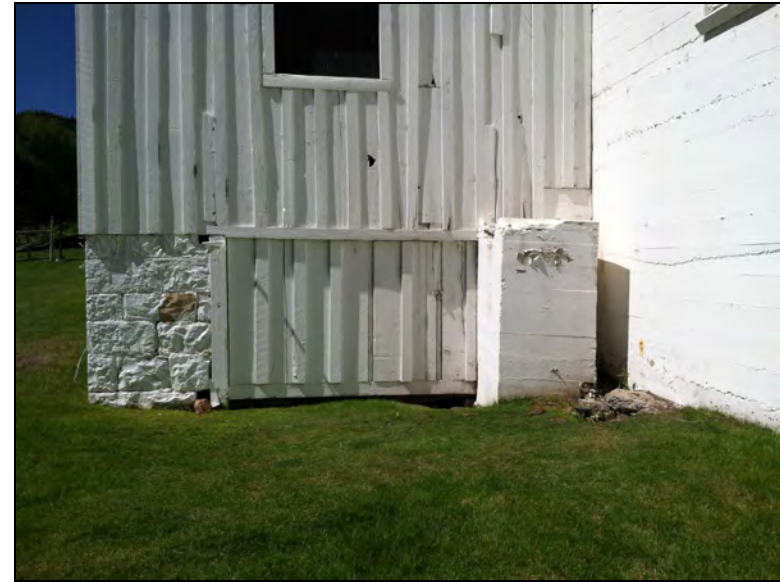
Figure 37. Board-and-batten door on northeast side of the barn leading to lower-level crawl space.

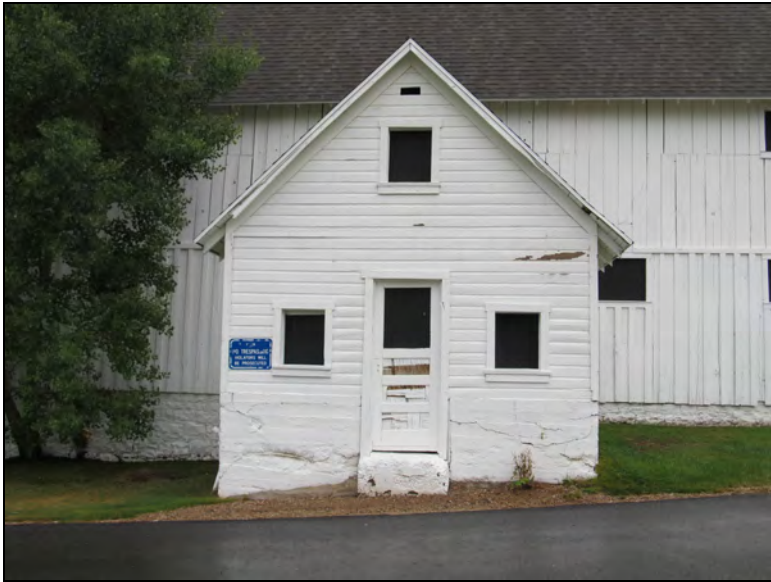
Figure 42. Milk house, facing southeast.

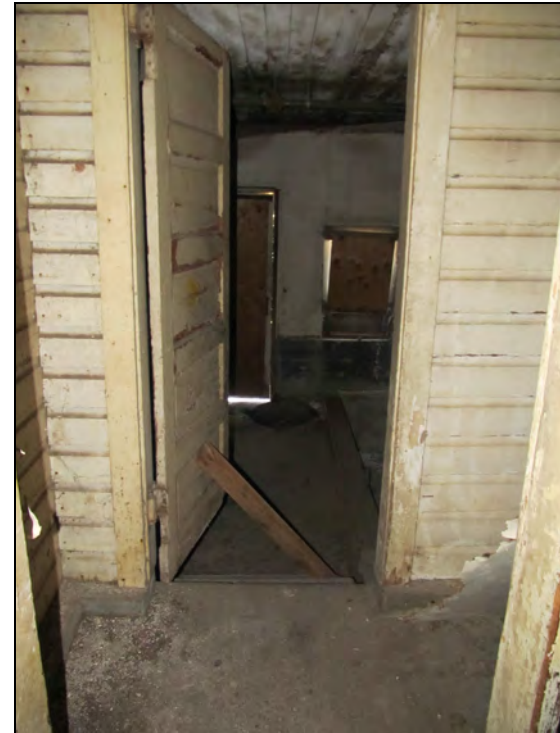
Figure 43. Vestibule and door leading from barn to milk house, facing northwest.

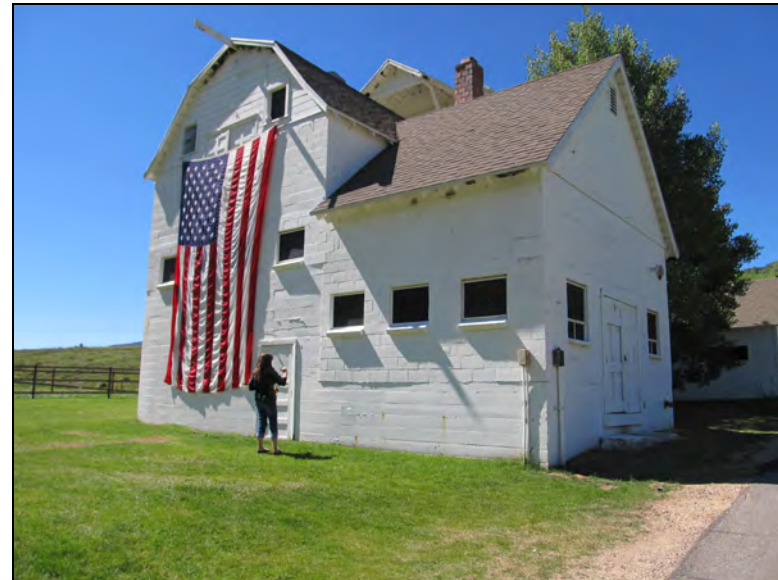
Figure 47. Milking parlor, facing south.

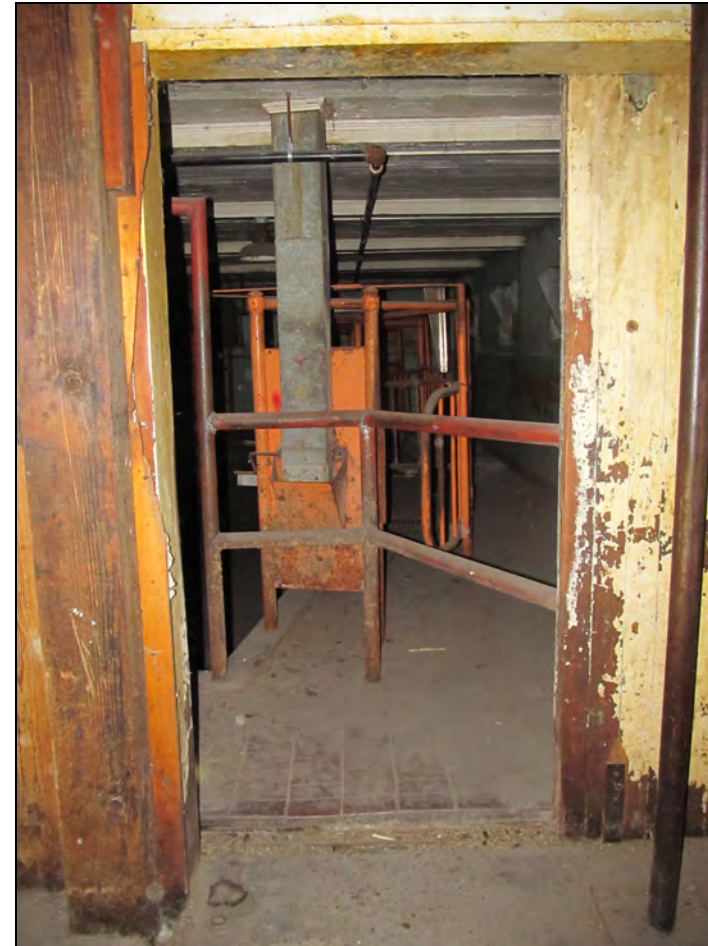
Figure 48. Door in northeast end of barn providing access to milking parlor, facing northeast.

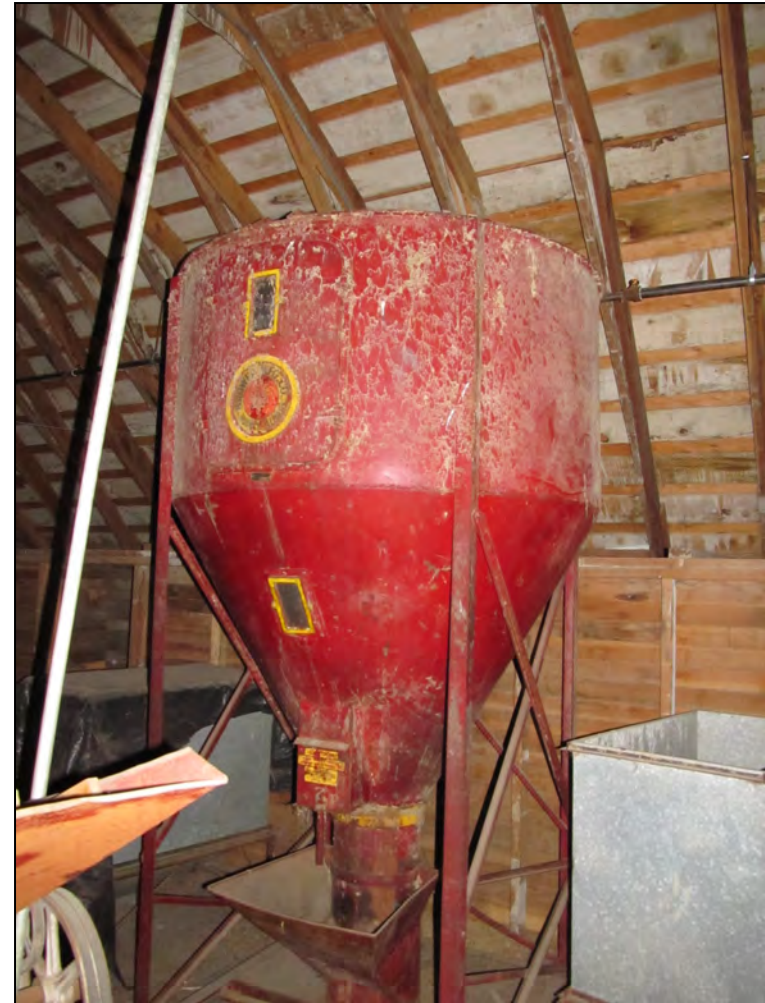
Figure 52. Second floor milking parlor with feeding machinery, facing southeast.

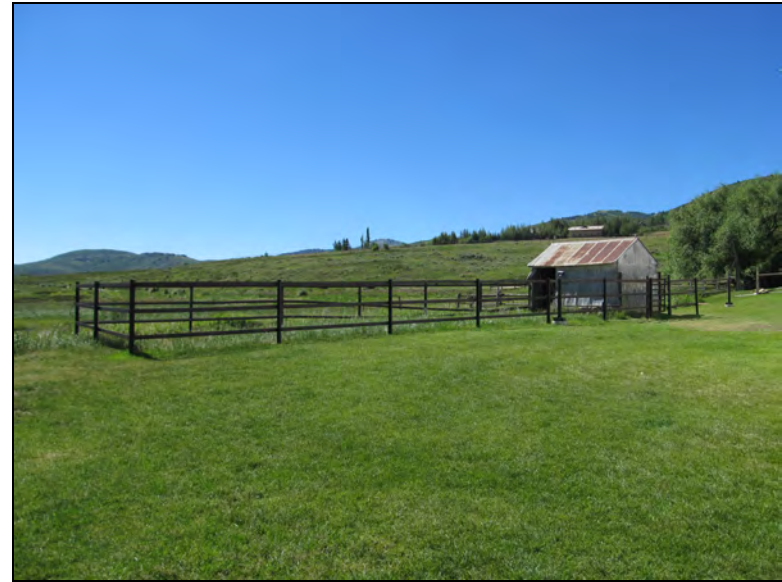
Figure 54. General view of corral with animal shelter, facing southeast.

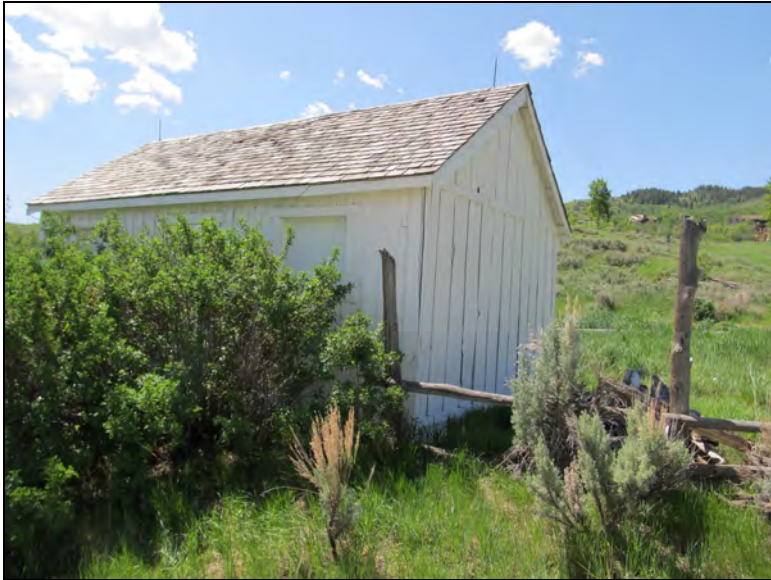
Figure 58. Granary, facing south.

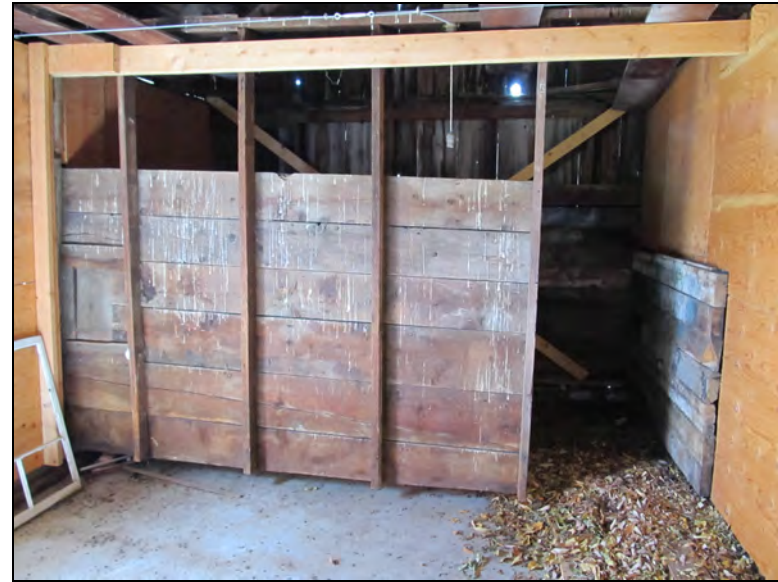
Figure 59. Half wall dividing interior of granary, facing southeast.

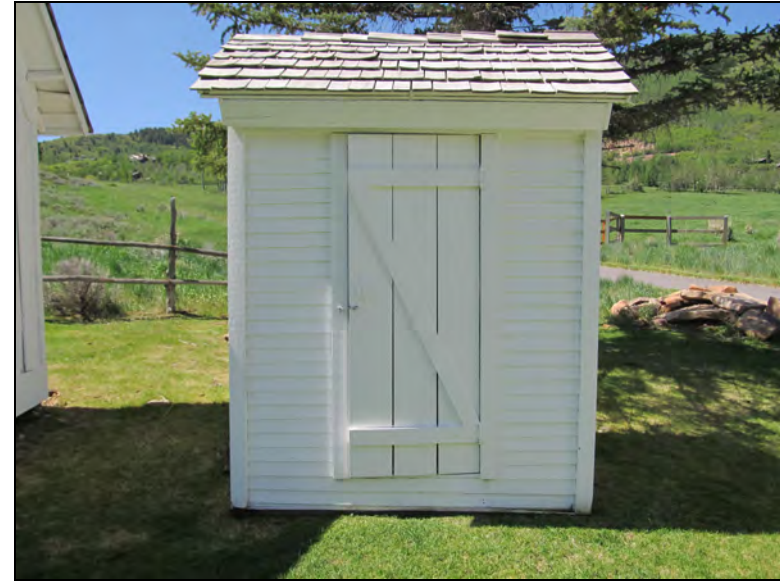
Figure 64. Outhouse, facing southwest.

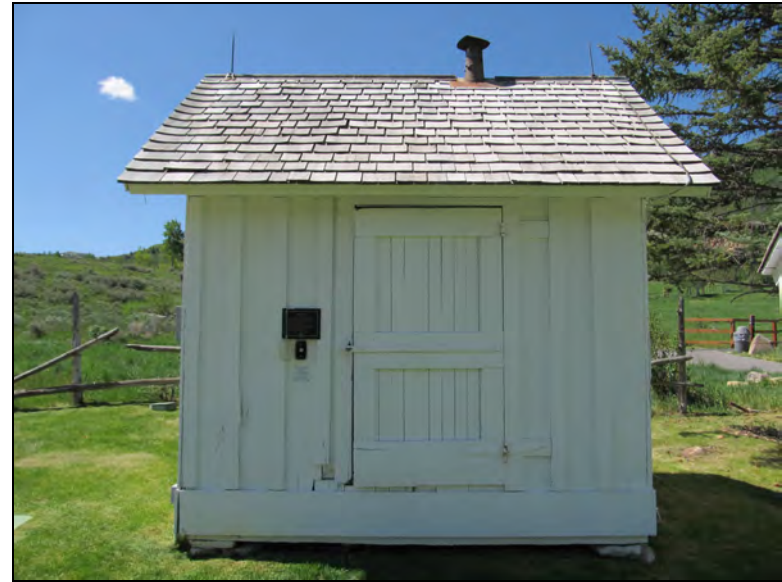
Figure 66. Bunkhouse, facing southwest.

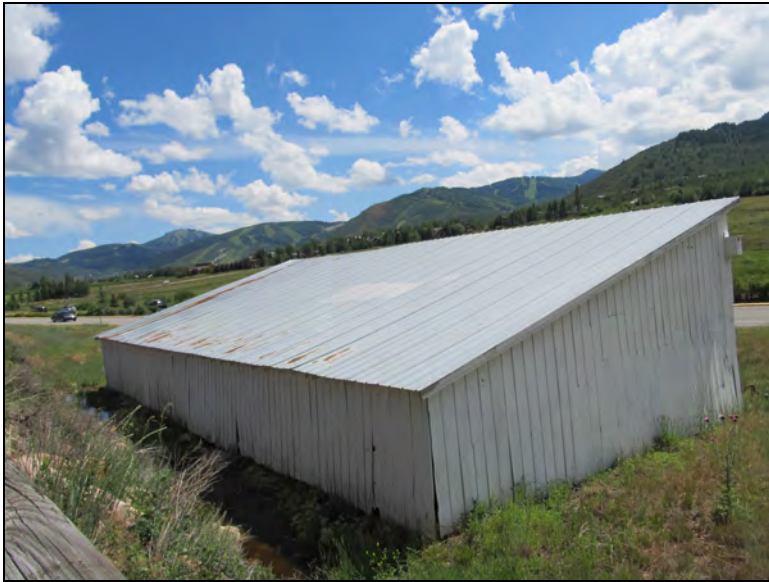
Figure 69. Osguthorpe shed, facing south.

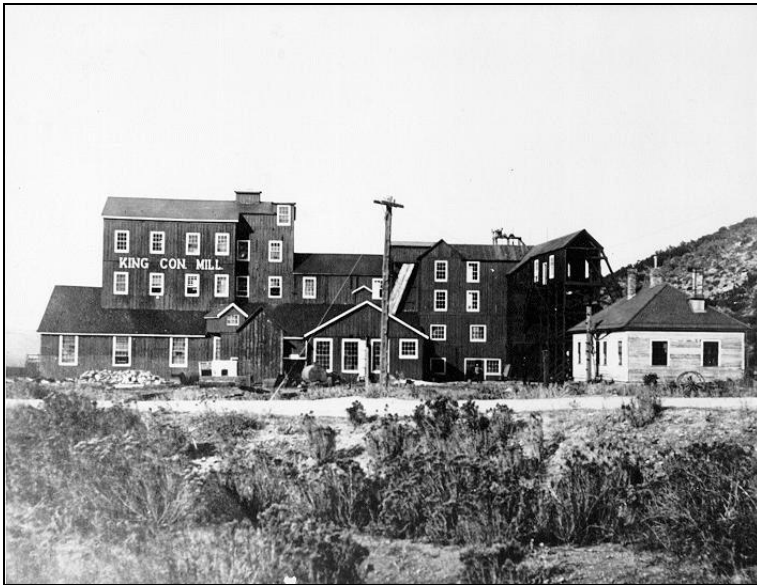
Figure 71. The King Con Mill, formerly the Grasselli Mill, with the main office at right, sometime after 1916. Image no. 19841121. Courtesy Park City Historical Society and Museum.

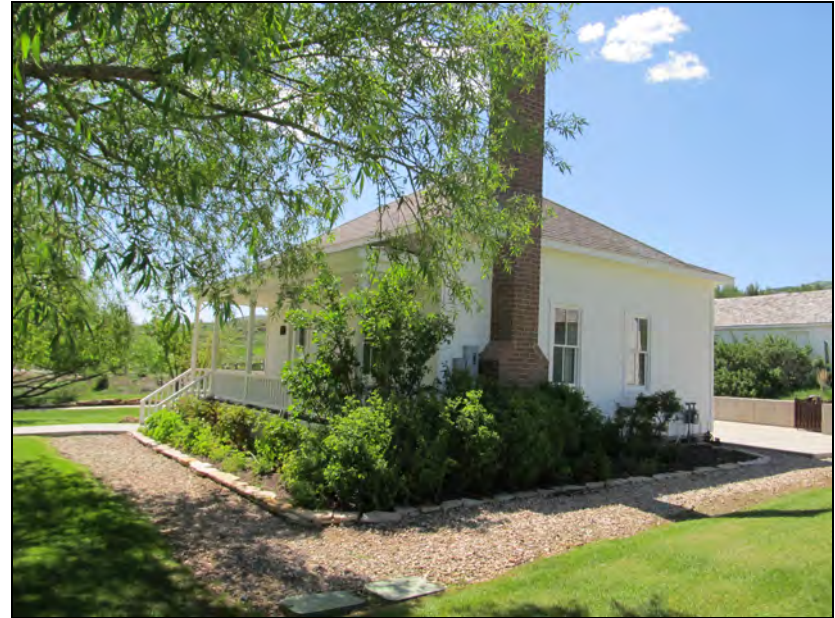
Figure 72. Reconstructed farmhouse, facing south.

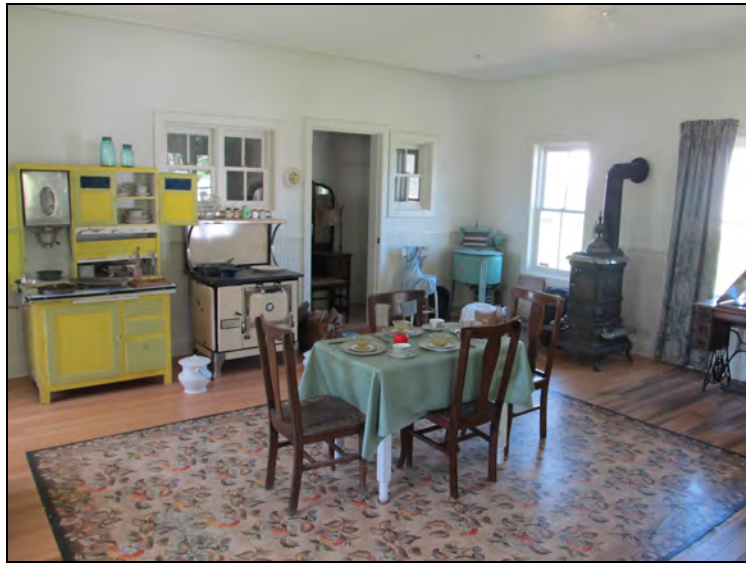
Figure 74. Main room of farmhouse, facing southwest.

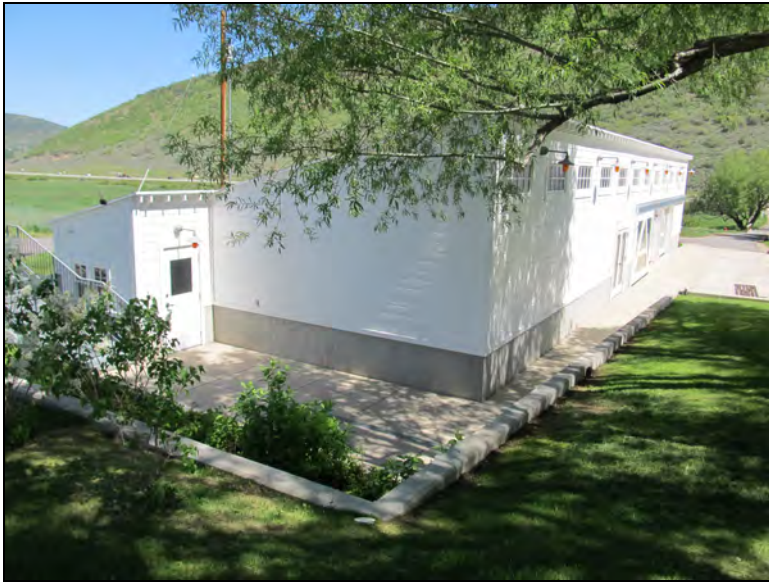
Figure 76. Reception center and locker room entrance, facing north.

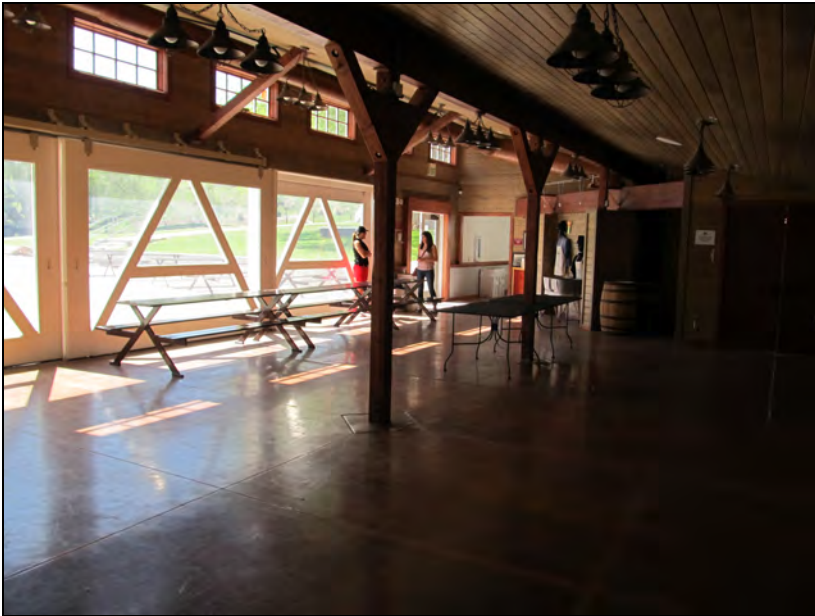
Figure 78. Main room of reception center, facing south.

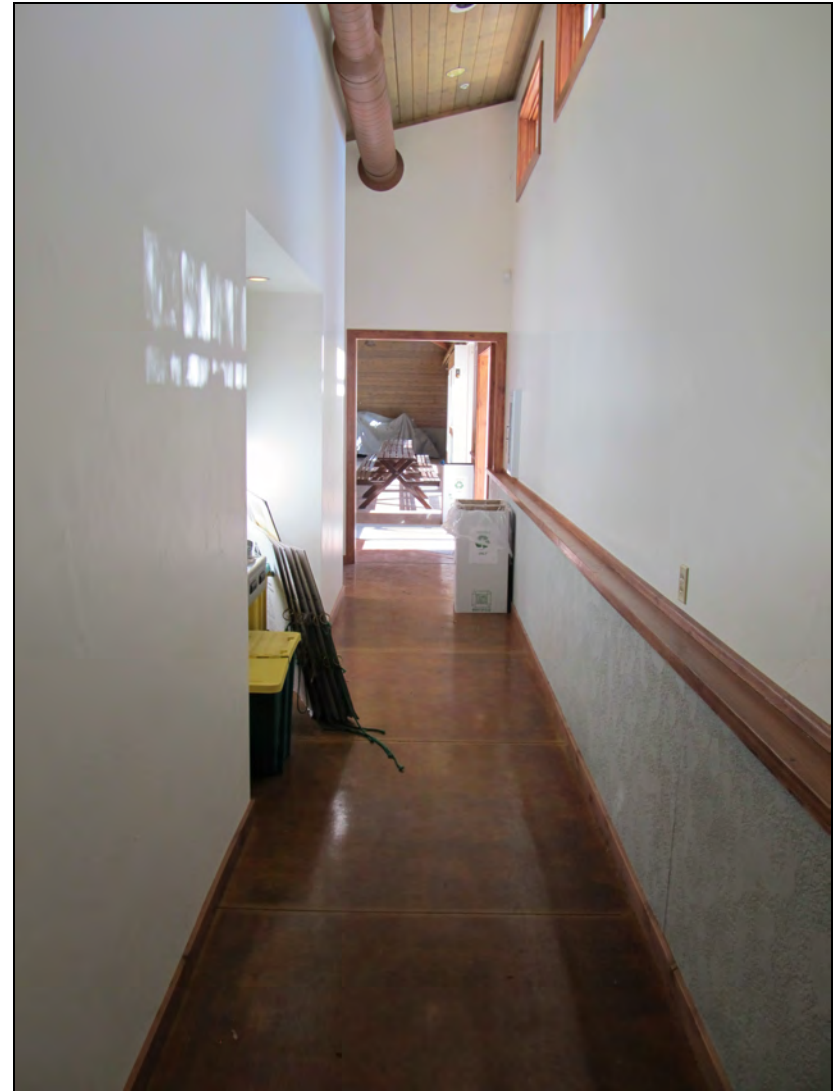
Figure 79. Service hallway leading from main reception room to locker room, facing southwest.

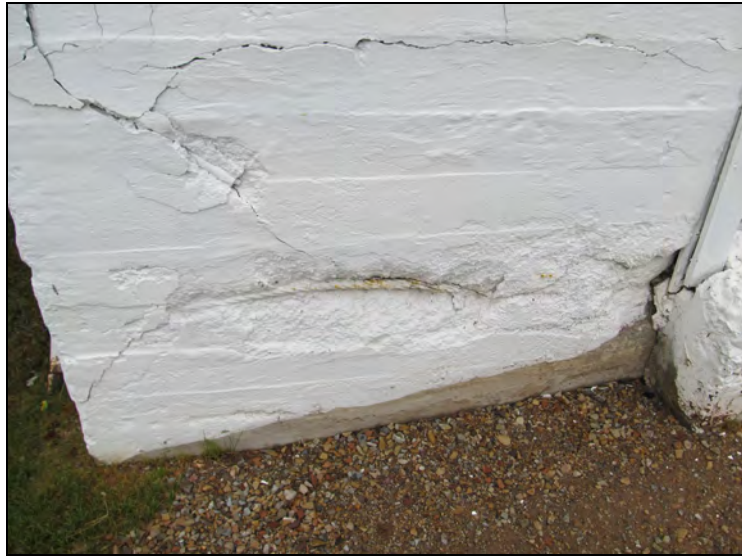
Figure 88. Cracking and spalling concrete on the milk house addition, facing southeast.

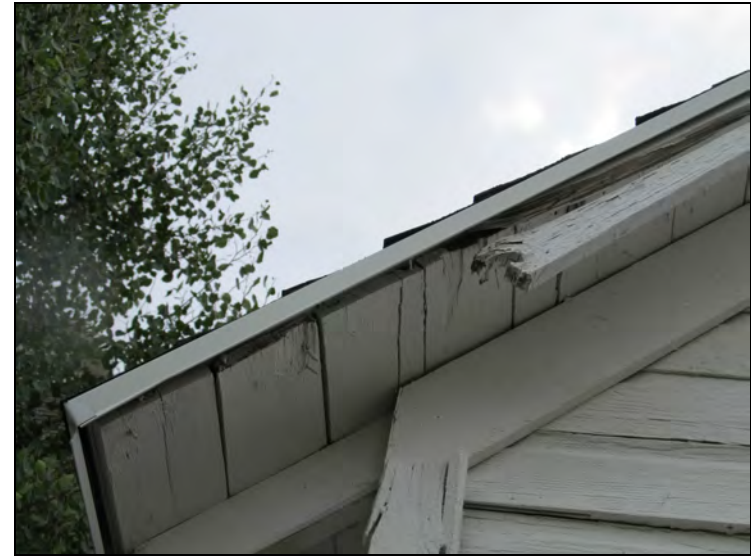
Figure 90. Loss of fly rafter on milk parlor addition due to past wood deterioration, facing southeast.

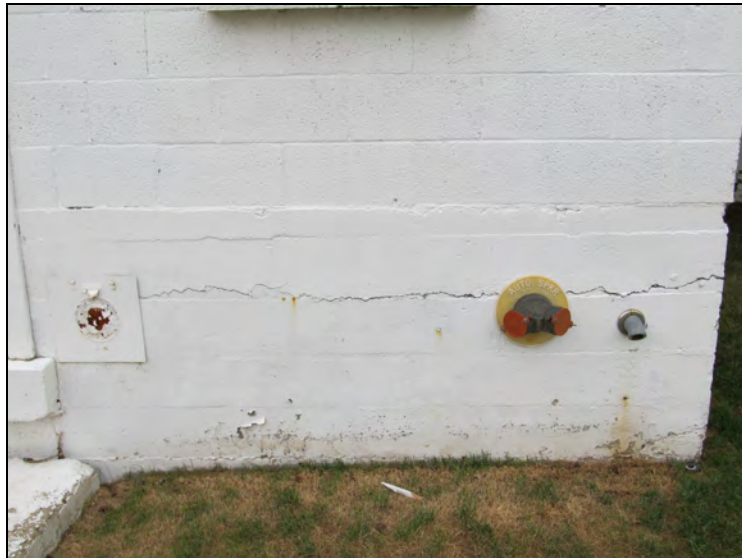
Figure 89. Horizontal crack at base of northwest milking parlor wall, facing southeast.

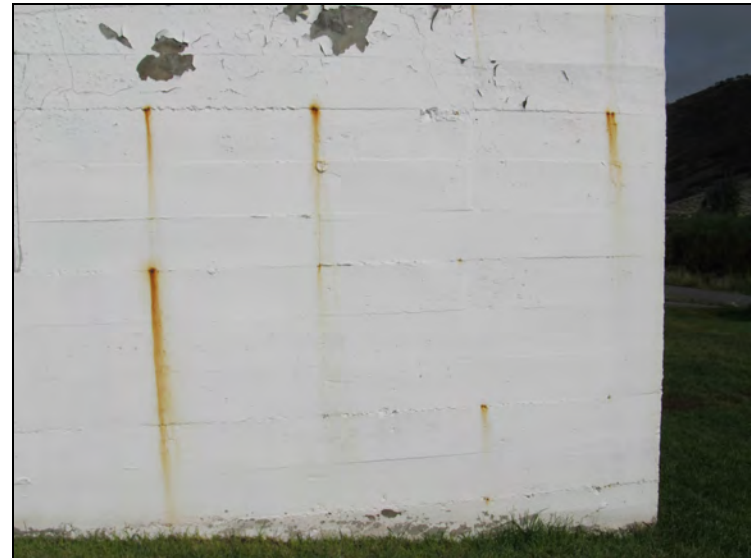
Figure 91. Corrosion and peeling paint on wall of milking parlor due to irrigation system overspray, facing northwest.

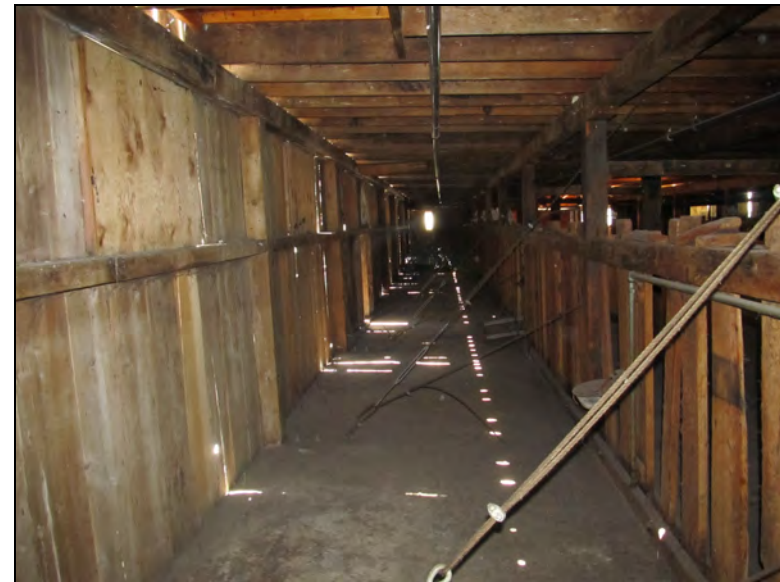
Figure 92. Cable bracing along a side aisle on the main level of the barn.

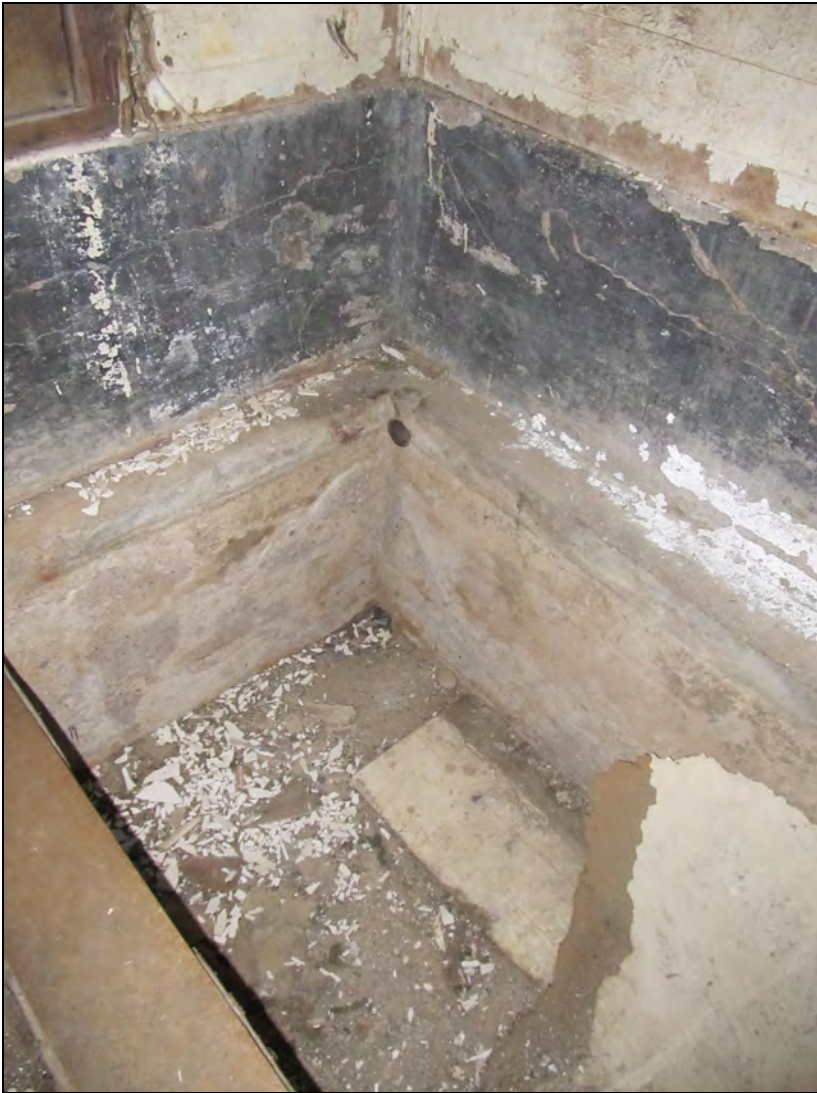
Figure 93. Paint deterioration on concrete walls of milk house interior.

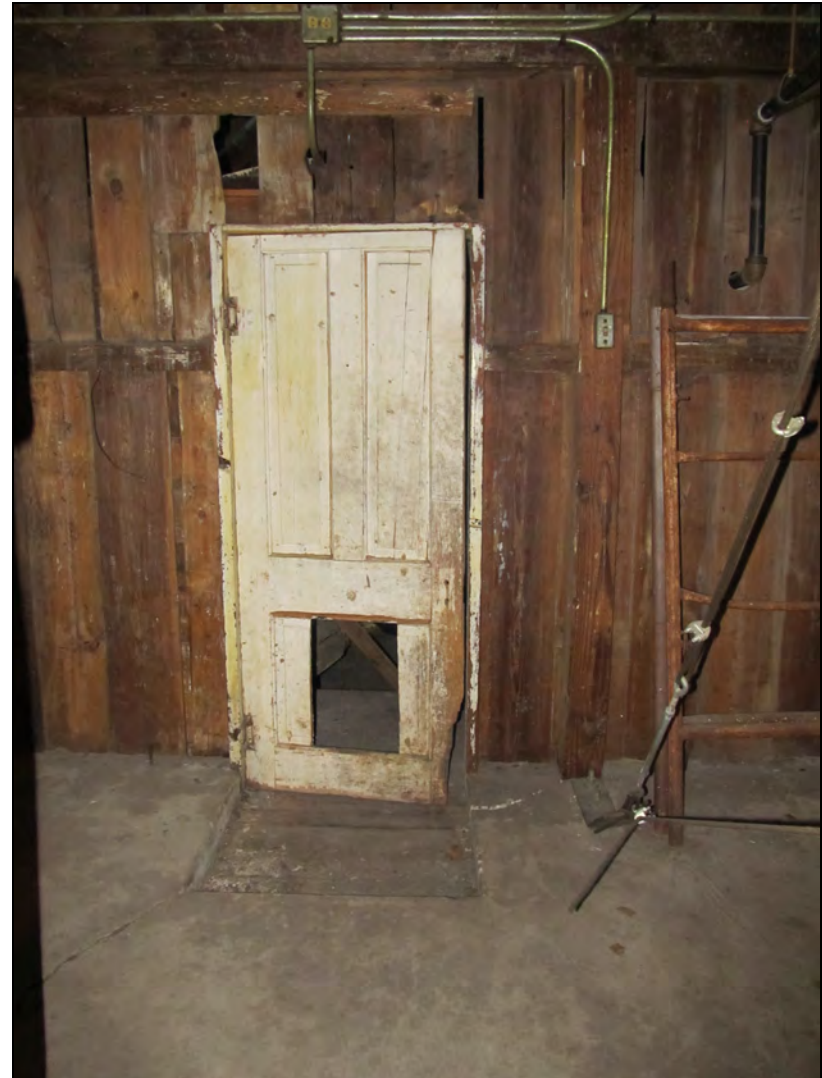
Figure 94. Damaged four-panel door leading from barn to milk house vestibule, facing northwest.

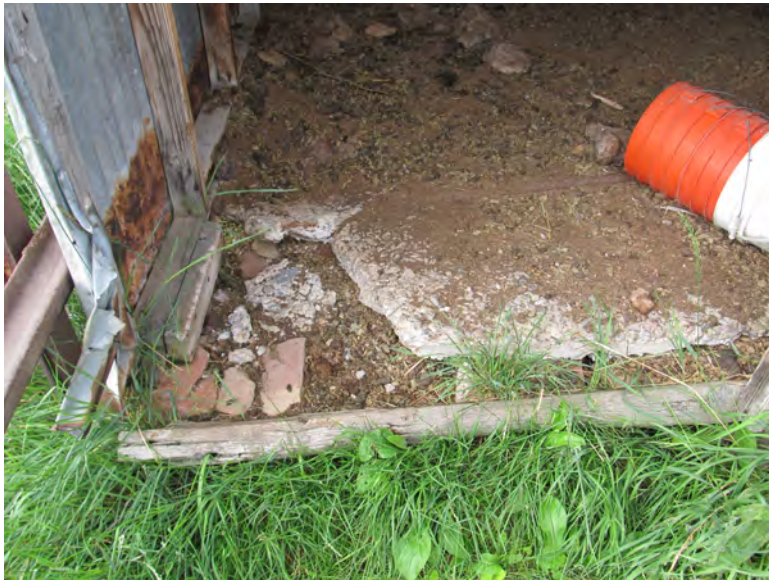
Figure 95. Damaged concrete floor and deteriorated wood sill on northeast side of animal shelter.

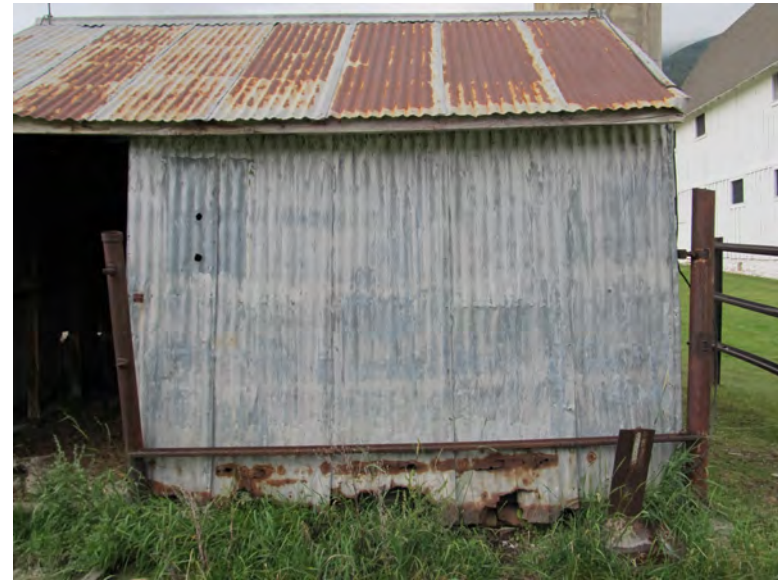
Figure 96. Corroded and detached metal panels on the walls and roof of the animal shelter, facing southwest.

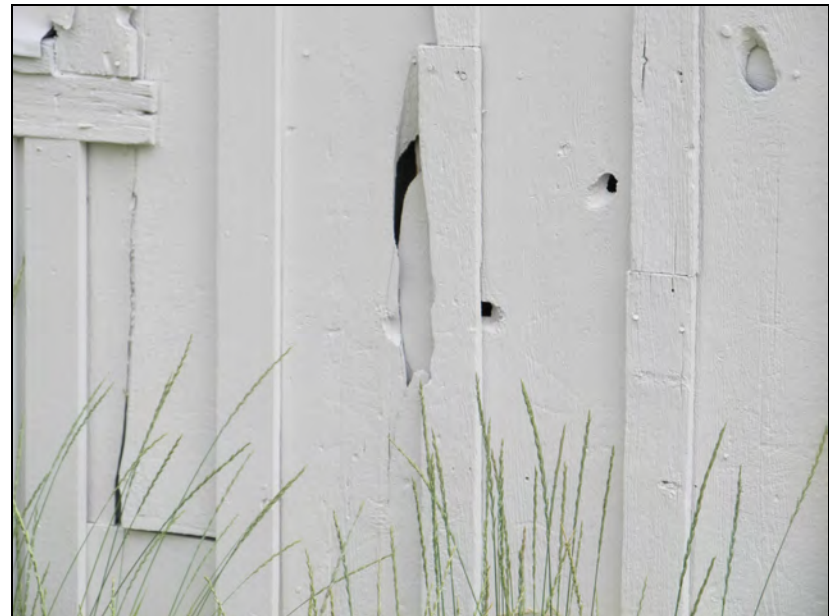
Figure 97. Evidence of past damage and repairs to the exterior board-and-batten walls of the granary.

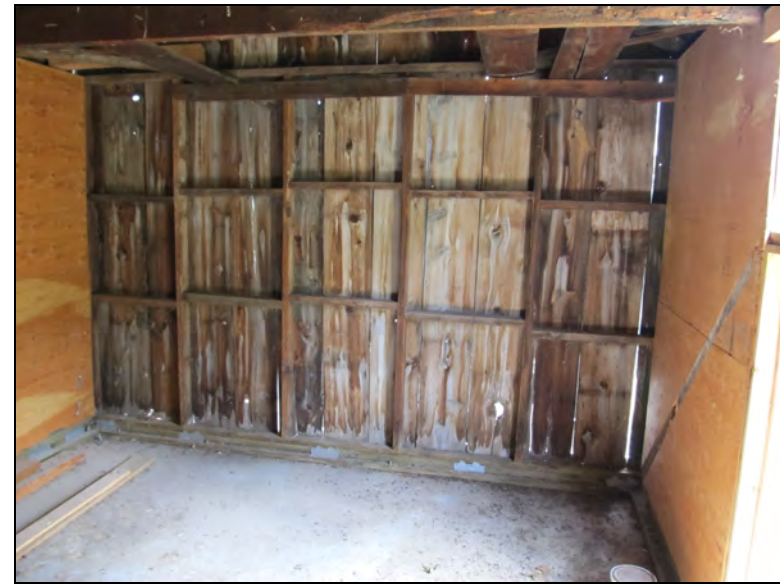
Figure 98. Modern interior plywood sheathing abutting a historic end wall of the granary.

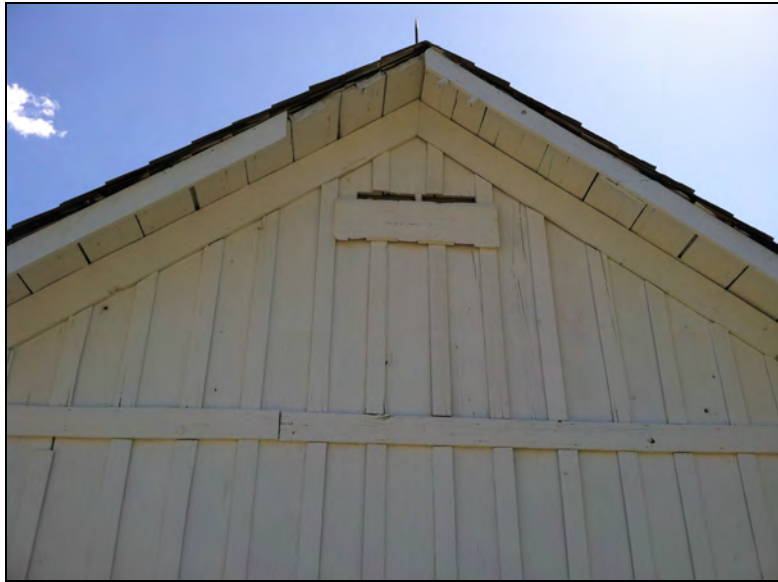
Figure 99. A missing section of fly rafter on the gable end of the tool shed.

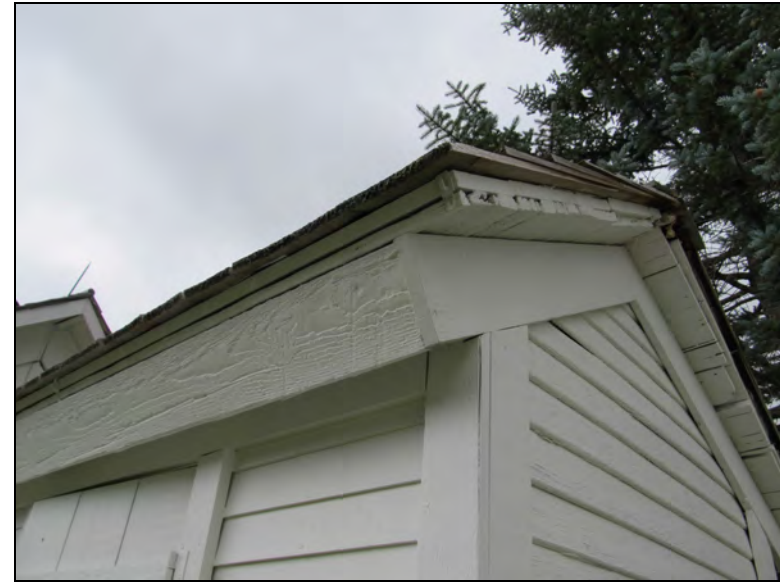
Figure 100. A new fascia board installed when the outhouse was reconstructed, facing south. Past deterioration of the roof sheathing is visible.

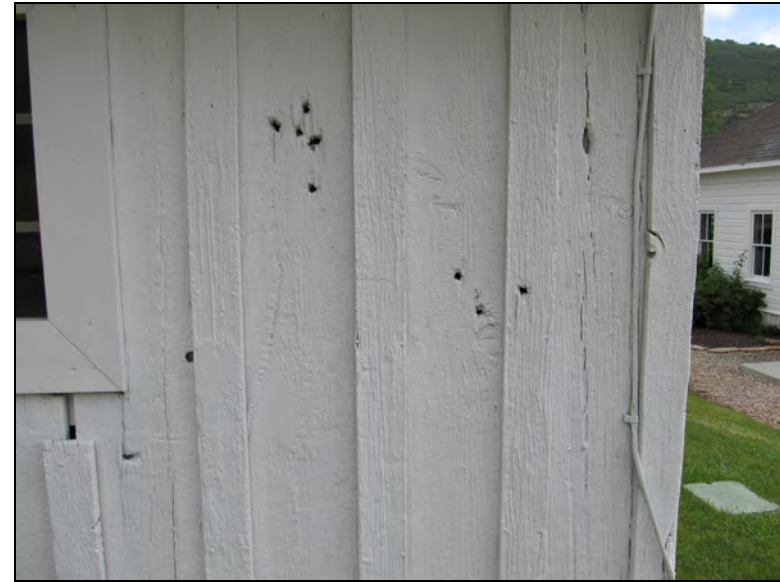
Figure 101. Past damage to the board-and-batten siding of the bunkhouse, facing northeast.

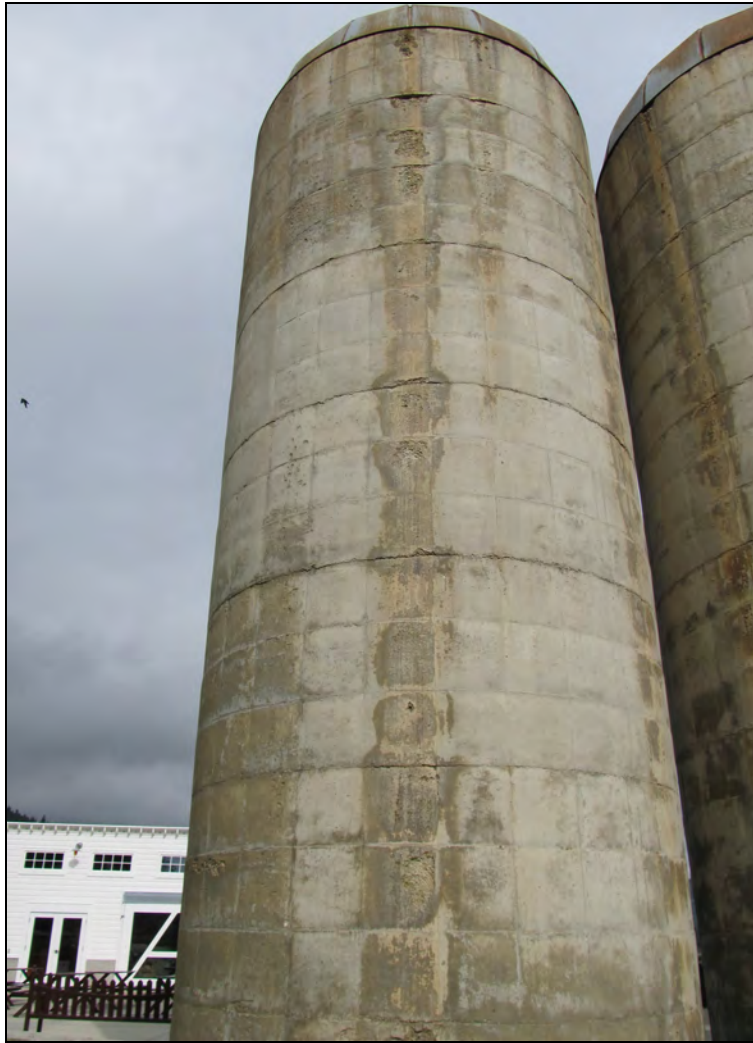
Figure 102. Rain runoff patterns on grain silos have caused some concrete discoloration, spalling, and metal corrosion; facing north.

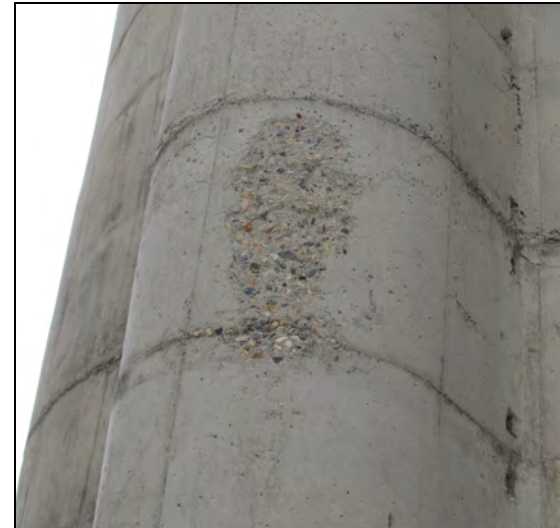
Figure 103. Concrete spalling and exposed aggregate on a grain silo wall.

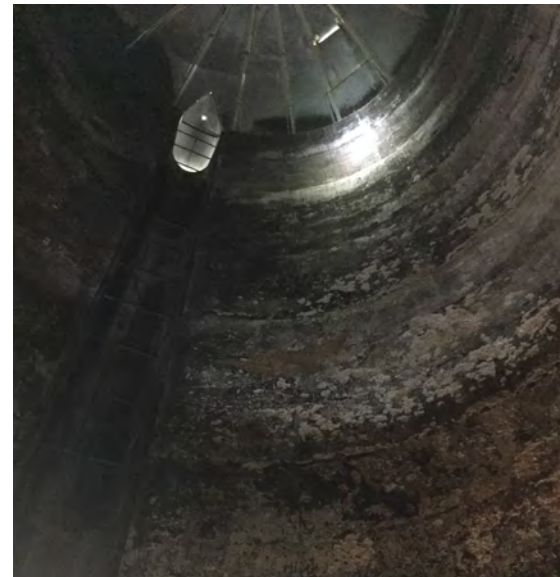
Figure 104. Grain silo interior, looking upward, showing concrete abrasion and discoloration.

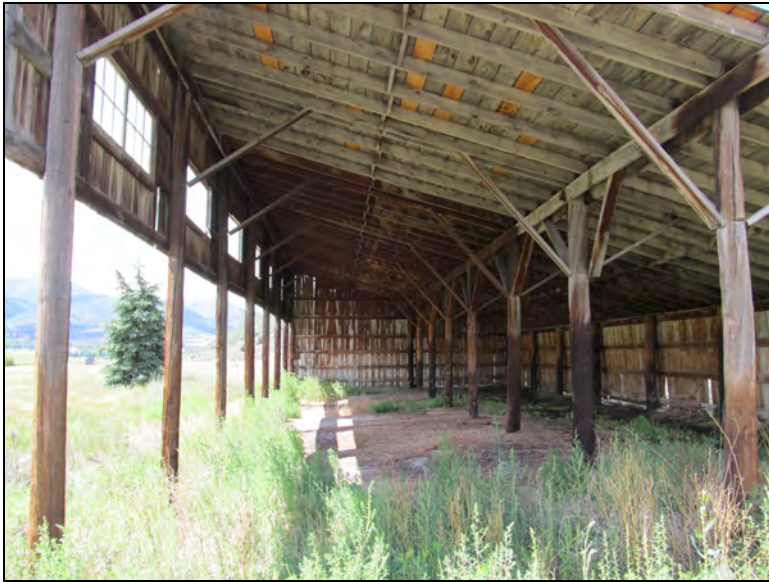
Figure 105. Interior view of Osguthorpe shed showing missing windows, water staining, moisture damage at wall bases, and roof repairs.

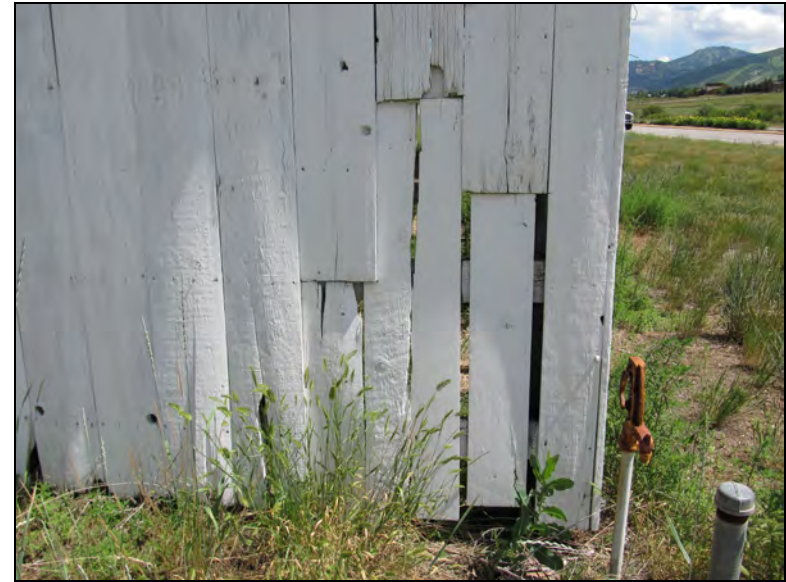
Figure 106. Cracking, rot, and detachment of wood siding on the northwest side of the Osguthorpe shed, facing northeast.
