Planning Department

Historic Preservation Board Staff Report

Author: Hannah M. Tyler, Planner
Subject: Material Deconstruction Review
Address: 1333 Park Avenue
Project Number: PL-16-03378
Date: March 1, 2017
Type of Item: Administrative – Material Deconstruction

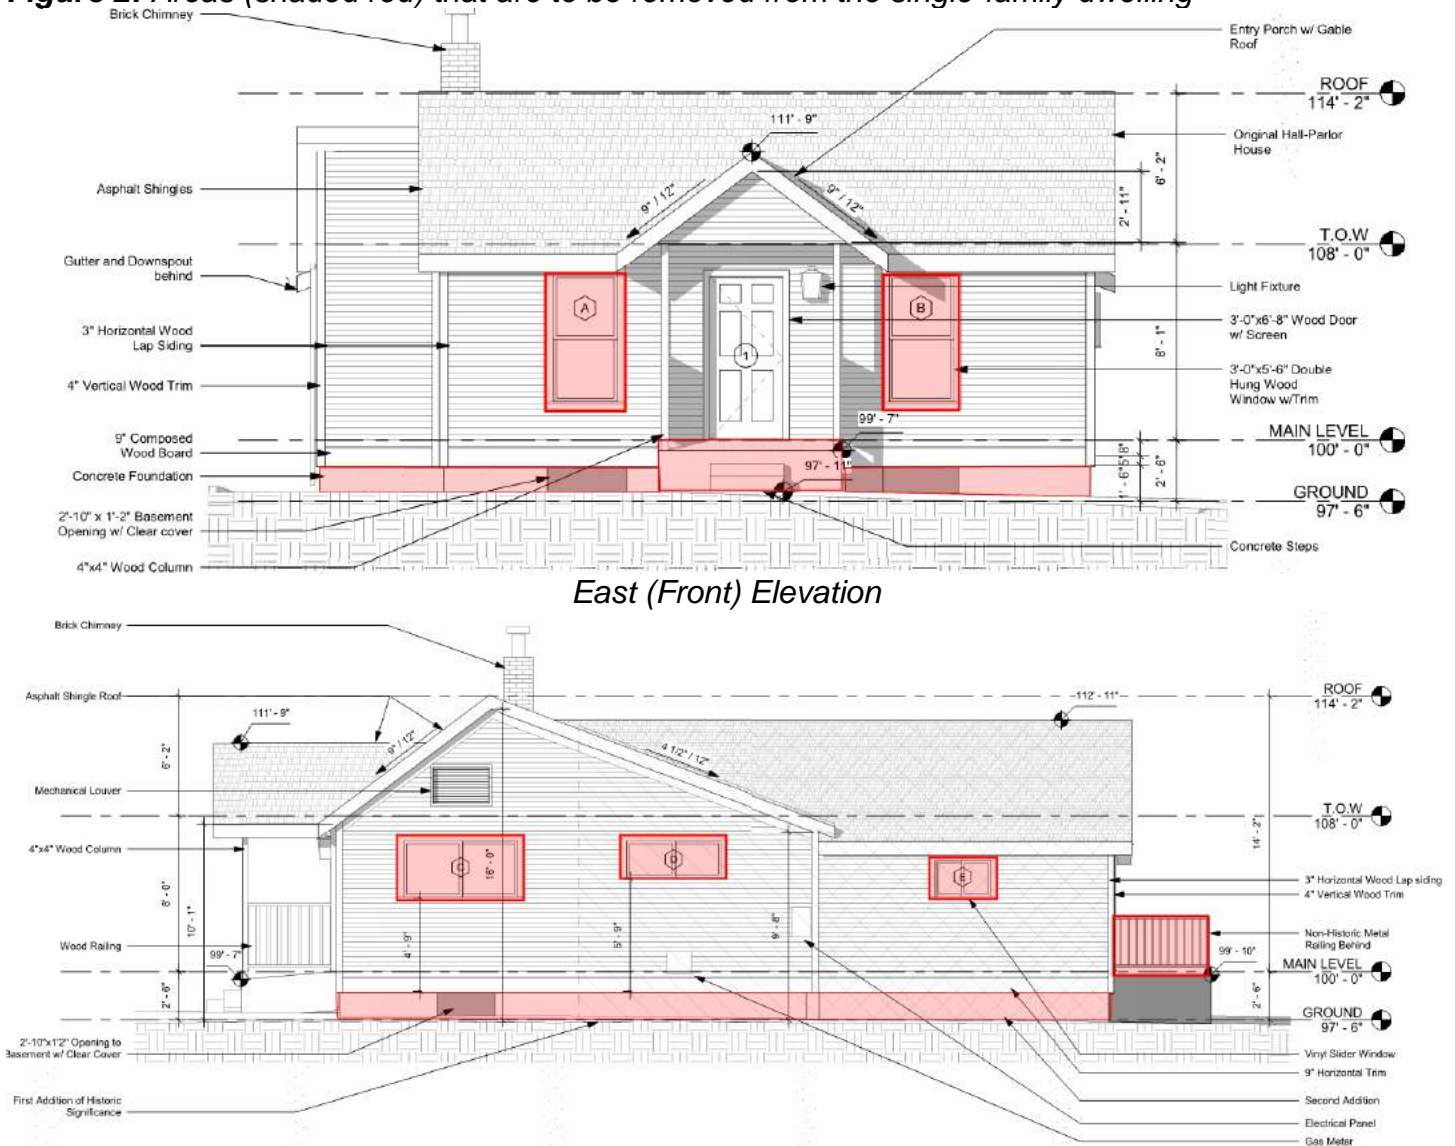
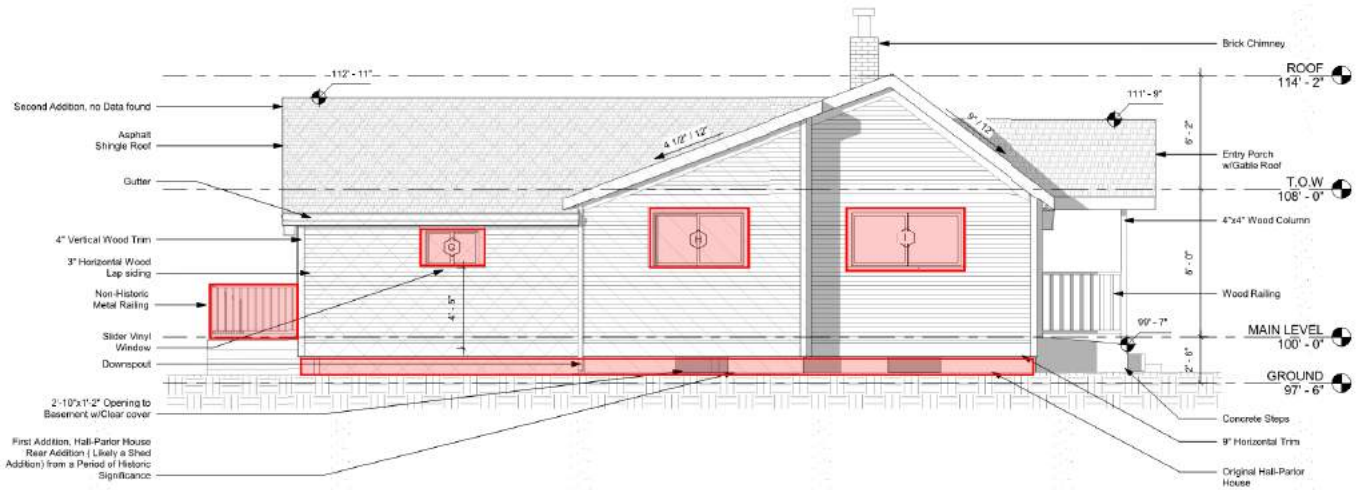
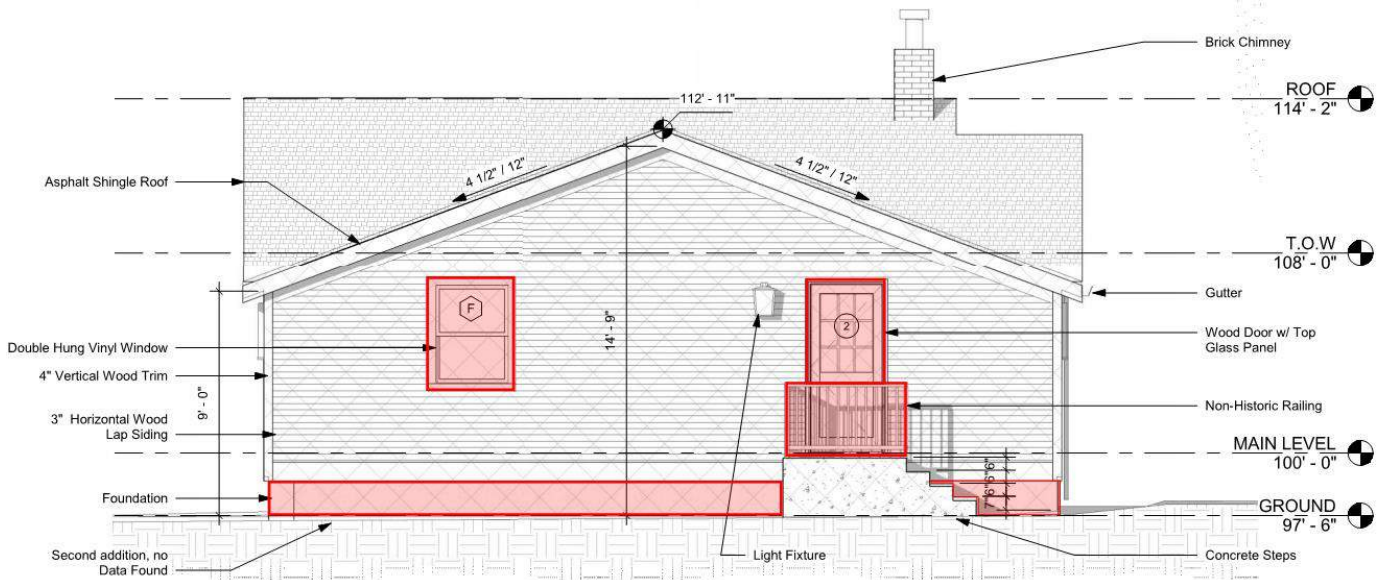
Figure 2: Areas (shaded red) that are to be removed from the single-family dwelling

- Removal of the non-historic windows. Non-historic windows were installed in the 1990s. Replacement windows will not change the dimensions of the existing windows and will be compatible with the historic structure.
- Removal of the non-historic rear metal railing. Non-historic rear metal railing was installed in the 1990s.

- Removal of the non-historic concrete porch landing and stairs. Non-historic concrete porch landing and stairs was installed in the 1990s.
- Repairs to the structurally compromised foundation. The existing foundation has little to no reinforcement within the concrete. The applicant is proposing to temporarily lift the historic structure in order to repair the concrete foundation and replace sections in-kind where necessary. Where replacements and/or repairs occur, the exterior of the foundation will remain historic compatible with the existing structure and existing concrete foundation.

The applicant intends to replace non-historic materials with historically compatible materials. Staff finds that the removal of the proposed non-historic materials will assist in restoring the single-family dwelling to its Historic Form because the existing non-historic materials are incompatible and/or beyond repair. Figure 2 identifies the areas that are to be removed (red shaded areas) on the single-family dwelling.

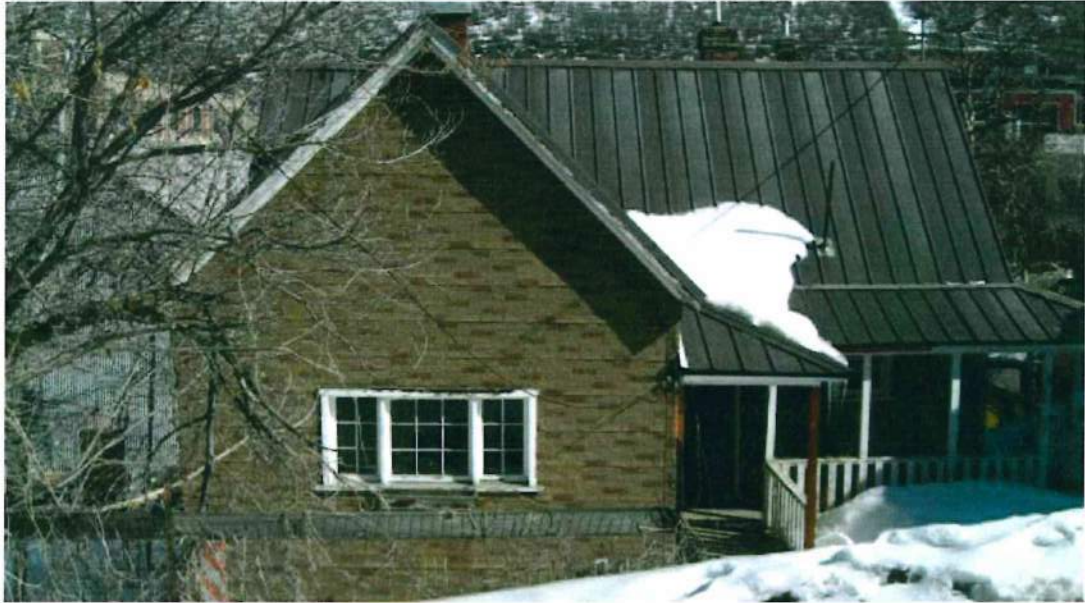
Photo #1: East Elevation

Several of the wood porch posts and horizontal members have been replaced. The new wood porch posts and horizontal members are unpainted. The remaining historic wood railings and balustrades, porch posts, porch ceiling, roof structure, and horizontal members are missing paint. The fascia board at the connection between the east facade gable and porch roof is rotted and damaged. Wires are hanging/detached near the east facade gable and porch roof connection on the east facade. The flashing between the main roof and the porch roof is showing signs of rust.

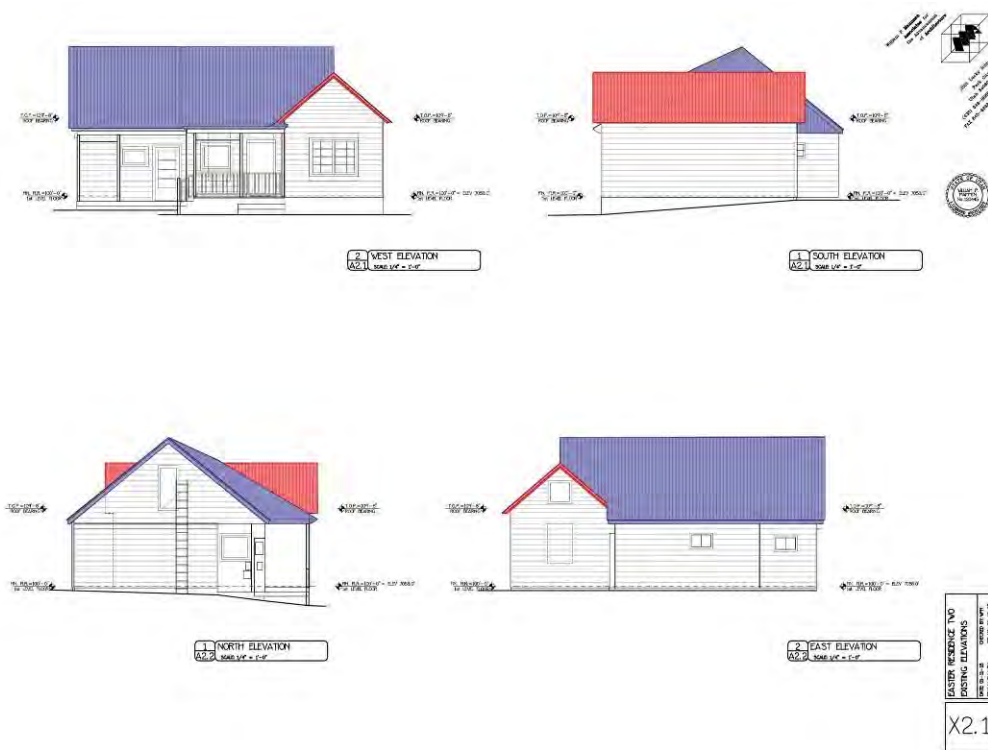
The applicant is proposing to rebuild the roof structure. The applicant will use the original roof framing beneath the 1941-1949 roof form to accurately depict the original roof dimensions. He will also rely on the geometry of the original gable forms to accurately depict the slope of the roof. The fascia will be replaced at this time as it has largely dry-rotted.

The blue highlighted roof forms represent the c.1941-1949 new addition and construction of a new roof form above the c.1906 original cross-wing form. The red highlighted roof forms represent those portions of the original c.1906 cross-wing that will need to be reconstructed based on physical evidence.

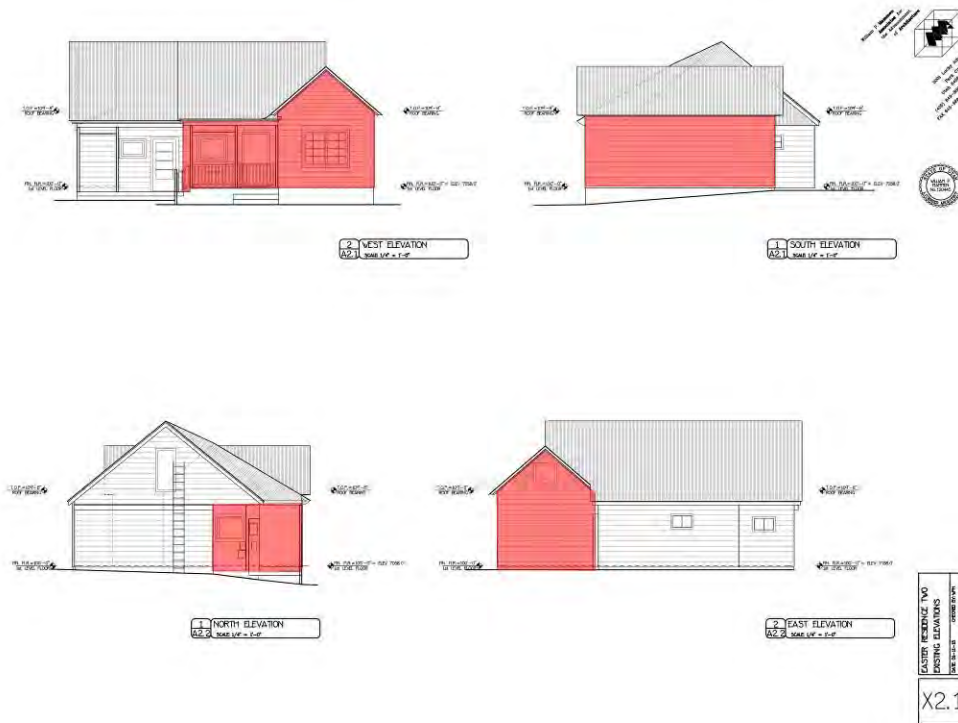
match and replaced damaged portions of the siding. Most of the damaged siding is on the non-historic additions.

The highlighted red walls show those areas where the asbestos and cement siding will be removed in order to restore the original wood drop-novelty siding.

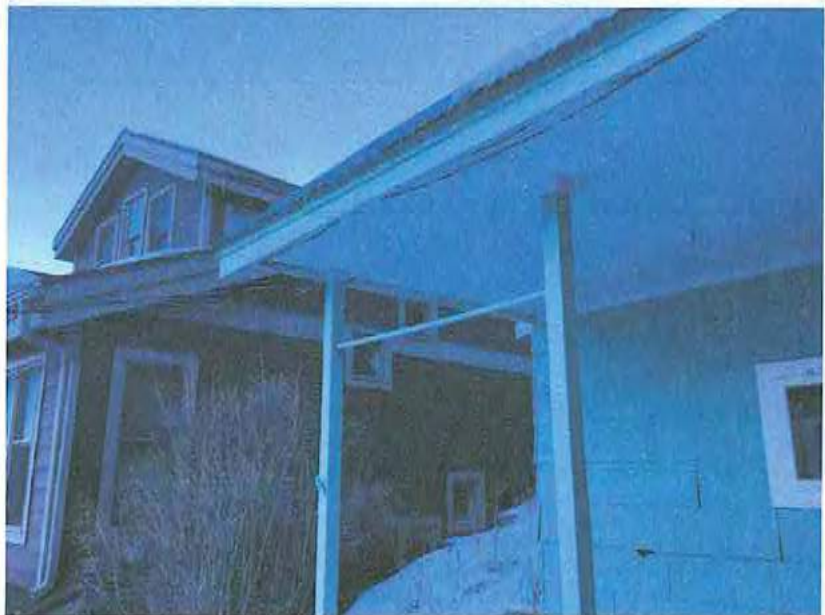
The existing porch on the north end was added in the 1970's. The construction is not sympathetic to the historic nature of the original house.

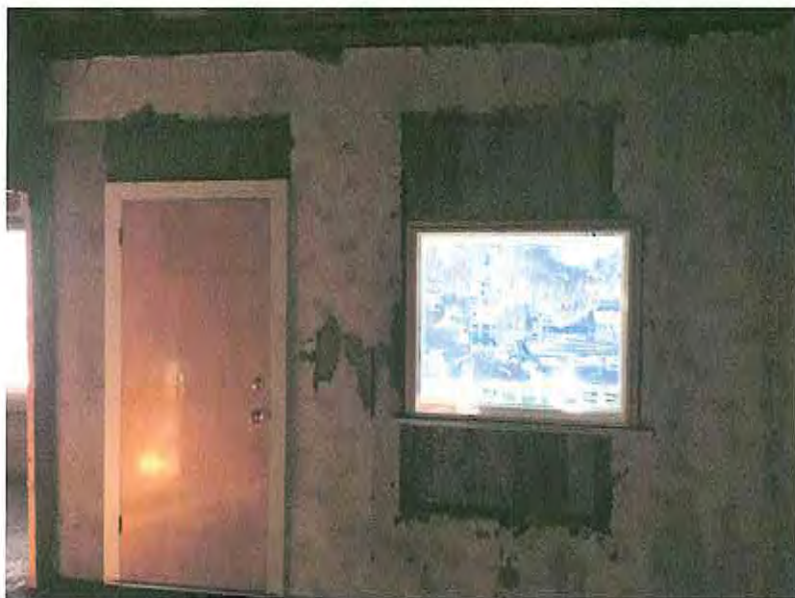
The location of the historic front door and windows. The construction is not sympathetic to the historic nature of the original house and the opening sizes have been modified .

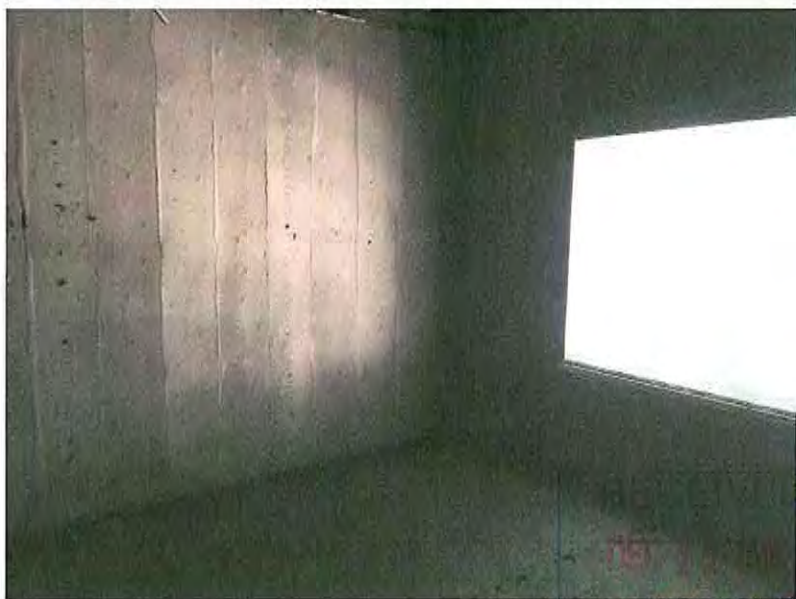
Inside the front room it is evident that the front windows have been changed.

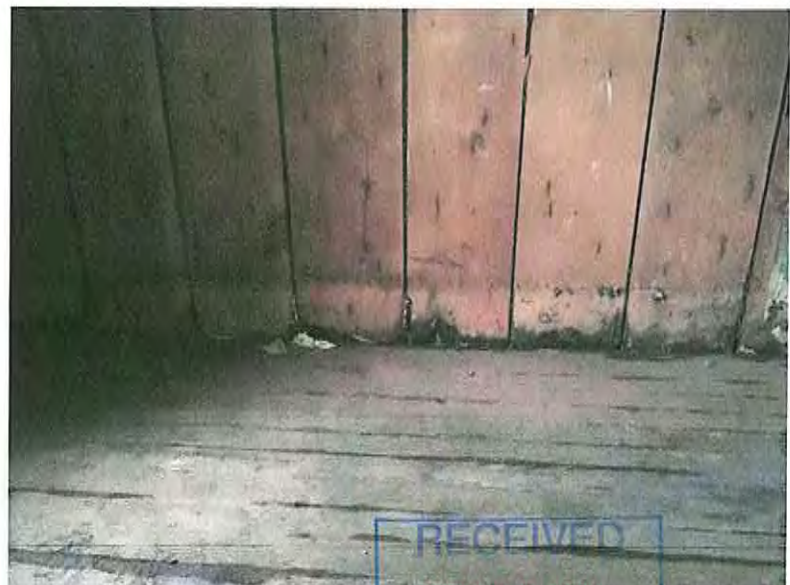
This photo shows how the original 1906 walls are beginning to rot at the floor line where the finish grade on the exterior is higher than the floor elevation.
