**PARK CITY PLANNING DEPARTMENT  
STAFF REPORT**

TO: HISTORIC DISTRICT COMMISSION  
FROM: PLANNING STAFF  
DATE: MAY 20, 1996  
RE: 332 DALY AVENUE - CERTIFICATE FOR APPROPRIATENESS FOR  
DEMOLITION

# PHYSICAL CONDITIONS REPORT

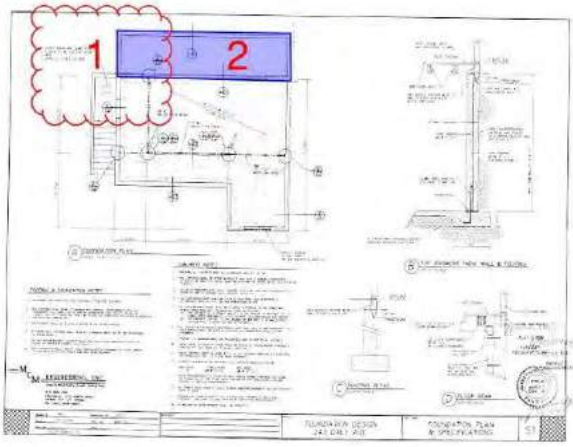
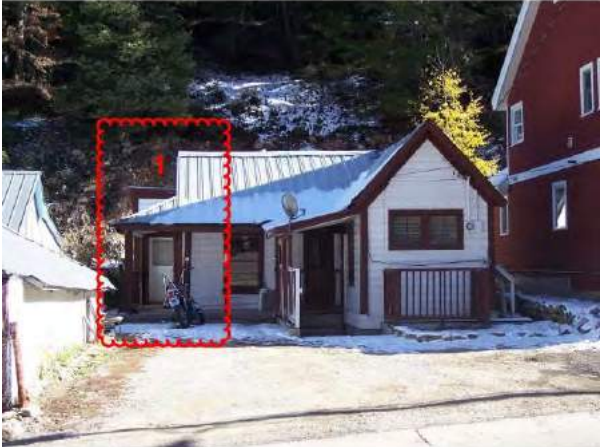
<p><b>1998 Building Permit Plans</b></p> <ol style="list-style-type: none"> <li>Shows the area where the side addition should appear.</li> <li>Is the non-historic addition off the rear elevation that exists today.</li> </ol>	<p><b>2009 Photograph of the House.</b></p> <p>The area clouded as 1 is the rear addition. A similar shed addition appears in the c.1941 tax card, but it is unclear whether or not this is the same addition.</p>

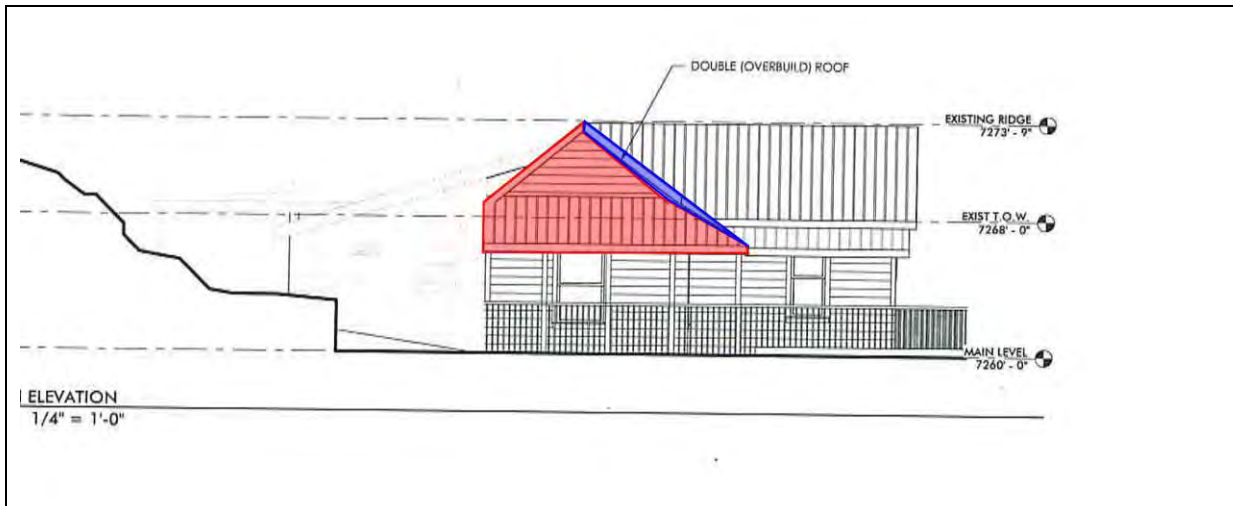
The roof structure consists of 2x4 trusses with 1x8 collar ties at 24" on center. There is an overbuild on the west side of the roof beginning at the ridge and continuing down to the edge of the porch which is not historic. This main roof form is undersized and will require additional stabilization to ensure it complies with current IBC requirements. The porch roof is failing due to the additional weight of the roof overbuild and will need to be reinforced.

*This drawing of the North Elevation shows the overbuild of the roof structure. The original roof (highlighted in red) consisted of a gable with wrap-around porch. Sometime after the c.1941 tax photograph, a new shed roof was constructed over the original gable and porch roof to create the overbuild.*

Staff finds that the roof may be able to be reinforced from the interior once the additional strain of the overbuilds have been removed. This would preserve the original materials and prevent the entire roof form from having to be reconstructed; however, staff also recognizes that additional work may be required due to the poor condition of the original roof form. For that reason, staff has added the following Conditions of Approval:

*#3. Should restructuring the roof from the interior not be possible due to the condition of the existing roof structure, the applicant shall schedule a site visit with the Chief Building Official and Planning Director to evaluate the condition of the roof structure. The applicant shall also submit a structural engineer's report to the Planning Director outlining the defects in the roof that prevent the new*

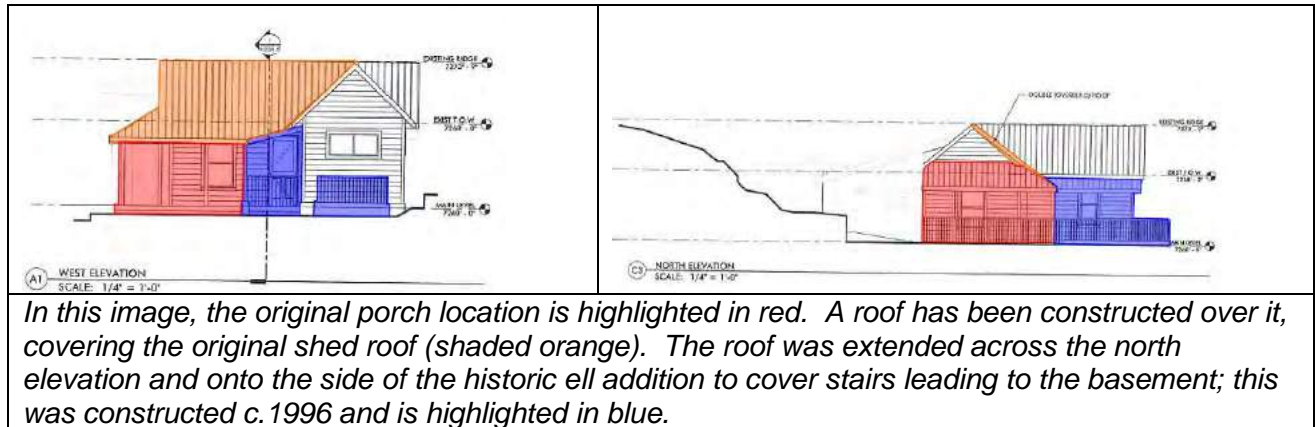
Existing porch floor is the new c.1996 concrete floor over the basement; it likely replaced an original wood deck. The porch posts are consistent in their location to those seen historically, however, overloading on the roof has caused them to be structurally unsound and require replacement. The porch railing consists of vertical 2x2 picket railing, but only around the non-historic c.1996 exterior basement stairs and north elevation of the wrap-around porch. The original porch roof has been modified; the original slope of the roof was built over with a new roof that extends from the top of the original ridgeline to the outside of the porch. The ceiling of the porch has been modified and covers the original open ceiling of the porch; these later additions have settled and are at varying slopes.

The roof structure will be reinforced and returned to its original form by removing overbuilt which exists over the original slope. The applicant proposes to remove structure added beneath the porch ceiling. The non-historic roof over the existing stairs will also be rebuilt to correctly tie into the reconstructed historic roof and correct drainage at the intersection with the historic porch. New railings will wrap the basement stairs. The historic porch will be reconstructed with new posts.

Staff finds that the proposed material deconstruction is required for the restoration of the original porch. Years of alterations have caused the materials to be replaced over time and settle at different rates. The introduction of an exterior basement stair in 1996 required an extension of the porch to protect the stairs from the elements. As the current owner is not proposing to modify the foundation, staff finds that reconstructing the porch roofs in a shed configuration is appropriate to maintaining the look and feel of the original porch structure.

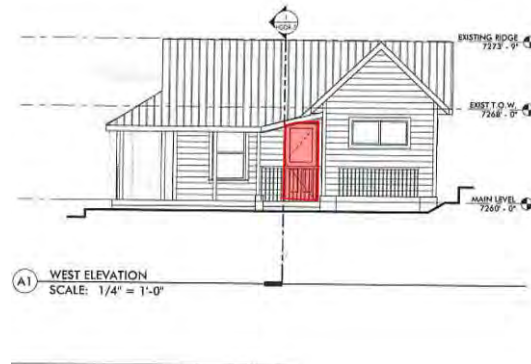
The applicant is proposing to remove the historic door on the front façade. The door is not a standard height and the frame has warped. The applicant has requested that they be able to expand the door opening to install a new IBC-compliant door. The original door opening is shaded in red below:

In the past, the HPB has been consistent about enforcing Specific Design Guideline B.4.1 which requires that historic door openings, doors, and door surrounds are maintained. Staff has added Condition of Approval #5 to address this issue:

*#5. The applicant shall maintain the dimensions of the extant historic door openings. The new door shall be consistent with historic door styles.*

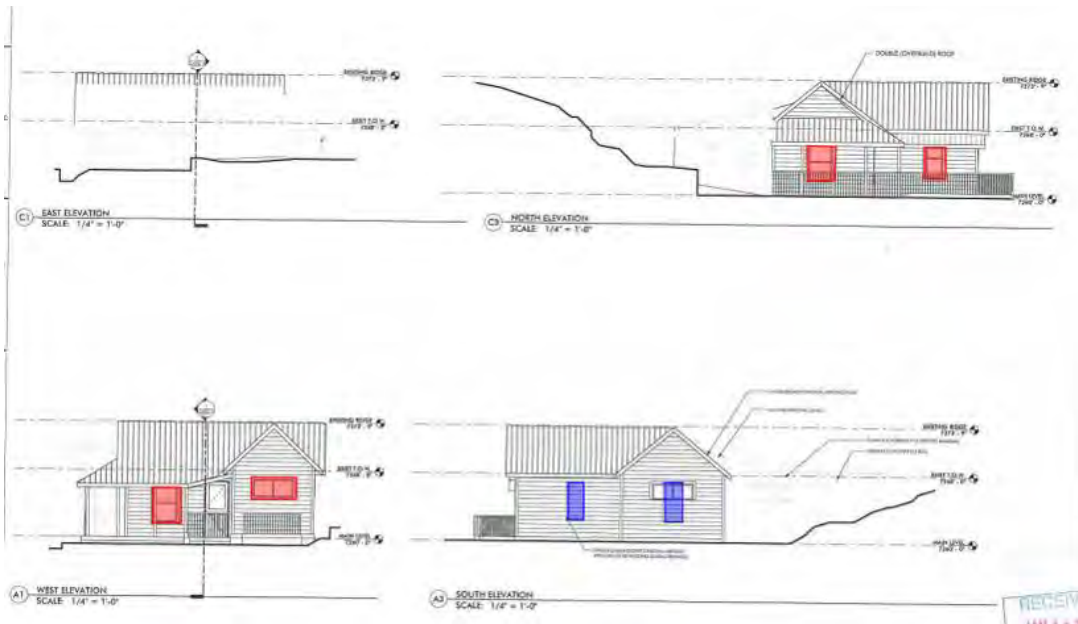
The existing windows are in poor condition and were added at multiple times. The frames are warped, the tracks don't allow for operation, the hardware is failing, and many were installed poorly to begin with. The applicant is proposing to replace the existing windows with new windows that match the historic window opening sizes. American Heritage Window Rebuilders has assessed the windows and found they are beyond repair (see Exhibit F). On the south elevation, windows have been covered and replaced with new sliding windows; the applicant is proposing to restore these original window openings. Staff has highlighted the original windows to be replaced in red and the original window openings to be restored in blue:

Staff finds that the proposed material deconstruction is necessary in order to restore and rehabilitate the house. Staff has added the following Conditions of Approval to ensure that the replacement windows will not detract from the architectural integrity of this structure:

*#6. Historic window openings shall be maintained where existing and restored where they have been lost. The applicant shall replace the historic windows with new wood windows that match originals in all respects: size, dimensions, glazing pattern, depth, profile, and wood material. Special consideration shall be taken to ensure historic trim that has deteriorated beyond repair is accurately reconstructed around the new window units.*

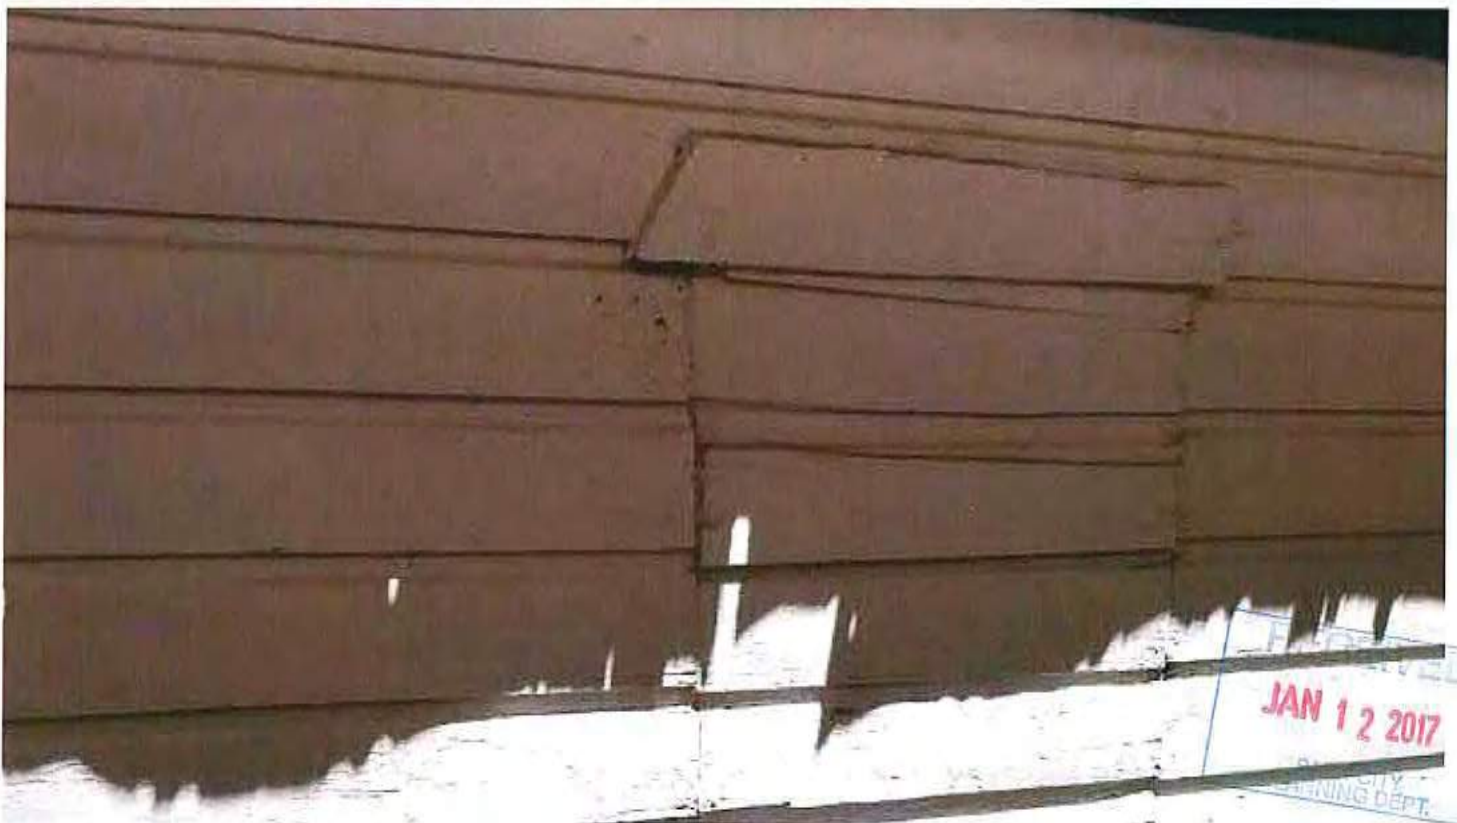
Photo #6: Infilled Window

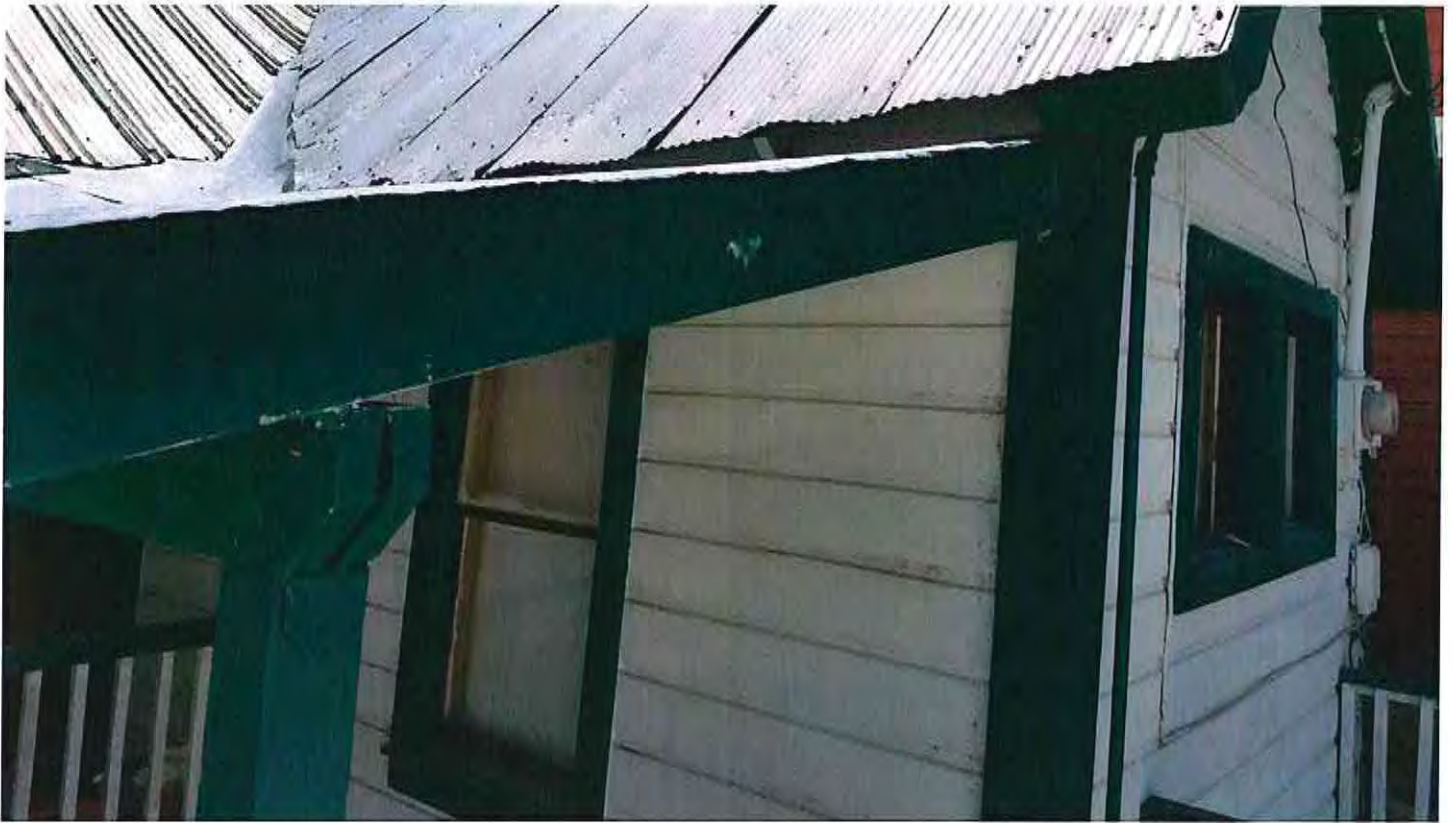
During the c.1996 renovation, a second east-west porch roof was improperly constructed to cover the new exterior stairs to the basement. Because of its weak connection to the main roof form, it is now failing due to the stress of both the historic structure and the supporting columns. Snow and ice buildup have added weight to this structure and caused additional deterioration.

Photo #11: Roof to Roof Connection

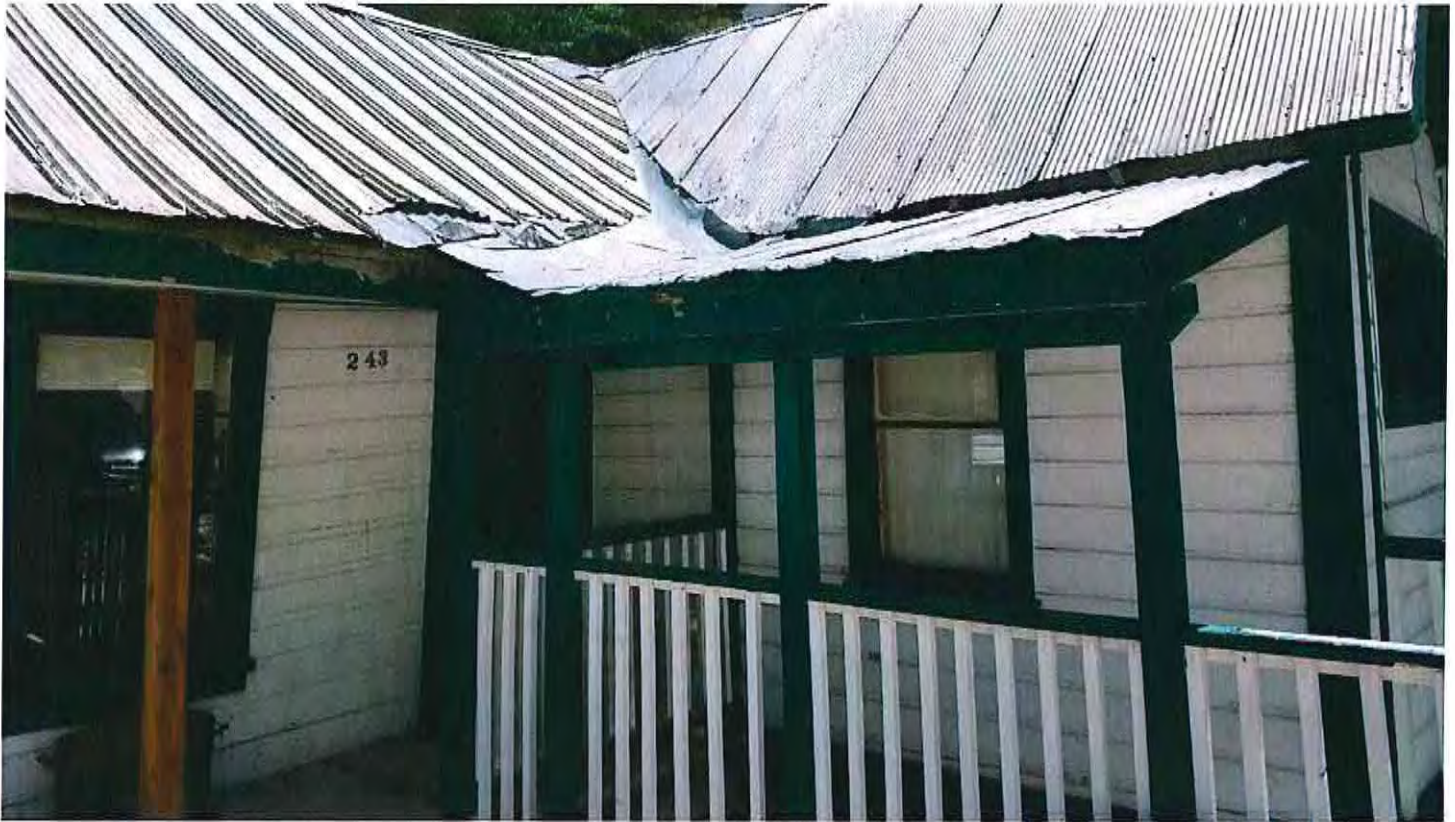
Photo #13: Roof Cricket

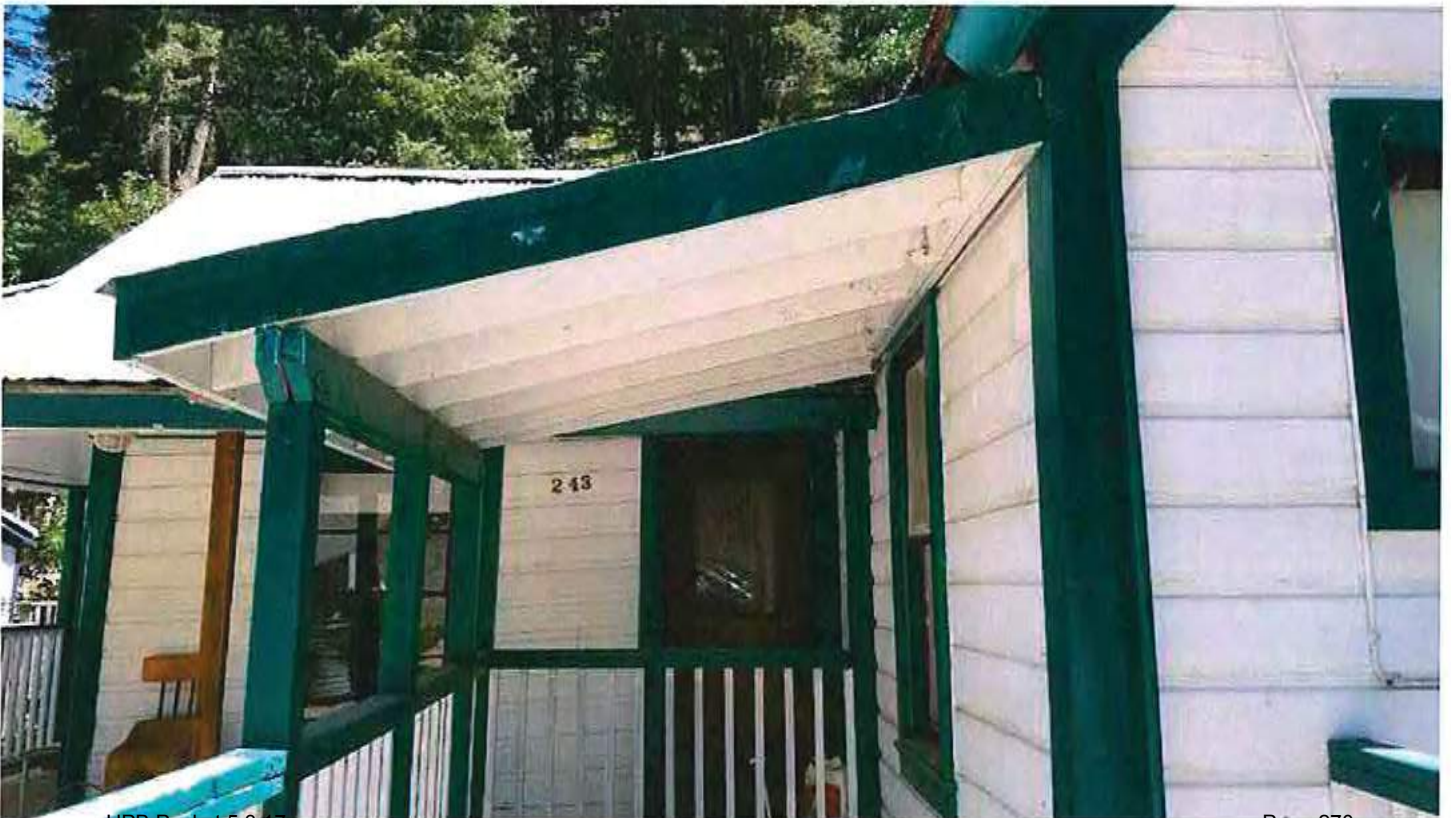
Photo #16: Patio Roof Structure

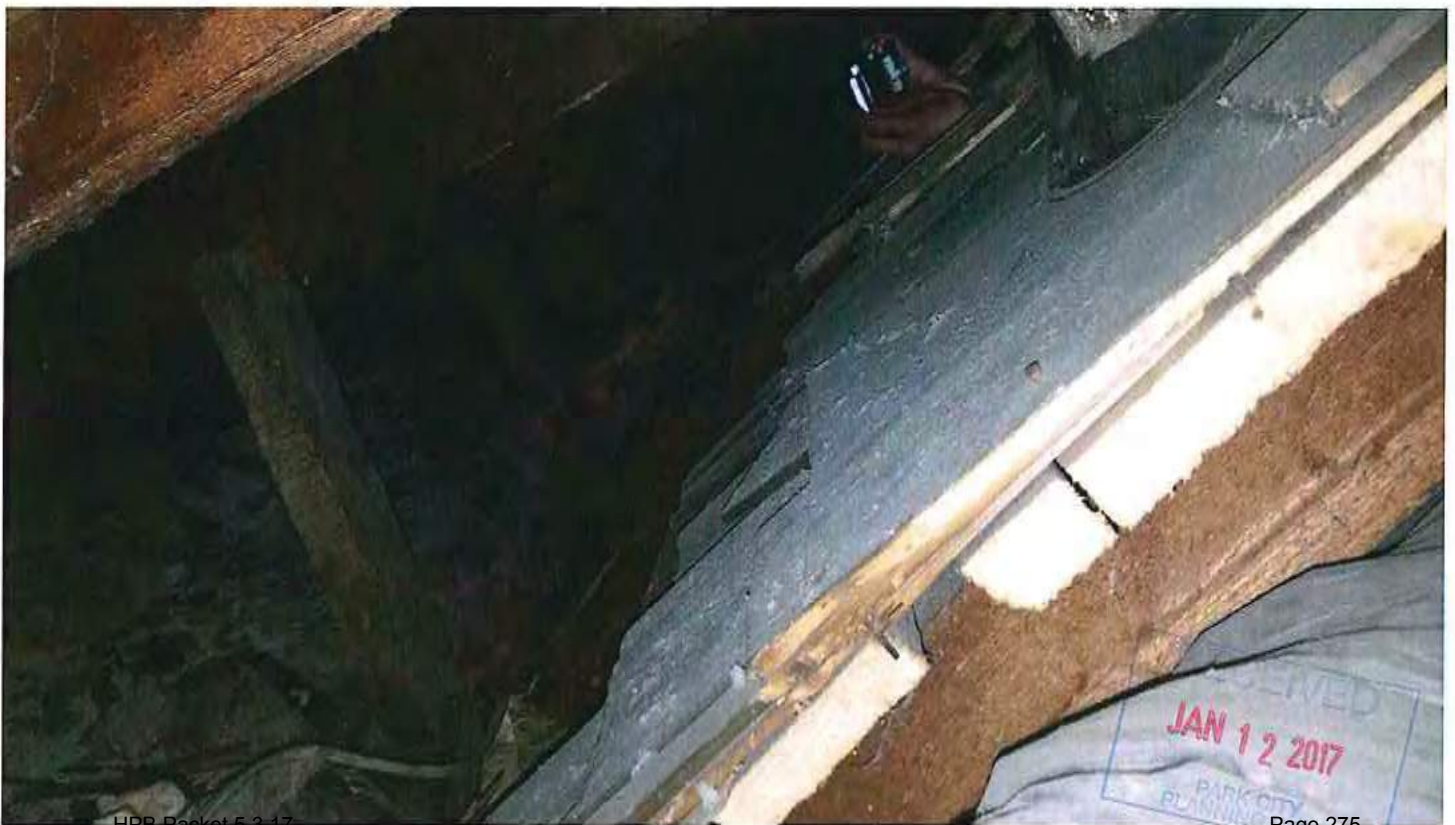
Photo #26: Roof Built Up

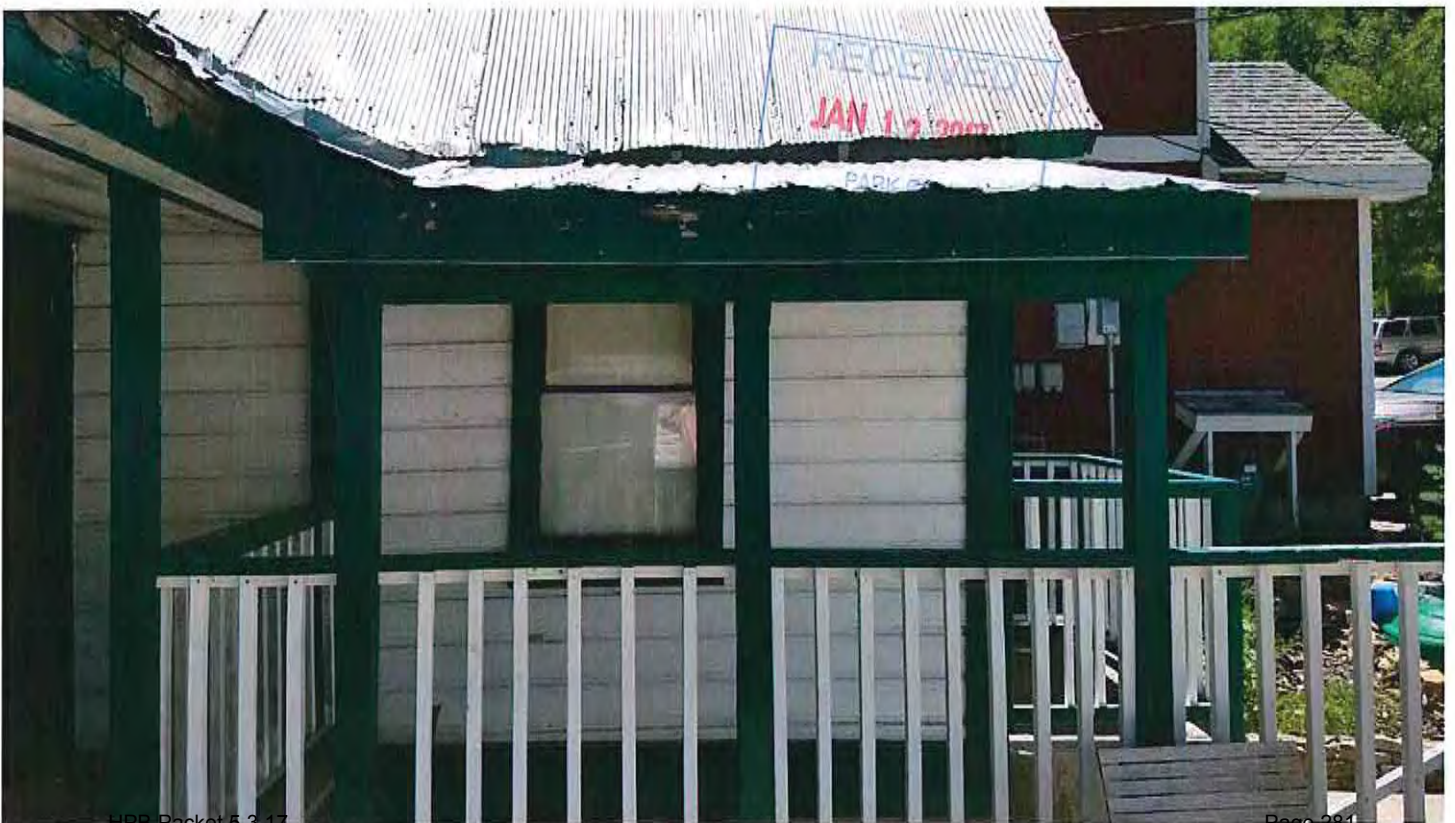
Photo #38: Roof Above Basement Stairs
