173 Daly Avenue, Park City, Summit County, Utah

Intensive Level Survey—Biographical and Historical Research Materials

Exhibit D
Historic District Design Review Physical Conditions Report

NAME: Residence
ADDRESS: 173 Daly Avenue
Park City, UT 84060
TAX ID: PC-622 OR
SUBDIVISION: _____ OR
SURVEY: _____ LOT #: _____ BLOCK #: _____
HISTORIC DESIGNATION: LANDMARK SIGNIFICANT NOT HISTORIC

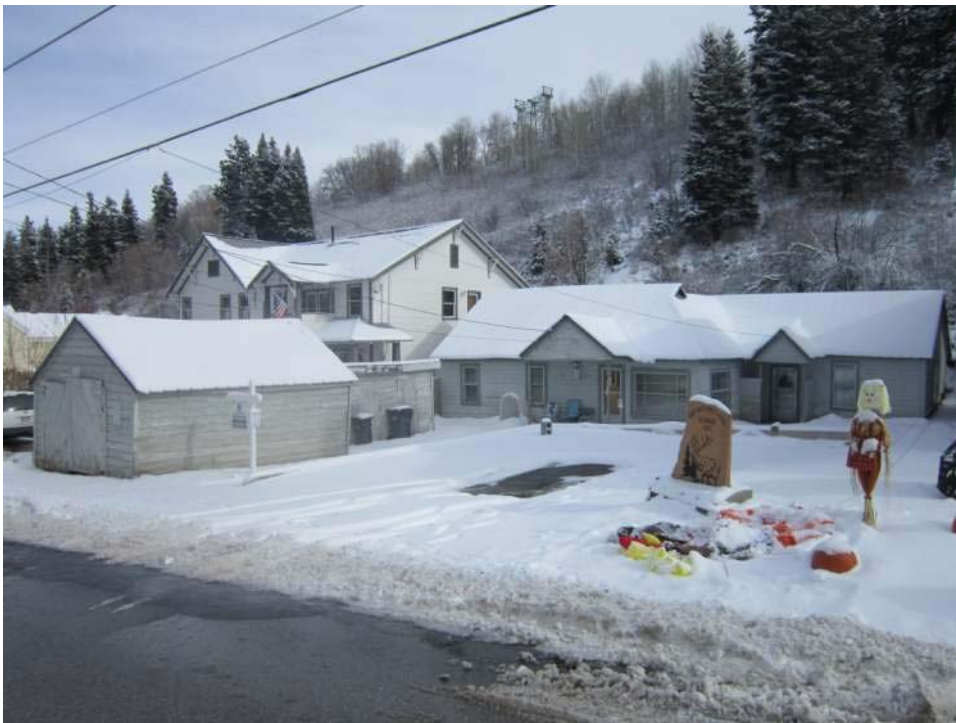
173 Daly Avenue. Southwest oblique. November 2013.

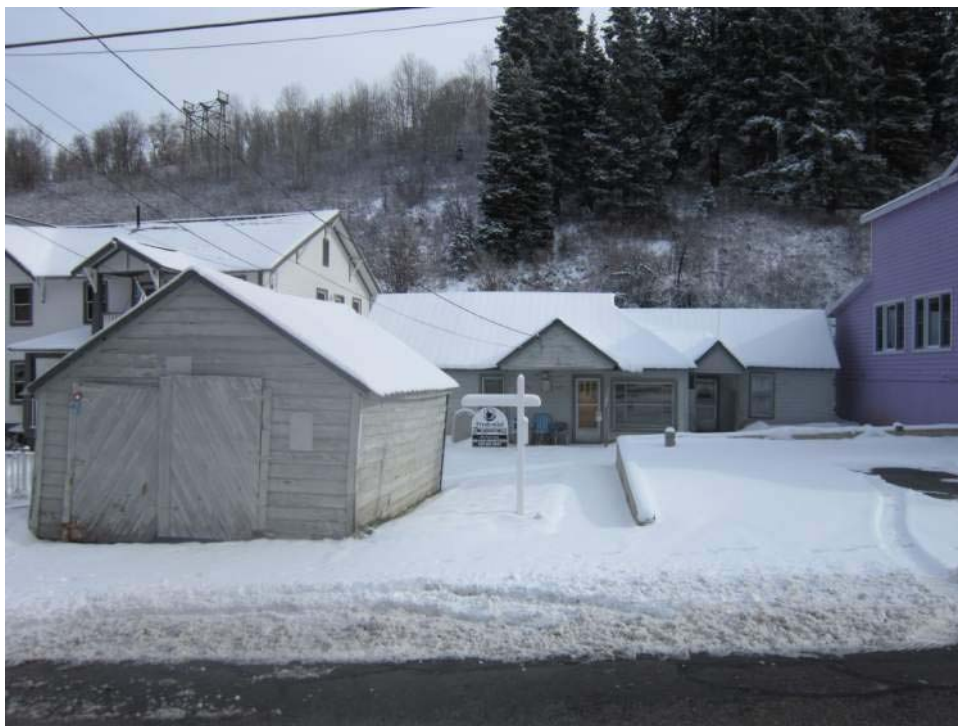
173 Daly Avenue. West elevation. November 2013.

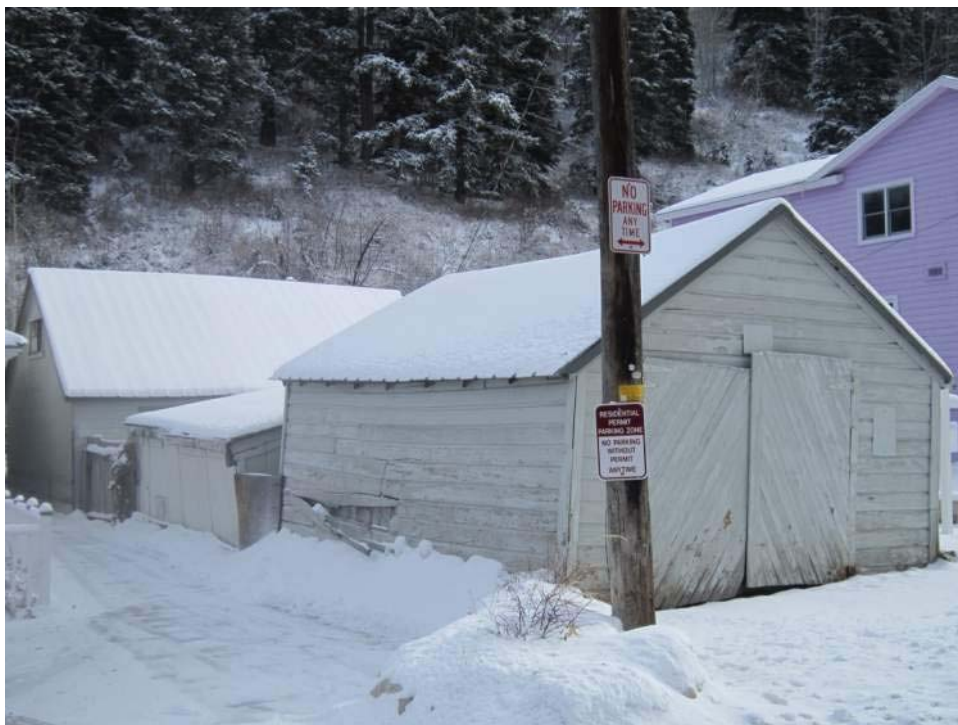
173 Daly Avenue. Northwest oblique. November 2013.
