**PARK CITY MUNICIPAL CORPORATION  
HISTORIC PRESERVATION BOARD  
CITY COUNCIL CHAMBERS  
May 2, 2018**

**AGENDA**

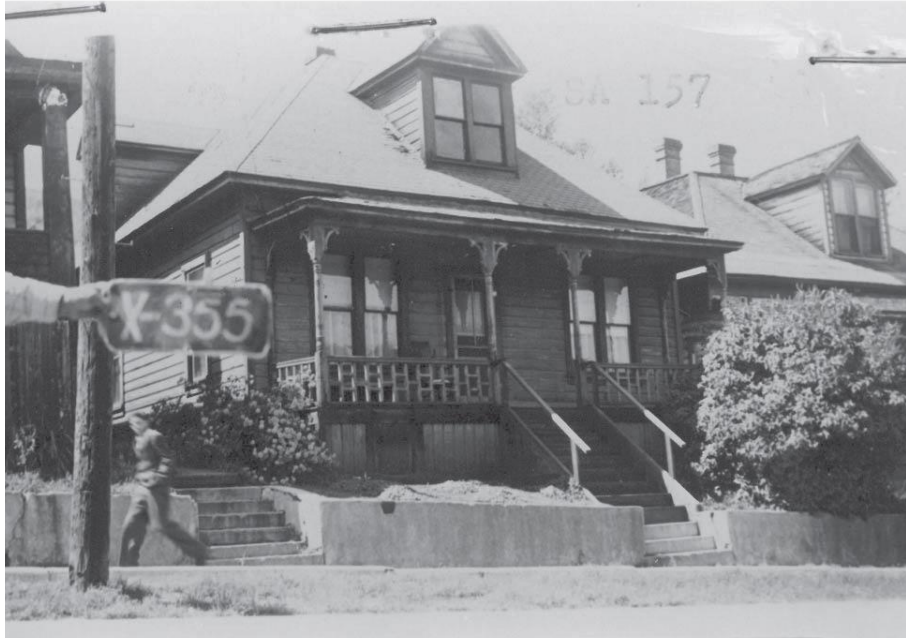
*c.1941 Tax Photograph*

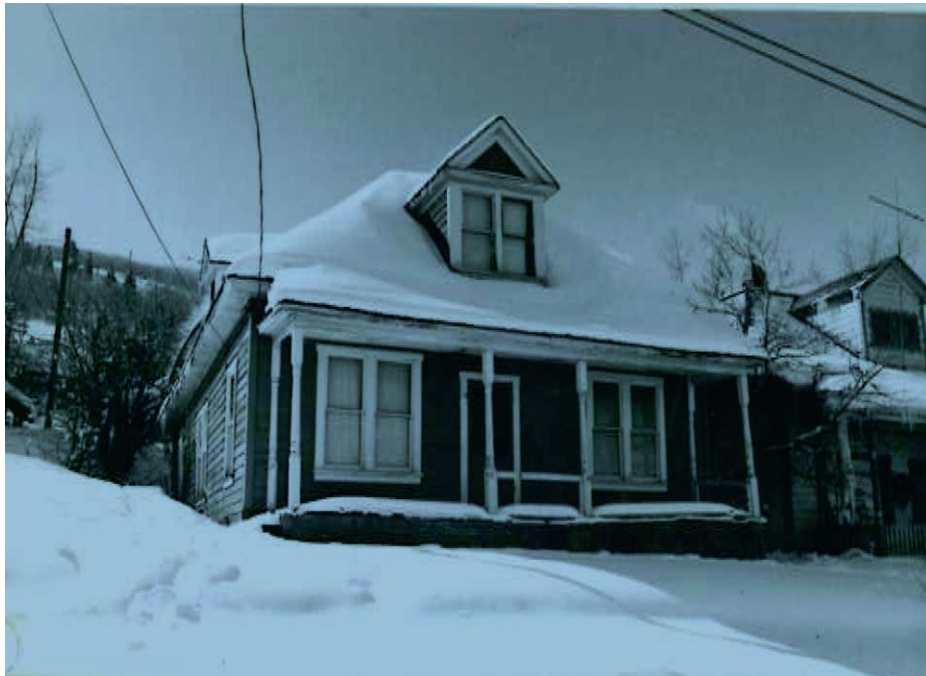
*Park City Survey Worksheet, 1982*

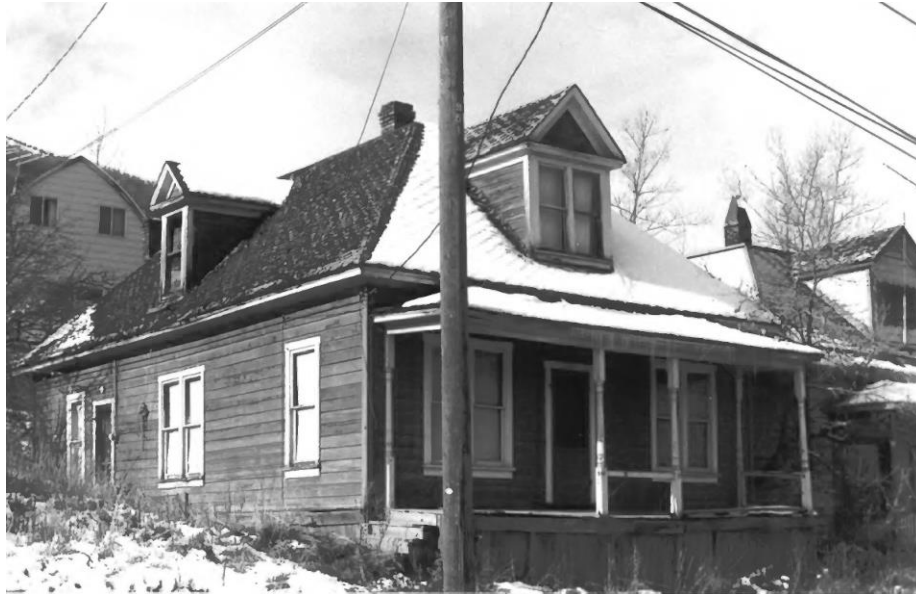
pyramid house, but were a larger 1.5 story variation of the traditional one-story form. The extended variation transformed the traditional one-story four-room pyramid-roof cottage (similar to those seen on Marsac Avenue) into a 1.5 story six-room house. Dormers were constructed on the east, west, and south sides of the house to create additional living space in the attic. The 1984 survey notes that the house was supported on battered concrete piers with a dugout basement.

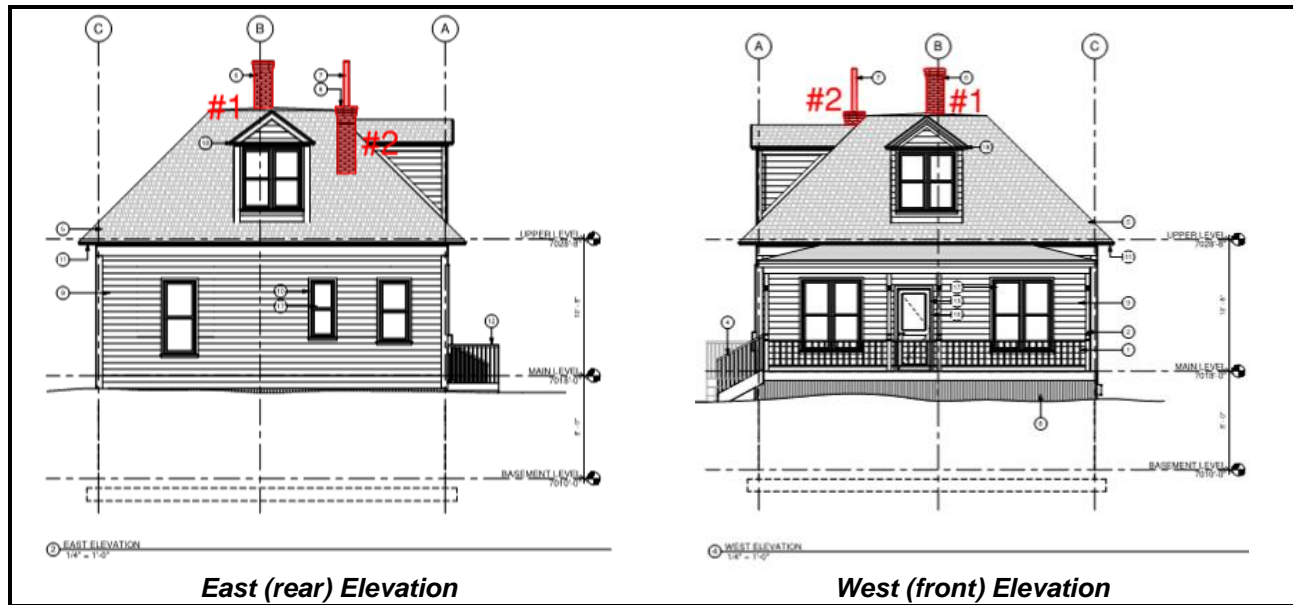
Because the front chimney (#1) is unreinforced masonry and does not meet building code, it will need to be rebuilt. The applicant has proposed a new fireplace in the living room that will be vented through the reconstructed chimney in the same location that it is today. Staff finds that the proposed Material Deconstruction of the front chimney is necessary for its restoration.

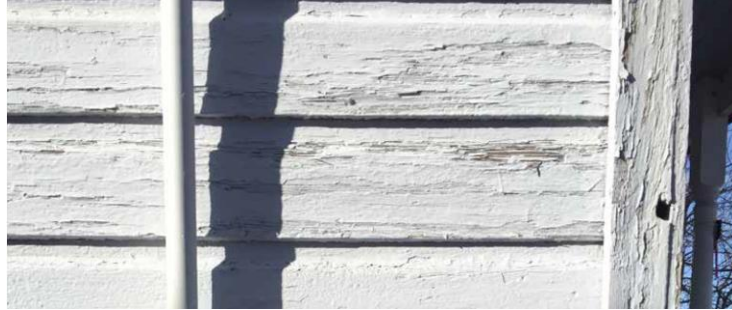
*Close-up of siding condition.*

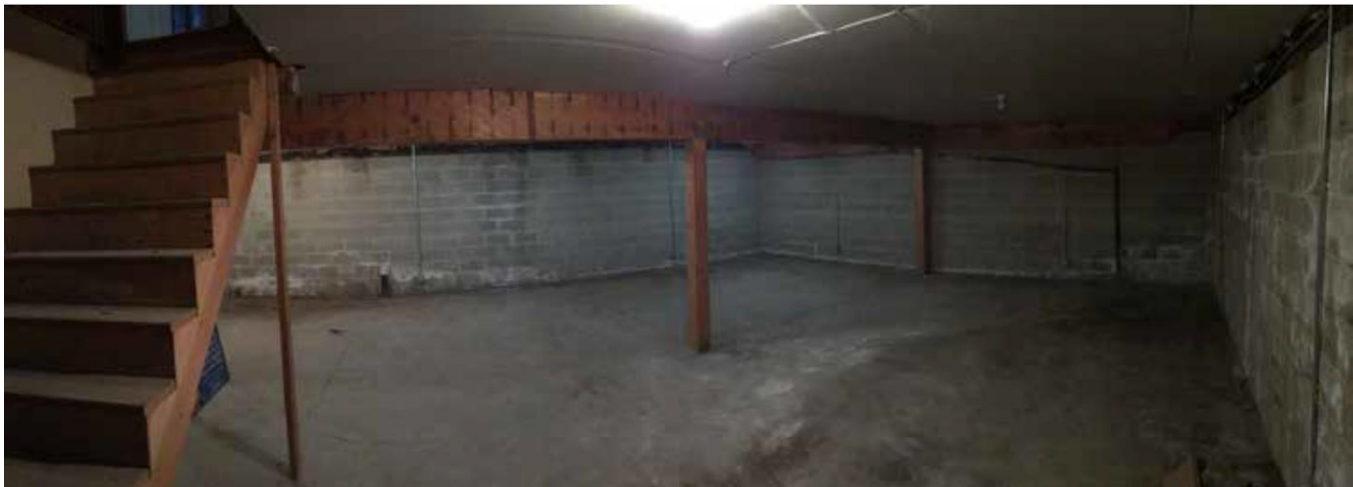
*Photo of the interior of the basement. Note the signs of **efflorescence** on the walls. The heavy timber framing is new and was likely installed when the basement was constructed.*

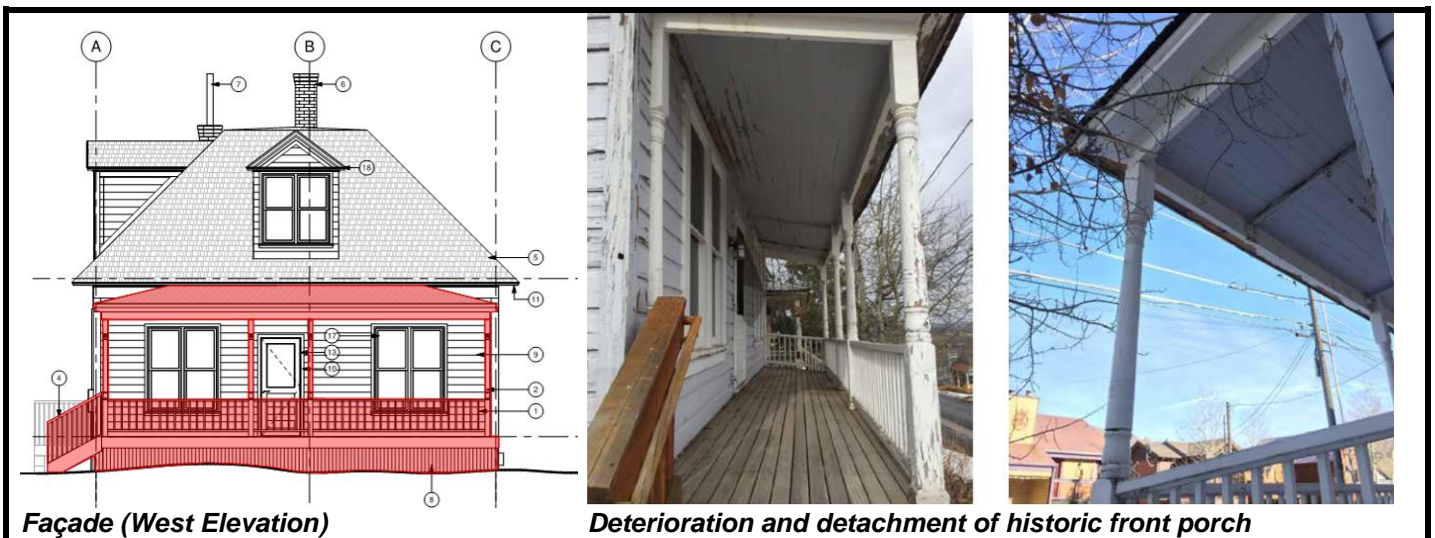
The porch is in fair condition. The deck and roof are currently sagging substantially toward the street, demonstrating a lack of structural integrity. The bottom of the porch posts show signs of deterioration and do not meet the bearing capacity of the roof. The trim and porch ceiling also show signs of deterioration and likely require replacement.

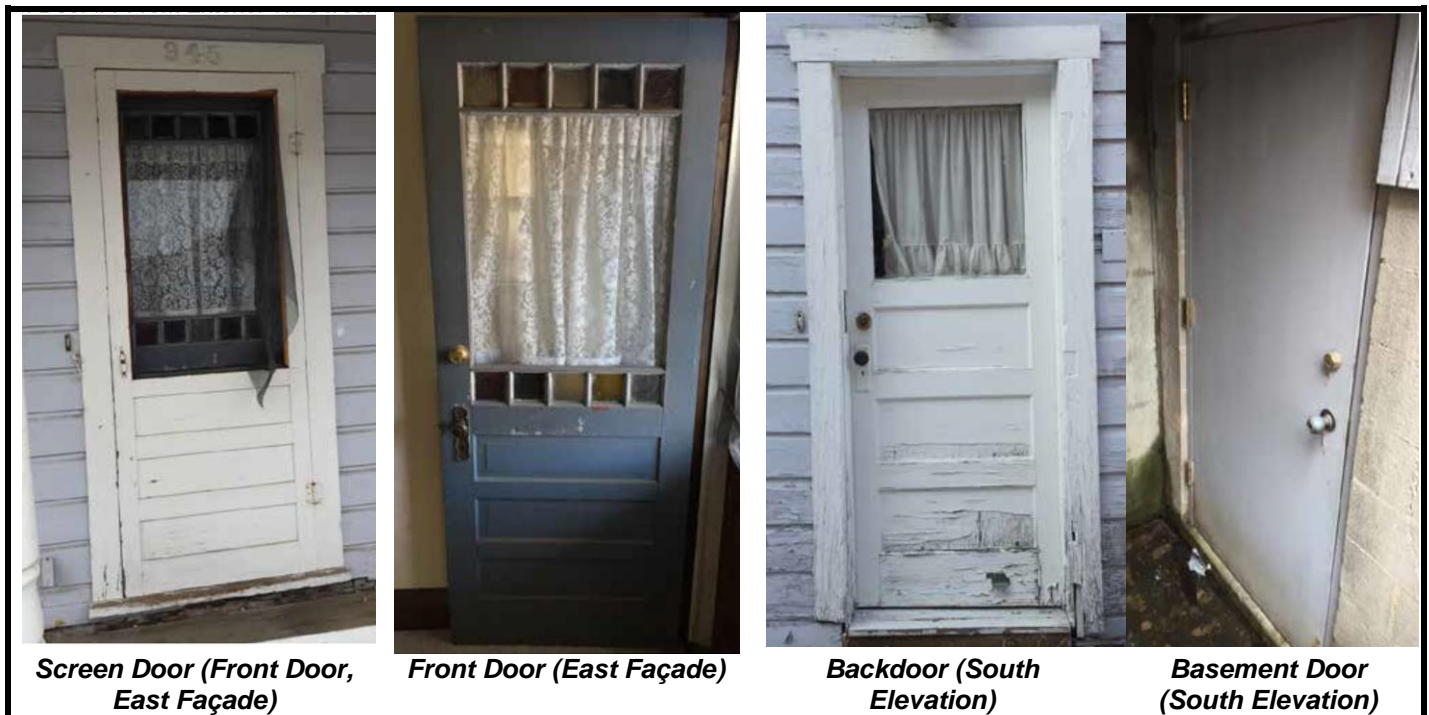
**Screen Door (Front Door, East Façade)**

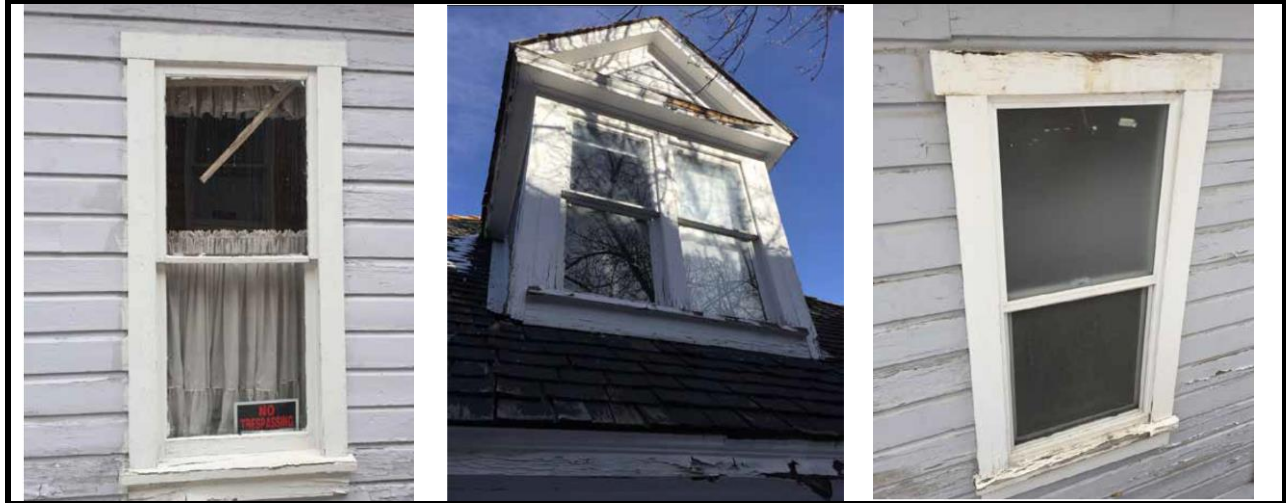
Staff finds that much of the wood rot on the windows may be able to be addressed through window restoration. The applicant has consented to having a window restoration specialist inspect the windows and determine their potential for restoration prior to replacing them in-kind. Staff finds that any proposed Material Deconstruction is necessary in order to restore the original wood windows; however, staff understands they may be beyond repair and has incorporated the following Conditions of Approval:

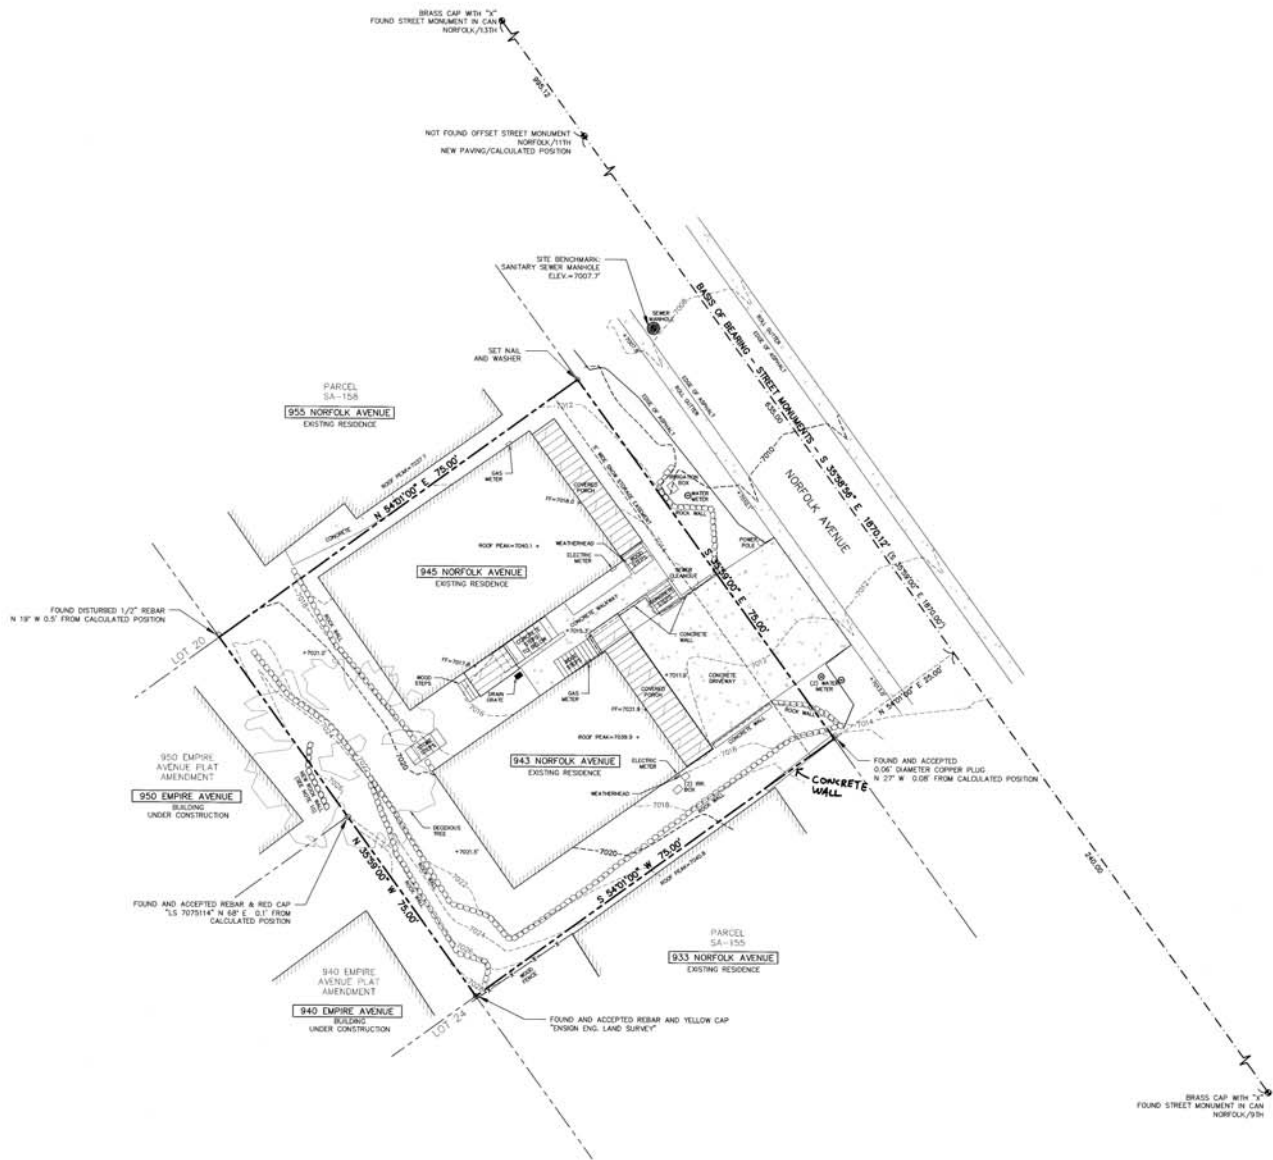
- ### LEGEND
- Set Nail & Washer (As-Noted)
  - Found Monument (As-Noted)
  - Found Street Monument (As-Noted)

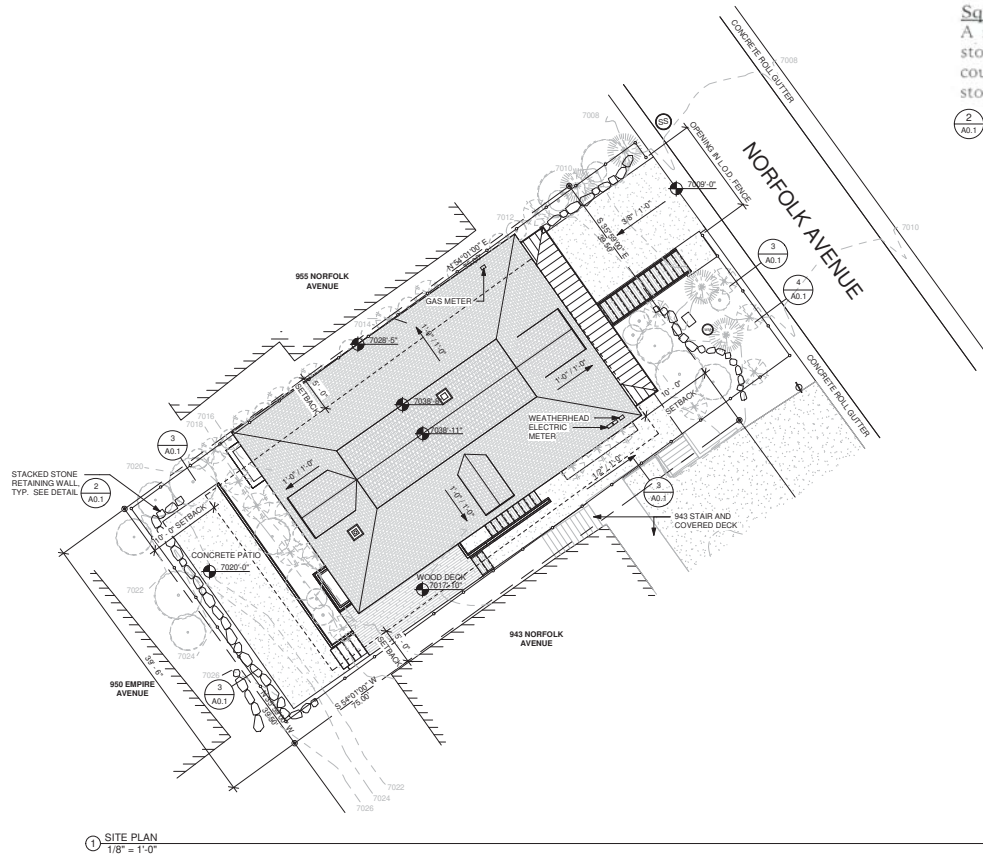
**1 SITE PLAN**  
1/8" = 1'-0"

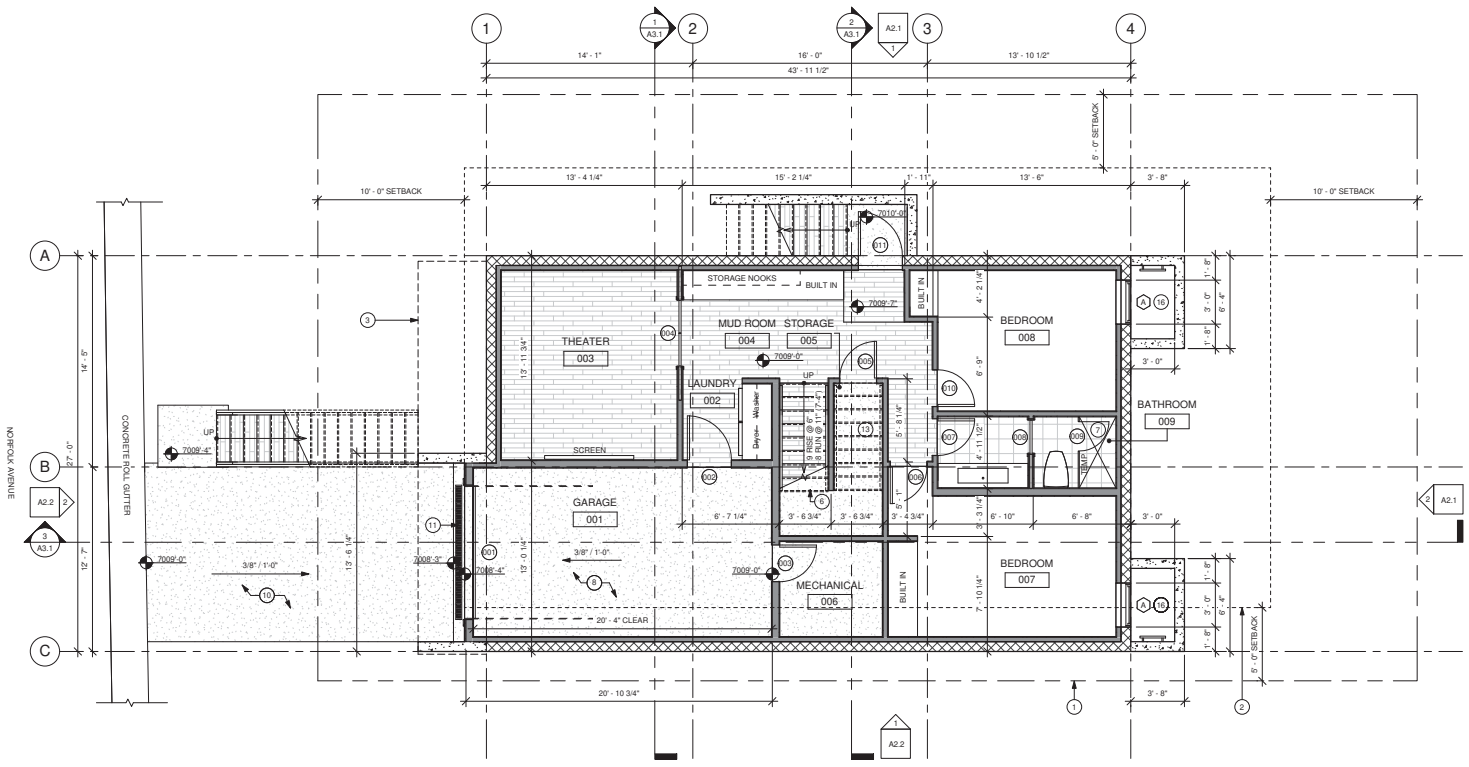
1 BASEMENT LEVEL PLAN  
 1/4" = 1'-0"

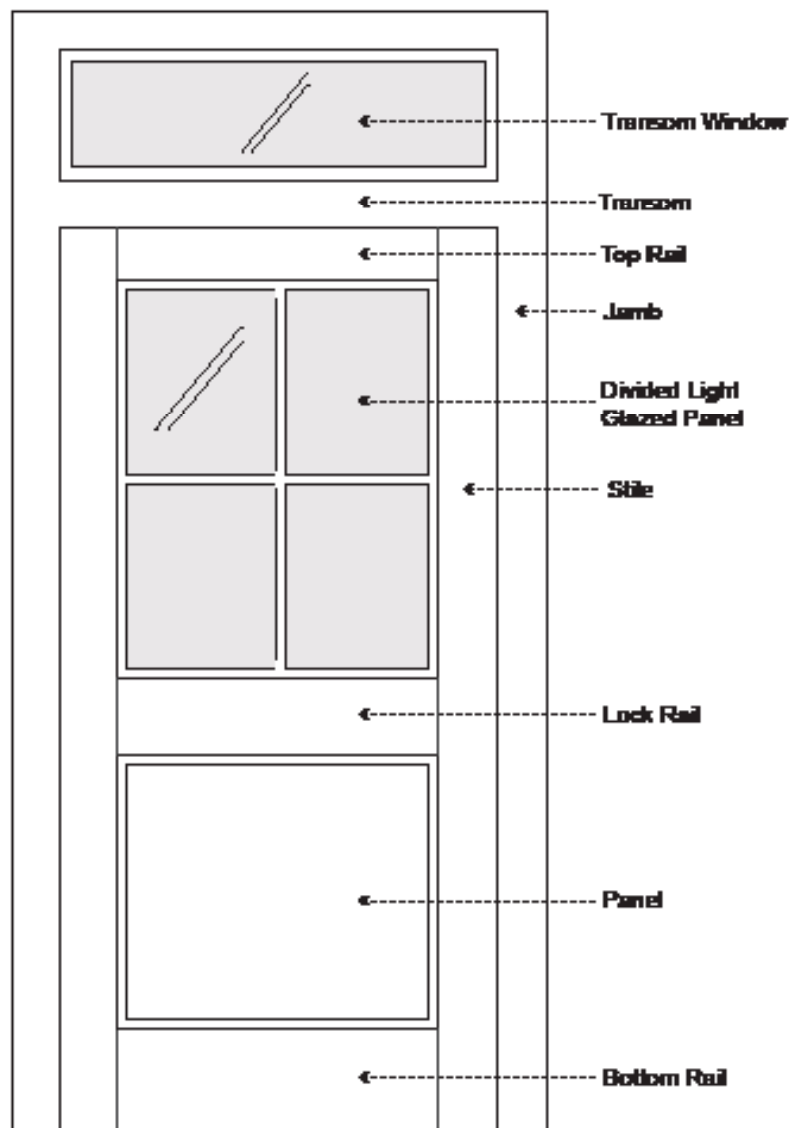
If you have questions regarding the requirements on this application or process please contact a member of the Park City Planning Staff at (435) 615-5060 or visit us online at [www.parkcity.org](http://www.parkcity.org). Updated 10/2014.

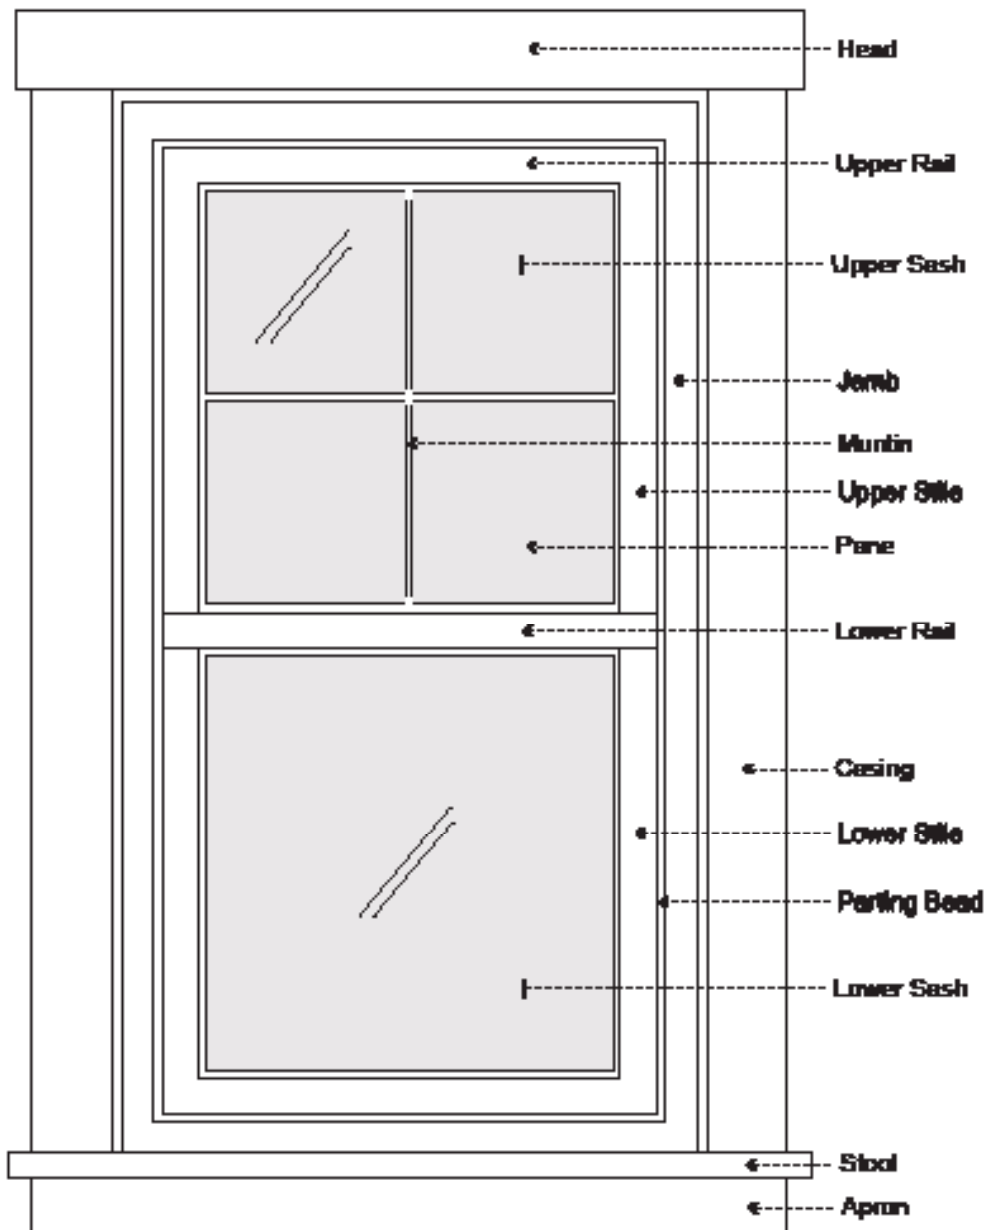
If you have questions regarding the requirements on this application or process please contact a member of the Park City Planning Staff at (435) 615-5060 or visit us online at [www.parkcity.org](http://www.parkcity.org). Updated 10/2014.

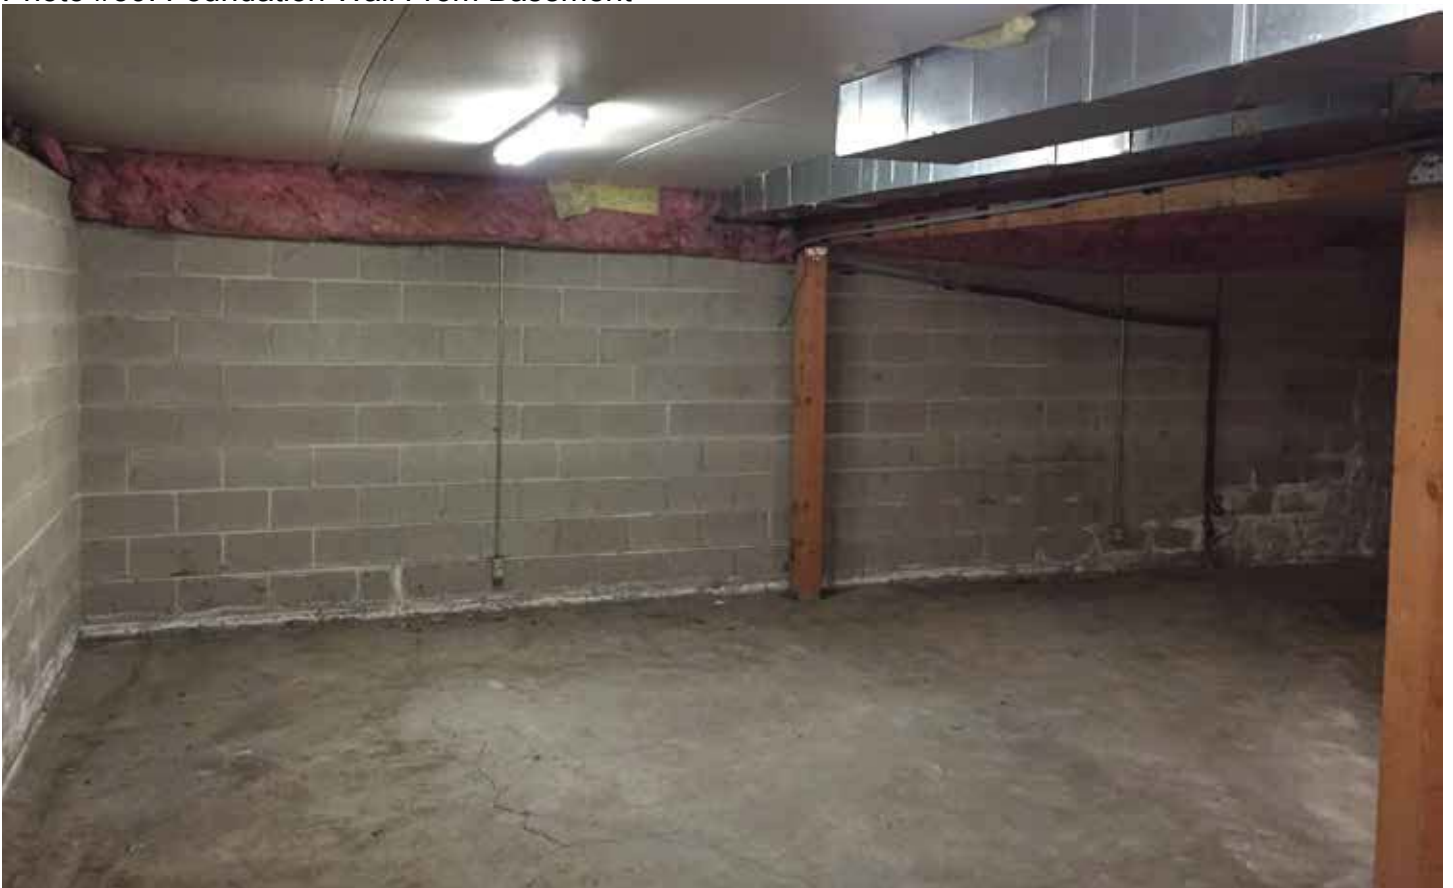
Photo #40: T.O Foundation Wall

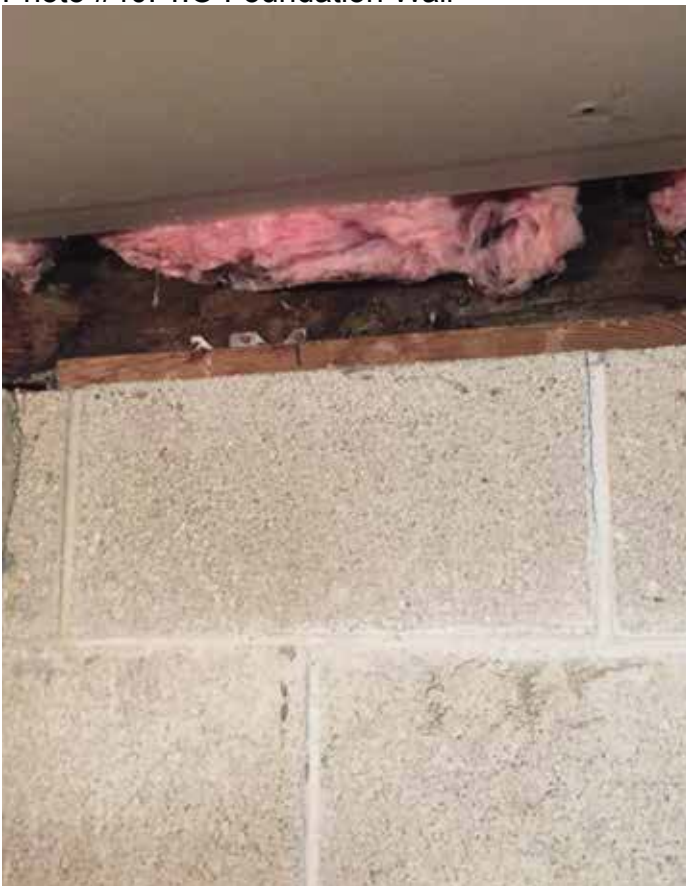
Photo #41: View From Underneath Porch
