**PARK CITY MUNICIPAL CORPORATION  
HISTORIC PRESERVATION BOARD  
CITY COUNCIL CHAMBERS  
May 16, 2018**

115 Sampson Avenue – HDDR Material Deconstruction and Reconstruction – The applicant is proposing to reconstruct the historic house designated as “Significant” on the City’s Historic Sites Inventory. In addition the applicant will be removing existing non-historic parking pad along with its associated wood staircases and railroad tie retaining wall; non-historic stacked stone retaining walls and 1990s wood slat fences; post-1947 addition on the west elevation and an underground root cellar; rebuilding the historic pyramid roof and dormers; reconstructing the existing masonry chimney; raising the house 2 feet to pour a new foundation; reconstructing the historic ca.1900 wraparound porch on the east and south elevations; replacing two non-historic doors; and removing non-historic aluminum windows and restoring 11 window openings.

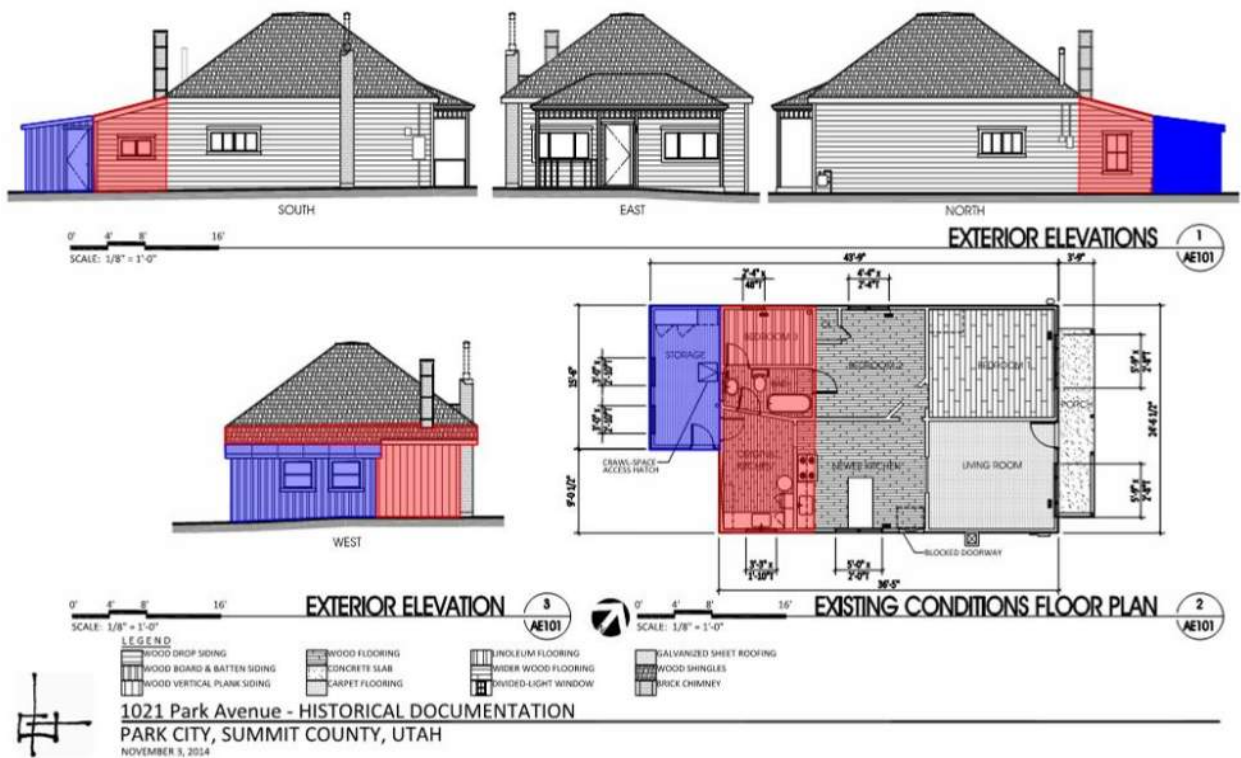
*This photograph shows the condition of the two additions in 2014. The additions had begun to pull away from the original pyramid-shaped roof and had significantly deteriorated due to inadequate foundations.*

These later additions were lien-to additions that had been haphazardly added to the west elevation of the historic house. Overtime, they had been significantly altered to create useable living space. Staff found that these later additions do not contribute to the historic integrity or historical significance of the structure or site and do not need to be reconstructed.

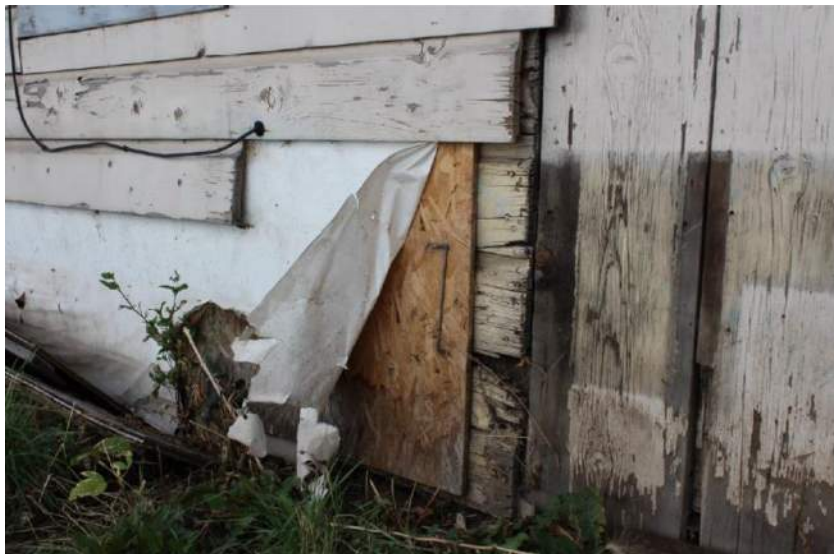
The exterior walls had been clad with layers of asbestos shingles, plywood, and non-historic wood siding by 2013. The layers of siding were in disrepair and had deteriorated significantly. The applicant was required to salvage those pieces of the original wood drop novelty siding that could be restored; however, the amount of material salvaged was limited due to the overall deteriorated state of the building.

*Layers of siding present at the time of the deconstruction in 2013*

The applicant proposes to reuse the salvaged siding on the façade of the historic house. New siding will be milled to match this original siding and used to clad the north, south, and west elevations of the reconstructed house.

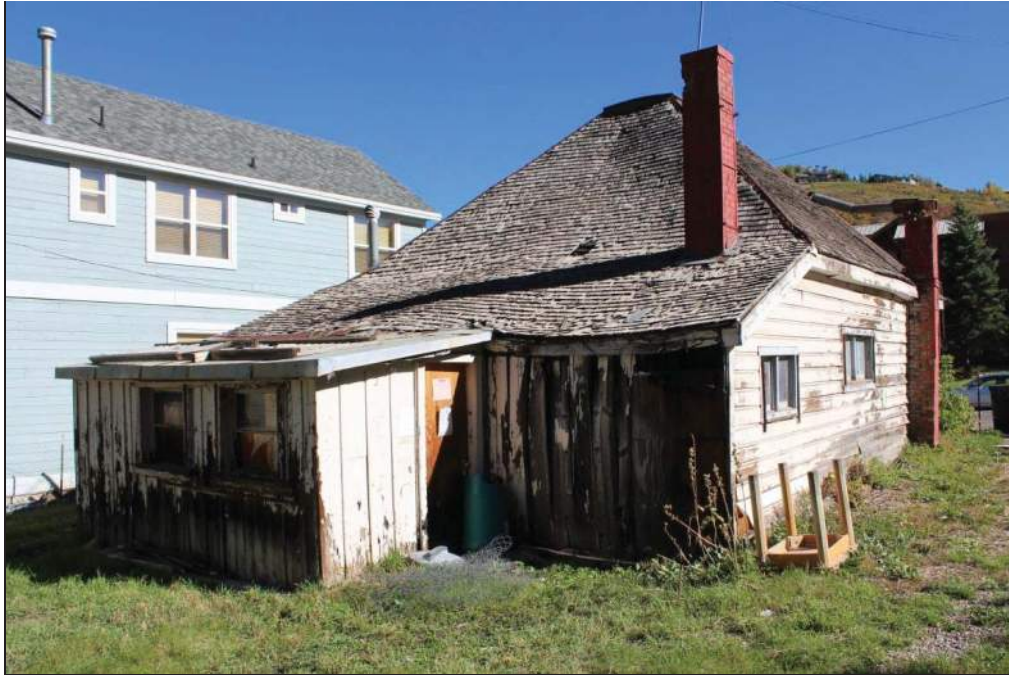
**B.1. ROOF:** Poor condition of west side of main building, Additions 1 and 2, facing northeast.

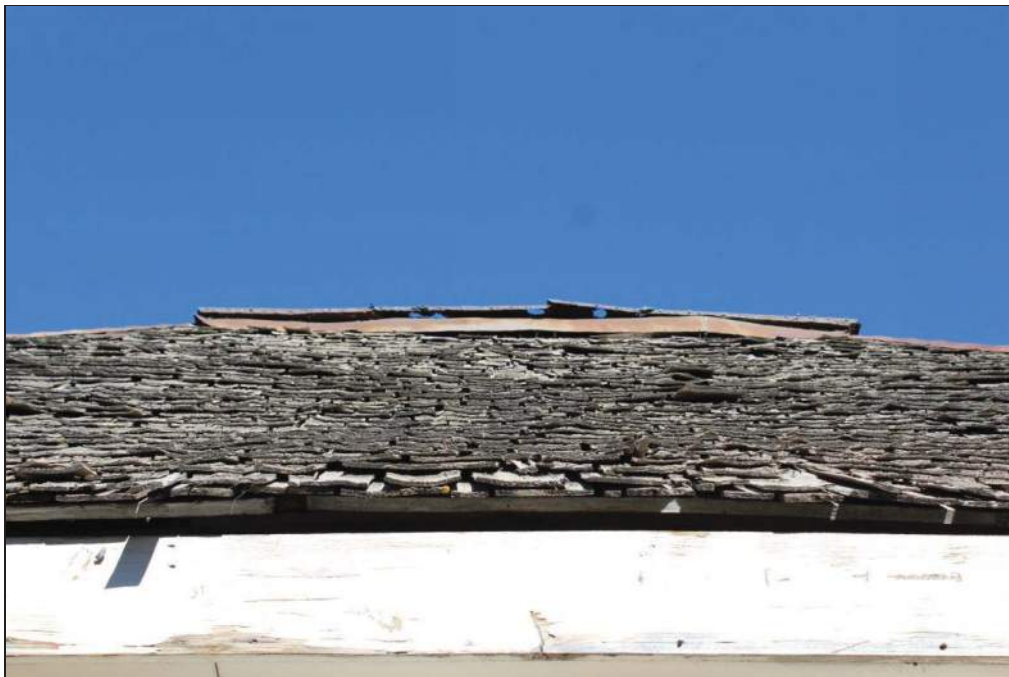
**B.1. ROOF:** Corroded and detached metal roof cap at top of hipped roof.

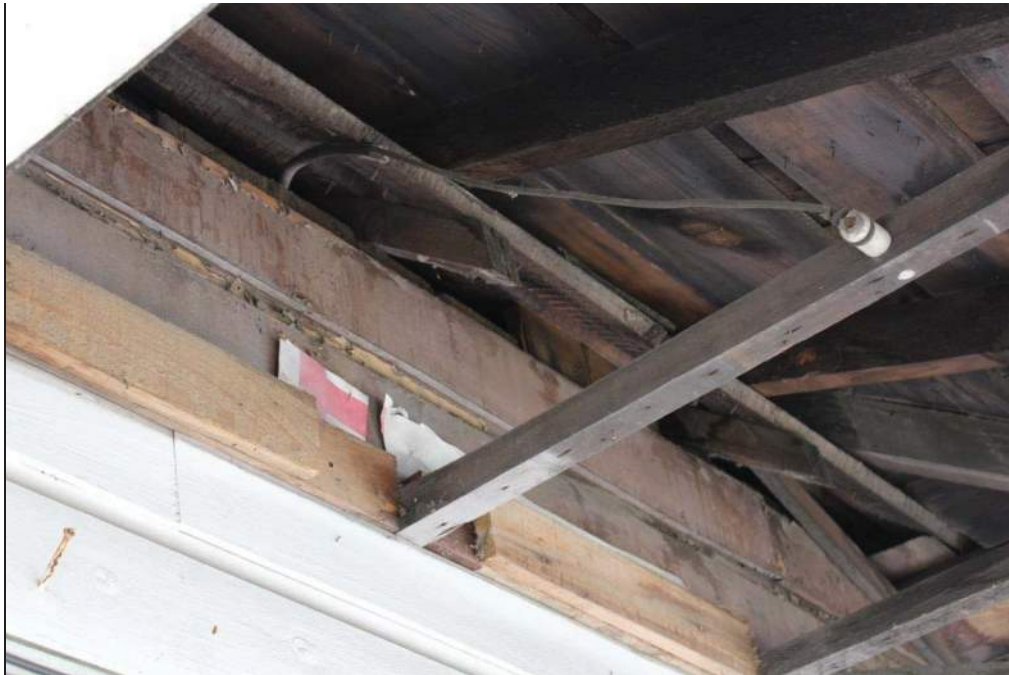
### B.2. EXTERIOR WALL – PRIMARY FAÇADE: Under porch roof, original dark-painted siding visible beneath c. 1995 white siding.

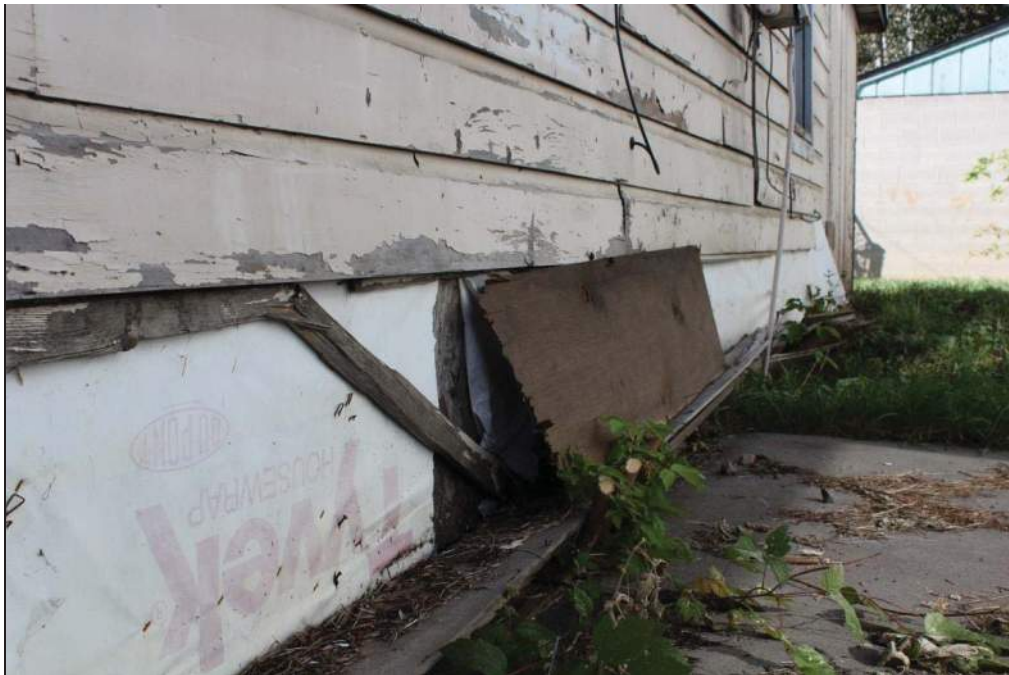
### B.3. EXTERIOR WALL – SECONDARY FAÇADE 1: North wall, poor condition at wall base, facing west.

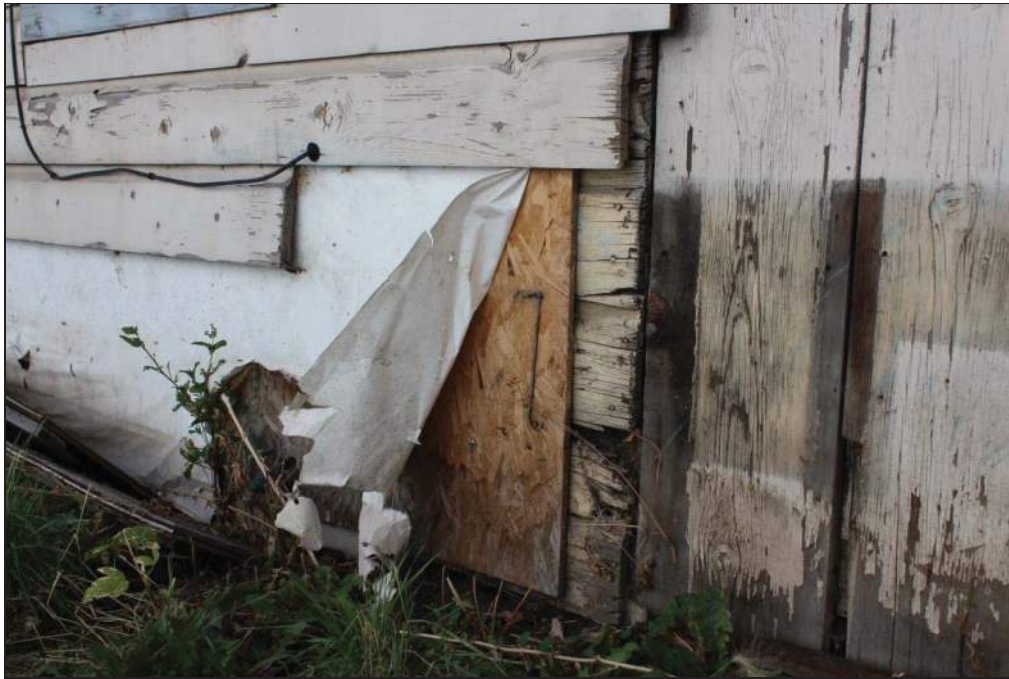
**B.3. EXTERIOR WALL – SECONDARY FAÇADE 1:** North wall, original siding in fair/poor condition beneath particleboard, Tyvek, new siding; shadow marks showing batten locations on Add. 2.

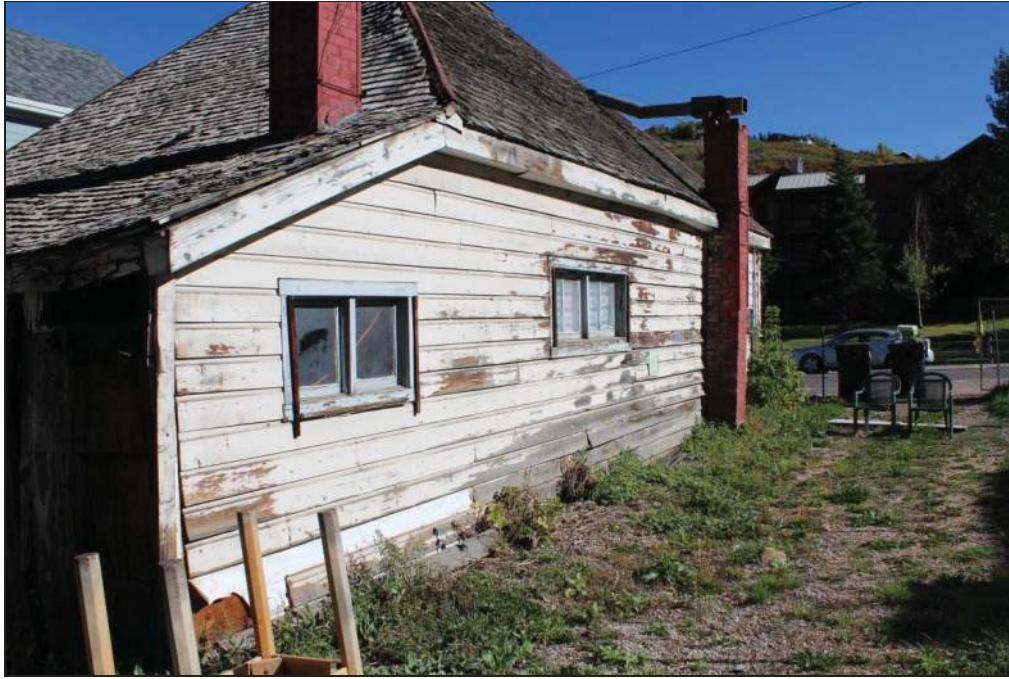
**B.4. EXTERIOR WALL – SECONDARY FAÇADE 2:** South wall, facing northeast. Note detached siding, paint loss.

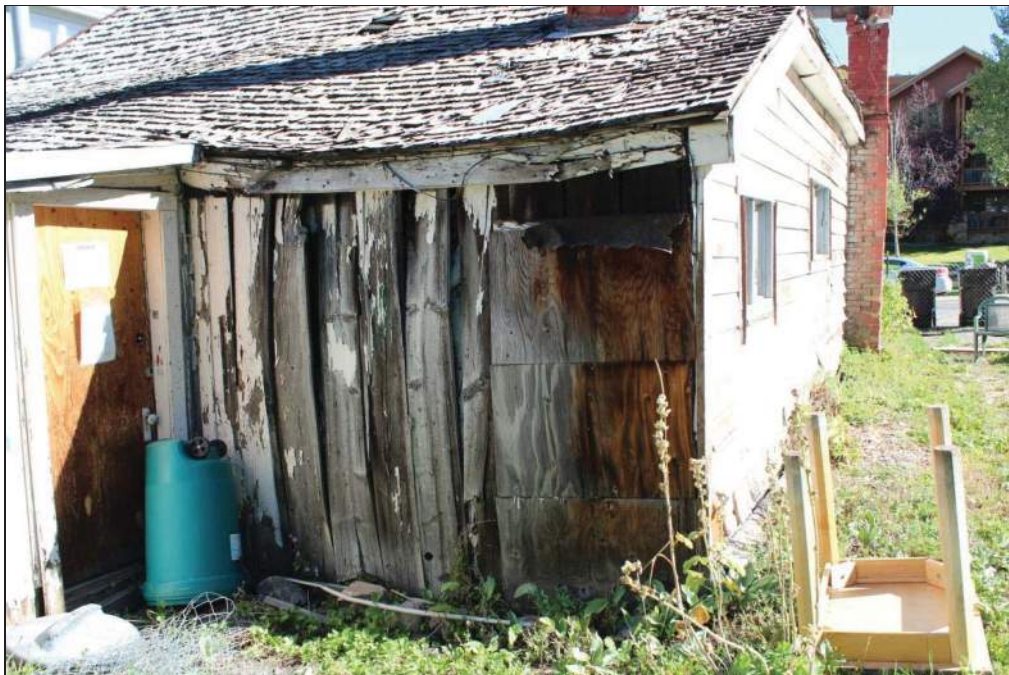
**B.4. EXTERIOR WALL – REAR FAÇADE:** West side, detail of Addition 1, facing east. Note single-wall construction, very poor condition.

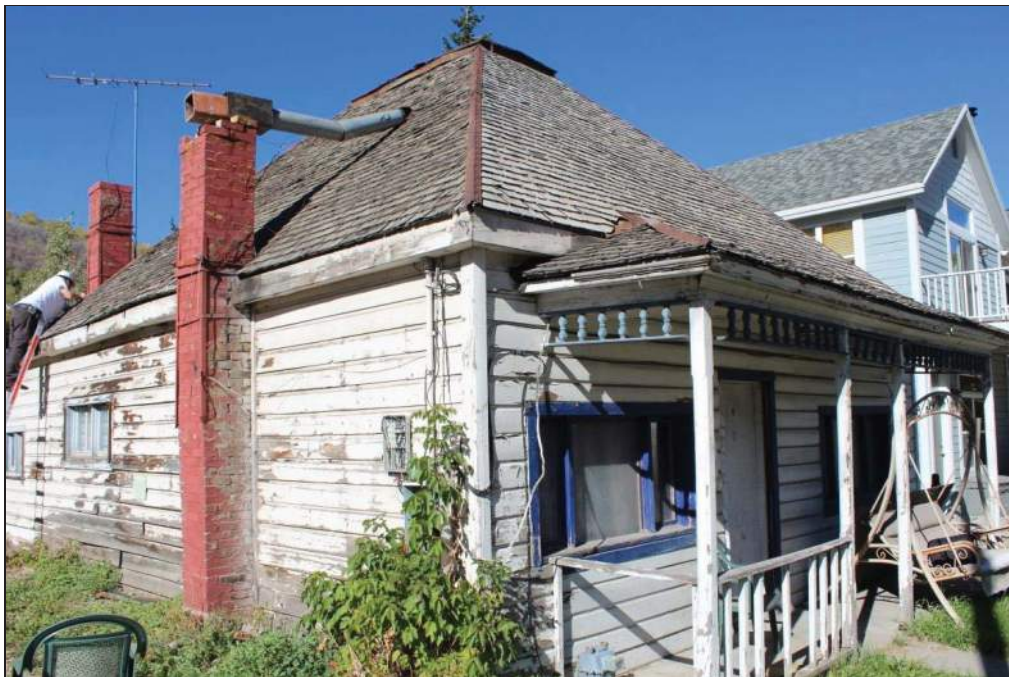
**B.10. MECHANICAL SYSTEM:** Second brick chimney abutting south wall of house, facing northwest. Note displacement and toppled stovepipe.

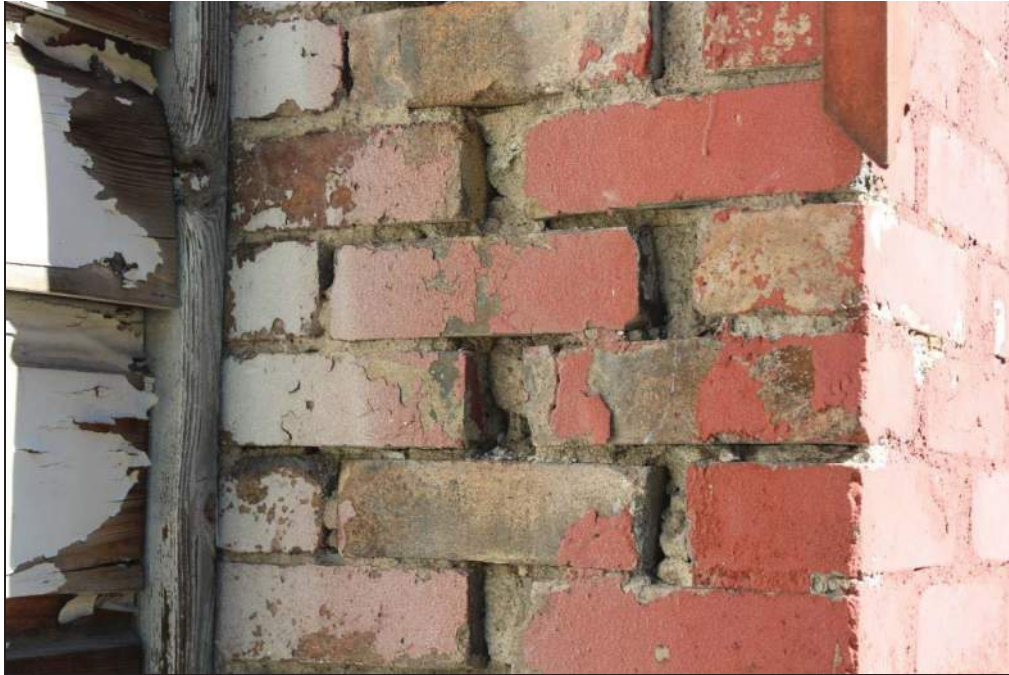
**B.10. MECHANICAL SYSTEM:** Mortar loss on west side of second brick chimney, facing east.

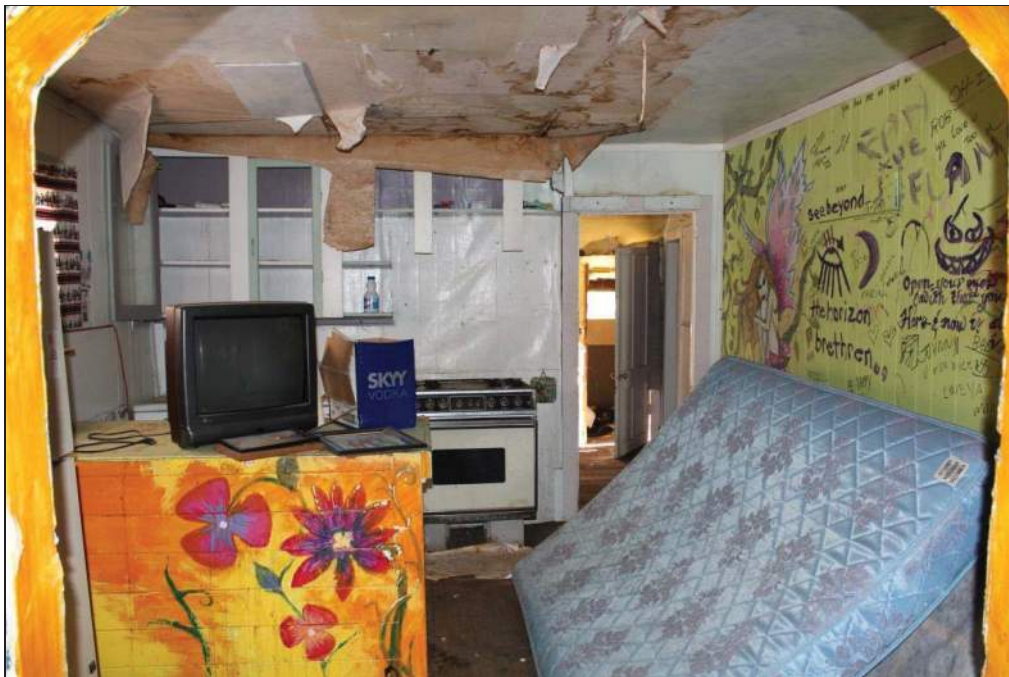
**B.12. STRUCTURAL SYSTEM:** Water damage in ceiling, southwest room of original building, indicating likely damage to roof members, facing west. See B.1. for photos indicating cracked or broken rafters and B.3. for damage at wall base and therefore likely at floor sill and joist ends.

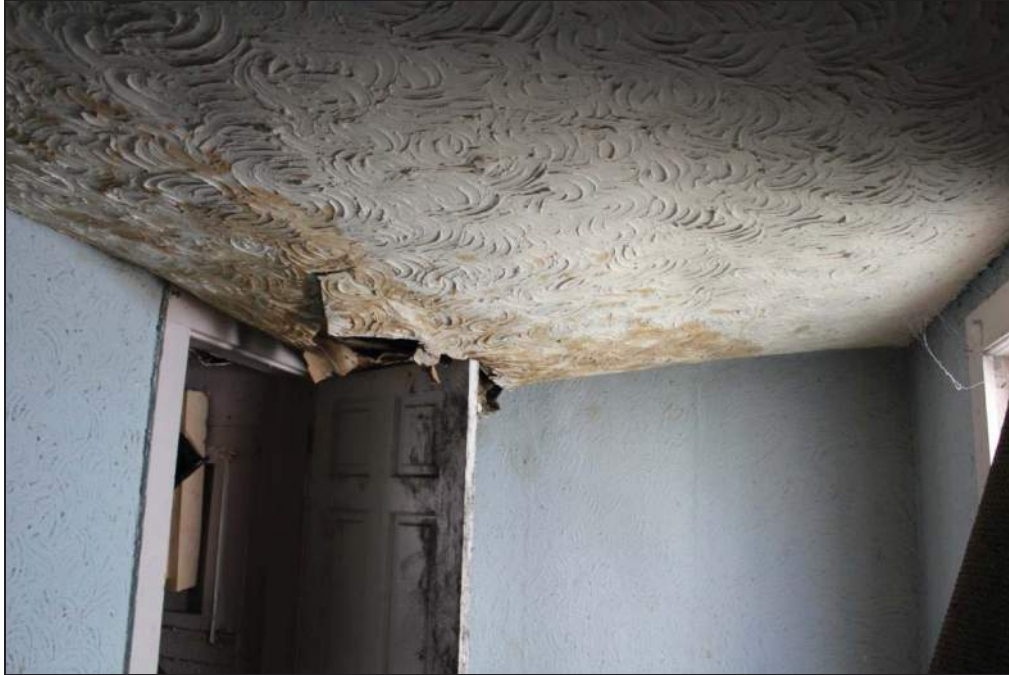
**B.12. STRUCTURAL SYSTEM:** Water damage in north end of Addition 1 ceiling, facing west.

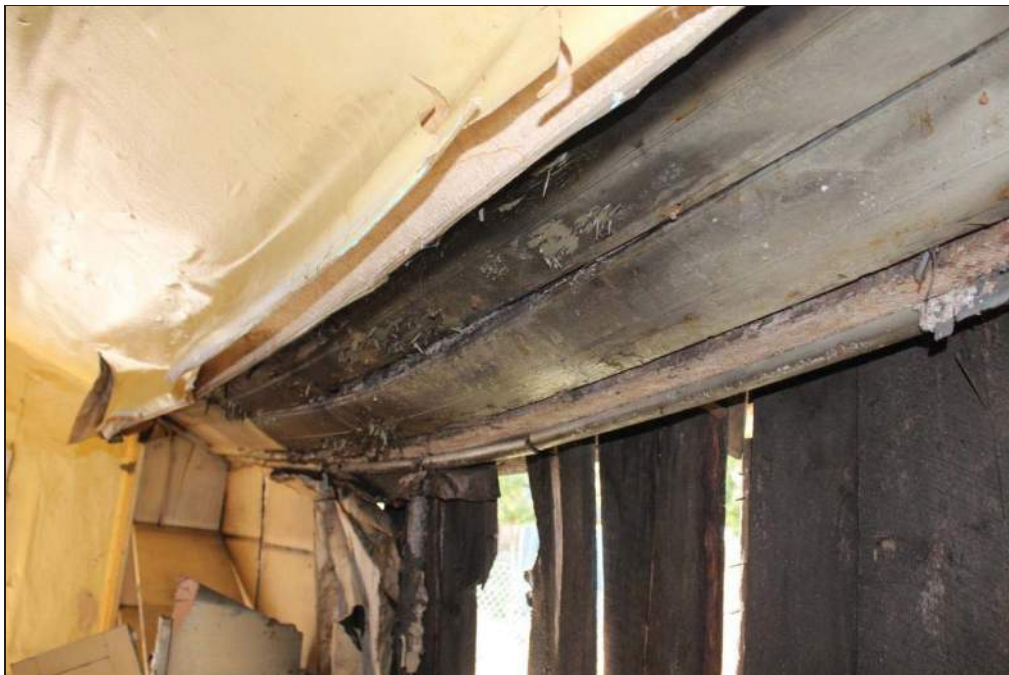
**B.12. STRUCTURAL SYSTEM:** Water damage to south end of Addition 1 ceiling paper (painted yellow), underlying original board finish, and original vertical-board wall, facing southwest.

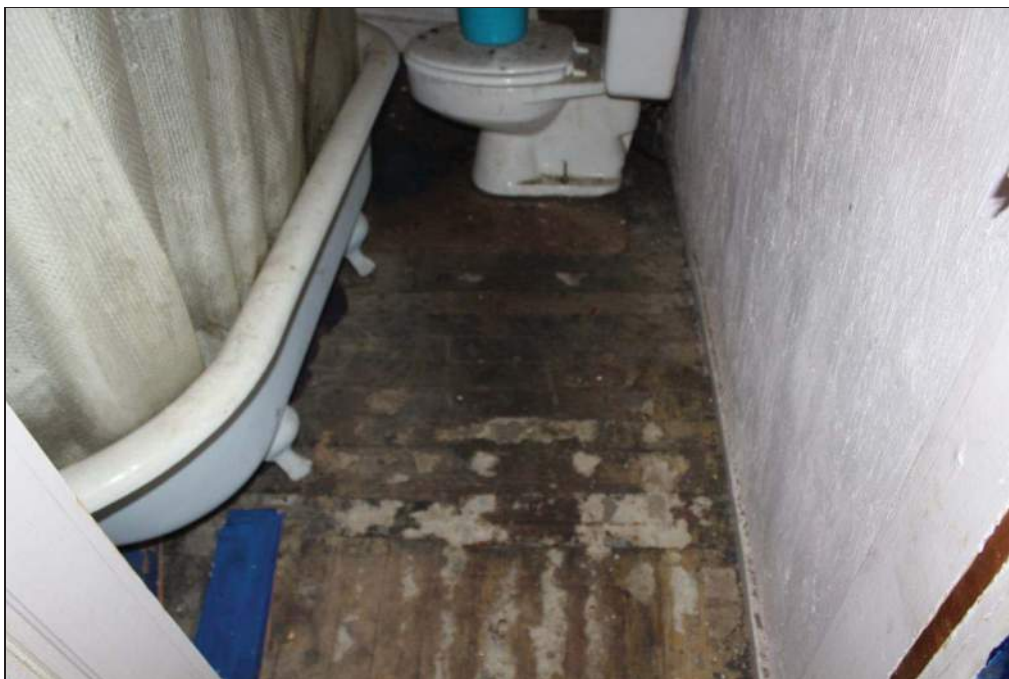
**B.12. STRUCTURAL SYSTEM:** Water damage in bathroom floor of Addition 1, indicating likely damage or rot in underlying floor joists.

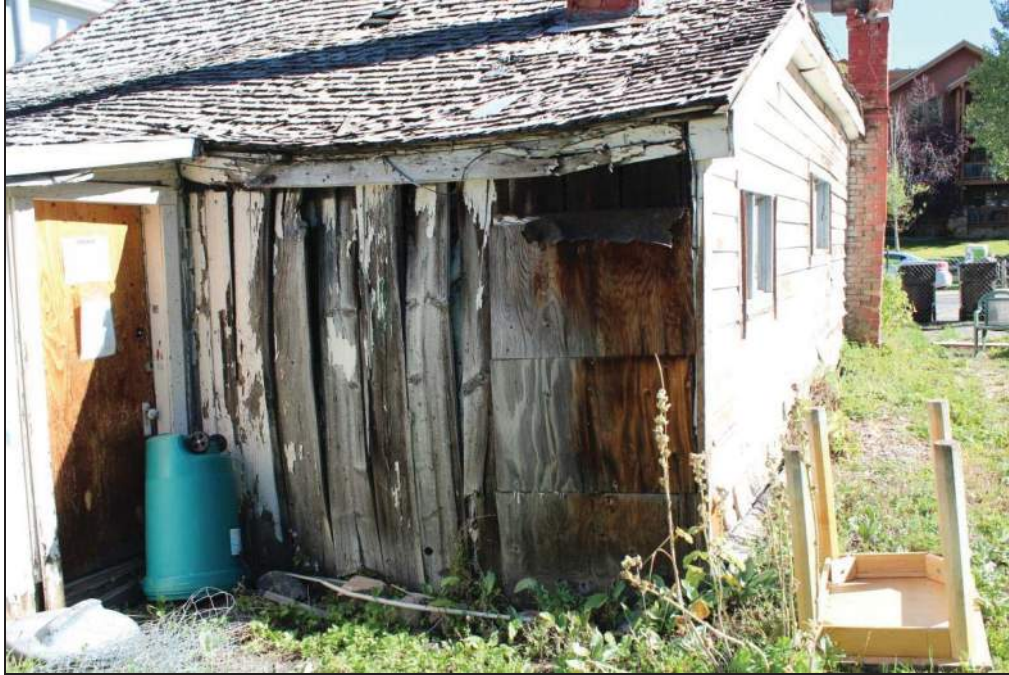
**C.3. TRIM:** Ca. 1990s boxed eave along south wall of house and original fascia/horizontal nailer for wall boards on west side of Addition 1 (in very poor condition), facing northeast.
