FLAGSTAFF MOUNTAIN RESORT
A PLANNED RESORT COMMUNITY
DEER VALLEY, UTAH

HISTORIC PRESERVATION PLAN
EXHIBIT 6

HISTORIC PRESERVATION PLAN

**HISTORIC PRESERVATION PLAN
FOR FLAGSTAFF MOUNTAIN RESORT
PARK CITY, SUMMIT COUNTY, UTAH**

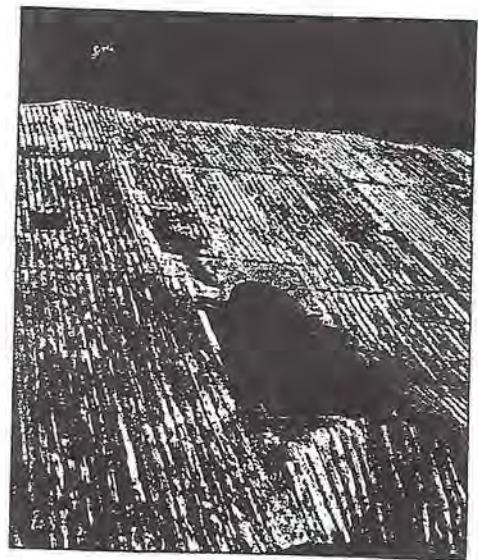
Deficiency Description – The corrugated galvanized roofing panels are in fair condition on the west side of the building, with only some minor rusting, but on the east side of the building, a number of panels are badly damaged. It appears that one of the chimneys and a sewer vent pipe have been pushed down, probably by a heavy snow load sliding off the roof, and have torn large openings in the roofing material (Figure 17). Water entering through these holes is damaging the adjacent wooden structural elements of the roof. The other chimney is missing, although it did not tear a large hole in the roof. A secondary problem is that the roofing nails have crept out about half an inch.

Figure 17 – Damaged roofing panels.

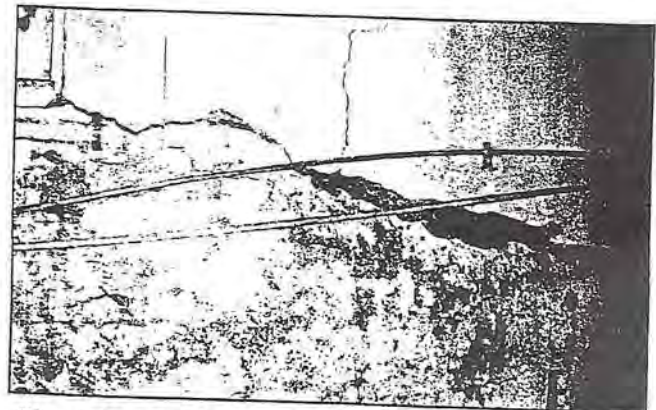
Deficiency Description – The exterior concrete walls are in good condition, with some exceptions. There are several large cracks in the east and south walls of the rear section (Figure 19) and at least two places where there has been lateral displacement of more than one inch. The exact cause of these cracks is unknown, but might include soil pressure, settling, or poor concrete quality. There is also a missing chunk of concrete in the shed-style entrance to the rear section of the building that could be described as a large "gouge" of some unknown cause. The degree to which these problems affect the building's structural integrity is unknown.

Figure 19 – Cracks in concrete wall.

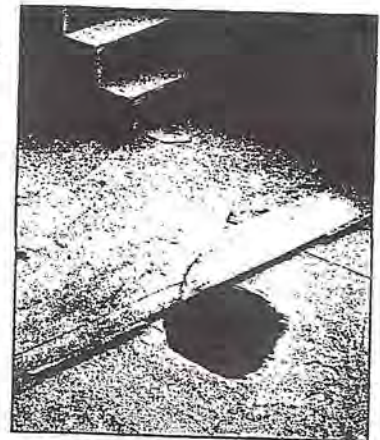
Figure 21 – Hole in flooring.

Suggested Mitigation Work – The floor joists and subflooring in the weak area by the Vault should be inspected and the affected components should be reinforced or replaced as necessary. The hole in the floor should be cut out square with the nearest joists and flush-patched with the same subflooring or flooring material. Doubling pieces should be added to the joists to support the repair material. The seams could also be placed over the center of the joists if allowed by code. The entire floor structure should be inspected from the crawl space, if possible.

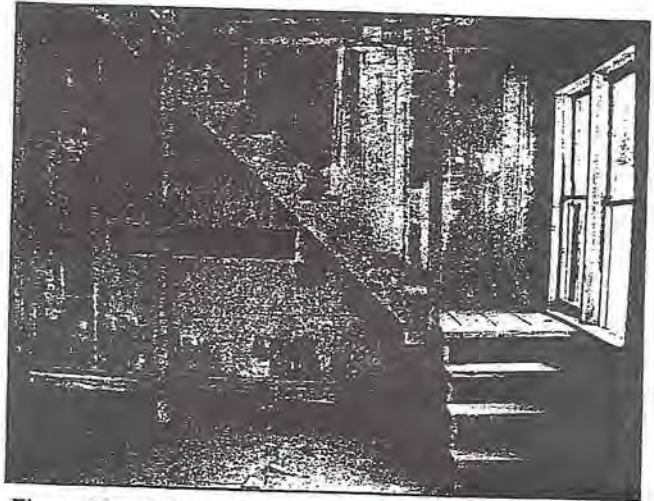
Figure 22 – Stairway in Main Office room, not original.

Suggested Mitigation Work – The stairway is not original and should be removed after it serves any useful purpose during roof repair work.

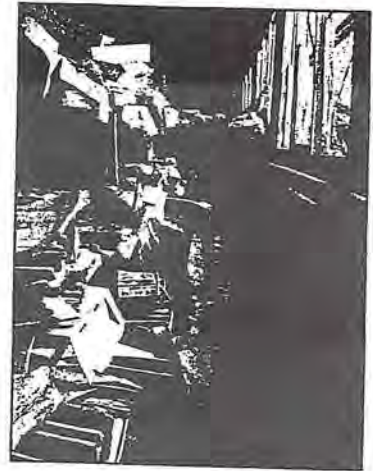
Figure 23 – Debris piles.

Some of this material may constitute a safety hazard. All debris should be removed in a manner that is safe and appropriate for the materials being removed. Monitoring may be advisable during the removal process to record any historic items that may be found. Some large or durable historic artifacts, such as the steel-and-wood dressing benches in the Changing Room, might be left in the structure and secured against theft. Monitoring may be advisable during the removal process to make sure that any historic artifacts are properly recorded.

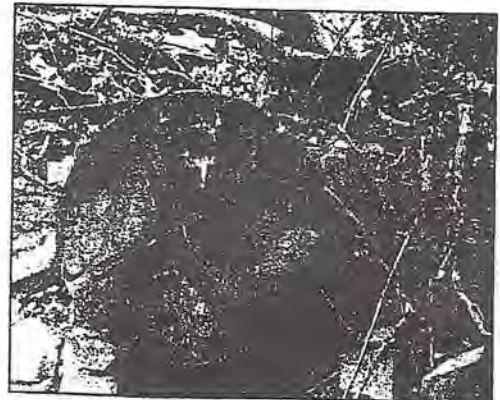
The larger, upper drum has been removed, and the bricks from the upper part of the brick enclosure are scattered around the base of the boiler. There are also some remaining vertical iron or steel straps that may have acted as supports or anchors for the brick boiler enclosure. It is difficult to make a determination of the boiler type without removing the debris that covers the remains of the boiler and firebox.

Figure 35 – Lower drum of boiler.

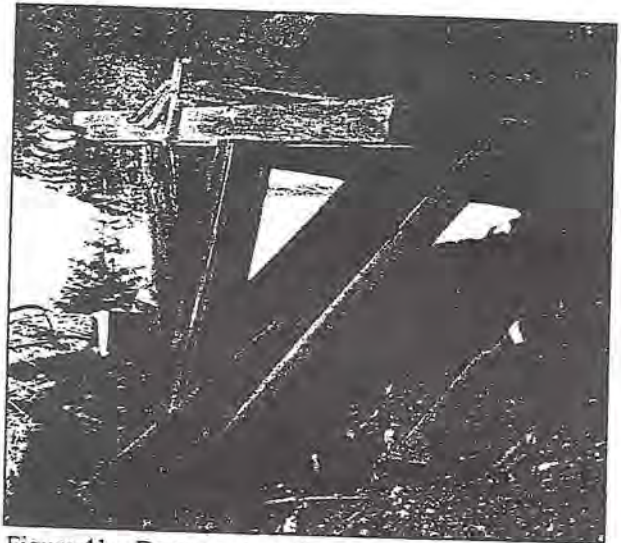
The northeast corner of the ore bin support framework has been damaged by an unknown event (possibly a collision, but this is only speculation). Whatever the event, it dislodged an 8" x 8" x 14' wooden beam, causing it to pivot; its north end was displaced to the west approximately 39 inches and its south end displaced to the east approximately 28 inches (Figure 41). In addition to swinging the beam out of place, this event also knocked out an 8" x 8" x 6' post that supported the northeast corner of the ore bin, rendering the adjoining cross brace ineffective. It appears that the wooden beam is still in good condition. The support post, however, is rotted at its lower end. The lower end of the cross brace also appears to have rotted to some degree, although it is difficult to determine the extent of the decay without removing the cross brace.

Figure 41 – Damage at northeast corner of ore bin.

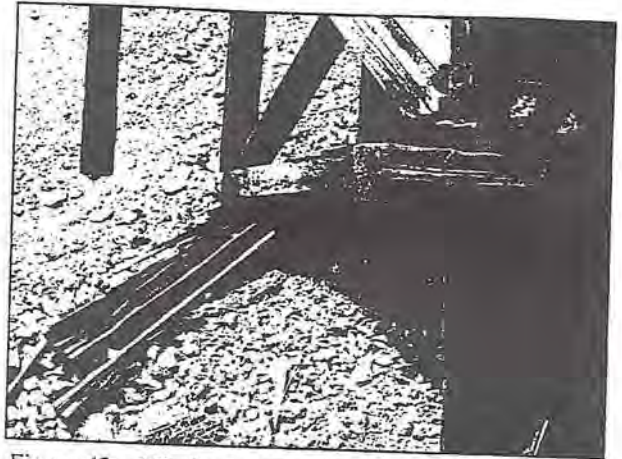
Figure 42 – Missing beam and post, rotted footing.

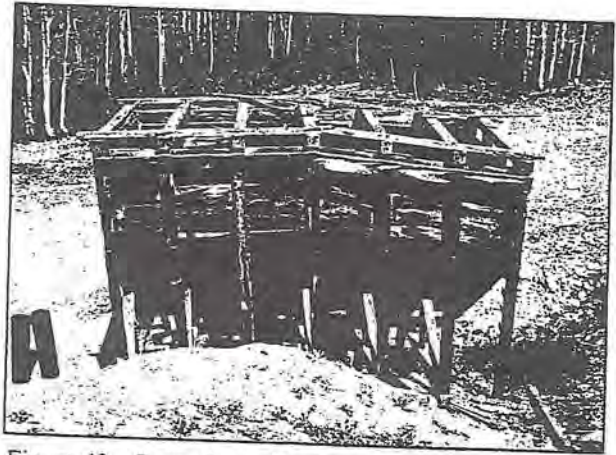
Figure 43 – Rear view, showing sagging corner.

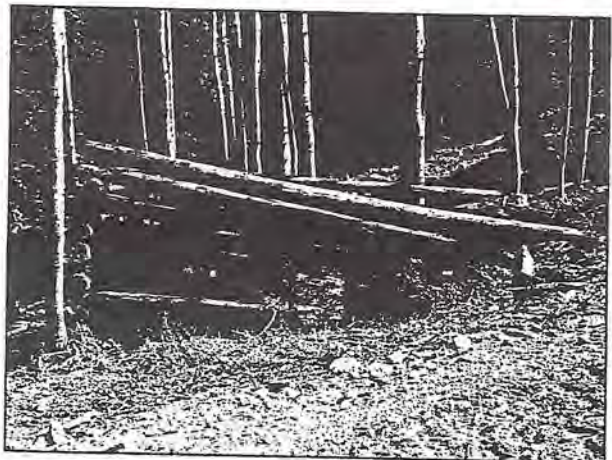
Figure 47 – West side of log structure.

Suggested Mitigation Work – A few of the logs that have rotted or shifted off center could be reinforced or replaced and shifted back into position directly over the underlying logs and secured against further movement. This would tend to stabilize the structure to some degree. It may also be advisable to install a few wood braces at key locations where shifting is possible. The logs next to the window and door openings could also be aligned more vertically and unobtrusively secured. Wood consolidants or water repellent solutions could be applied to the remaining logs, as appropriate.

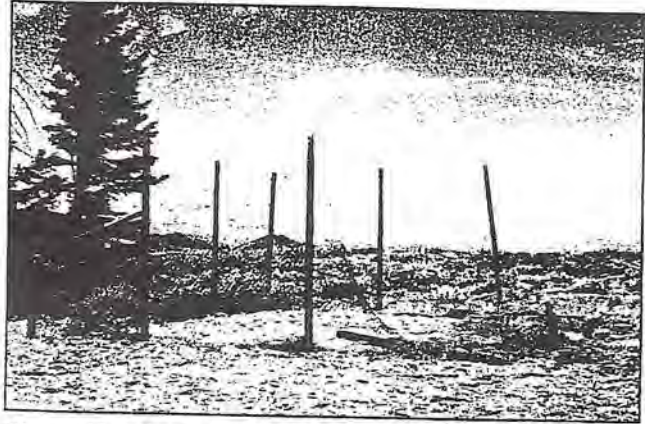
Figure 48 – Capped shaft of Flagstaff Mine.
