Historic Preservation Board Staff Report

Subject: Material Deconstruction and Reconstruction Review

Address: 115 Sampson Avenue

Project Number: PL-17-03580 Date: May 16, 2018

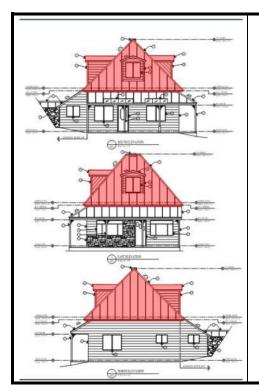
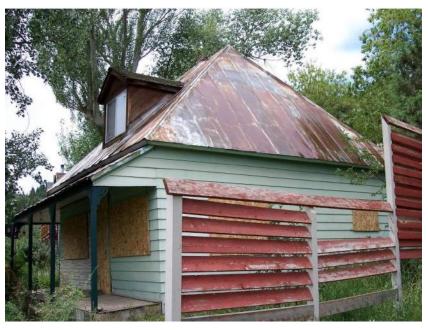
The historic house has a pyramid roof form. The east and west sides have a 12/12 pitch and the north and south sides have a 12/14 pitch. The west side of the roof transitions into a shed at an 8/12 pitch and extends into the hillside. There are simple gable dormers perpendicular to the roof on the east, west, and south sides. The roof structure consists of 1 inch by 4 inch joists at 24 inches on center, covered by 1x wood planks. The original wood shake shingle roof is covered by a standing seam metal roof that was installed after 1970. The roofing materials are in poor conditions, with the drip, fascia, and soffits requiring replacement.

In 2018, Structural Engineer Henry Shen provided an analysis of the roof structure (Exhibit E). In his report, he finds that the existing roof joists consist of 2 inch by 6 inch structural members that span 8 to 12 feet. The 8 foot joists are operating at 28% capacity and the 12 foot joists are operating at 18%. The existing roof deck is 1x wood plank installed perpendicular to the existing joists. It does not have any capacity of shear diaphragm value. The extent of repairs needed to stabilize the roof and the need to panelize the historic house make reconstructing the original pyramid roof form the best alternative.

The applicant is proposing to reconstruct the roof form. He proposes to construct dormers on all four (4) sides of the pyramid roof. Staff finds that the reconstruction of the roof and dormers on the east side of the roof are part of the restoration of the original roof form; the new dormers on the north and south sides of the roof will be incorporated into the roof form in a manner that is consistent with other historic houses. Staff is working with the applicant to ensure that the dormers are consistent in mass and scale to those that were seen historically.

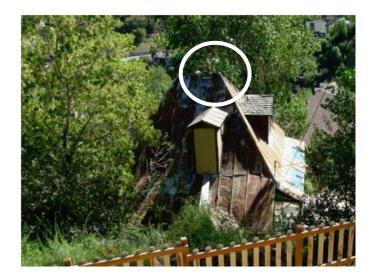
There is an existing masonry chimney that protrudes from the top of the pyramid roof structure. The chimney is original to the structure, but has been modified over the years and no longer functions as a smoke flue. It has been significantly shortened, likely as layers of the brick deteriorated. The applicant is proposing to salvage the bricks from the historic chimney and reconstruct it on the outside of the house. Staff finds that this is necessary to restore the original chimney.

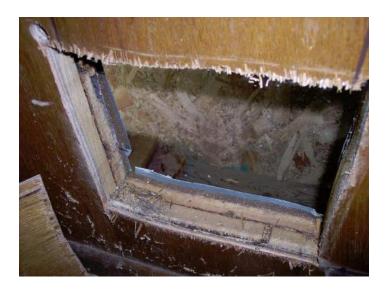
The exterior walls are comprised of single-wall construction with 1x12 vertical planks beneath 1 inch by 6 inch horizontal planks. They have been covered with ½ inch fiberboard and aluminum siding that was added after 1970. The structural engineer has determined that the exterior walls have no capacity for wind, seismic, or gravity loads. On the west side of the house, these walls retain the hillside, and the moisture from exposure to the ground has caused them to rot. The structural engineer found that 75% of the walls were deteriorated and would require reconstruction.

The photograph below shows the typical exterior wall construction with aluminum siding, fiber board, 1x8 horizontal lap siding and 1 inch by 10 inch vertical planks to form an interior wall.

The applicant is proposing to disassemble and preserve the north, south, and east walls of the historic house; the west wall is too deteriorated to be saved. The walls will then be reassembled over a new framed wall structure. Staff finds that the

#7. Where the historic siding materials cannot be repaired, they shall be replaced with materials that match the original in all respects: scale, dimension, texture, profile, material, and finish. The replacement of existing historic material shall be allowed only after the applicant has demonstrated to the Planning Department that the historic materials are no longer safe and/or serviceable and cannot be repaired to a safe and/or serviceable condition. The Planning Department shall approve in writing the disposal of any historic siding materials.

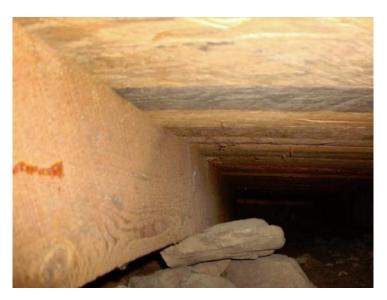
The historic structure does not have a foundation, but there are some minimal foundation walls around the perimeter of the structure. The posts, beams, and bearing walls all sit on stacked stone, wood piles, and/or soil (see following photo). The floor joists are 2 inch x6 inch at 24 inches on center; many of the floor joists span 8 to 12 feet unsupported. The structural engineer estimates that 90% of the posts supporting the floor structure have rotted due to the amount of moisture beneath the floor structure. He recommends removing the existing foundation walls and constructing a new foundation.

The applicant is proposing to raise the historic house two feet (2') as permitted by the Design Guidelines in order to construct a new code-compliant foundation. Staff finds that the proposed work mitigates any impacts that will occur to the architectural integrity of the structure.

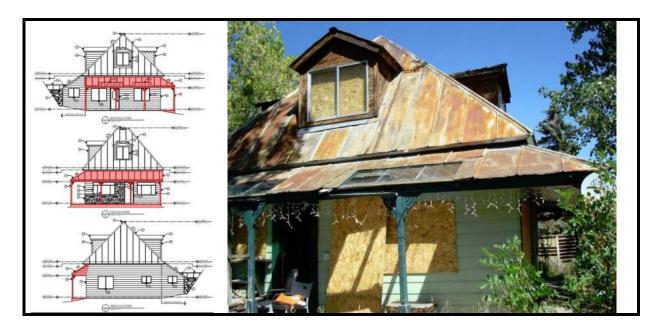
with that of the main roof and the roof joists do not meet code. A portion of the roofing was removed in the 1970s and new glass skylights/roofing material was added to the porch on the east elevation. The ceiling of the porch is 1x6 bead board. The porch posts and decorative ornamentation do not appear to be original. It has 1 inch by 6 inch tongue-and-groove decking above 2 inch by 4 inch joists at 24 inches on center; the decking has rotted and detached from the porch's floor structure.

The applicant is proposing to reconstruct the historic porch form and restore its historic appearance while meeting the structural requirements of the code. Staff finds that the proposed material deconstruction is necessary in order to restore the original wraparound porch.

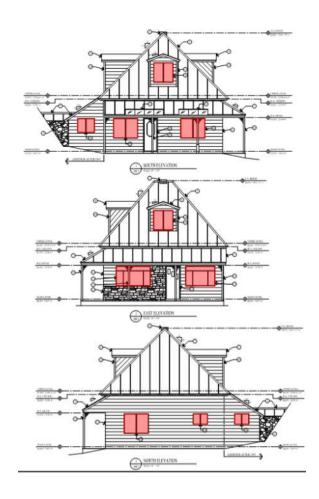
There are a total of 11 window openings on the exterior of the structure. One of the windows is completely missing; however, the other 10 openings appear to have been altered. These aluminum frame windows are not historic. The applicant is proposing to restore the original window openings and install new wood windows on the historic house; these existing window openings are highlighted in red below.

Staff finds that this material deconstruction is necessary in order to restore the historic house. To ensure that the original window openings are restored, staff has added Condition of Approval stating:

#6. Following removal of the non-historic aluminum siding, the applicant shall update his Historic Preservation Plan with a conditions report detailing the locations of original window openings. The applicant shall base any window modifications on the façade (east elevation) or secondary facades (north and south elevations) that will be visible from the Norfolk and Sampson Avenue rights-of-way on physical, measured evidence uncovered during the demolition process. Planning staff shall review and approve the updated window configuration based on this new physical evidence.

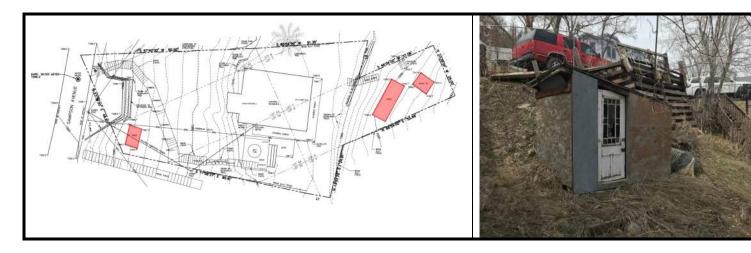
There are three (3) existing sheds on the property. These sheds were not designated as Historic on the 2009 Historic Sites Inventory. Upon closer examination, staff finds that they were likely constructed of reclaimed materials after 1960. The sheds were built on flatter portions of the lot, so that one shed is visible near the parking pad along Sampson Avenue and two are in the eastern corner of the site. Because the eastern side of the site is overgrown, staff was not able to successfully photograph these two sheds. The shed on the west side of the property is constructed of plywood.

The applicant is proposing to demolish these sheds as part of their site improvements. Staff finds that these sheds are not historic and do not contribute to the historical significance of the site.

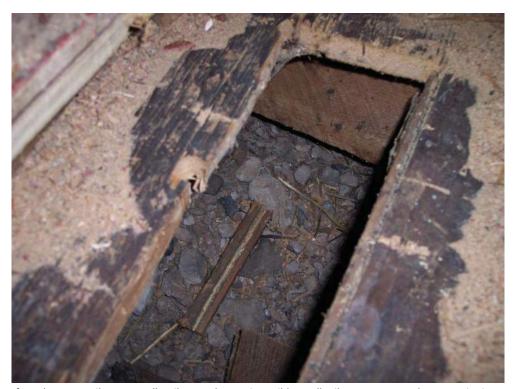
Photo 2a: Typical floor assembly 1x6 plank on 2x6 joist bearing on stone/soil

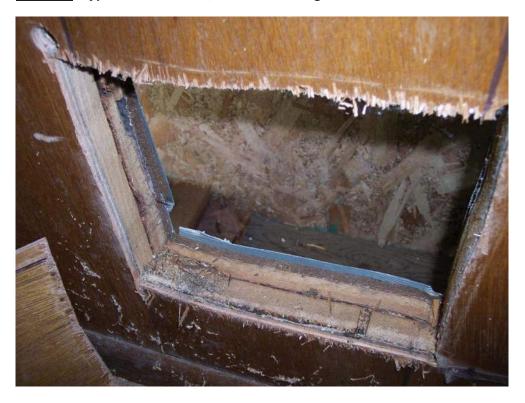
Photo 2b: Typical exterior wall, aluminum siding on 1/2" fiber board in 1x8 horiz. lap on 1x10 vert. plank

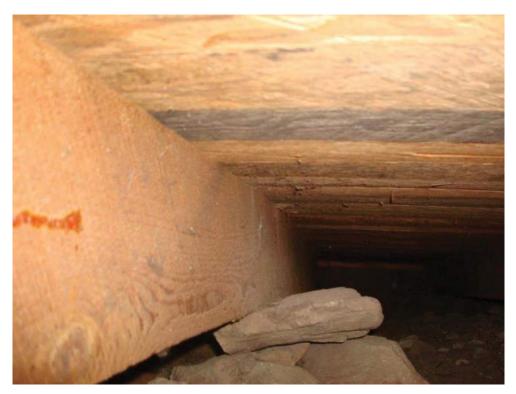
Photo 2c: Typical joist bearing on stone/soil
