# Historic Preservation Board Staff Report

**Author:** Anya Grahn, Historic Preservation Planner  
**Subject:** Material Deconstruction Review  
**Address:** 911 Empire Avenue  
**Project Number:** PL-17-03441  
**Date:** May 3, 2017  
**Type of Item:** Administrative – Material Deconstruction and Reconstruction

## PHYSICAL CONDITIONS REPORT

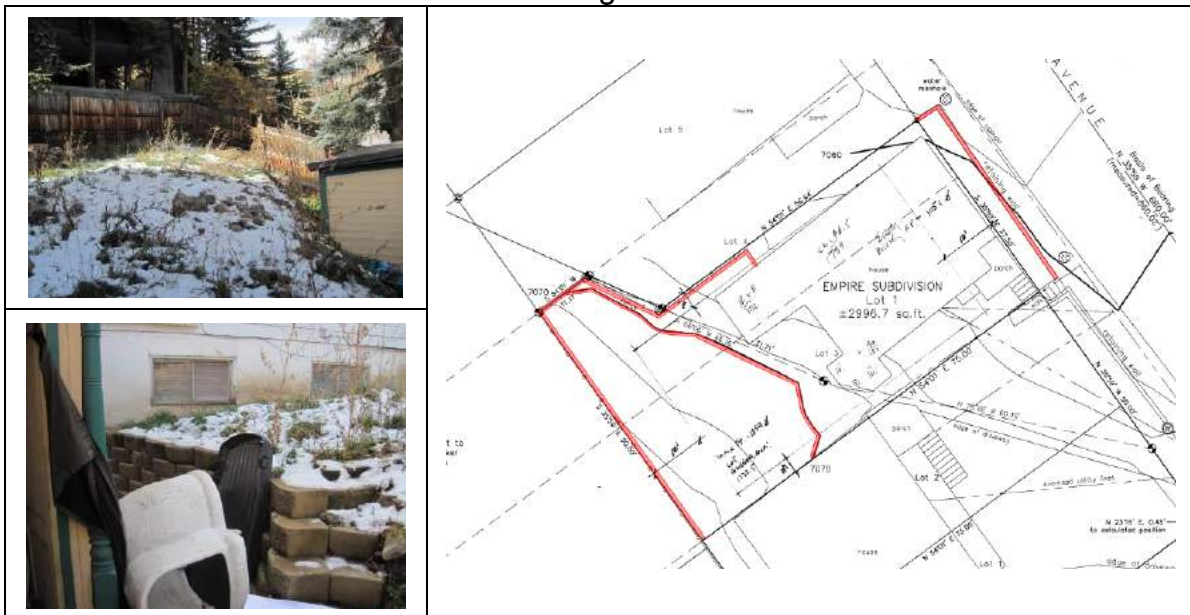
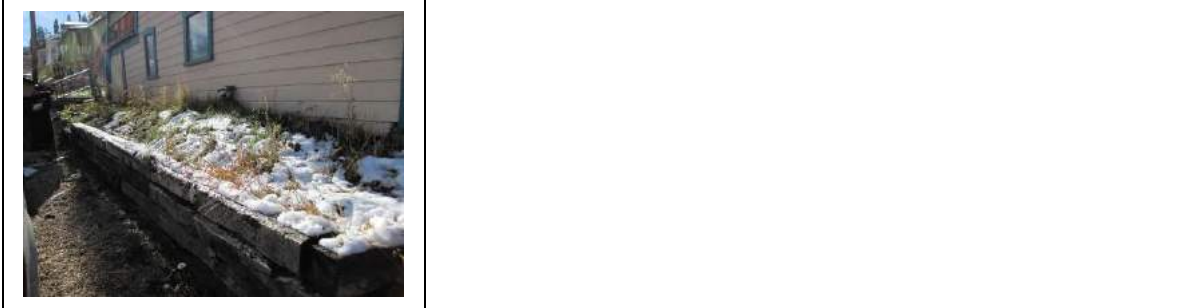
The topography of the site slopes uphill from east to west along Empire Avenue; however, the steepest grades on the site are located in the rear yard. There is a two foot (2') tall railroad tie retaining wall that runs parallel with the street and that is located in the city's right-of-way; according to staff's photographic analysis, this retaining wall was likely constructed after 1983. There is also a four foot (4') tall concrete block retaining wall along the rear property line; the concrete blocks are contemporary in design and not historic. Additionally, there is a non-historic, contemporary fence that following the rear lot line and continues down the north side yard to the back of the house.

Staff has identified the fence and retaining walls in red below:

The applicant is proposing to remove these non-historic improvements. The front yard will be regraded and revegetated as a lawn. In the backyard, the applicant will be regrading and terracing the backyard with new stacked stone retaining walls, concrete planters, and vegetation in order to create an outdoor living space.

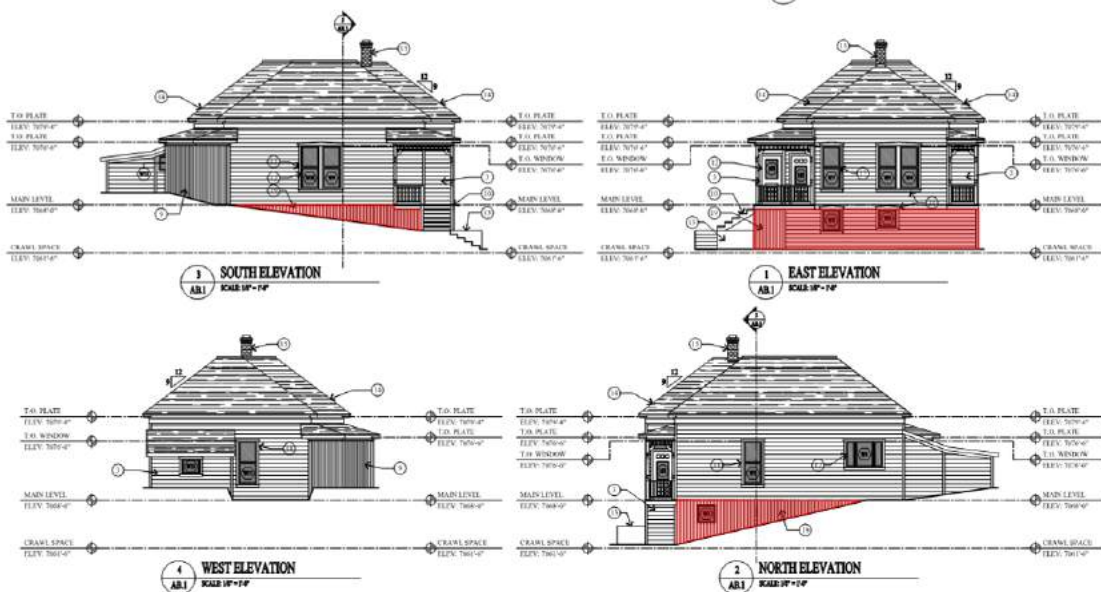
The house currently has no foundation. All of the posts and bearing walls sit directly on soil, which has led to portions of the original wood siding suffering from wood rot and deterioration. The applicant proposes to temporarily lift the structure in order to pour a new foundation.

Staff has shaded the areas to be (potentially) impacted by the construction of the foundation in red:

The applicant has not yet completed exploratory demolition. At this time, they are not proposing to remove the walls of the basement in order to temporarily lift the house and pour a new foundation; however, they anticipate that this may need to occur if the walls are in poor condition.

*#2. Following interior demolition, the applicant shall schedule a site visit with the Chief Building Official and Planning Director to evaluate the condition of the foundation level walls. Should these walls need to be removed due to their deteriorated state, they shall either be removed in the largest panels possible or reconstructed with materials that match the original in all respects: scale, dimension, texture, profile, material, and finish. The Physical Conditions Report and Preservation Plan shall be amended to document the condition of these walls and provide an updated scope of work to the satisfaction of the Planning Department. Any changes, modifications, or deviations from the approved scope of work shall be reviewed and approved by the Planning Director in writing prior to construction.*

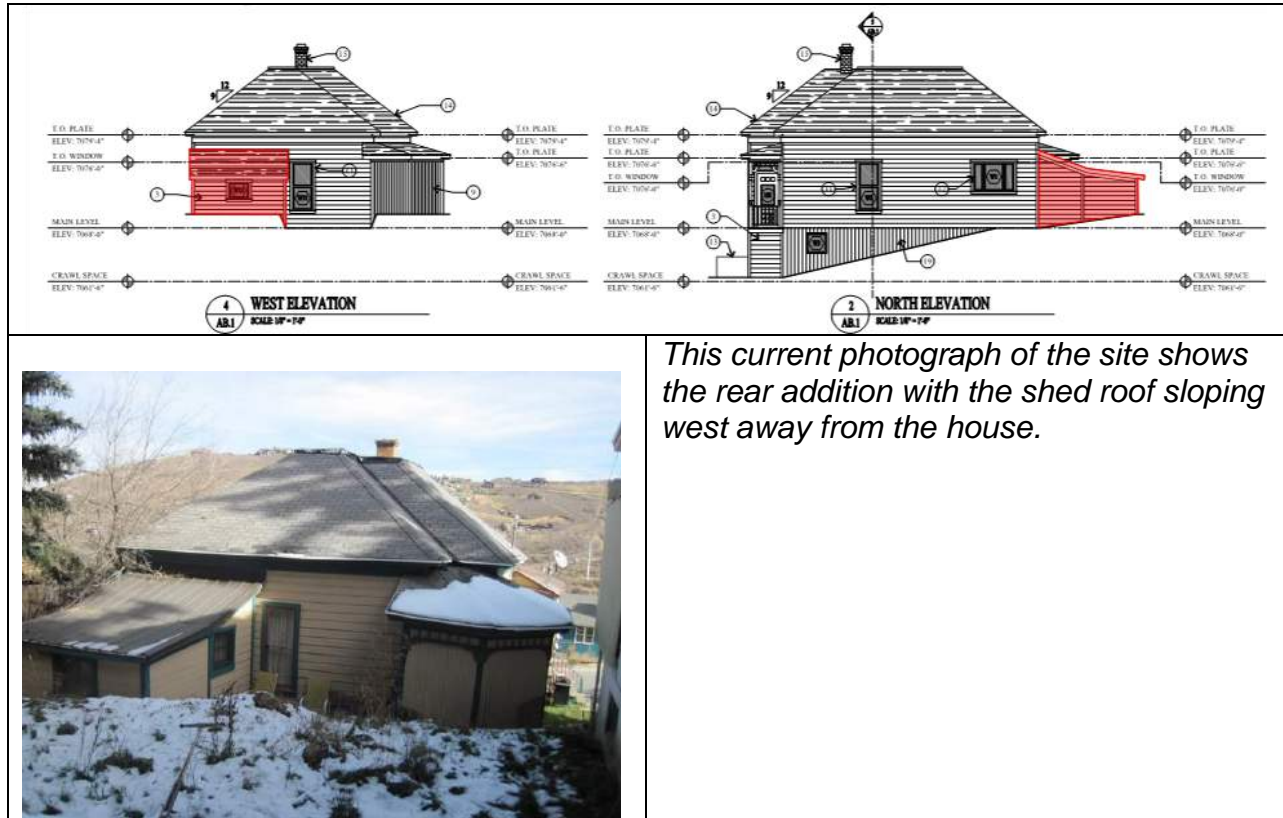
There are two existing additions on the back of the house. The first rear addition (shaded in red below) was likely constructed sometime after 1941, based on staff's analysis of the Sanborn Fire Insurance Maps and tax photographs. It features a 4.5:12 pitch and 3:12 pitch shed roof that slopes west away from the house; this change in roof pitch demonstrates that the rear addition was likely built in two phases. The addition is wood-framed and clad in horizontal lap siding.

*This current photograph of the site shows the rear addition with the shed roof sloping west away from the house.*

The applicant is proposing to remove this addition in order to construct a new addition to the west (rear) elevation of the house. Staff finds that this addition is not historic and does not contribute to the historic integrity or historical significance of the structure.

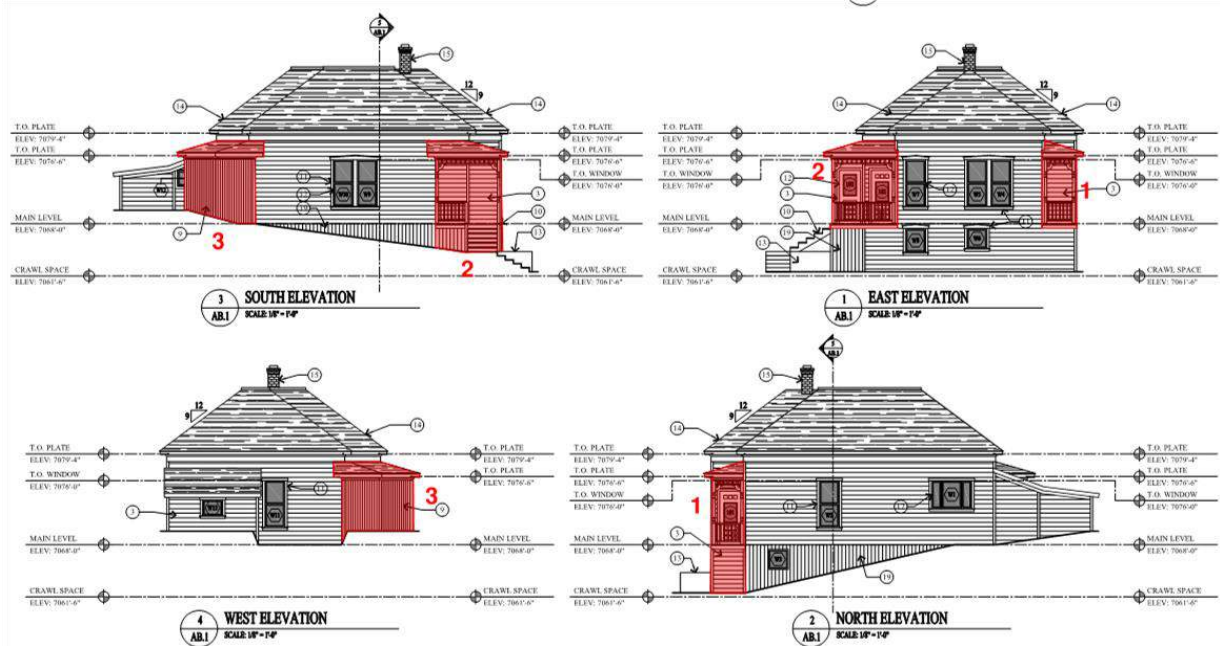
The first porch on the northeast (front) corner of the house maintains its original location. No stairs lead away from this porch; it acts as a balcony. Sometime between 1941 and 1983, the wood railings were replaced with a simple wood railing. The decorative turned posts, ornamental brackets, and decorative cornice have survived. The porch has a 3.5:12 hipped roof covered with asphalt shingles.

The porch on the southeast corner of the house has retained its original location. The turned posts, ornamental brackets, and decorative cornice have survived; however, the railing was replaced between 1941 and 1983. The porch has a 3.5:12 hipped roof covered with asphalt shingles. The porch stairs have been rebuilt.

Staff has shaded these three porches in red below:

The applicant believes that Porches 1 and 2 can be lifted with the house to pour the foundation. The applicant believes the historic materials will be able to be preserved. Contemporary additions to the porches, such as the wood railing, will be replaced with new materials. Staff finds that the material deconstruction is required for the restoration of the building.

The applicant believes that Porch 3 on the southwest corner of the house will need to be demolished and reconstructed to facilitate the lift. They anticipate trying to salvage any historic materials they find on this porch to reuse in the reconstruction following construction of the foundation. Staff finds that the material deconstruction is required for the reconstruction of Porch 3 as an open porch.

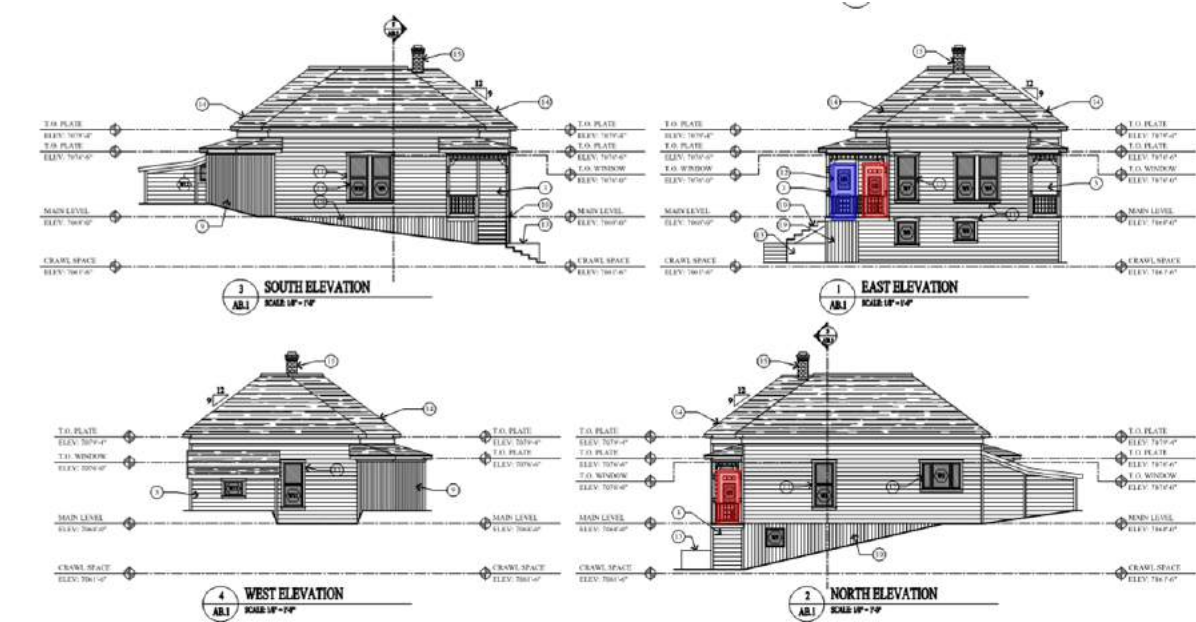
There are three (3) historic doors on the exterior of the historic house. The applicant's physical conditions report finds that these doors are in fair condition. The doors on the front of the house may be restored or may require replacement. The door on the enclosed porch will be removed as part of the restoration of the original open porch design.

The two doors to be restored are shaded in red and the third door to be removed is shaded in blue below:

The applicant is proposing to review with staff the condition of the two (2) historic doors on the front of the house. Staff has added Condition of Approval #4 which states requires that the applicant shall coordinate with staff to determine if the two (2) historic doors on the front of the house can be restored or will require replacement. Should the doors need to be reconstructed due to their deteriorated state, they shall be replaced in-kind with new doors that match the original in all respects: scale, dimension, texture, profile, material, and finish. The replacement of the doors shall be approved by the Planning Director in writing prior to removal.

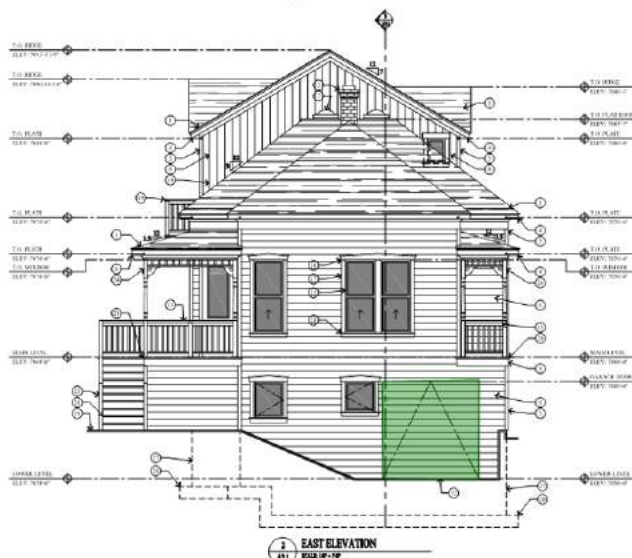
The applicant is also proposing to remove a section of the wall on the lower level of the façade in order to accommodate a new garage. Staff has shaded the location of the new garage door in green below:

The applicant is proposing to salvage the historic siding from this wall and install it over the new garage door so as to conceal its appearance. The photos below

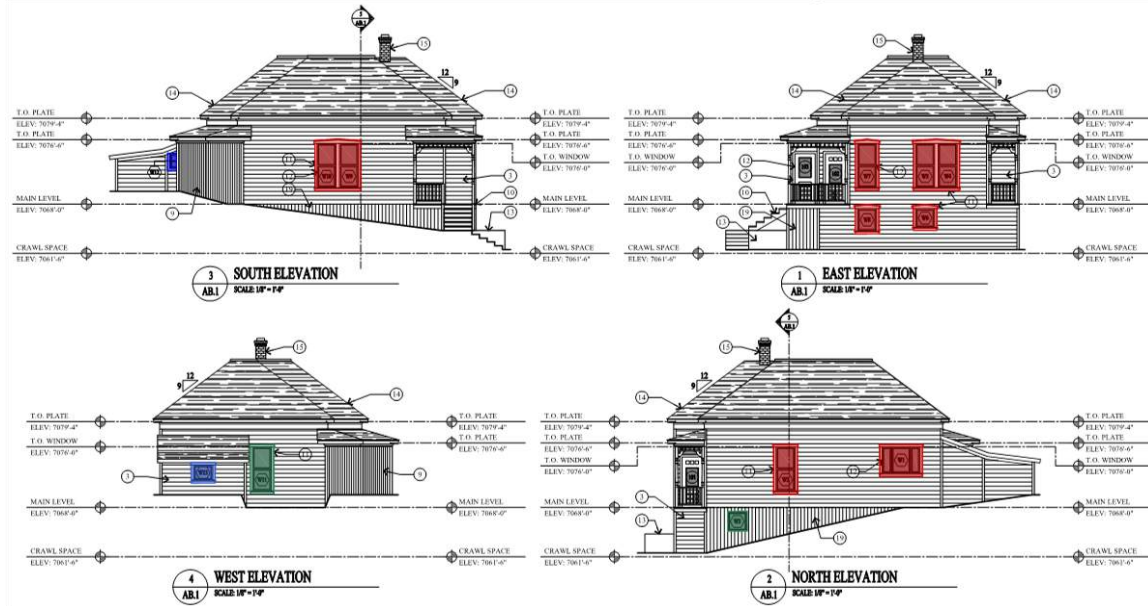
There are thirteen original window openings on the house; eleven of these openings are located on the original pyramid-roof cottage and two (2) are located on the post-1941 rear addition.

Staff has shaded the historic window openings in red, non-historic openings in blue, and openings to be altered in green:

The applicant is proposing to remove the historic windows (shaded red) and replace them with new wood windows. The applicant has had a window assessment completed by American Heritage Window Rebuilders (Exhibit E), and they found that the windows were beyond restoration. They need to be replaced in-kind.

The non-historic windows (shaded blue) are on the rear addition and are proposed to be removed along with the addition.

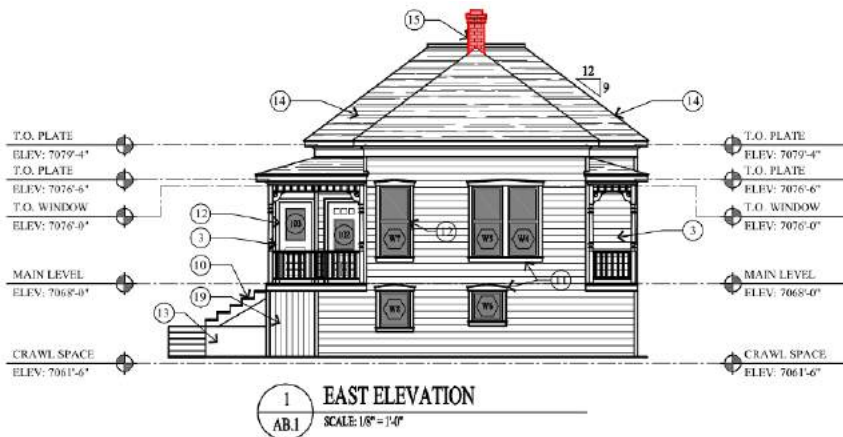
There is one (1) existing historic chimney on the front portion of the house that is original to the c.1895 structure. The chimney no longer functions as a smoke flue and has been modified on the main level. It is in need of repair. The chimney is highlighted in red below:

The applicant is proposing to deconstruct the existing brick chimney. He will salvage the existing bricks and reconstruct the historic chimney from the roof ridge. It will not be rebuilt on the interior.

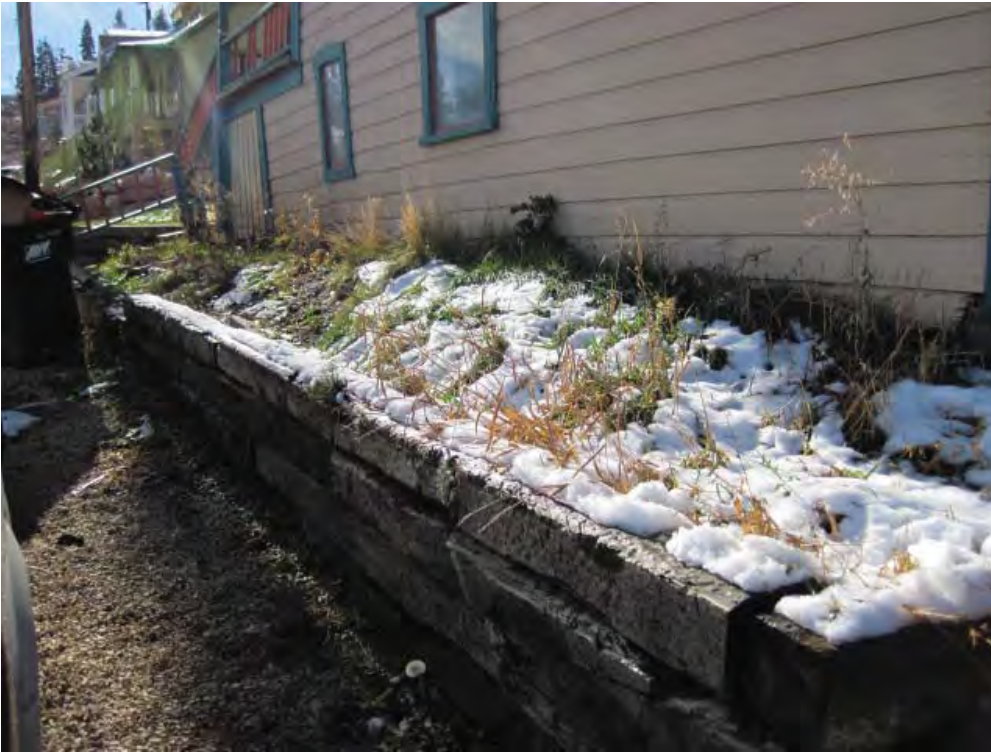
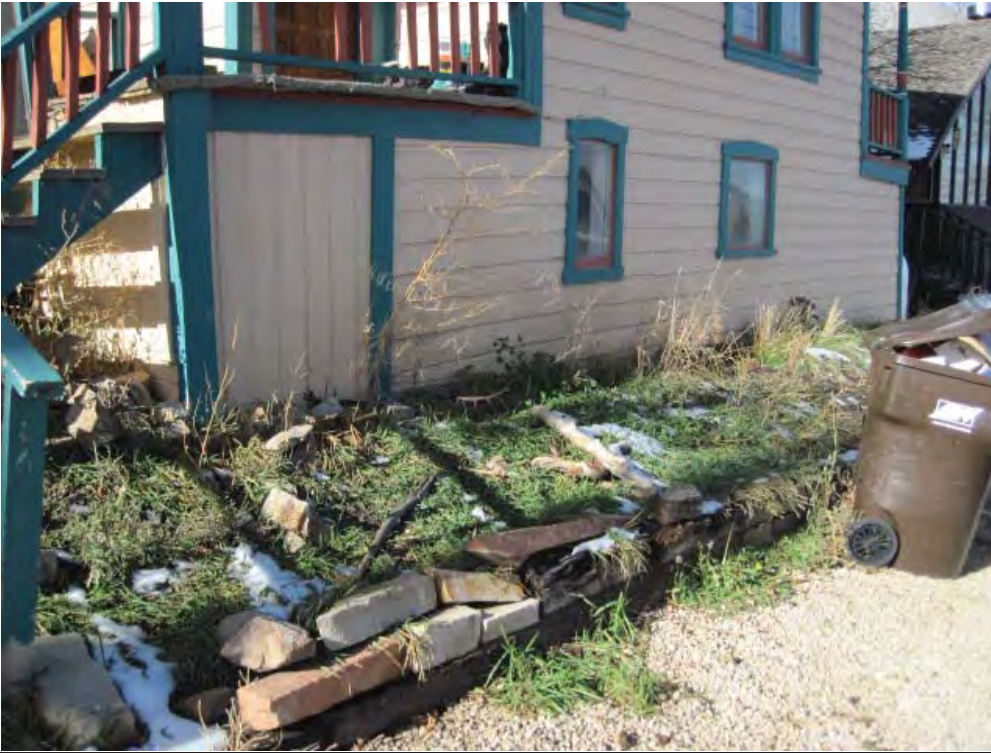
**Photo #1: Wood tie retaining wall**

**Photo #1A: Wood tie retaining wall**

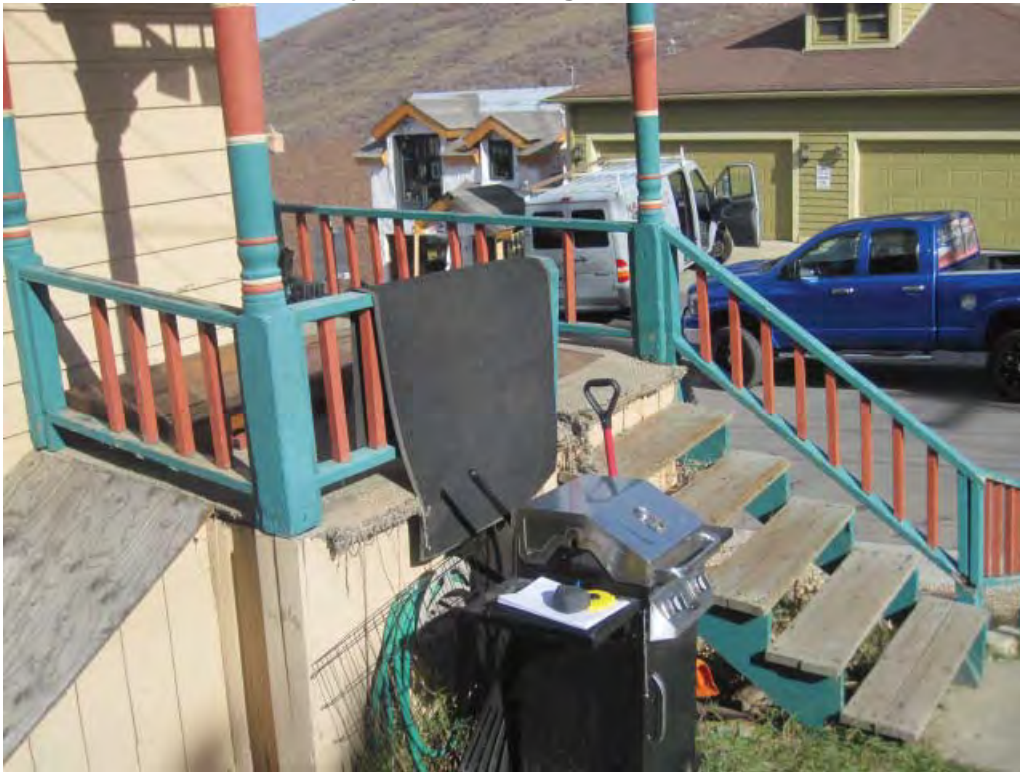
***The stairs and railing on the southeast entry porch are not original to the house and are in need of repair. The railing on the northeast porch is not original and needs repair.***

**Photo #2: Southeast entry stairs & railing**

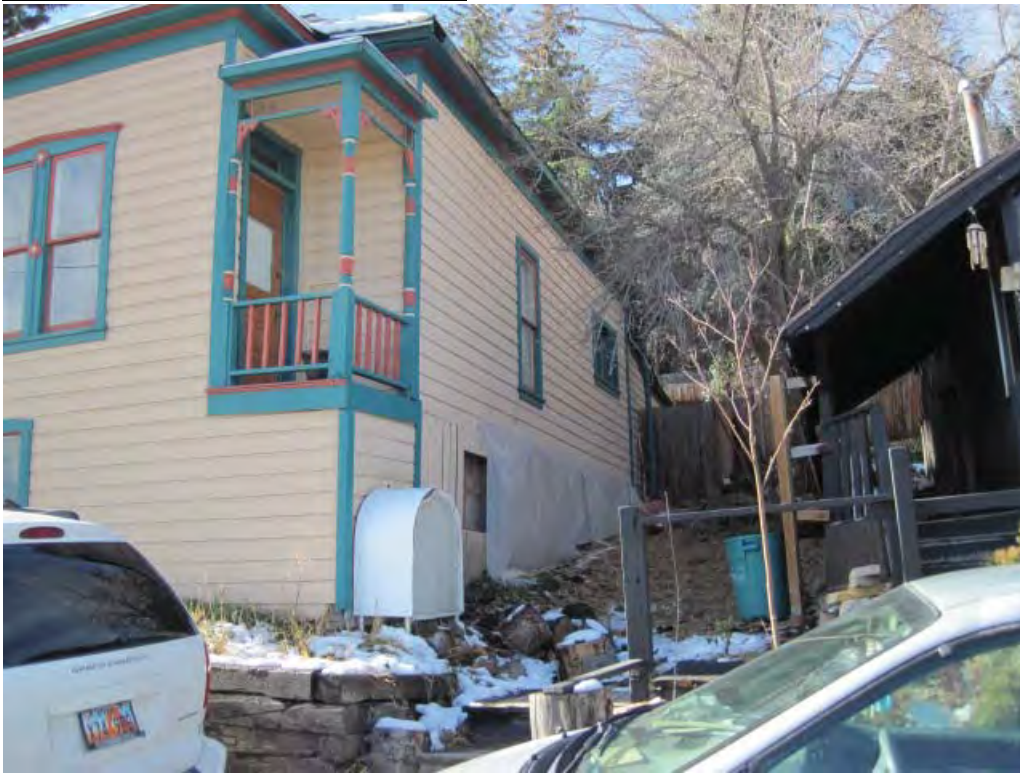
**Photo #3: Northeast porch railing**

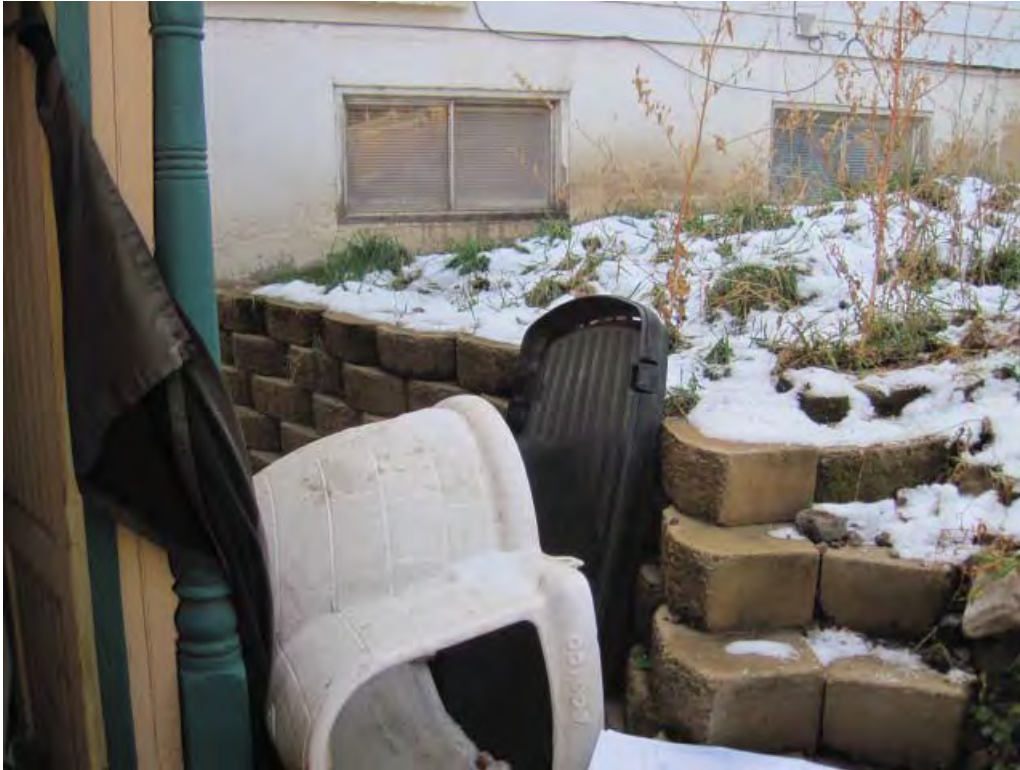
**Photo #4: Concrete block retaining wall**

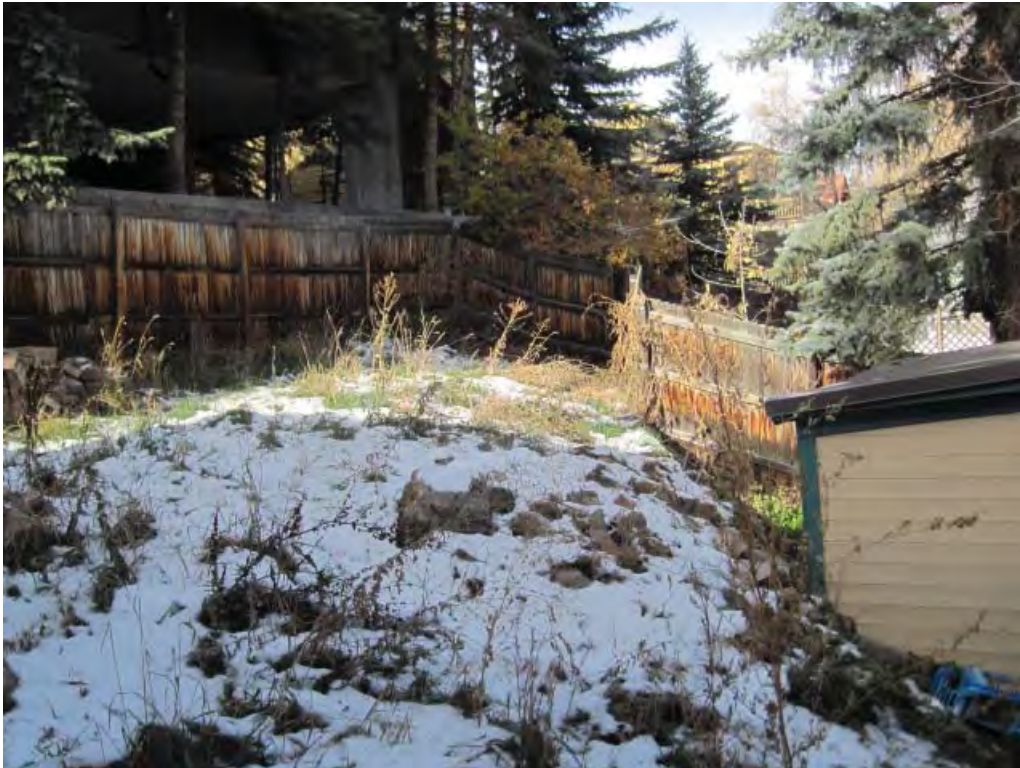
**Photo #5: West & North wood fence**

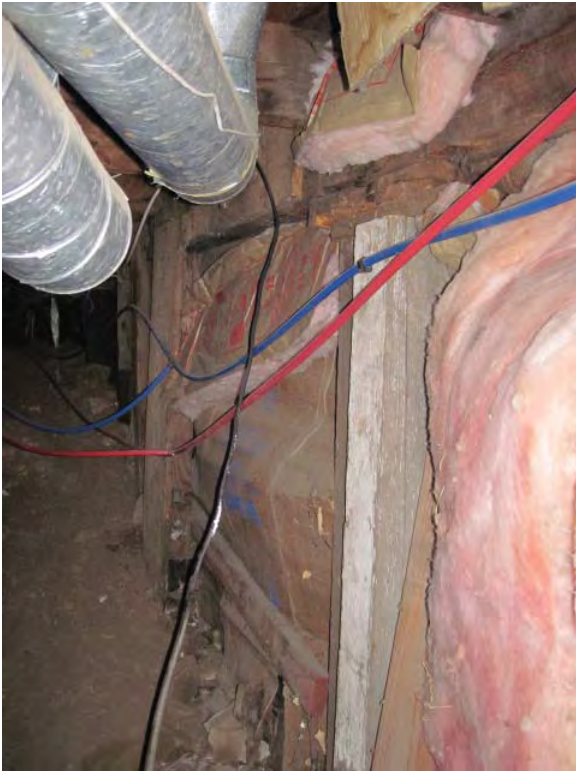
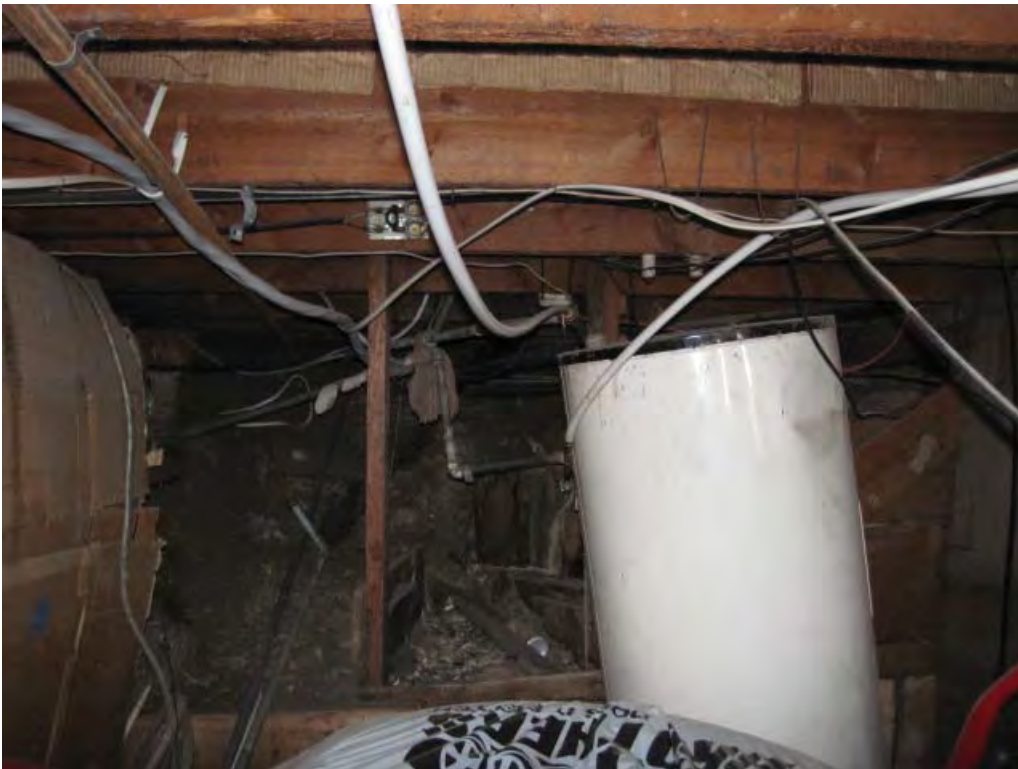
**Photo #6: Bearing walls and post on soil**

**Photo #7: Bearing walls and post on soil**
