PARK CITY MUNICIPAL CORPORATION
HISTORIC PRESERVATION BOARD
CITY COUNCIL CHAMBERS
August 2, 2017

632 Deer Valley Loop —Disassembly/Reassembly (Panelization) and Material Deconstruction—Significant House. The applicant is proposing to disassemble and reassemble the north, east, and west walls of the existing historic house on its lot. In addition, the applicant will be removing non-historic broken wood stairs and overgrown landscaping; historic c.1918 floor structure; c.1941 enclosed porch addition; c.1969 rear addition; c.1918 fire-damaged roof structure; c.1918 brick chimney; non-historic c.1969 concrete block chimney; c.1969 T-11 siding; 18 linear feet of the historic c.1918 west wall; historic c.1918 front porch and c.1969 ornamental porch posts; c.1930 exterior door on north façade; non-historic service door on west elevation; 9 non-historic single-pane, replacement windows.

PARK CITY MUNICIPAL CORPORATION
HISTORIC PRESERVATION BOARD
MINUTES OF JUNE 7, 2017

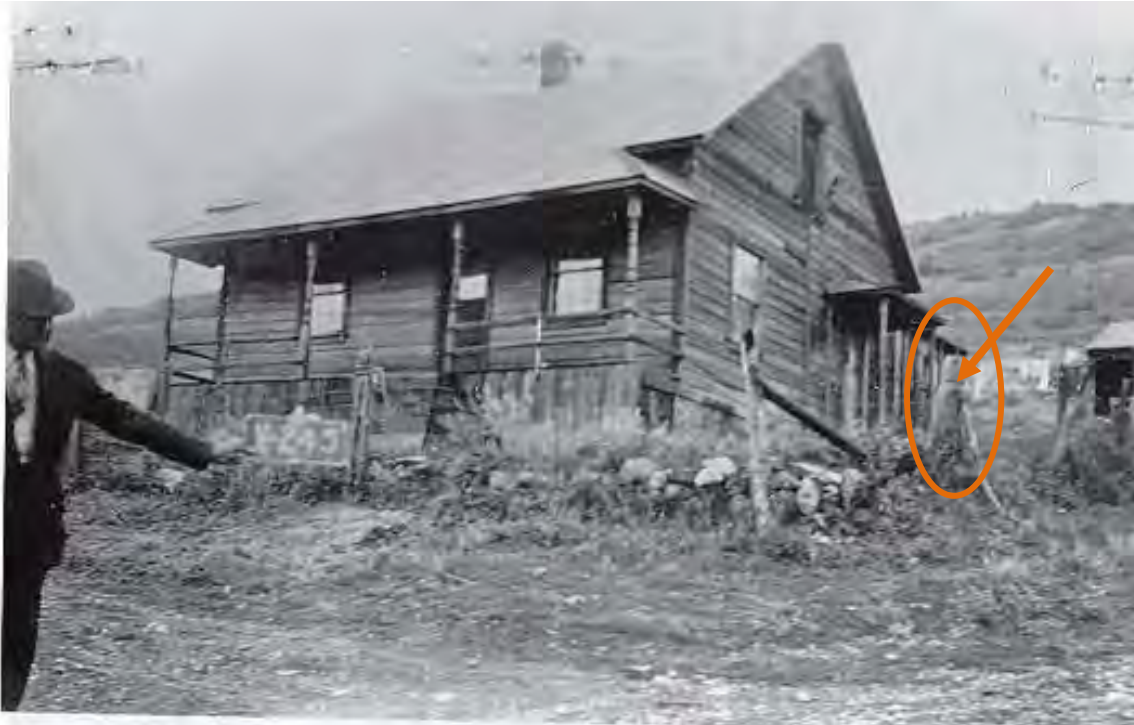
Above: The arrow denotes the structure to the back of the building c.1941. It is unclear if this is a short-lived addition or an unidentified outbuilding.

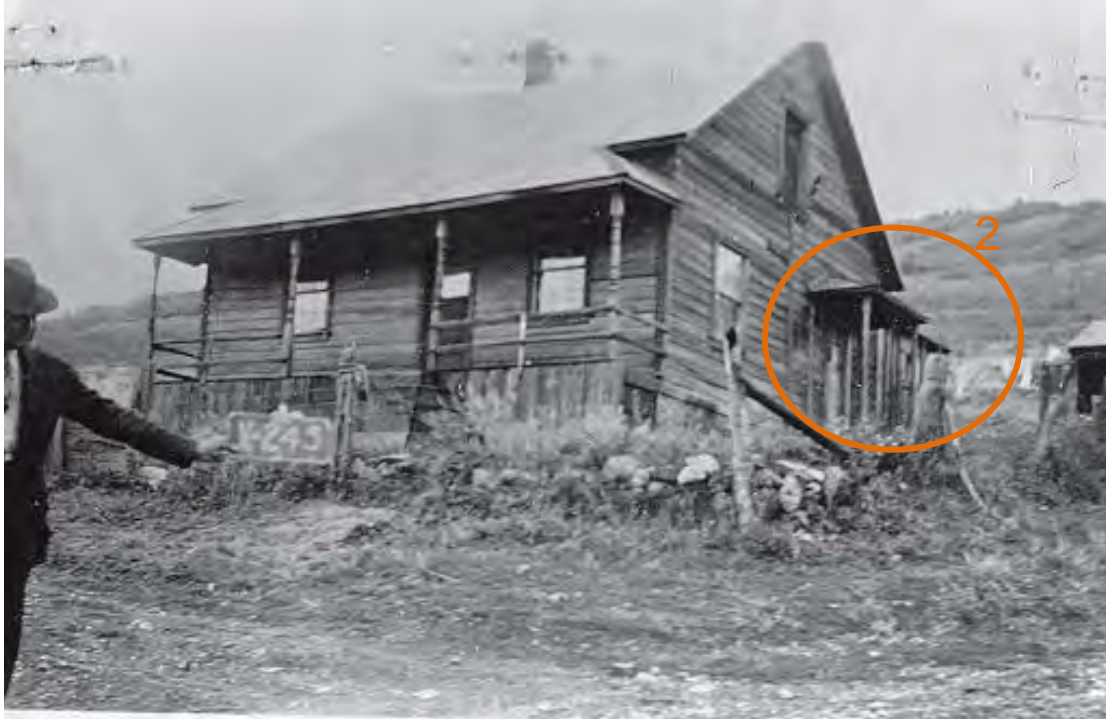
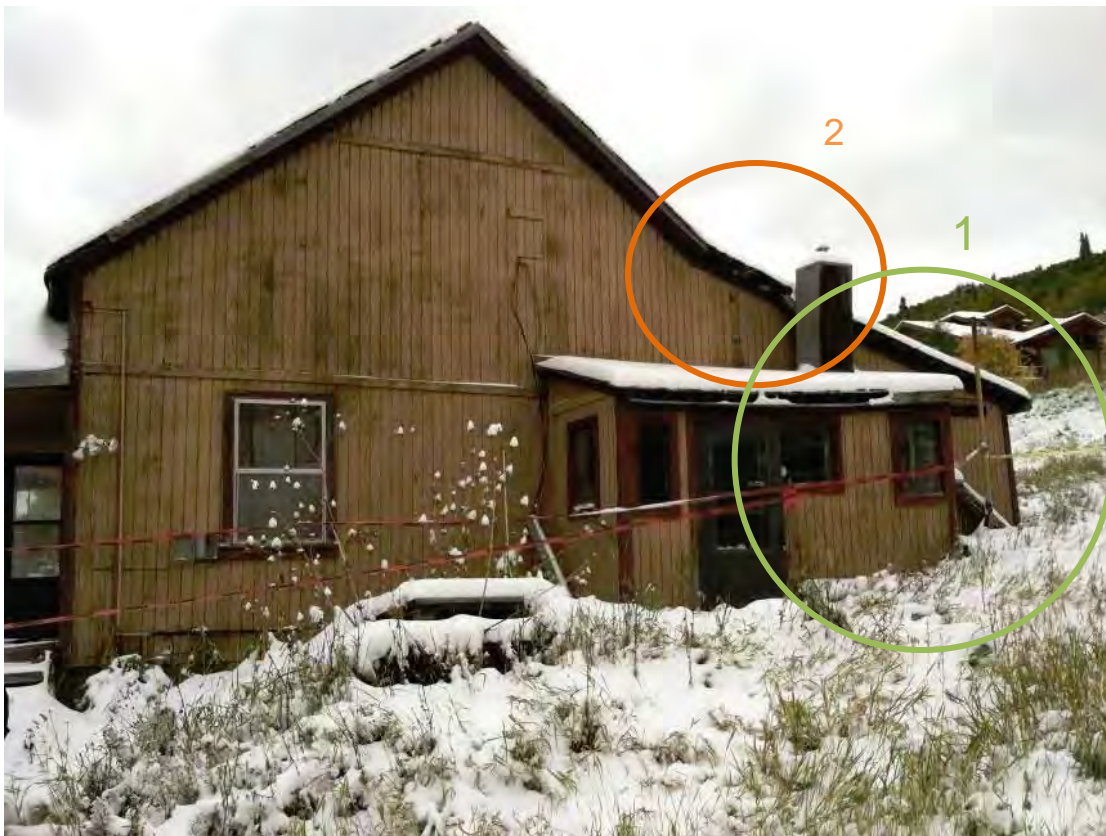
1. *Mudroom extends beyond the original south wall of the side-gable structure.*
2. *The historic photograph shows that the side-gable is symmetrical and the eave is detached. The c.2013 photograph shows that the gable has been shortened in*

order to add the c.1969 shed-roof addition.

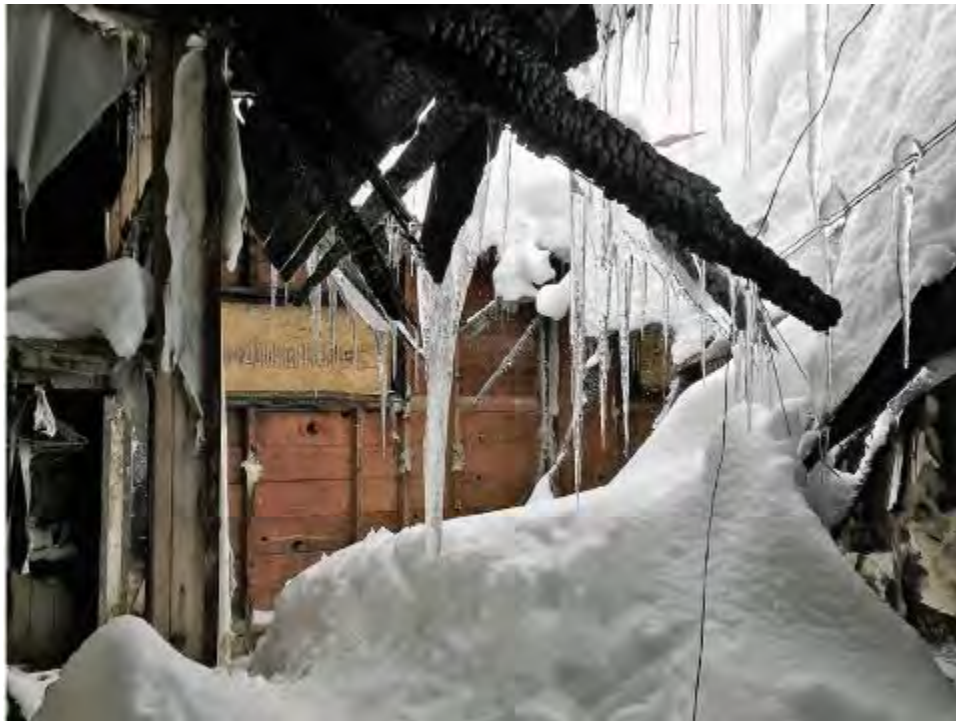
The rear portion of the house was severely damaged in a fire on May 17, 1999. Since that time, the building has been vacant and exposed to the elements. In his Physical Conditions Report, the applicant finds that "the walls of the historic portion of the house are largely intact, though portions of the East wall are fire damaged. The South wall of the original house is heavily fire-damaged and not salvageable. Roof rafters in the original house are either burned or smoke and fire damaged. The fire caused roof collapse in the South addition and portions of the South side of the historic home."

Photo of interior of c.1969 addition and historic wall of the house. Due to the hole in the roof of the c.1969 addition, the back portion of the historic house and the c.1969 addition have been largely exposed to the elements.

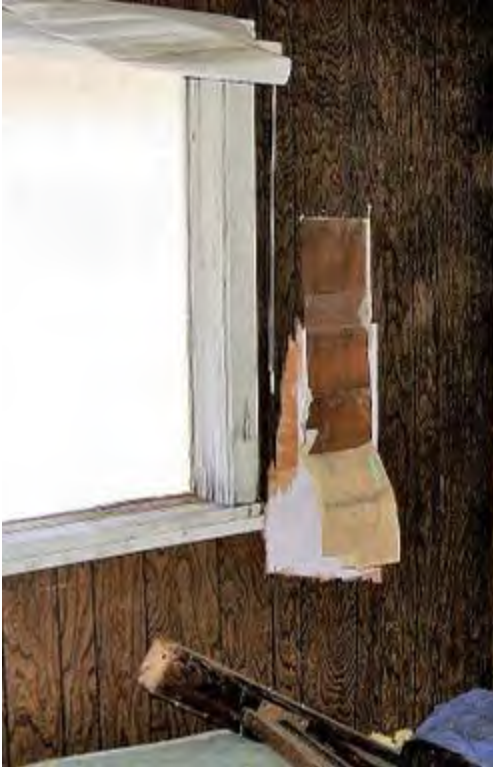
The exploratory demo on this interior wall of the east elevation showed that wallpaper had been applied over horizontal wood planks, typical of single-wall construction. On the opposite wall on the west elevation, stud framing was present.

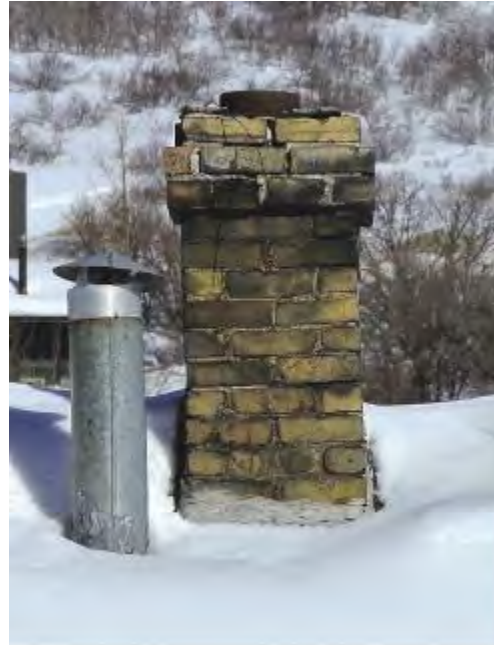
On the west elevation, there is a concrete block chimney that runs through the roof of the c.1969 roof of the enclosed porch addition. There are also a metal chimney flues on the south (rear) elevation of the house. Staff finds that the concrete block chimney and metal flue do not contribute to the historic integrity and historical significance of the structure.

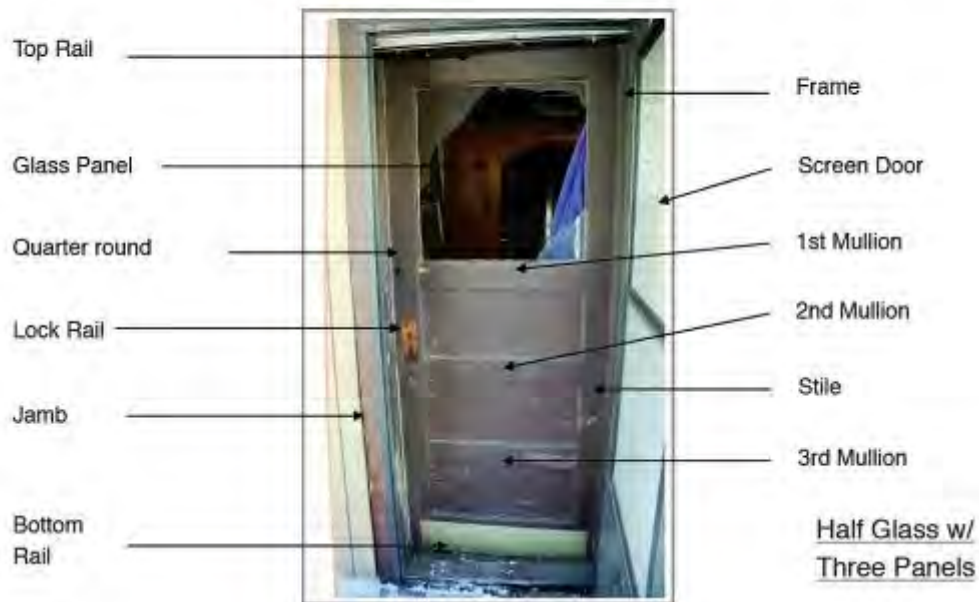
Photo #19: Entrance Door #1

Historic front door proposed to be salvaged and reused.

8. The applicant shall work with the Historic Preservation Planner to determine whether or not the historic door on the historic house can be salvaged and reused as an operable door on the rehabilitated house. The Historic Preservation Planner shall make a determination in writing prior to material deconstruction on the door.

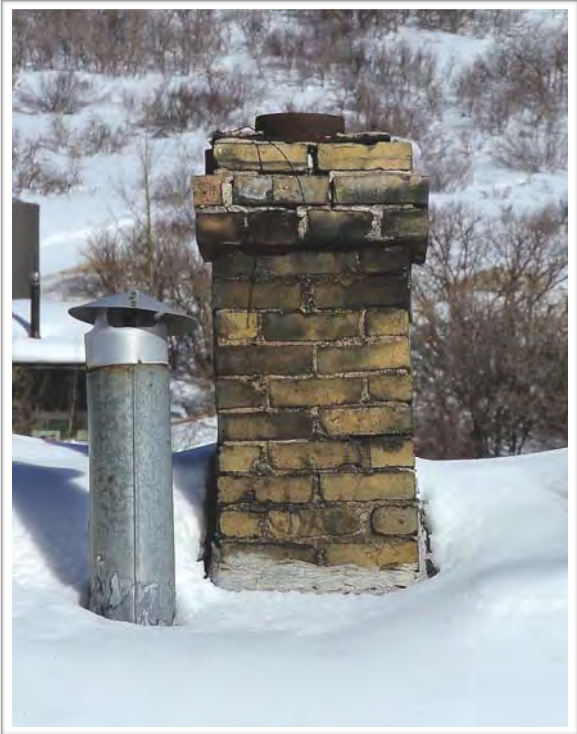
Photo #8: Brick Chimney

There is a brick chimney in the center of the historic house that is original to the building. The chimney is in fair condition and the applicant believes it can be salvaged. The chimney likely provided a vent for a wood stove, so the brick chimney base only exists through the attic and does not continue to the ground floor. The chimney served as a fire break in the attic.

6. Should the historic chimney not be able to be removed in one piece, the applicant shall disassemble the chimney in the largest workable pieces possible. All the elements of the chimney shall be systematically separated from the chimney. The markings shall be removable or made on surfaces that will be hidden from view when the chimney is reassembled. The process of the disassembly shall be recorded through photographic means.
