**PARK CITY MUNICIPAL CORPORATION
HISTORIC PRESERVATION BOARD
CITY COUNCIL CHAMBERS
November 1, 2017**

632 Deer Valley Loop —Reconstruction—Significant House. The applicant is proposing to reconstruct the north, east, and west walls of the existing historic house. PL-17-03512 17
Planner Grahn

Staff recommends the Historic Preservation Board review and discuss the application, conduct a public hearing, and approve the reconstruction of the historic house at 632 Deer Valley Loop pursuant to the following findings of fact, conclusions of law, and conditions of approval. This site is listed as Significant on the City's Historic Sites Inventory (HSI).

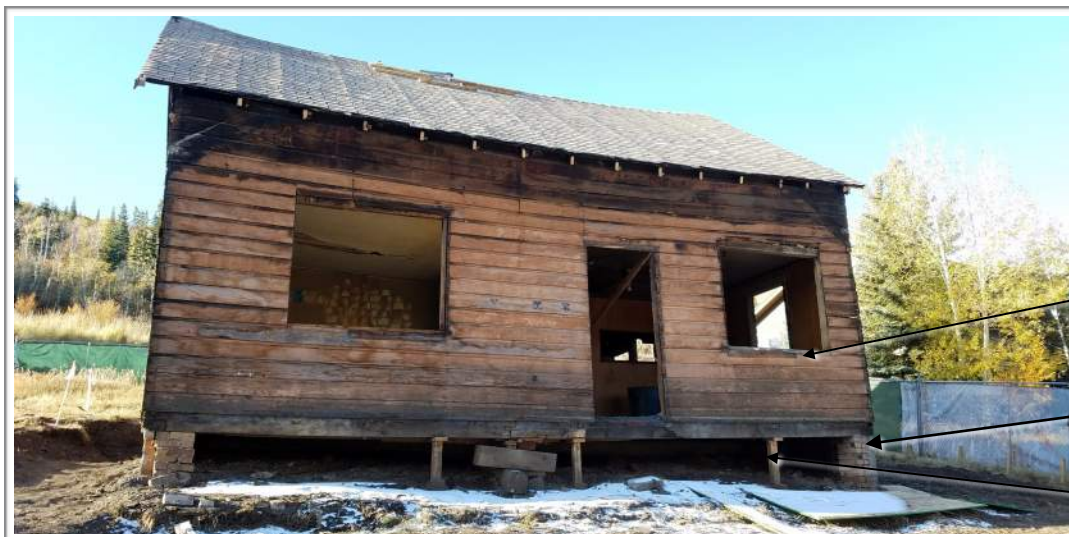
Photo #1: North Elevation - October 10

Window Shadow

Triple Wythe
Brick Columns

Post-Beam Floor
Construction

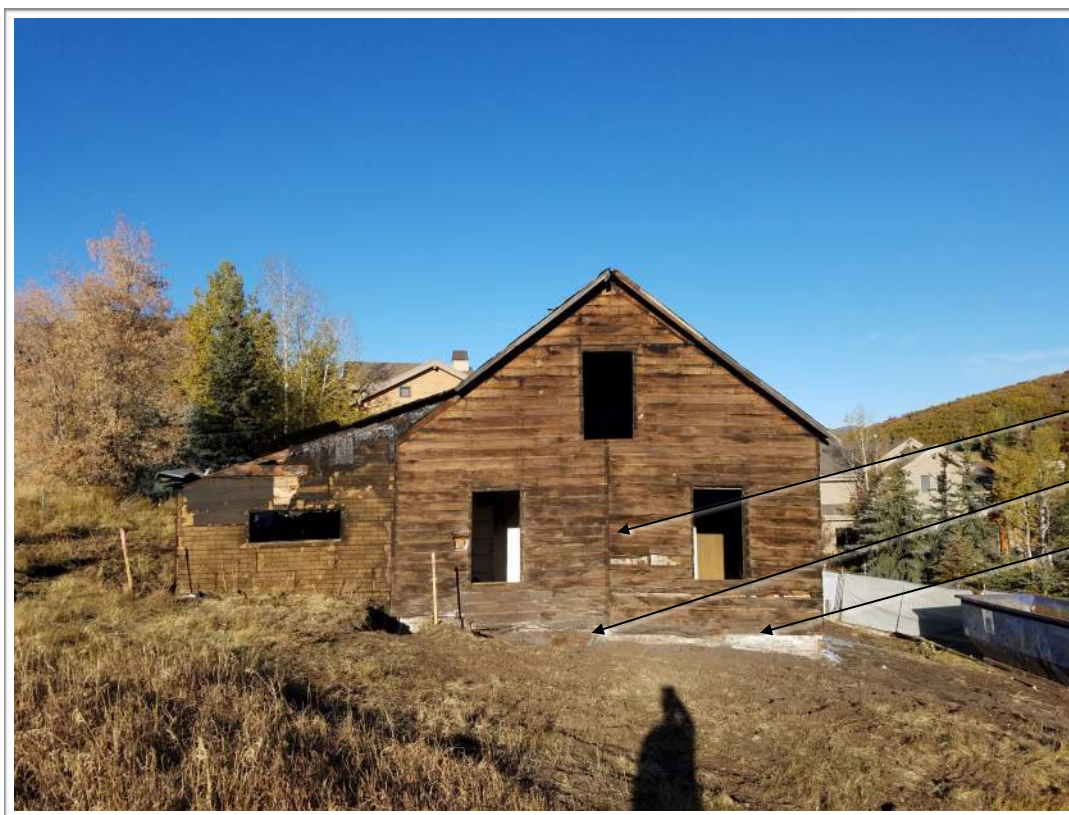
Photo #2: East Elevation - October 10

Vertical Seam

Wood Foundation

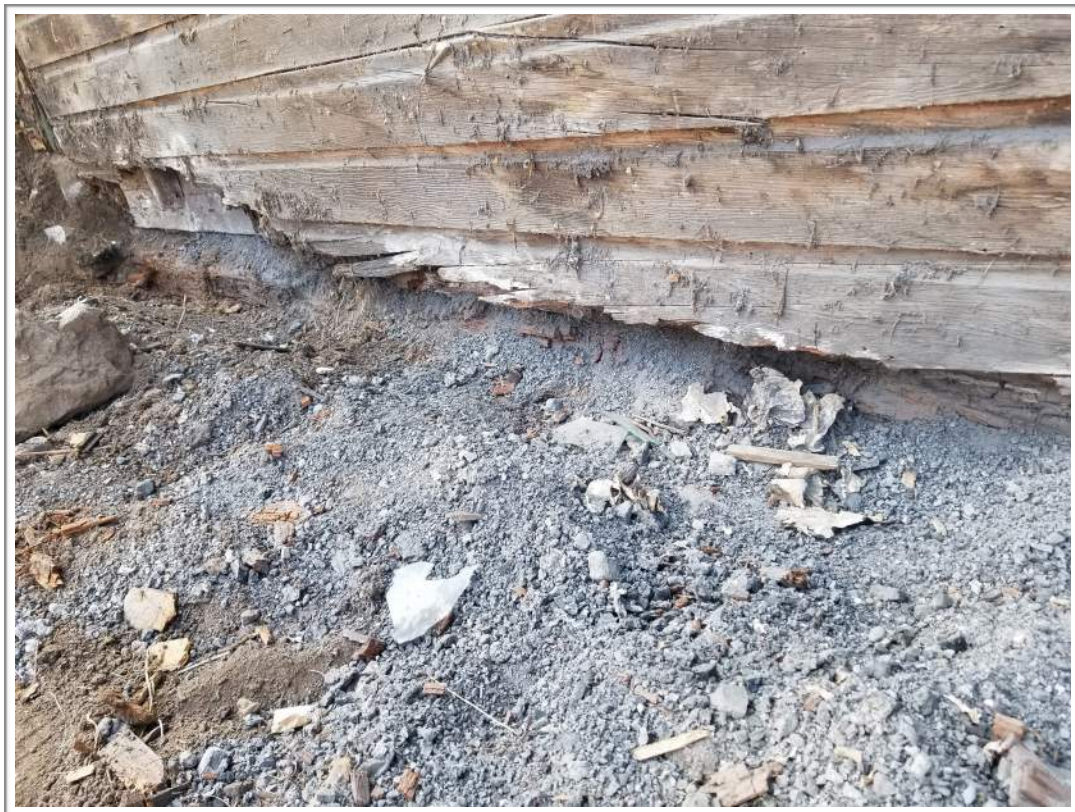
As outlined in the applicant’s analysis (Exhibit A), the foundation was ~~hobbled~~ “hobbled together” at best. On the east and west sides of the house, a [single wythe foundation](#) – a wall consisting of a single layer of stacked bricks—was haphazardly added as the grade falls away from the main floor level of the house. The north façade is held up by a post and beam foundation that sags some six inches (6”) across the length of the house. The

Photo #13: Deteriorated Foundation and Ash Mixture

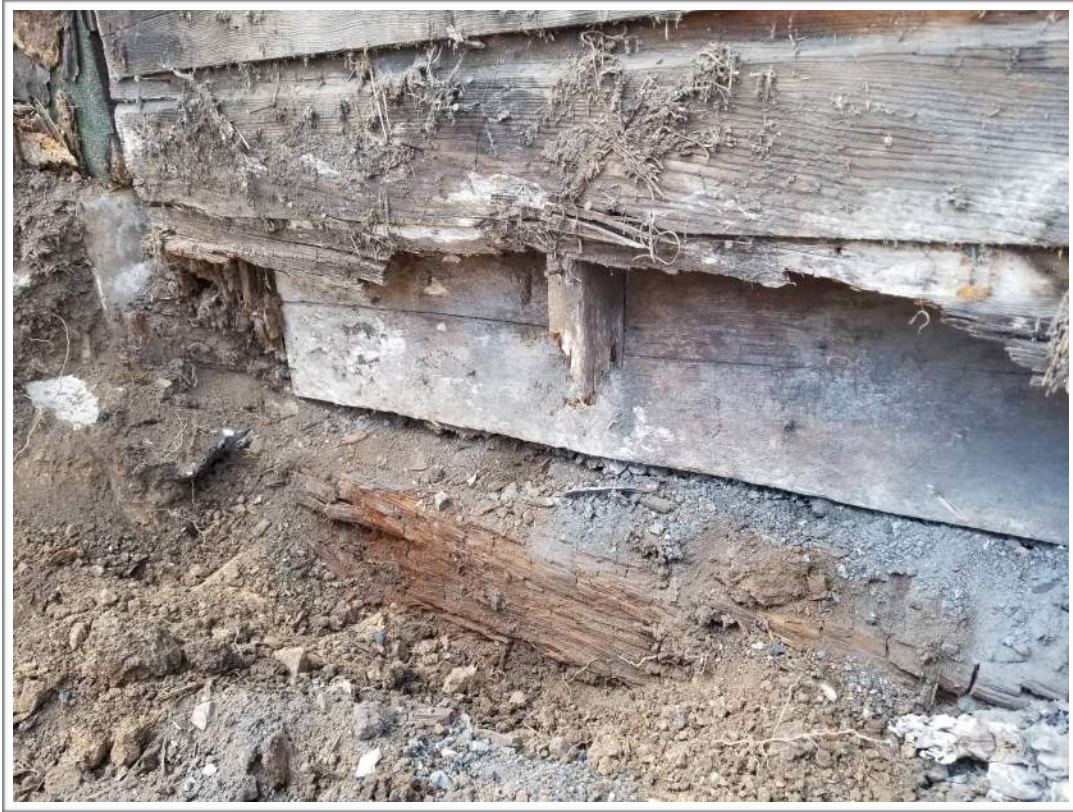
beam under the north wall of the house consists of two large timbers connected by a dovetail rabbet joint; the joint has failed and contributes to the sagging structure. On the south half of the house (original hall-parlor), the wood floor structure sits directly on the dirt. This floor structure is held up by a combination of dirt, rotted wood posts and beams that sit directly on the ground. It is in failing condition.

Photo #14: Deteriorated 6x6 Foundation Beam & Wall Construction

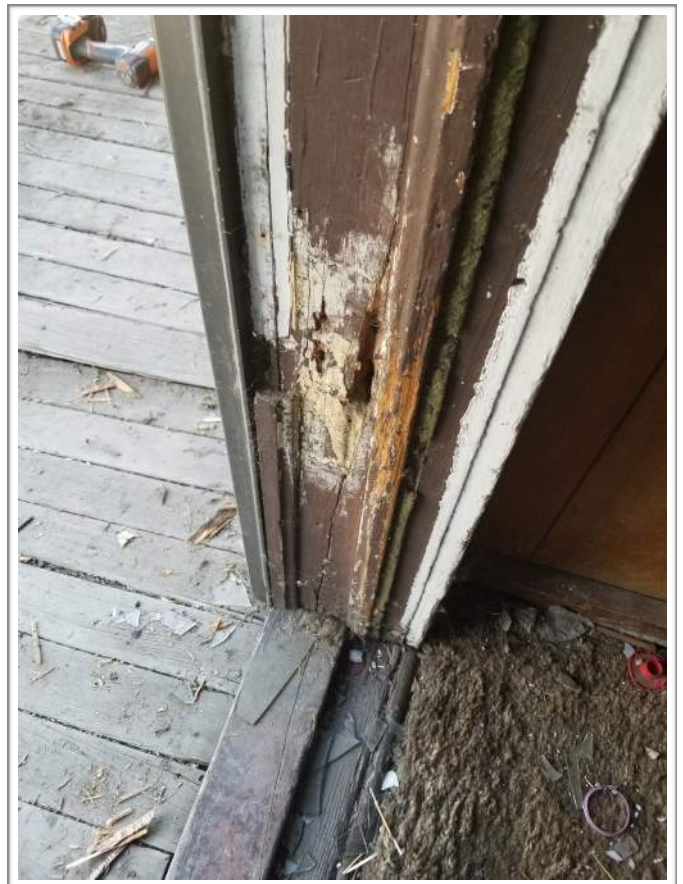
Photo #16: Damaged Door Frame

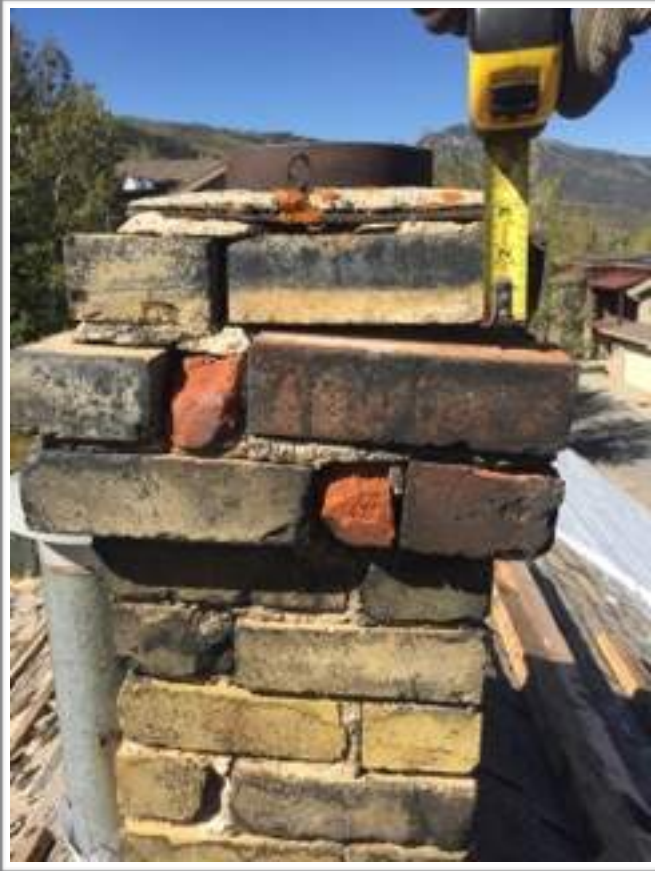
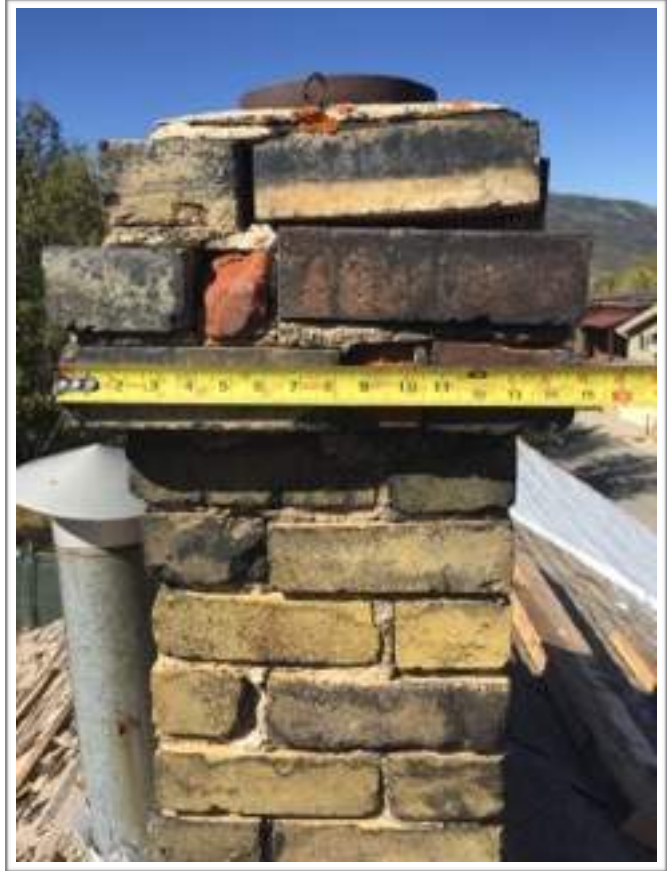
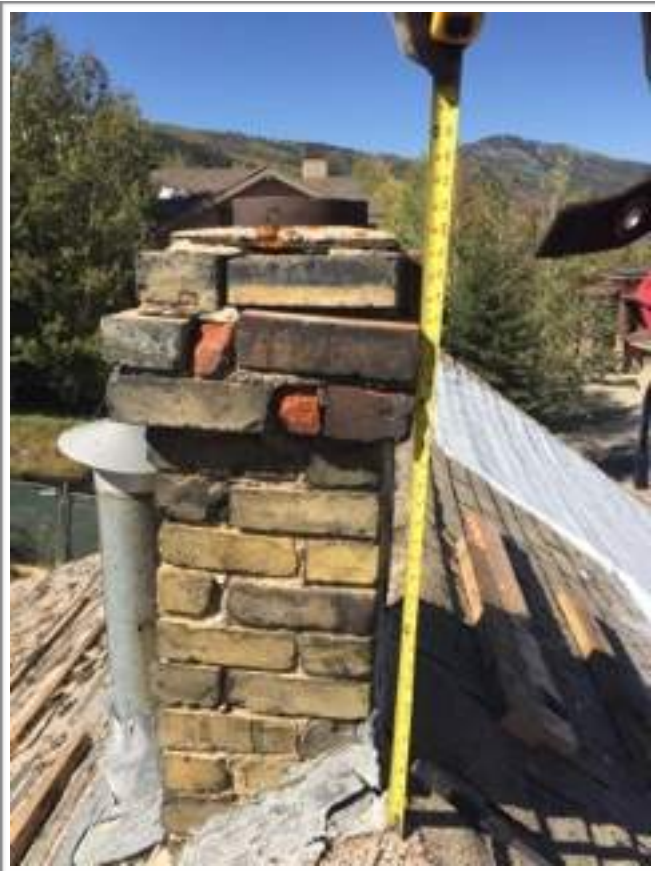
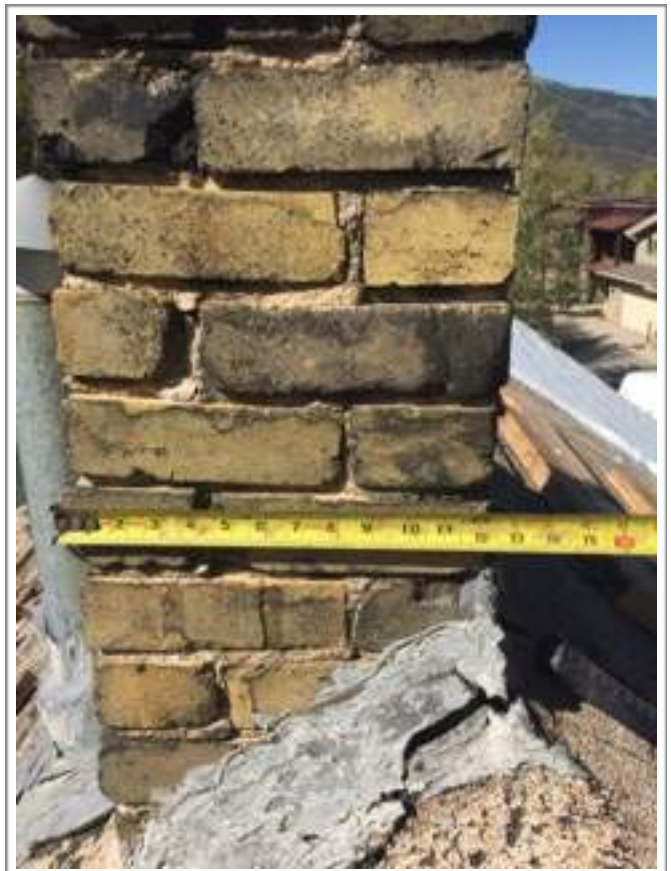
Photo #19-22: Example of Chimney Condition and Documentation

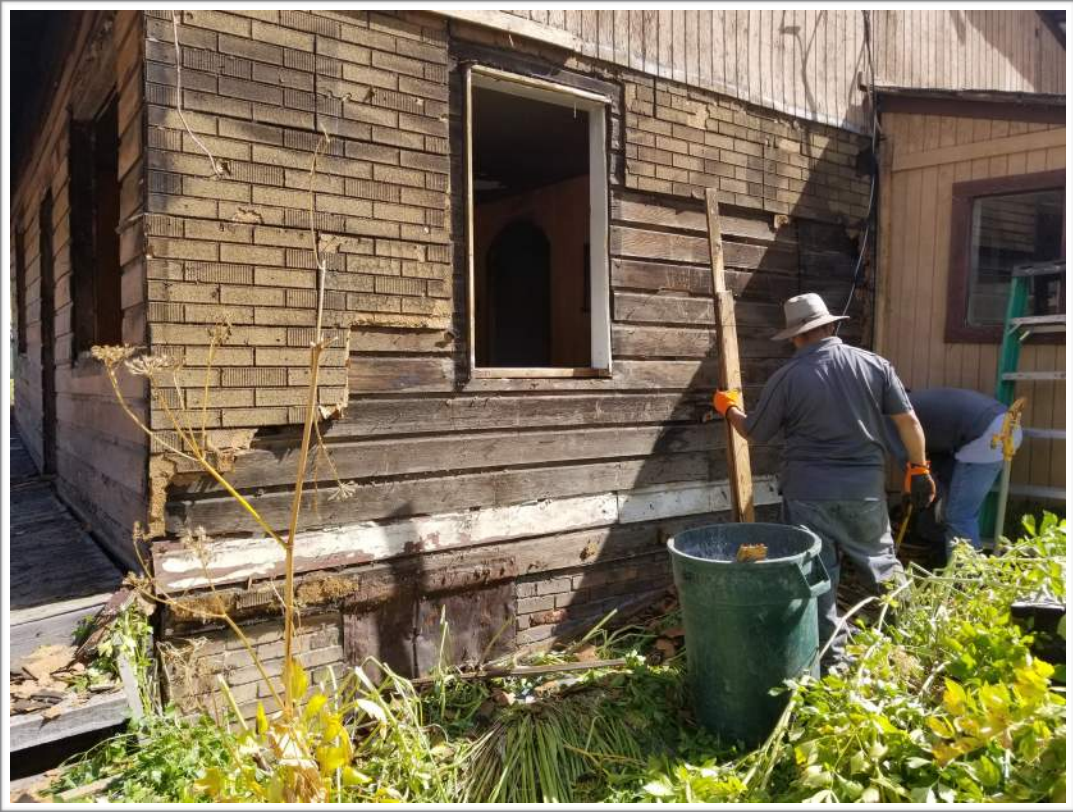
Photo #23: West Elevation - Image Showing Layering of Siding

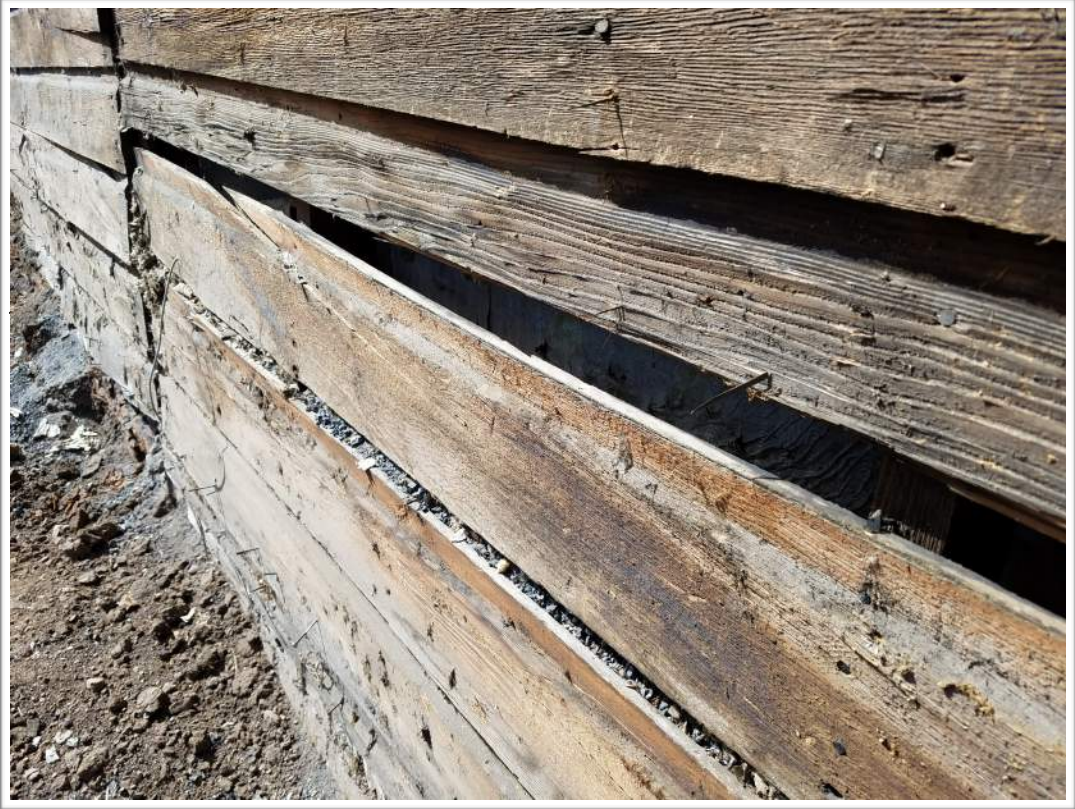
The structure is a hybrid between balloon framing and typical Park City Mining Era single-wall construction. There is no sill plate, which has caused the lower two to three feet of the framing studs to rot. Because of the fire, the wall framing above the top plate is charred in many cases and would not hold new bracing if the walls were panelized. The vertical seam between the original building and north addition has allowed water penetration into the interior structure which has furthered the rot and caused wood rot on the original siding.

Photo #25 East Facade Siding Condition
