**PARK CITY MUNICIPAL CORPORATION
HISTORIC PRESERVATION BOARD
CITY COUNCIL CHAMBERS
May 2, 2018**

945 Norfolk Avenue – HDDR Material Deconstruction– The applicant is proposing to remove existing improvements in the front yard such as the non-historic stone retaining walls in the front yard, stairs and decks in the south side yard, and a c.1990 rock retaining walls in the backyard; reconstruct the historic c.1896 roof form and c.1990 wood shake roofing materials; reconstruct two c.1896 chimneys; reconstruct c.1997 basement; reconstruct c.1983 reconstructed front porch; replace c.1900 front door and two non-historic doors; replace 12 total historic wood windows.

PARK CITY MUNICIPAL CORPORATION
HISTORIC PRESERVATION BOARD
MINUTES OF APRIL 18, 2018

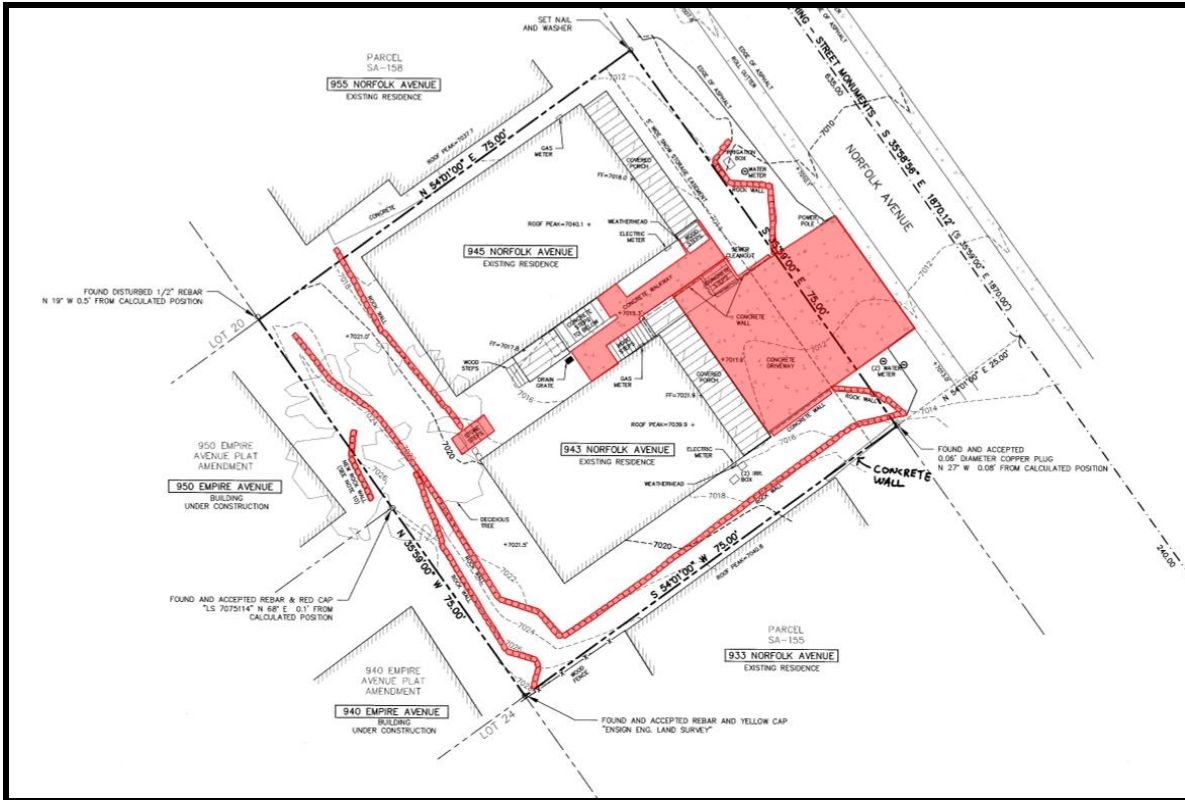
These improvements have been highlighted in red in the following site map.

Staff finds that these improvements to the site are not historic and do not contribute to the historic integrity or historical significance of the site. Further, the proposed work to remove these improvements mitigates any impact to the visual character of the neighborhood, the historical significance of the building, and the architectural integrity of the building.

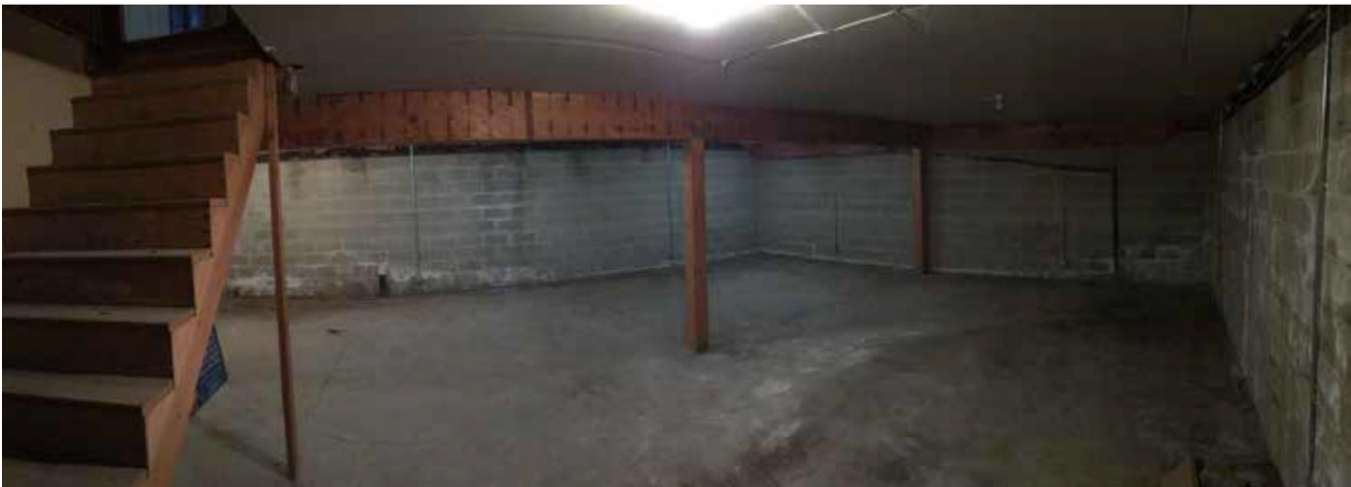
Per the structural engineer's report and the applicant's analysis, the foundation is in poor condition. The structural engineer believes the concrete blocks were not solid grouted, which has caused moisture penetration and deterioration. There are water leaking spots and lines. The structural engineer recommends reconstructing the foundation with reinforced concrete walls and new footings.

*Photo of the interior of the basement. Note the signs of **efflorescence** on the walls. The heavy timber framing is new and was likely installed when the basement was constructed.*

The applicant is proposing to demolish and rebuild the existing basement foundation. As part this, a new basement-level garage will be constructed beneath the porch and finished space will be added to the basement level. The site will be re-graded to minimize the appearance of the new foundation. Staff finds that this basement addition does not contribute to the historic integrity or historical significance of the house or site. Additionally, the proposed exterior changes will not damage or destroy the exterior architectural features of the property that are compatible with the character of the historic site.

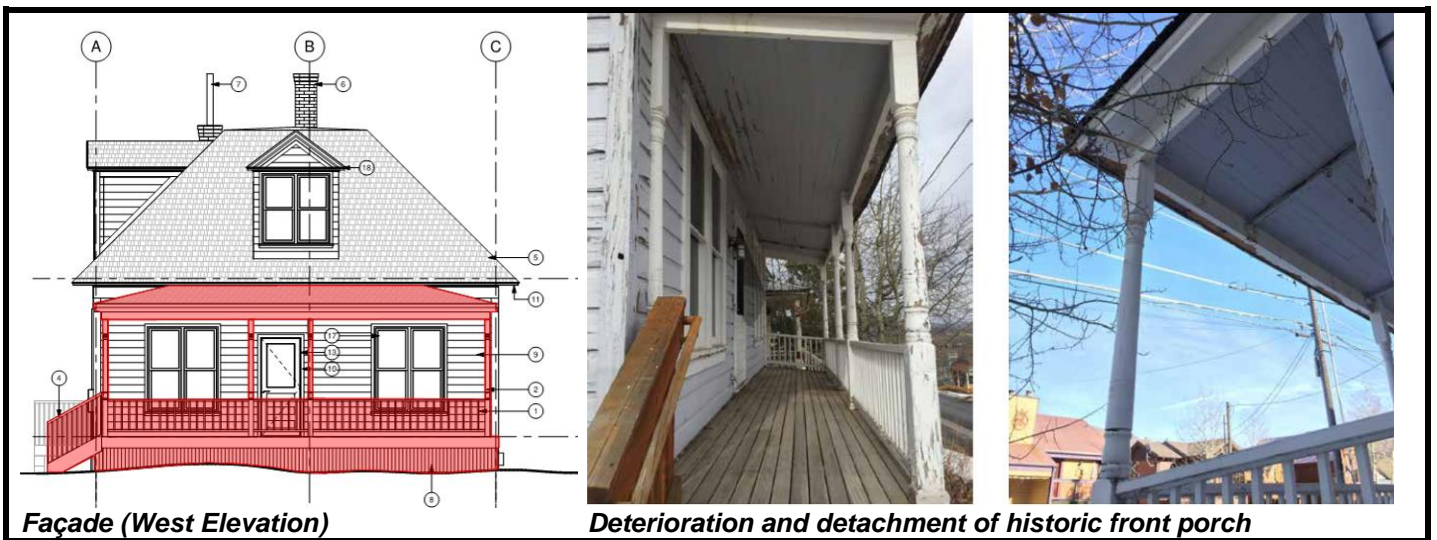
Façade (West Elevation)

The porch is in fair condition. The deck and roof are currently sagging substantially toward the street, demonstrating a lack of structural integrity. The bottom of the porch posts show signs of deterioration and do not meet the bearing capacity of the roof. The trim and porch ceiling also show signs of deterioration and likely require replacement.

Deterioration and detachment of historic front porch

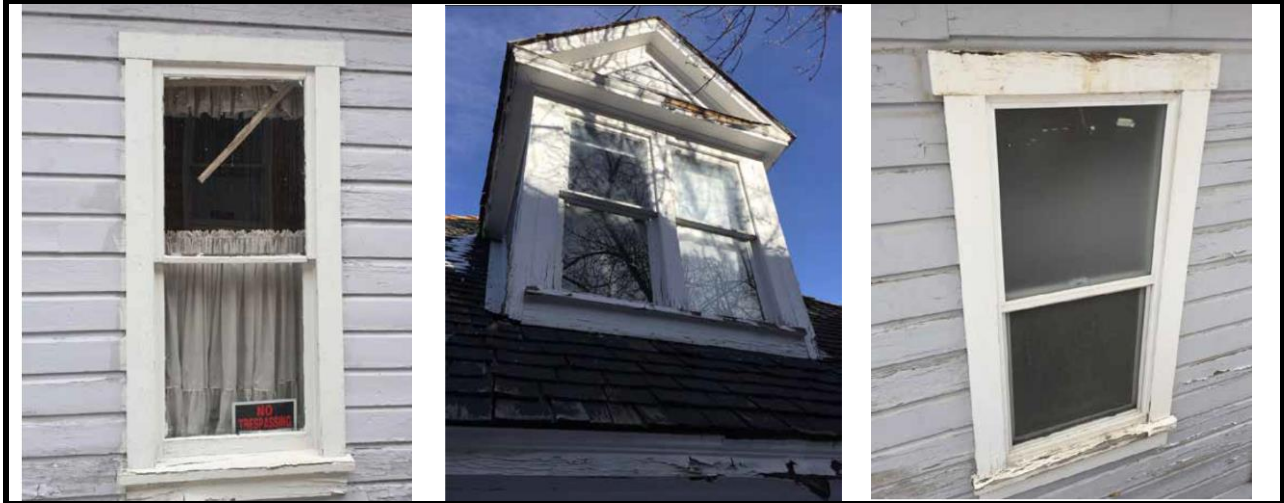
The photos below show common deterioration problems of the original windows:

Staff finds that much of the wood rot on the windows may be able to be addressed through window restoration. The applicant has consented to having a window restoration specialist inspect the windows and determine their potential for restoration prior to replacing them in-kind. Staff finds that any proposed Material Deconstruction is necessary in order to restore the original wood windows; however, staff understands they may be beyond repair and has incorporated the following Conditions of Approval:

#13. An independent window evaluation specialist will assess and report on the existing window conditions and outline options for rehabilitation or replacement in satisfaction of the Planning Director.
