**PARK CITY MUNICIPAL CORPORATION
HISTORIC PRESERVATION BOARD
CITY COUNCIL CHAMBERS
August 1, 2018**

The originally scheduled meeting of July 18, 2018 has been cancelled. The new meeting date is August 1, 2018.

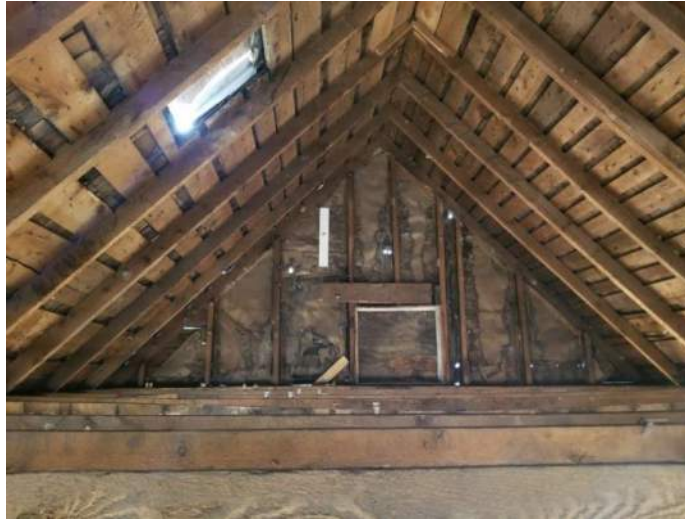
Staff finds that the proposed material deconstruction to reconstruct the house roof is necessary to rehabilitate the historic house.

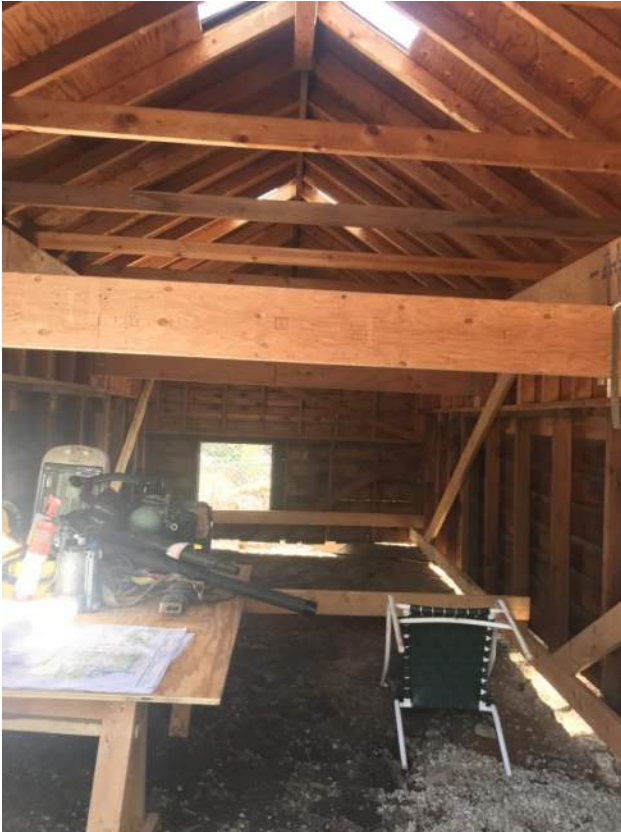
Staff finds that the proposed material deconstruction to reconstruct the garage roof is necessary to rehabilitate the historic garage.

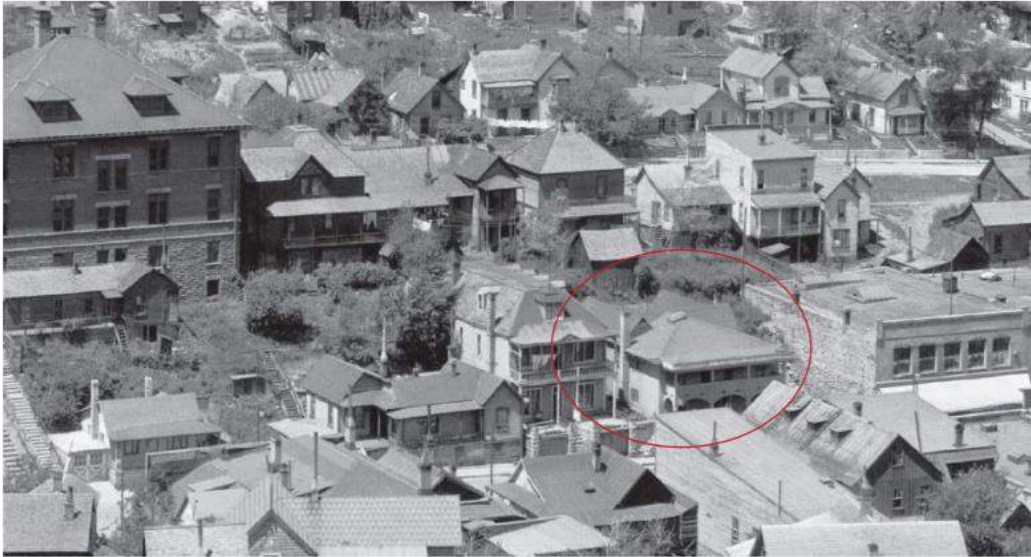
c. 1930s (Photo courtesy of Park City Historical Society & Museum, Pop Jenks Collection)

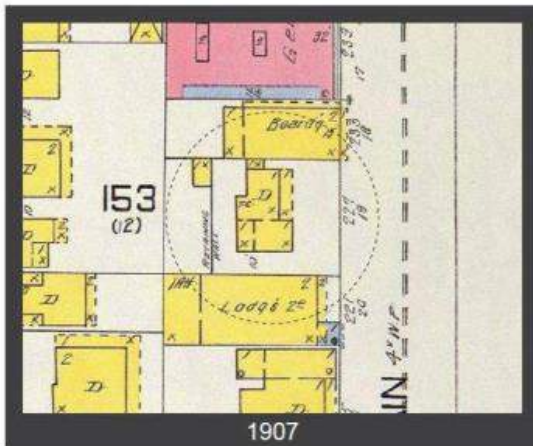
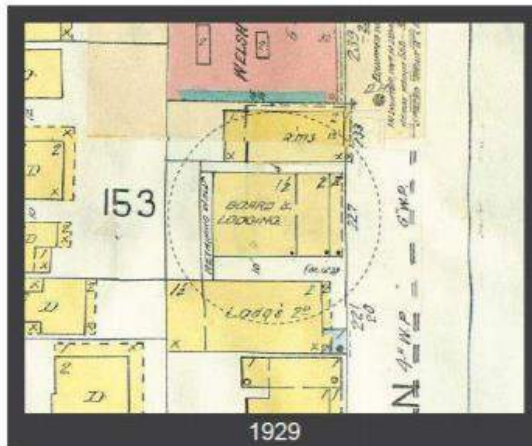
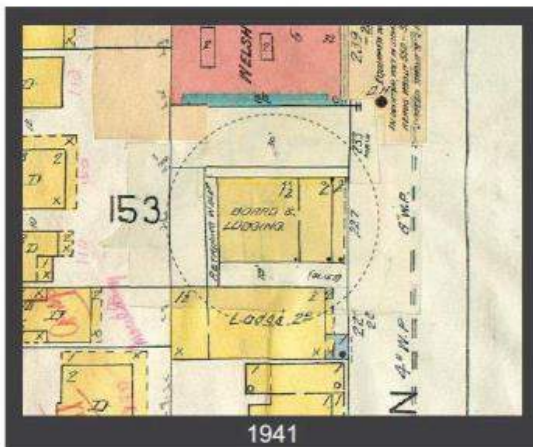
The Sanborn Fire Insurance maps show that the Boarding & Lodging house had replaced the L-shaped cross-wing cottage by 1929.

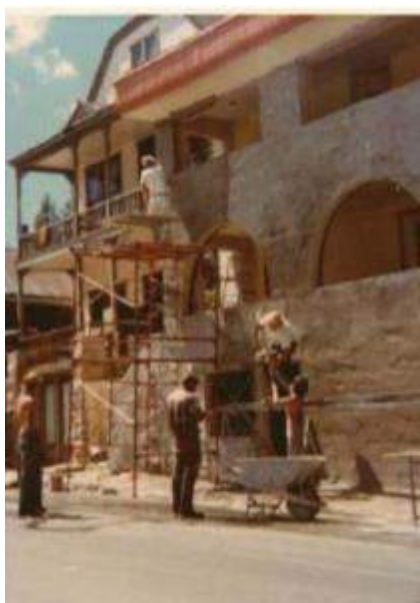
c. 1976 photo of Rixies remodeling the front of the building

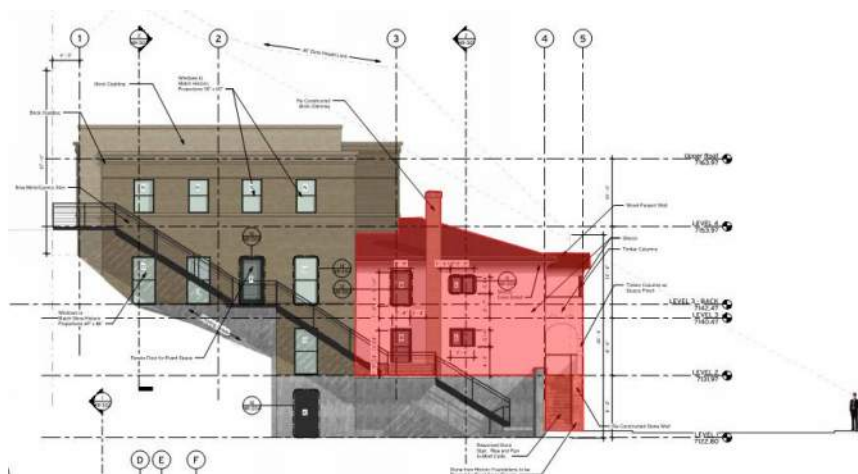
The image below highlights in red the portion of the building to be reconstructed:

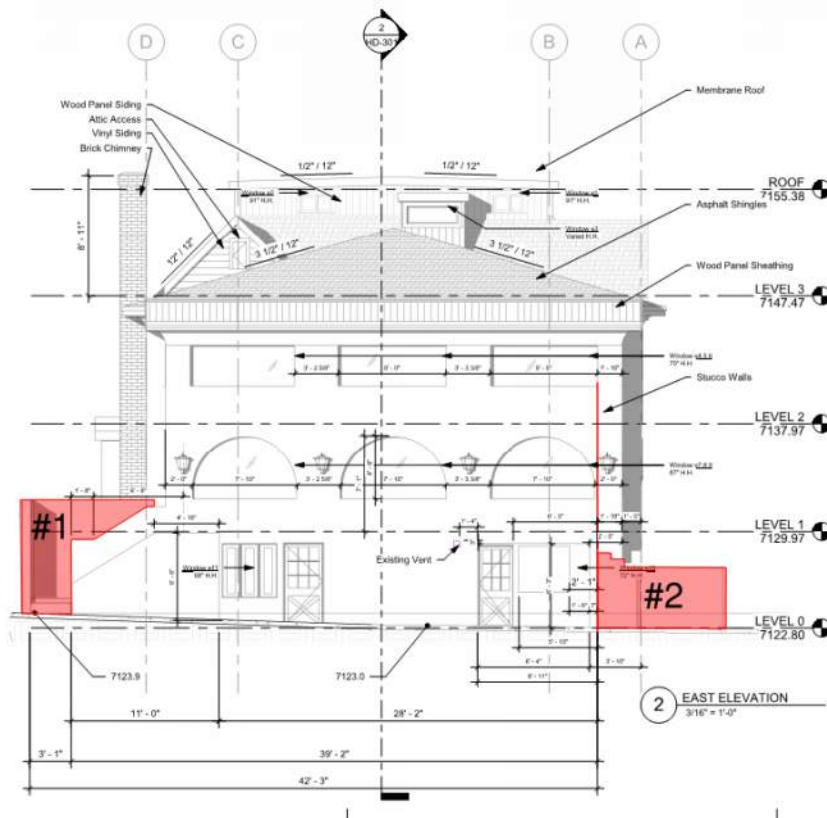
To the north of the Star Hotel, there is a second retaining wall visible from the Main Street right-of-way that is also built of stacked stone (#2). This wall is not historic and was likely built after the 1976 renovation. The applicant is planning on demolishing this wall.

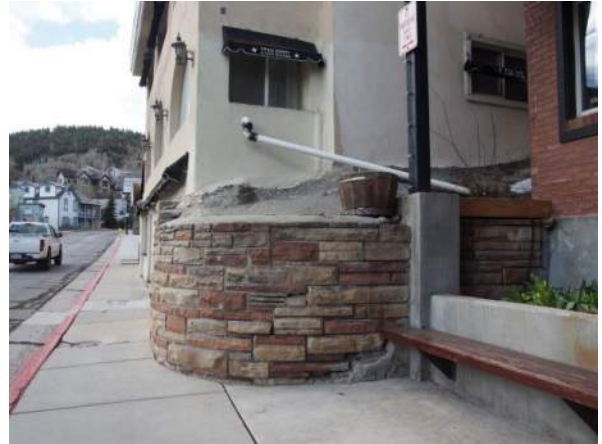
Retaining Wall #2 (North Side of Façade)

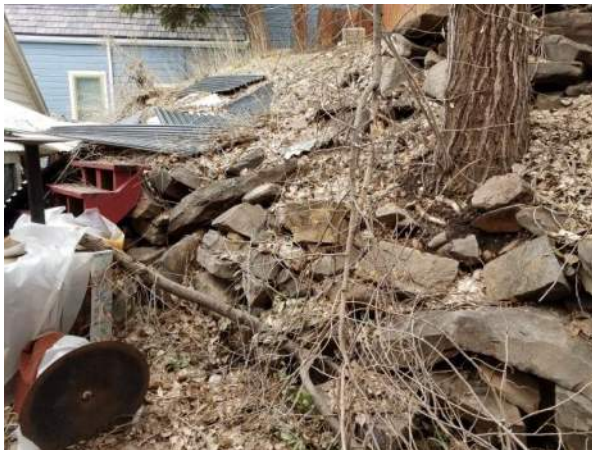
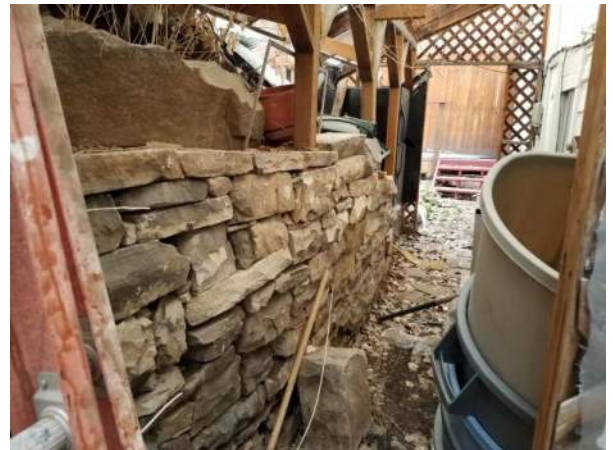
Retaining Walls in the backyard

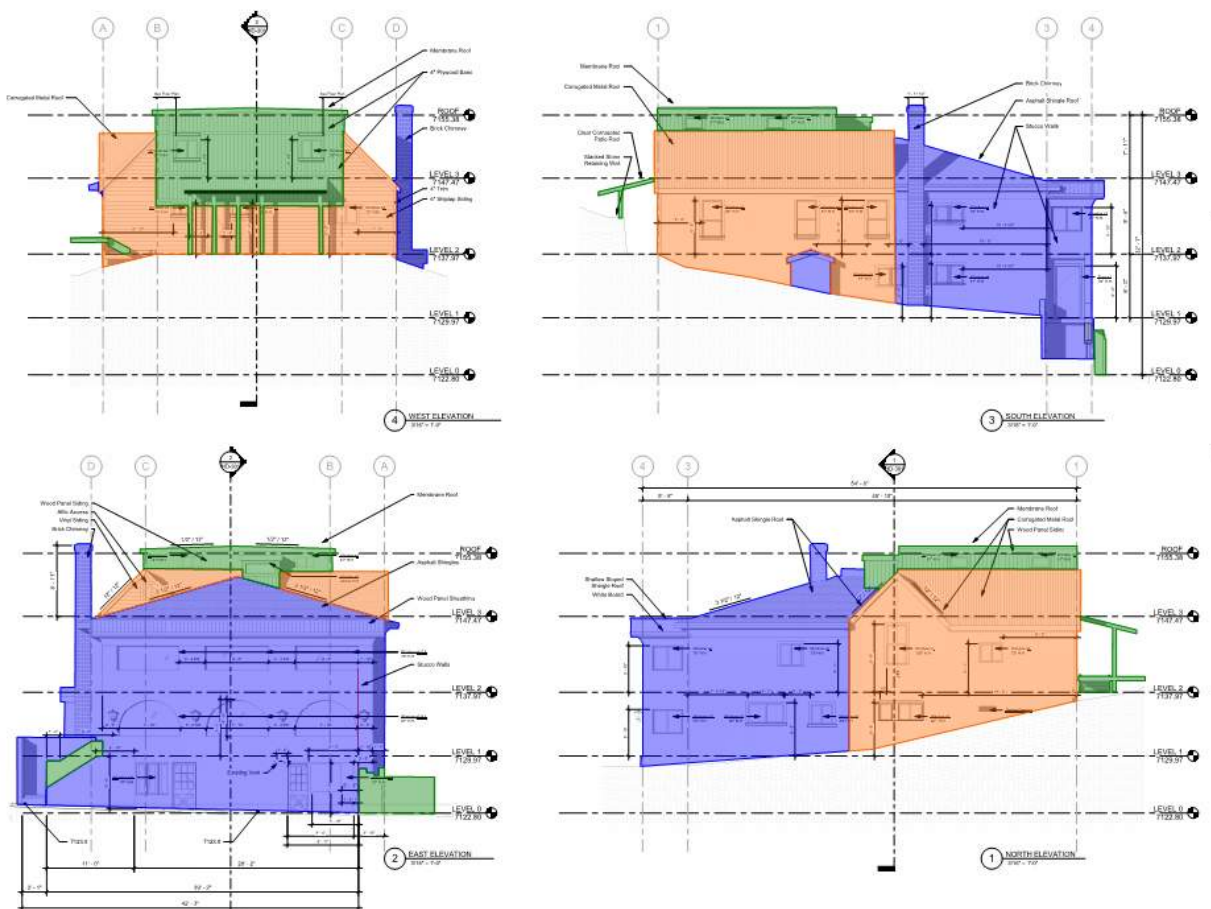
The c.1929 and 1970s additions were added haphazardly to the original c.1889 cross-wing house with poor connections. Because the different structural components and building methods differ between the sections of this building, they are not properly tied into each other. This has caused the different sections of the building to settle at different rates and at times, even pull away from each other. The lack of foundation beneath the entire structure has caused additional problems. In the past, the uneven settling and deterioration of floor joists resting directly on dirt has been addressed by adding new timber posts, beams, and dimensional lumber. Because these have often been used as shims and also sit directly on stone or piles of rubble, they too are not structurally sound and have deteriorated.

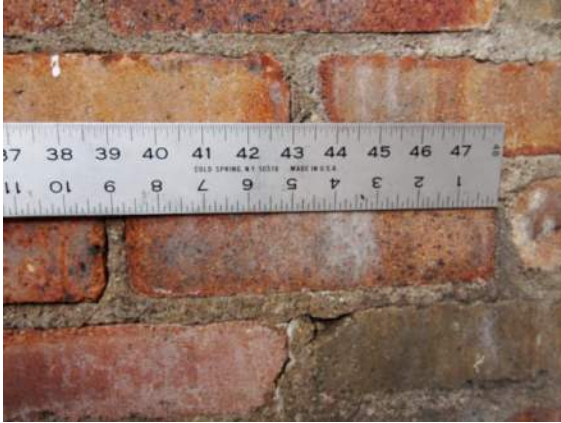
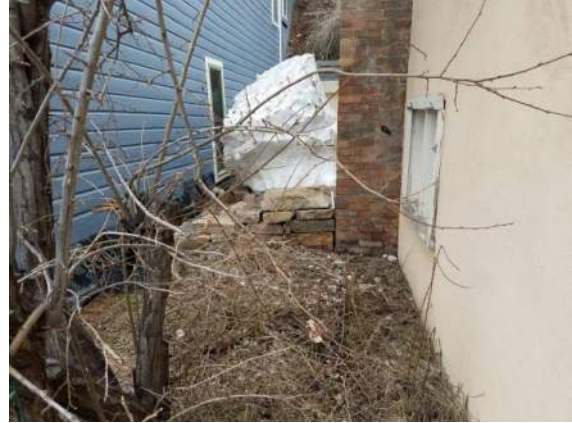
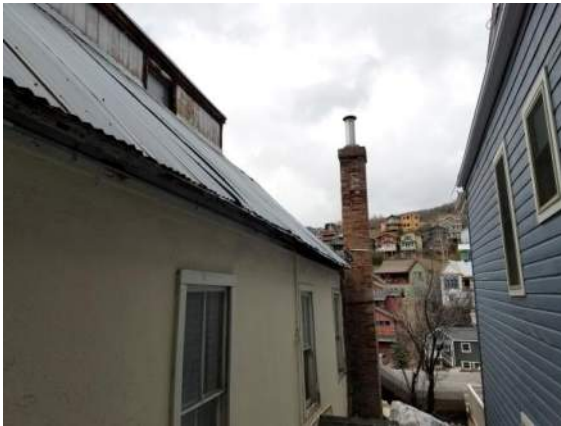
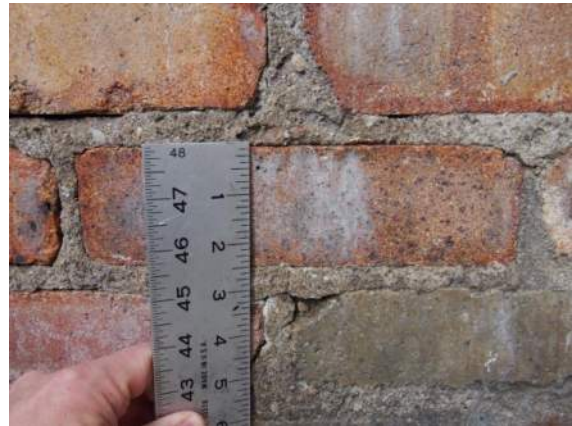
These photos of the chimney document the dimensions, color, and texture of the original bricks. As seen in the photos above, the chimney has been tied into the building using metal supports. A contemporary metal vent protrudes from the top of the original chimney.

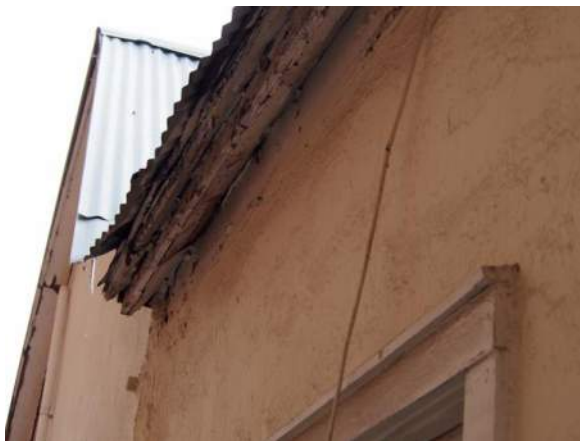
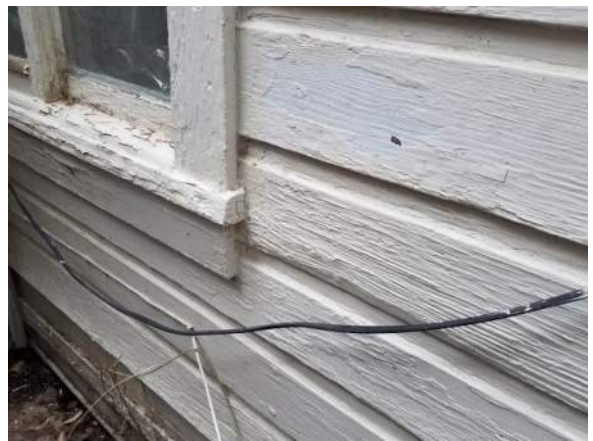
The exterior walls are in fair condition. Though the majority of the stucco is in good condition due to layers of paint, there are spots where the stucco is peeling away. Cracks in the stucco have generally indicated areas where the building is heaving outward due to poor structural capacity, disconnected structural members, and/or weather damage. On the west elevation, salvaged drop novelty siding has been used as a cladding and is suffering from wood rot and deterioration. On the 1977-1976 addition, wood paneling was used as a siding material. Staff believes that the lowest level of the building, consisting of a stone foundation, was originally built as a retaining wall in the front yard of the c.1889 cross-wing house. The foundation walls disappear into the hillside, creating dirt walls and floors on the west end of the basement.

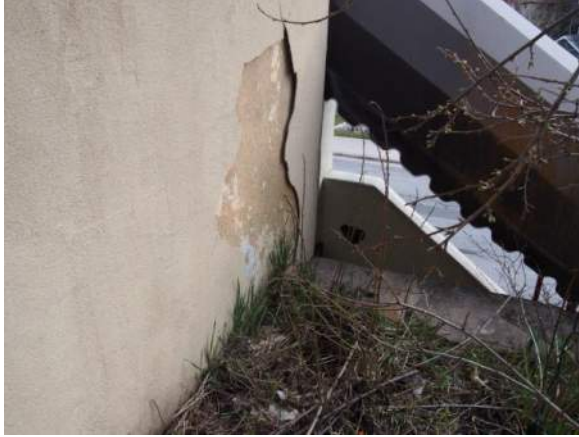
Common defects of the exterior siding materials

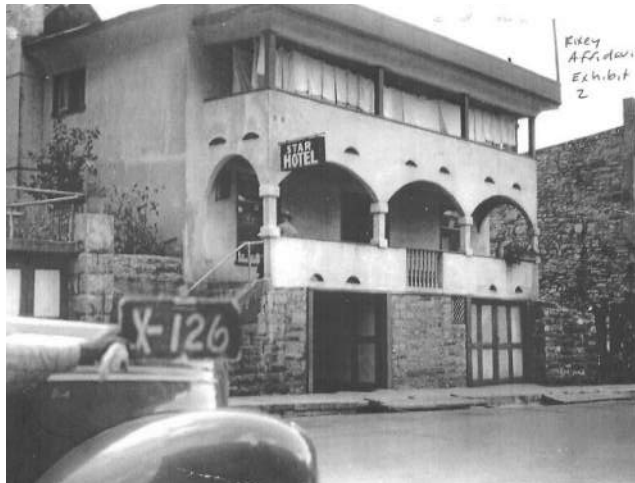
c. 1940 Photograph of the Star Hotel

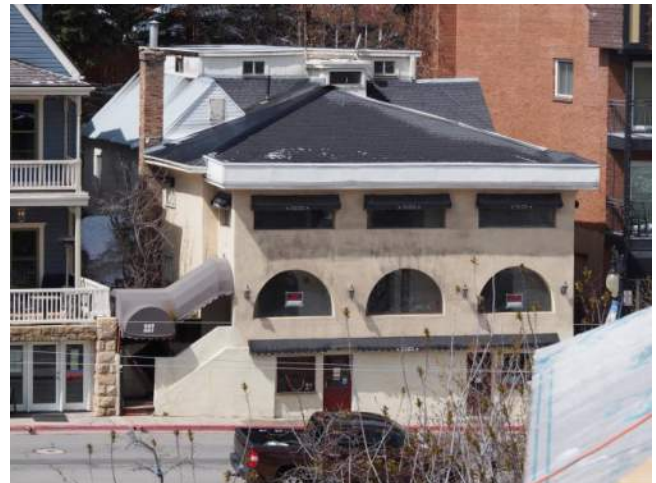
c. 2017 Photograph of the Star Hotel

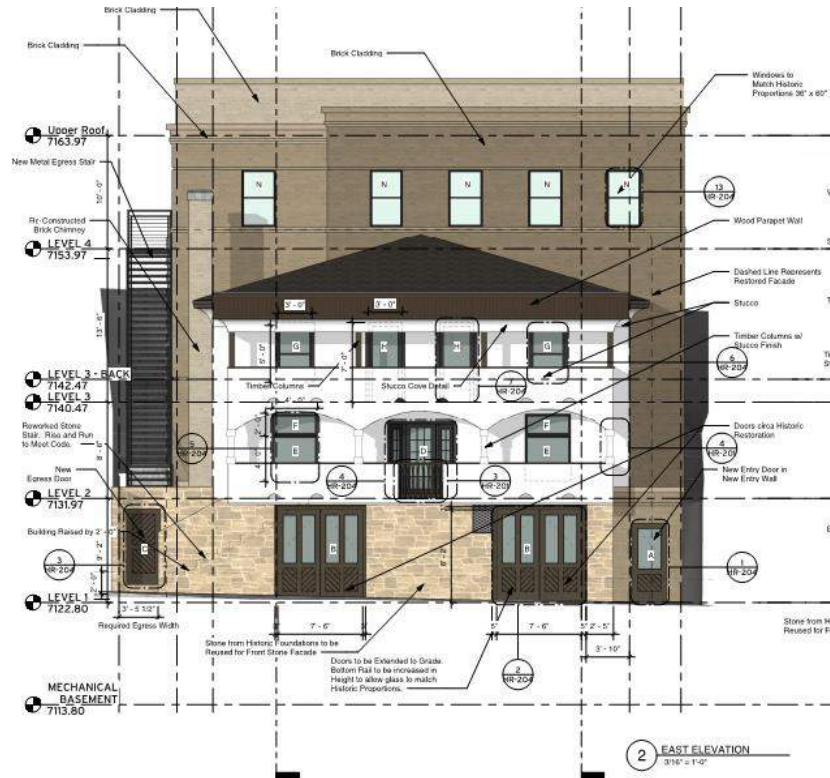
Staff finds that the proposed material deconstruction is needed in order to reconstruct and restore the original appearance of the façade.

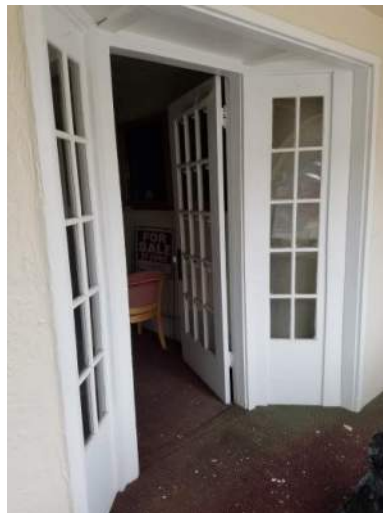
On the lower level of the building, the applicant proposes to reconstruct the original carriage door openings and demolish the service doors and picture windows added c.1976. New carriage doors will have a paneled lower level with a chevron design, consistent with the carriage doors shown in the historic photograph. The upper panels of the door will be glass. On the north and south sides of the building, new doors will be installed in the reconstructed retaining walls. These doors will have a similar design to the reconstructed carriage doors.

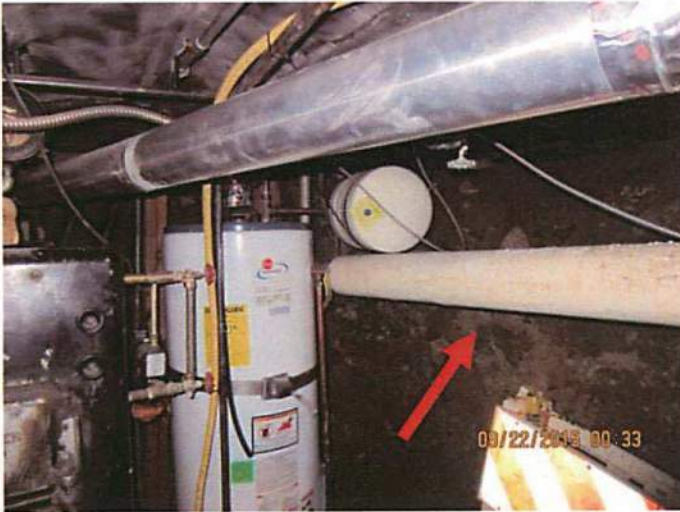
Photo 1 The structure has no concrete or stable foundation. The foundation consists of rubble, dirt and loose stone matter.

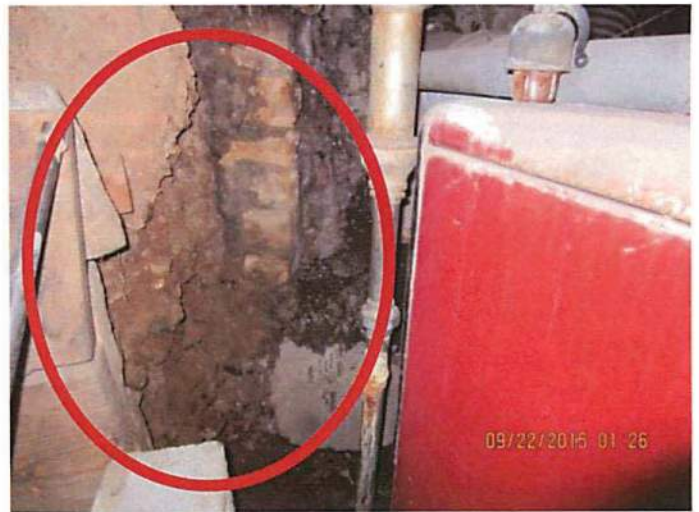
Photo 2 Decay of the rubble foundation due to water infiltration

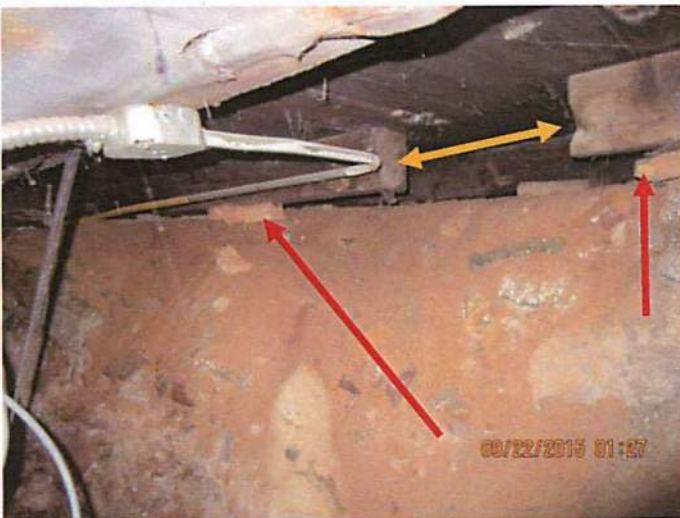
Photo 3 The red arrows show improperly installed shims are blocking to level the floor above. Not permitted on dirt . The yellow arrow shows the removal of floor joist, this is consistent throughout the floor area

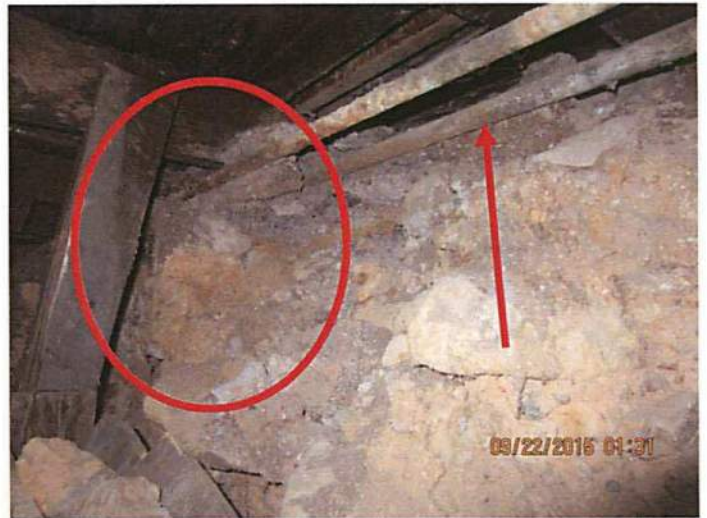
Photo 4 The red circle shows movement of the rubble foundation and decay of the floor joist members resting directly on top of the rubble. The red arrow shows decay of water lines used to heat the structure

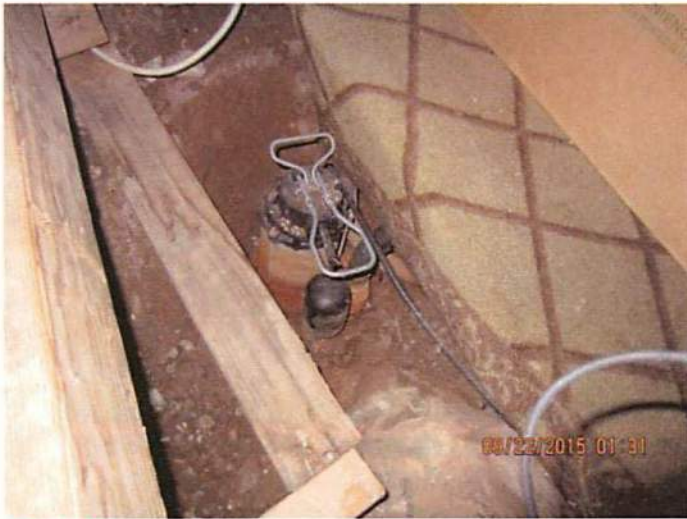
Photo 5 A sump was installed to remove water from the area but was not properly maintained and currently is not in working condition

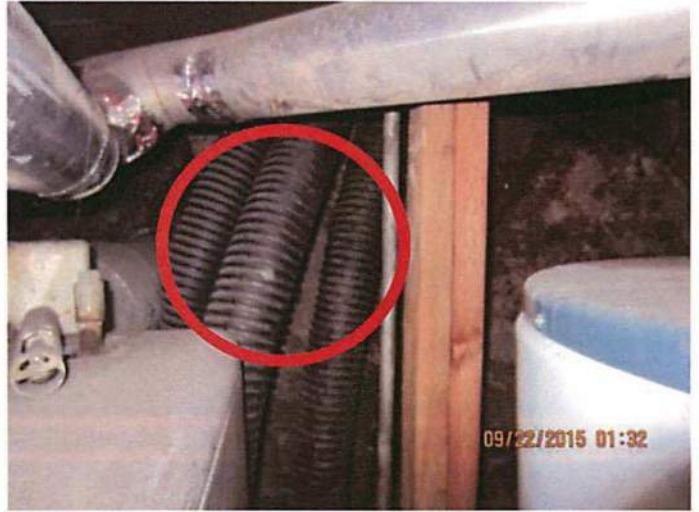
Photo 6 A drainage system was improperly installed and permitted to drain directly on top of the dirt floor causing decay, mold and erosion

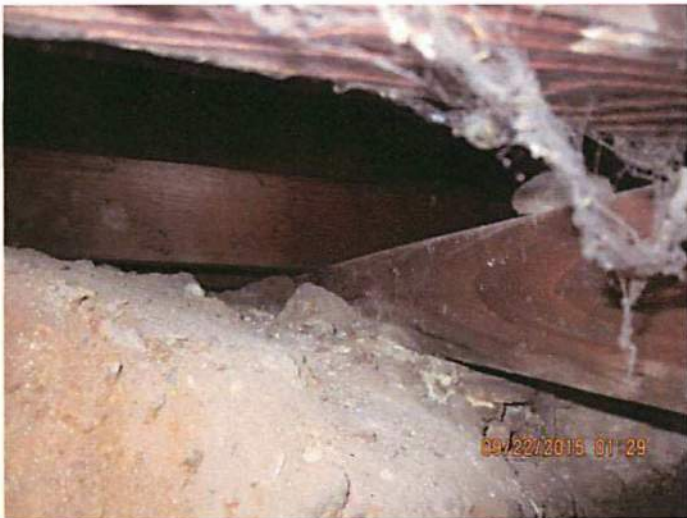
Photo 7 The floor joist of the structure are resting directly on top of dirt and rubble. Not permitted under building codes

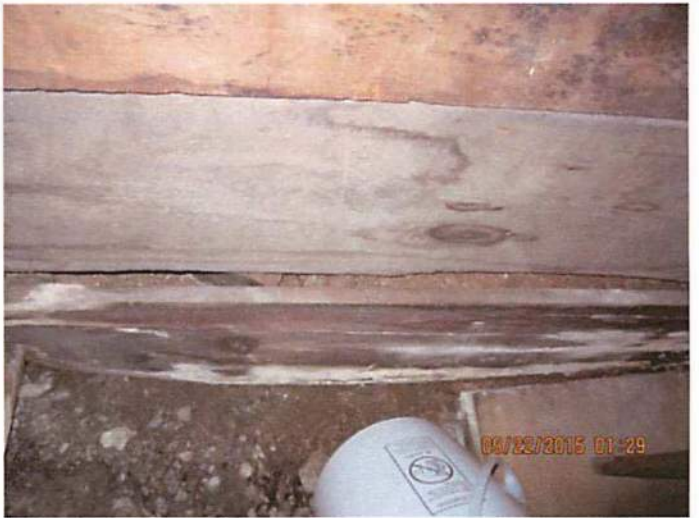
Photo 8 Wood backing being used to prevent rubble from filling the storage area. Backing is failing and decayed . Serious mold and water concerns

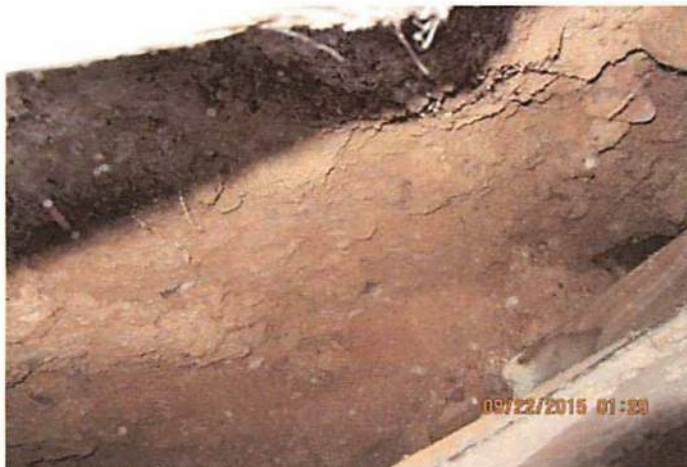
Photo 9 Back side of photo 8

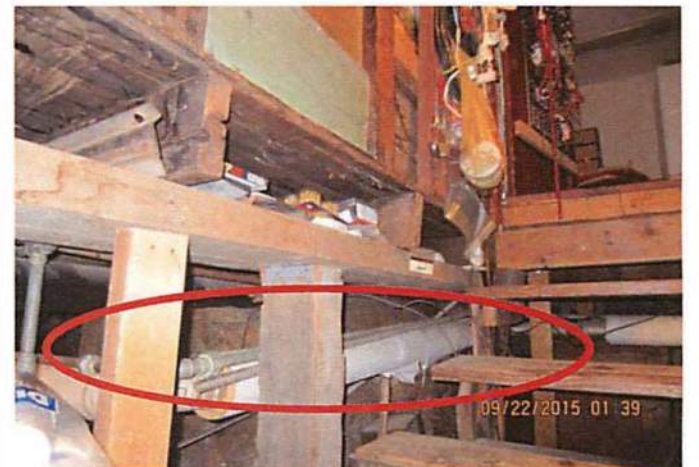
Photo 10 Example of missing foundation under support member. Connection to support from attic 3rd floor

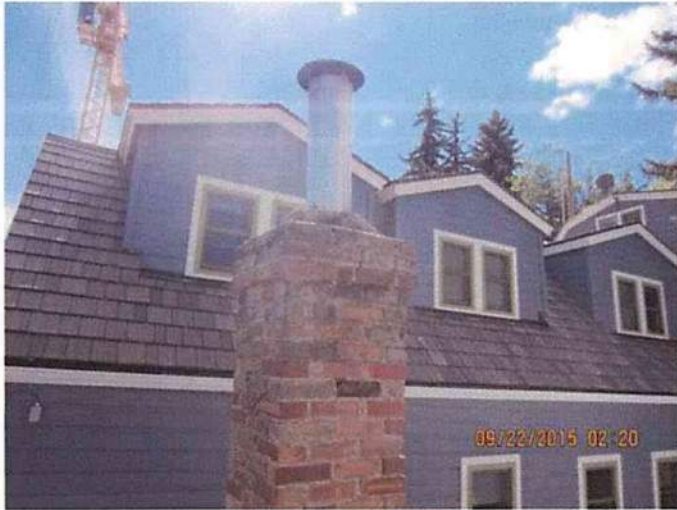
Photo 1 The chimney shows signs of decay and instability. To be removed or evaluated by a structural engineer

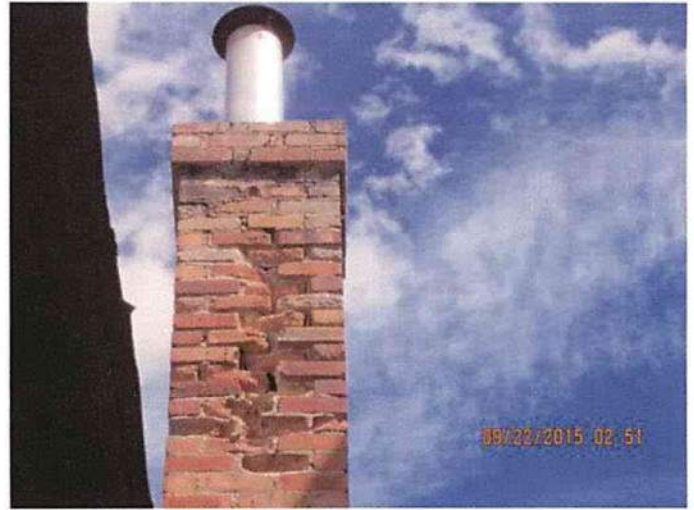
Photo 2 Structural brick has decayed or is deteriorated in such a way is may fail

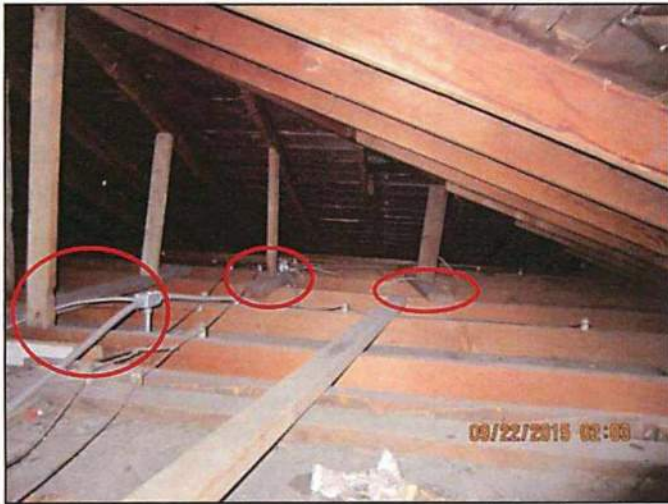
Photo 1 The structural members supporting the roof are not properly installed and are not plumb. Excessive load could cause the members to fail

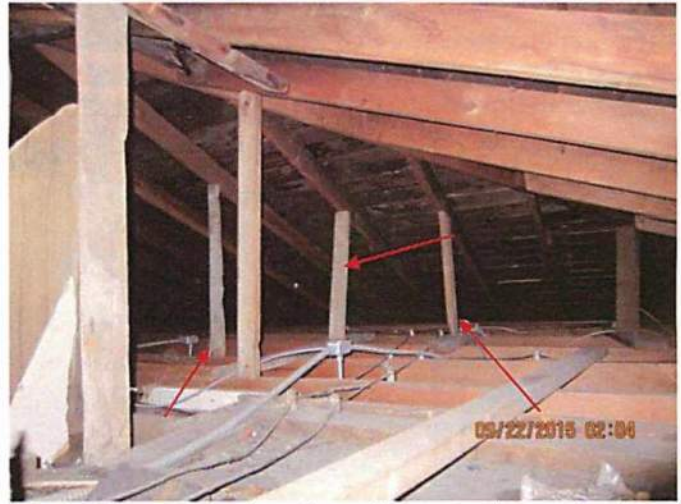
Photo 2 Support members for roof are not adequate for the purpose being served. Engineer to justify

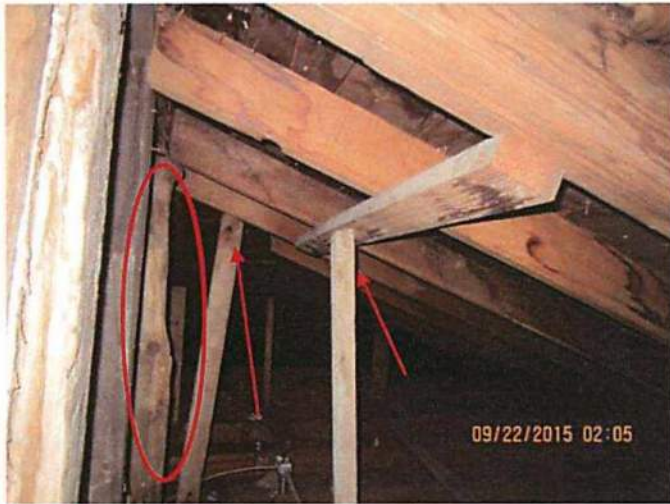
Photo 3 Damaged, decayed or improperly installed structural members

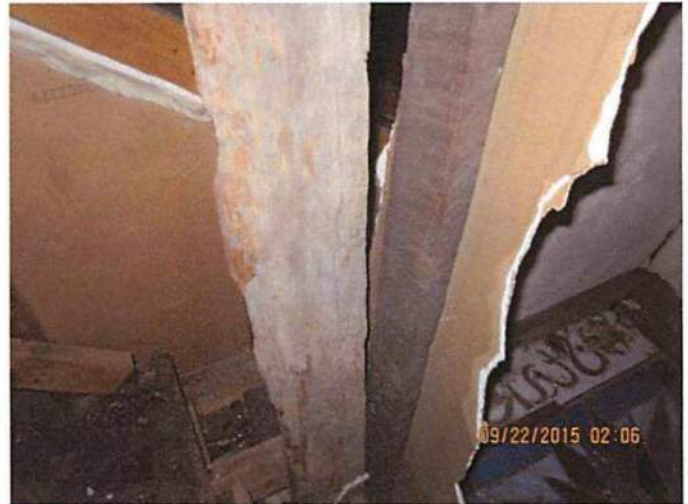
Photo 4 Structural members not properly supported

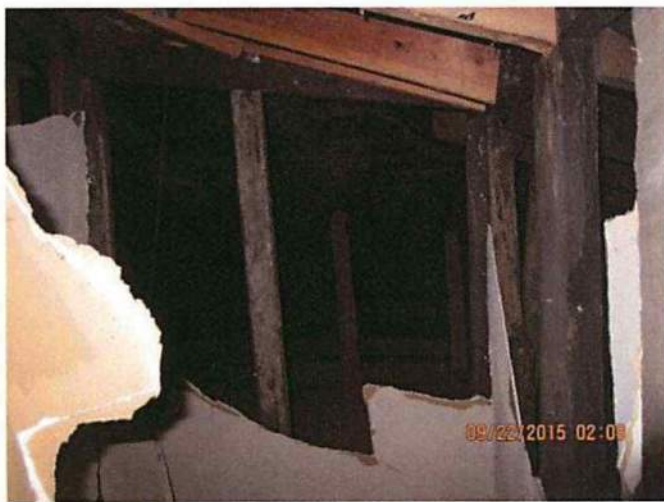
Photo 7 Roof has been repaired, support members not properly installed. Engineer to evaluate and justify

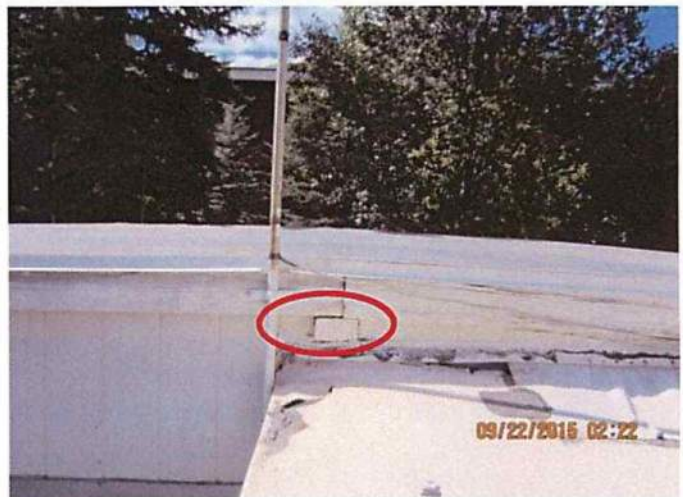
Photo 8 Note structural beam. Refer to photo 9

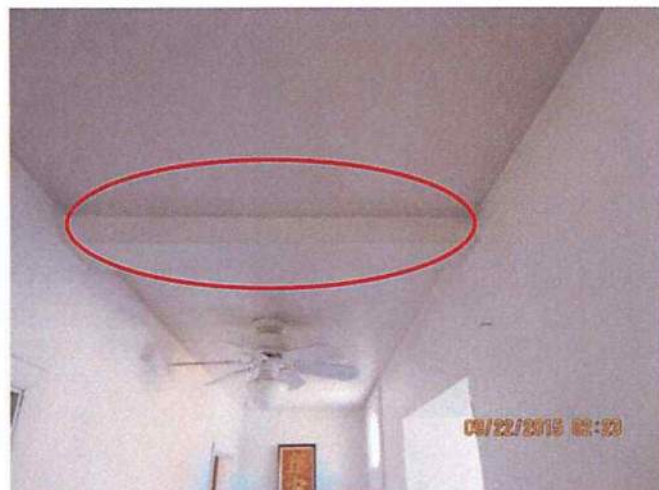
Photo 9 The third level of the structure was added in the 1970's. The addition will need to be evaluated by a structural engineer. The support beam in this photo is missing a point load.

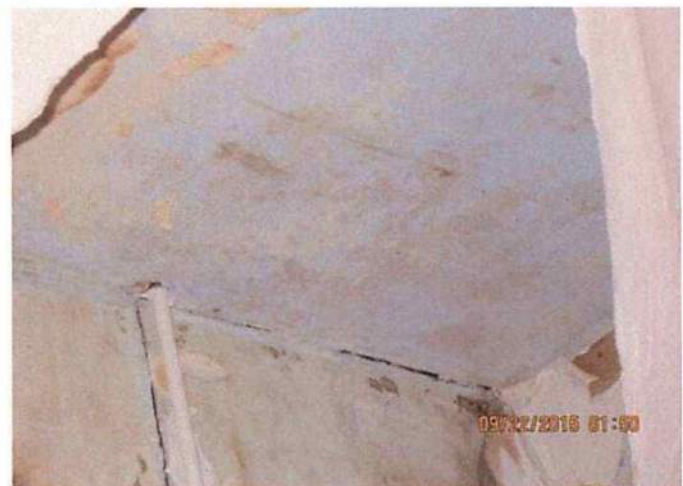
Photo 10 Water damage second floor. Settling cracks noted. Structural engineer to justify

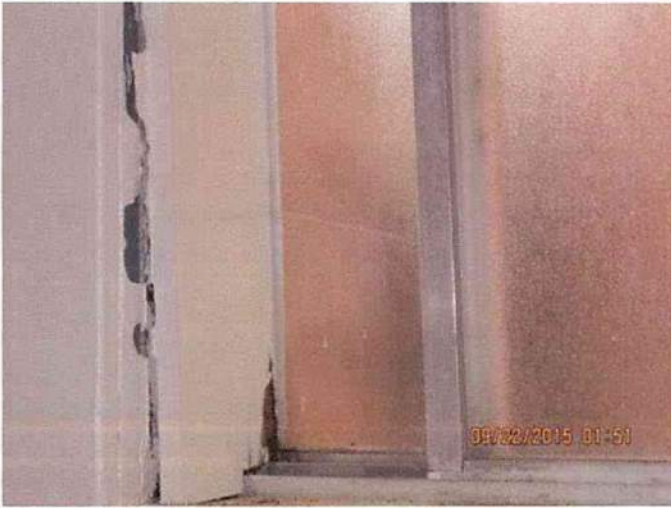
Photo 11 Noted settling around the bathroom window on the second floor. Consistent with improperly installed support beam on third floor.

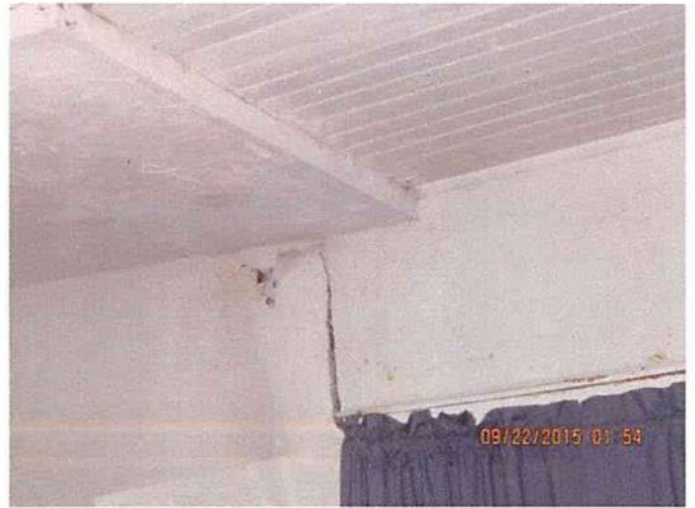
Photo 12 Structural separation in second floor bedroom. Consistent with missing point loads and missing foundation

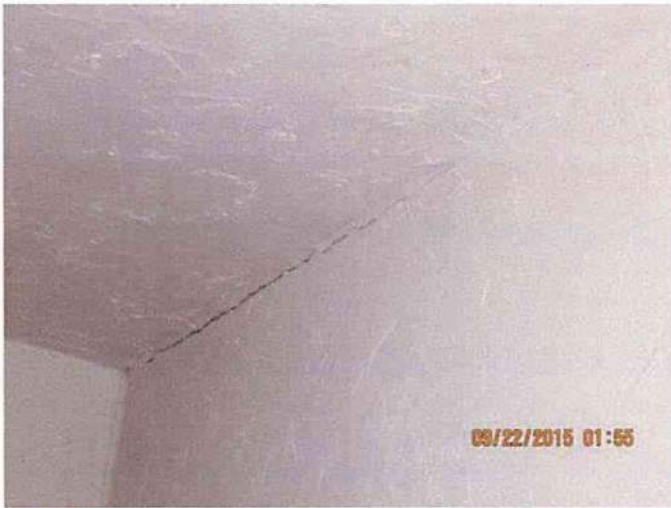
Photo 13 Structural separation in second floor bedroom. Consistent with missing point loads and missing foundation

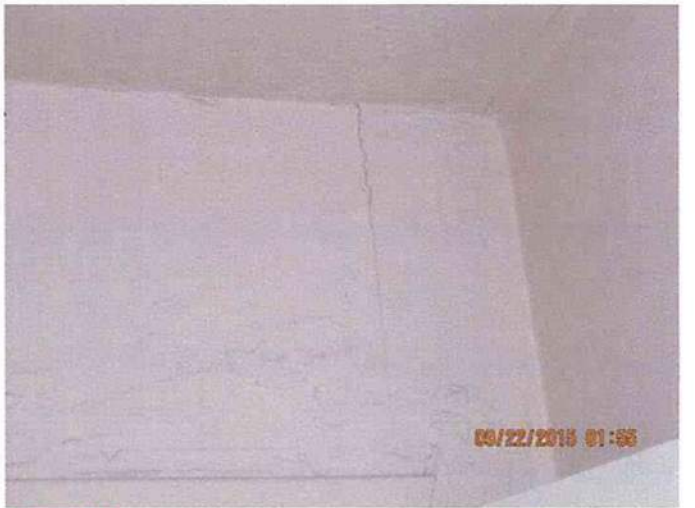
Photo 14 Structural separation in second floor bedroom. Consistent with missing point loads and missing foundation

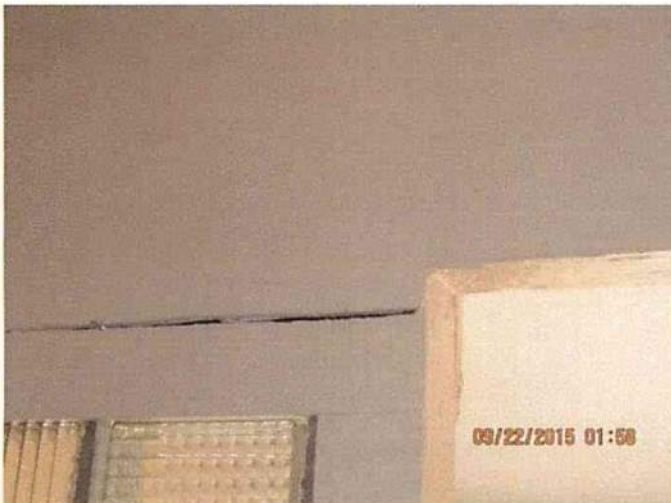
Photo 15 Structural separation in second floor bedroom. Consistent with missing point loads and missing foundation

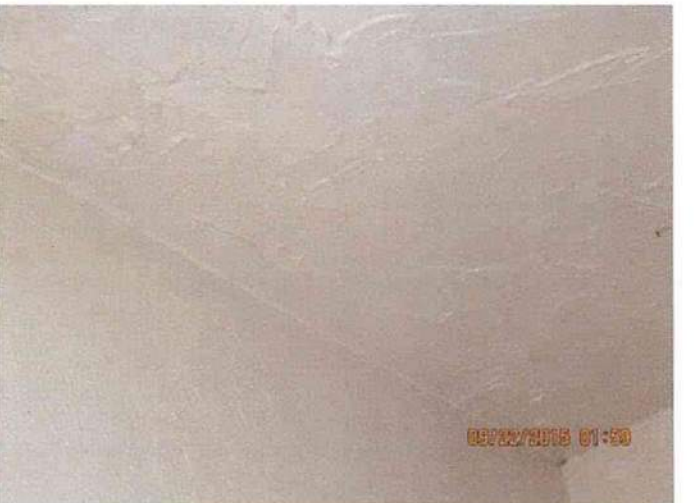
Photo 16 Use of heavy texture was noted on recent repairs. Possibly being used to hide structural separation. Noted cracking and voids behind texture

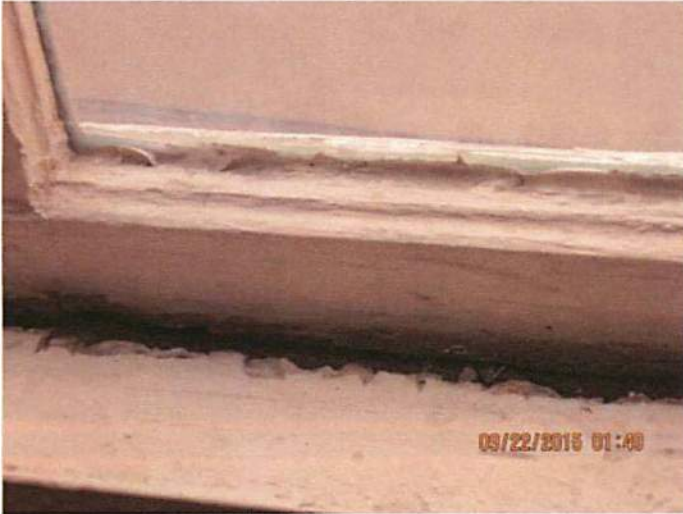
Photo 17 Several windows on the second floor have separated and have been nailed shut. This is consistent with wacked and warped walls due to structural stability of the building

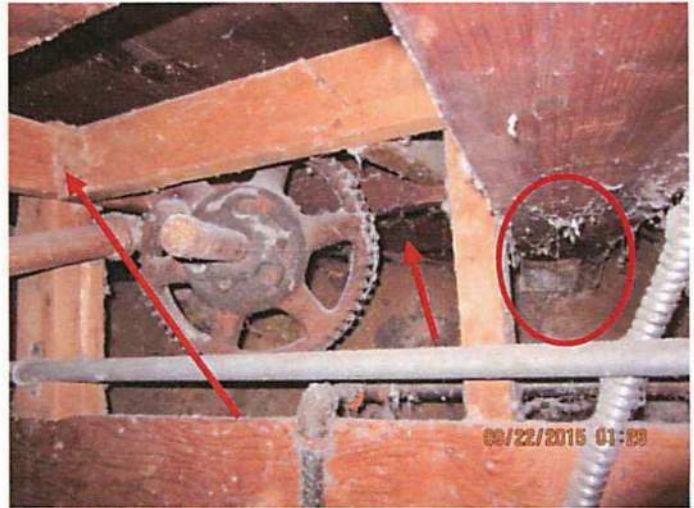
Photo 22 Floor joist bearing directly on dirt. Shims and bracing added for support. Improperly installed

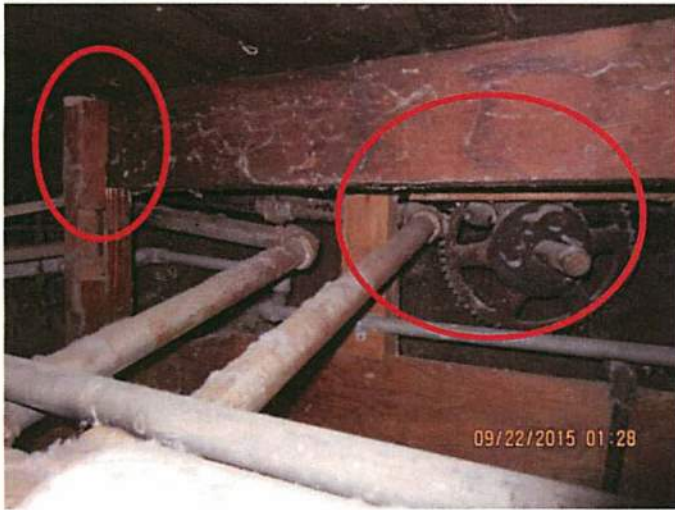
Photo 23 The addition of bracing and shims to prevent settling of the building. Cannot have bearing directly on soils. All bearing is directly on soils. Engineer to justify

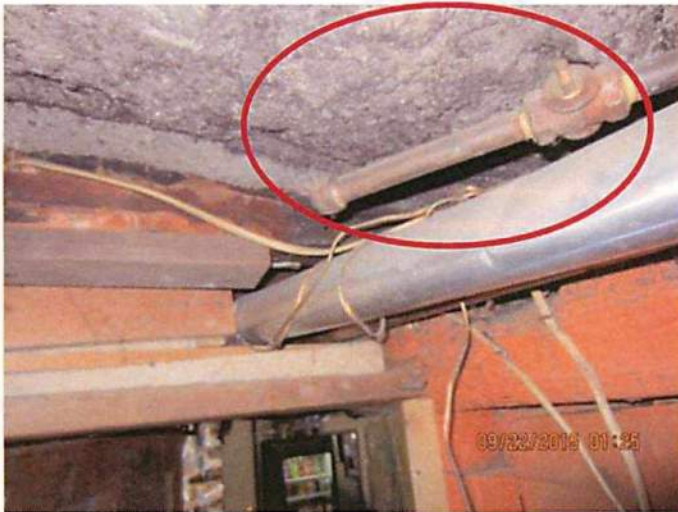
Photo 1 Gas lines that have terminated in hidden rooms that are not properly secured. This room is located in the deli in the front area between entry doors

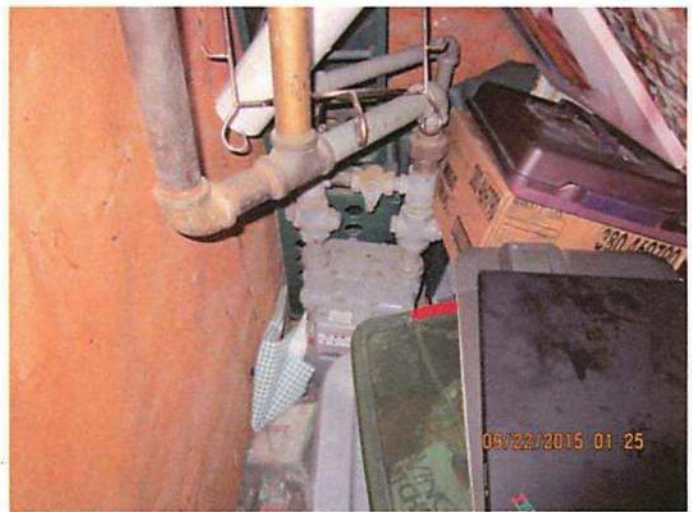
Photo 2 Gas meter is located in a hidden room with possible improper connections to the building. The room is located in the front of the deli between the entry doors

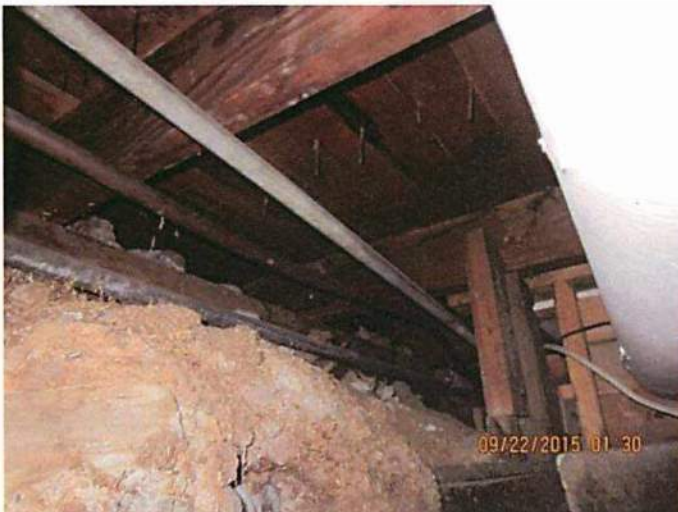
Photo 3 There are numerous pipes consisting of potable water, heating water lines and gas lines that are in direct contact with soils and not properly secured. Decay and deterioration of piping is noted throughout the underground area

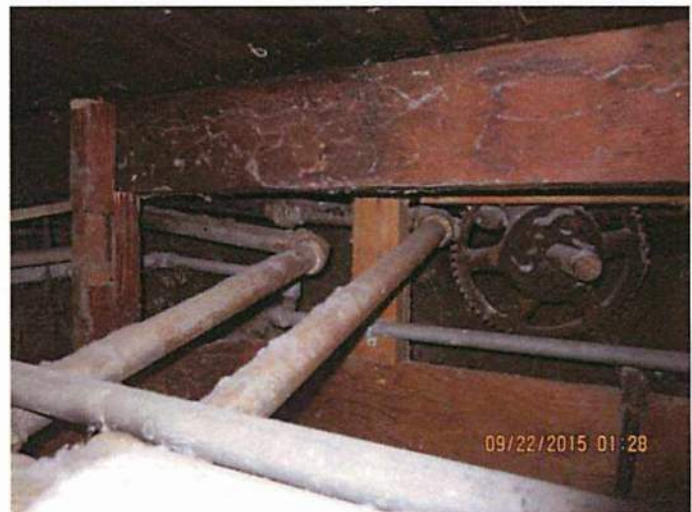
Photo 4 Unsecured gas lines, unknown valves that are not properly maintained or marked

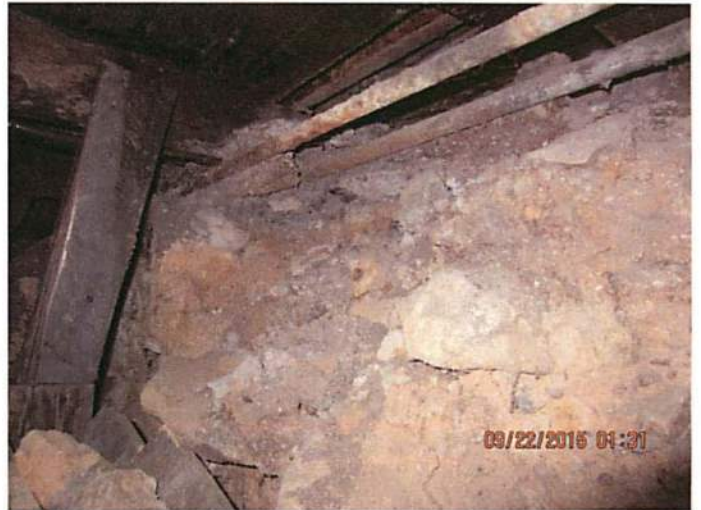
Photo 6 Water lines used for the heating of the building are damaged by decay and deterioration. Erosion and sloughing of the rubble foundation. Severe stability concerns for the structure

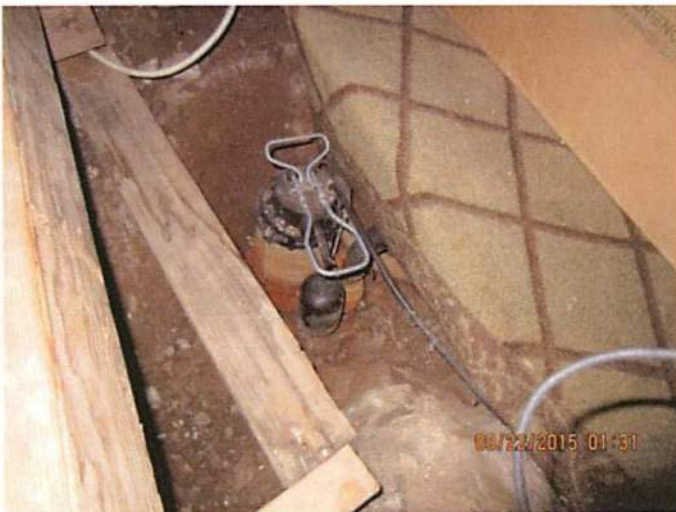
Photo 7 A water/trash pump is located directly below photo 6, the pump is not in working condition
