**PARK CITY MUNICIPAL CORPORATION
HISTORIC PRESERVATION BOARD
CITY COUNCIL CHAMBERS
August 1, 2018**

The originally scheduled meeting of July 18, 2018 has been cancelled. The new meeting date is August 1, 2018.

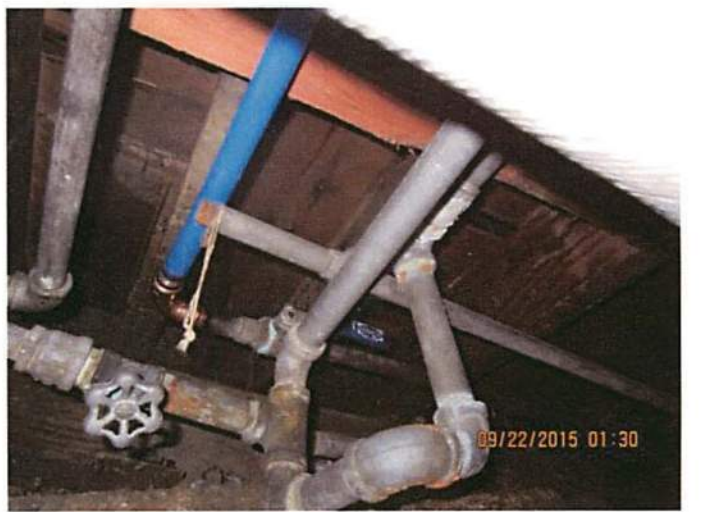
Photo 8 Improperly installed plumbing repairs. Ends not properly capped. Copper to galvanized requires a brass coupler

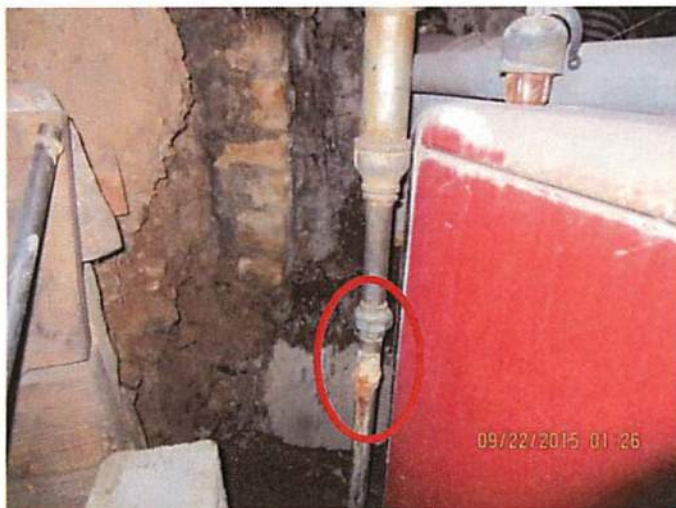
Photo 9 Gas line shows decay and deterioration needs to be shut off ASAP

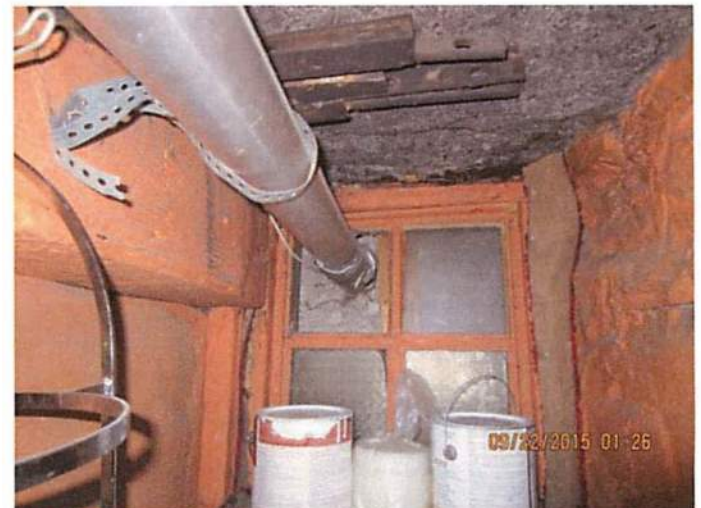
Photo 10 Vent line for hot water heater exceeds the maximum length. Possible carbon dioxide (CO₂) concerns. Located in deli

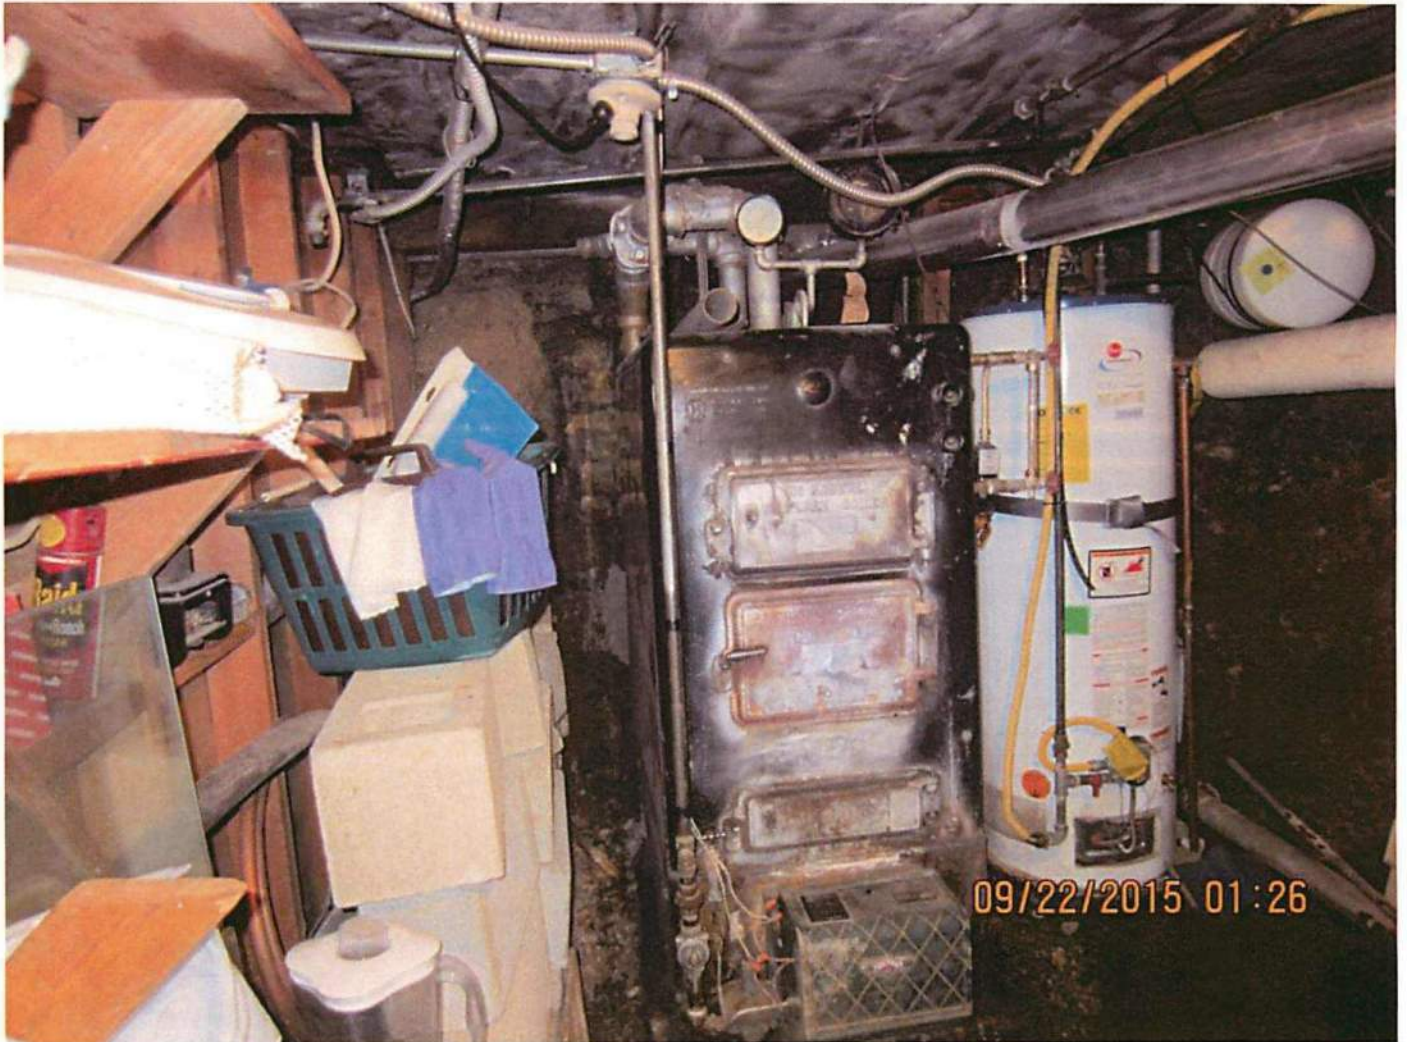
Photo 11 The building is being heated by a 1930's era boiler that has been converted from coal/wood to natural gas. The boiler has no current state boiler inspection tags and required by state law to be inspected annually. It is advised the state boiler be notified for a immediate safety check on the boiler. The gas line that feeds the boiler is unsafe and should be terminated .

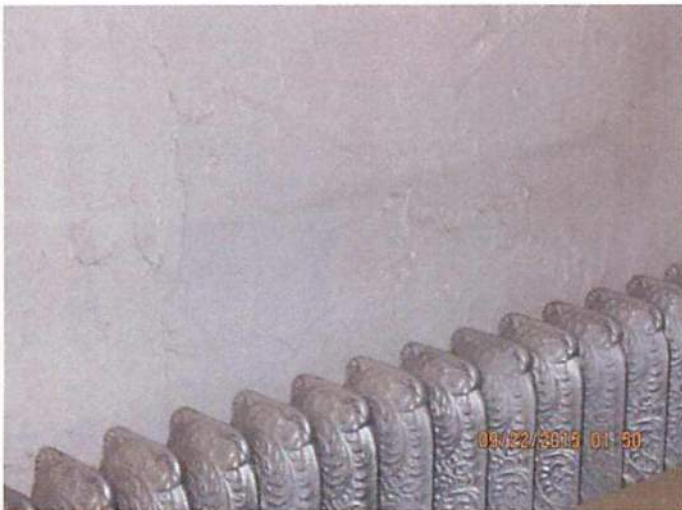
Photo 12 Example of the radiator heating system that uses the boiler to heat the building

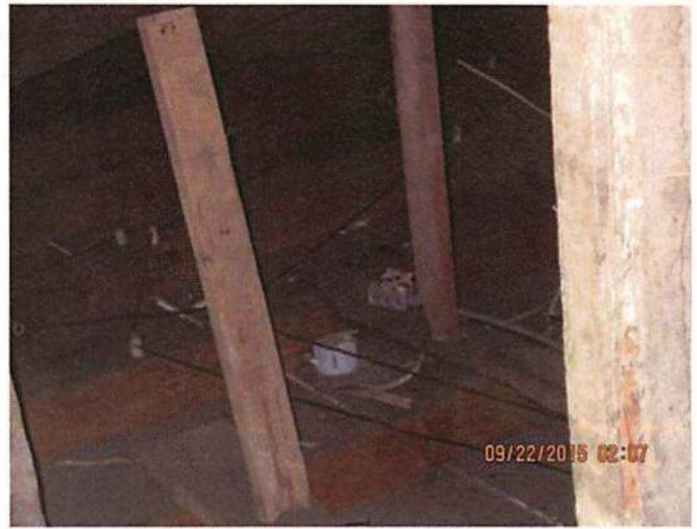
Photo 18 General inspections noted that the knob and tube is most likely active

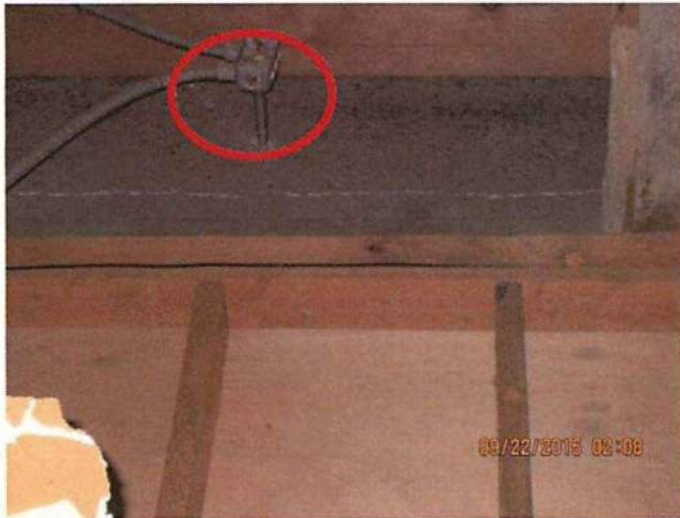
Photo 18 Open electrical boxes noted throughout the building. Electrocutation hazard, fire hazard. Located in attic

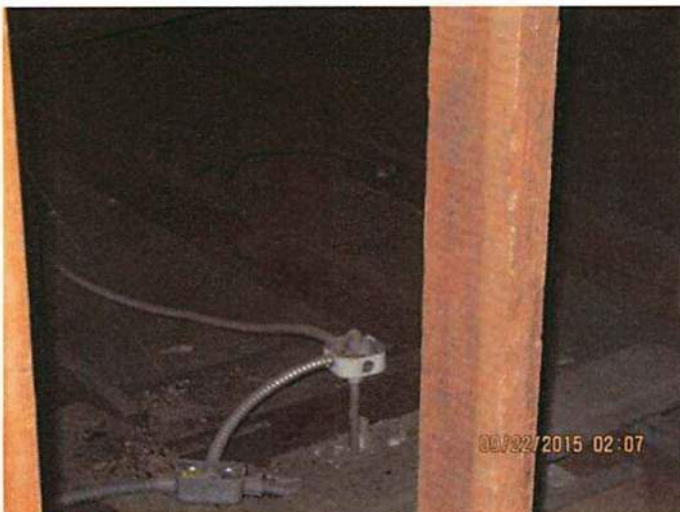
Photo 20 Open electrical boxes noted throughout the building. Electrocutation hazard, fire hazard. Located in attic

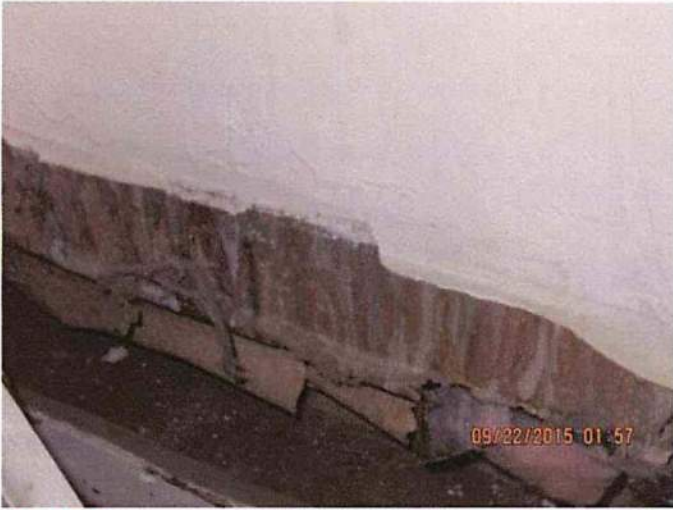
Photo 22 Decay and deterioration noted throughout the building, cause appears to be lack of proper maintenance and infiltration of water from damaged roof

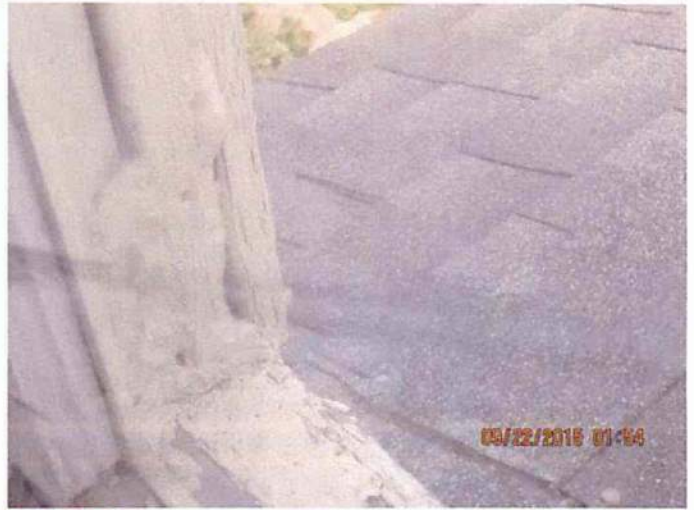
Photo 23 Decay and deterioration noted throughout the building, cause appears to be lack of proper maintenance and infiltration of water from damaged roof

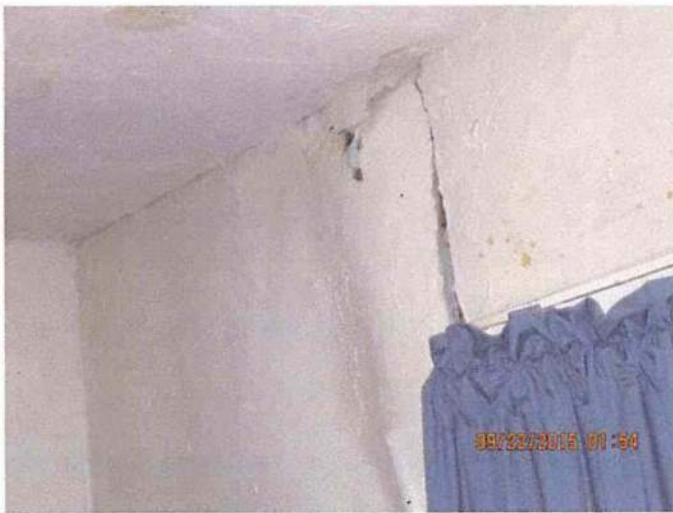
Photo 24 Decay and deterioration noted throughout the building, cause appears to be lack of proper maintenance and infiltration of water from damaged roof

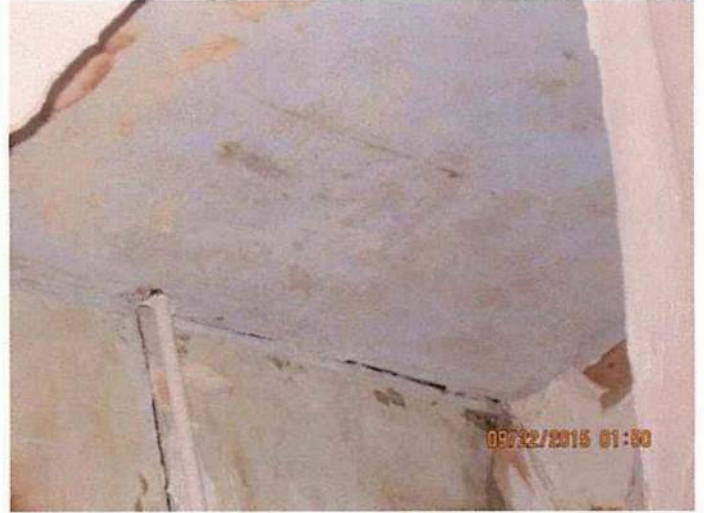
Photo 25 Decay and deterioration noted throughout the building, cause appears to be lack of proper maintenance and infiltration of water from damaged roof

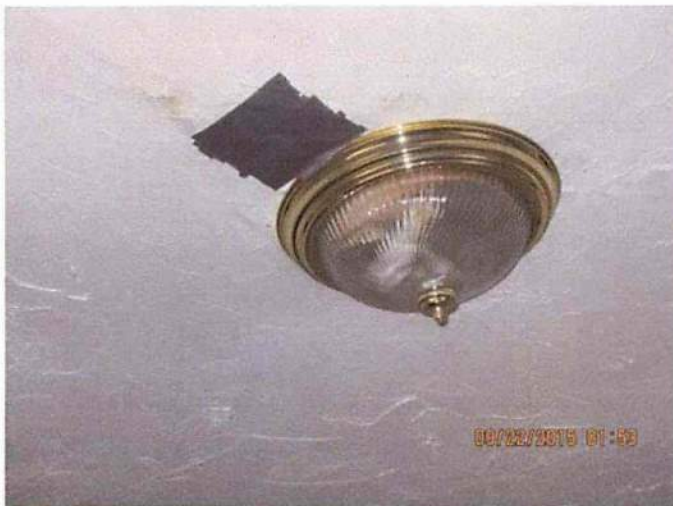
Photo 26 Tape being used to cove water damage next to electrical outlet that feeds light

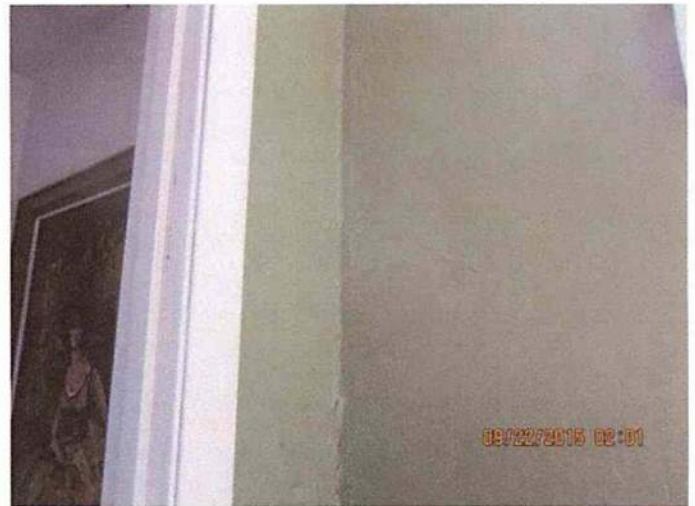
Photo 27 Water damage and structural concern behind wall

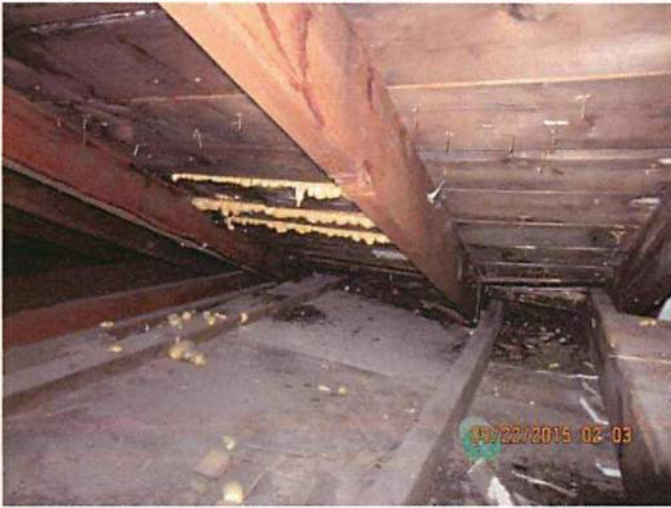
Photo 28 Roof leaks being repaired with a product that is not designed for such use

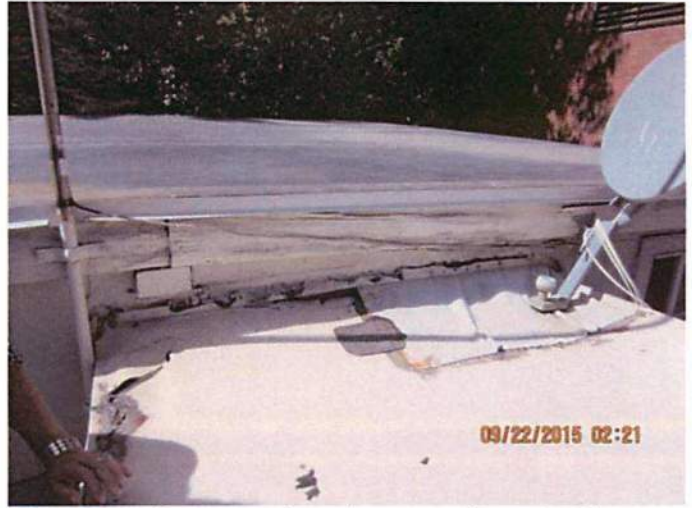
Photo 29 Roof appears to have been recently repaired but some areas are damaged and show signs of possible water infiltration

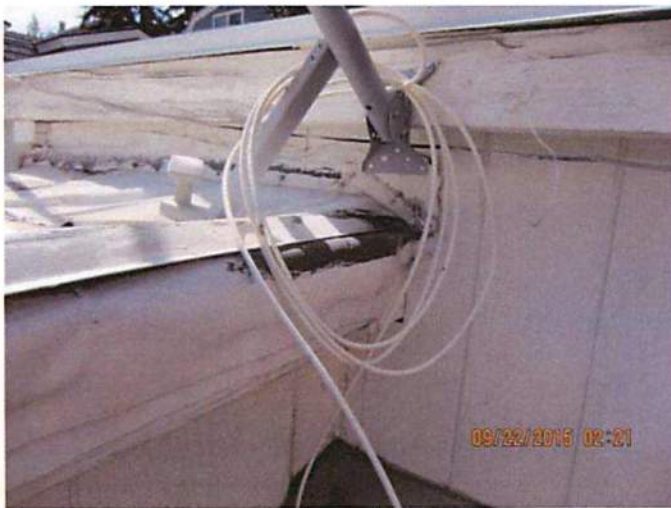
Photo 30 Possible location of water infiltration

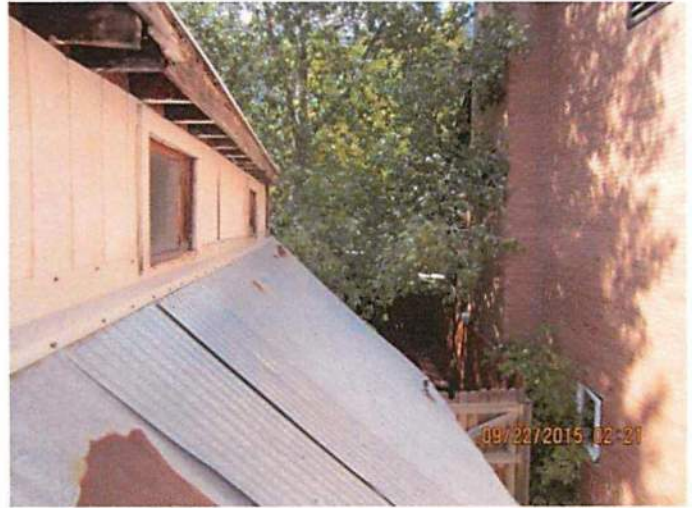
Photo 31 Roof shows sign of decay and rot damage, soffit and fascia are missing, possible location of water infiltration

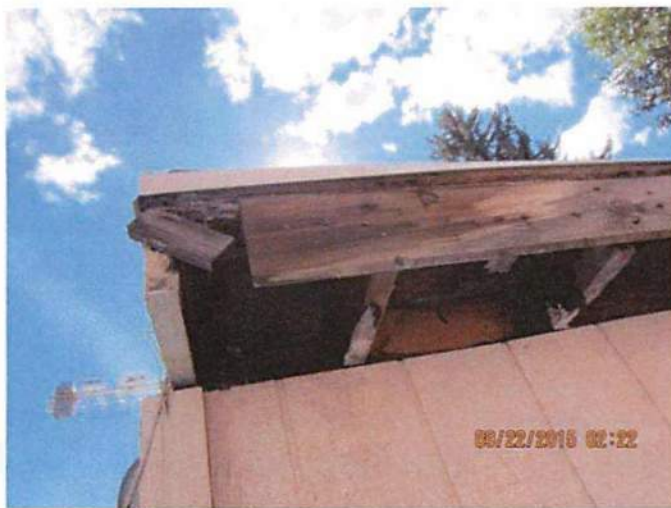
Photo 32 Roof shows sign of decay and rot damage, soffit and fascia are missing, possible location of water infiltration

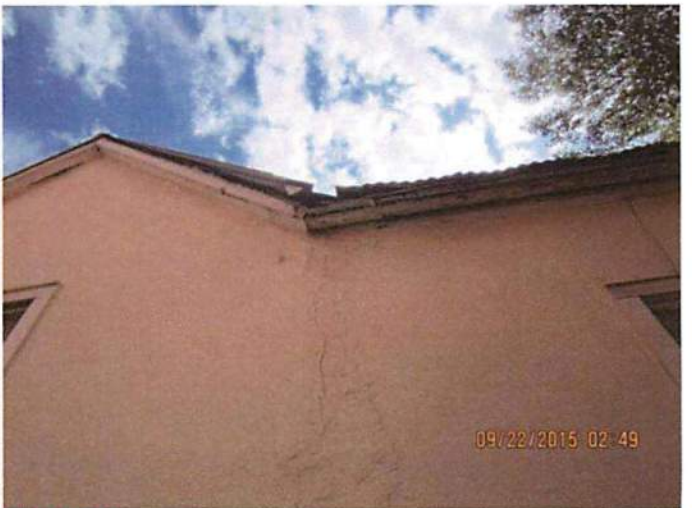
Photo 33 Structural concerns possibly related to the drainage from the roof

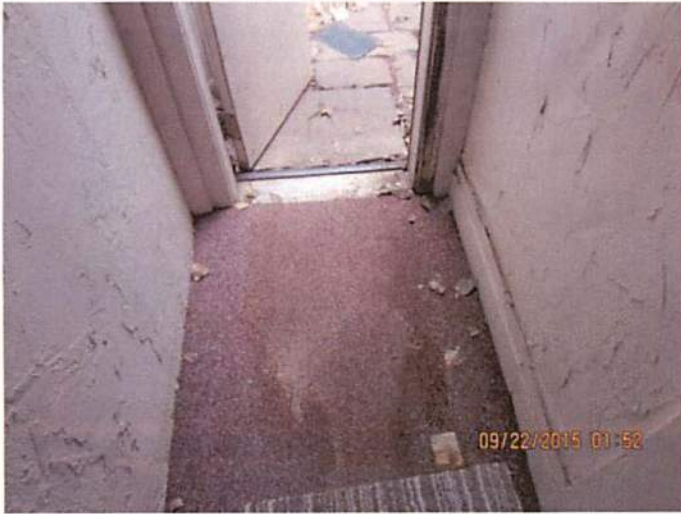
Photo 35 Egress from the back of the dwelling serving 50% of 8 units or 22 occupants cannot be used. Gates are locked to prevent escape and no safe access to the front of the building is provided. Limited egress, direct violation of the fire code for egress requirements for type R-3 buildings and occupant load

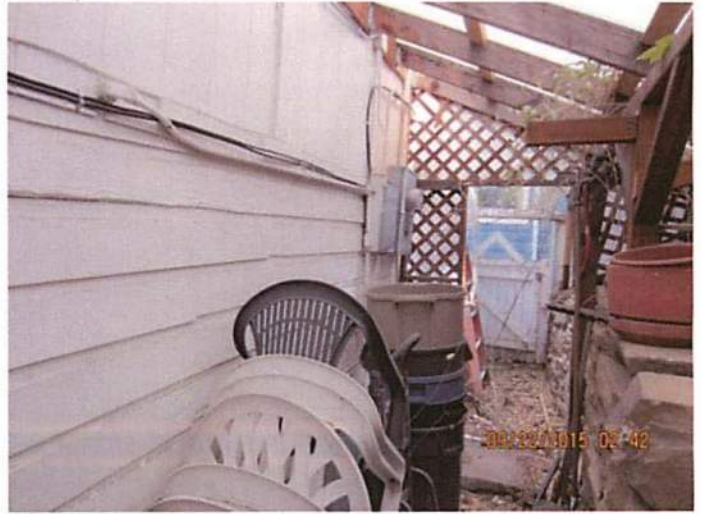
Photo 36 Egress path rear of building. No access to safe location

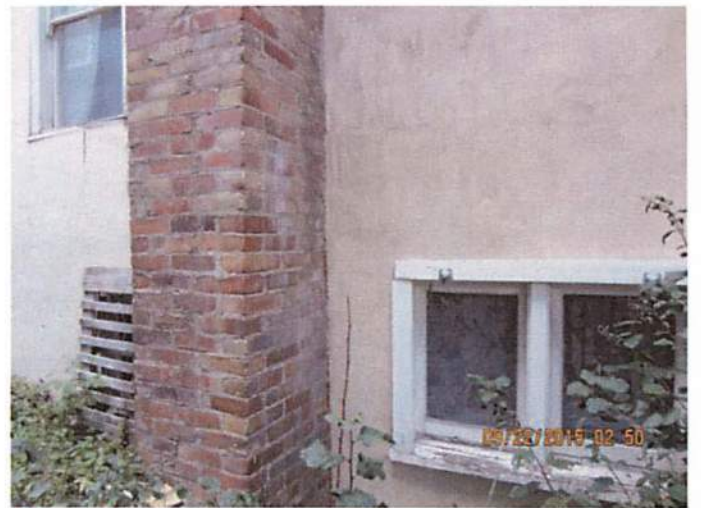
Photo 40 Egress path from other side of building. No safe access to main street

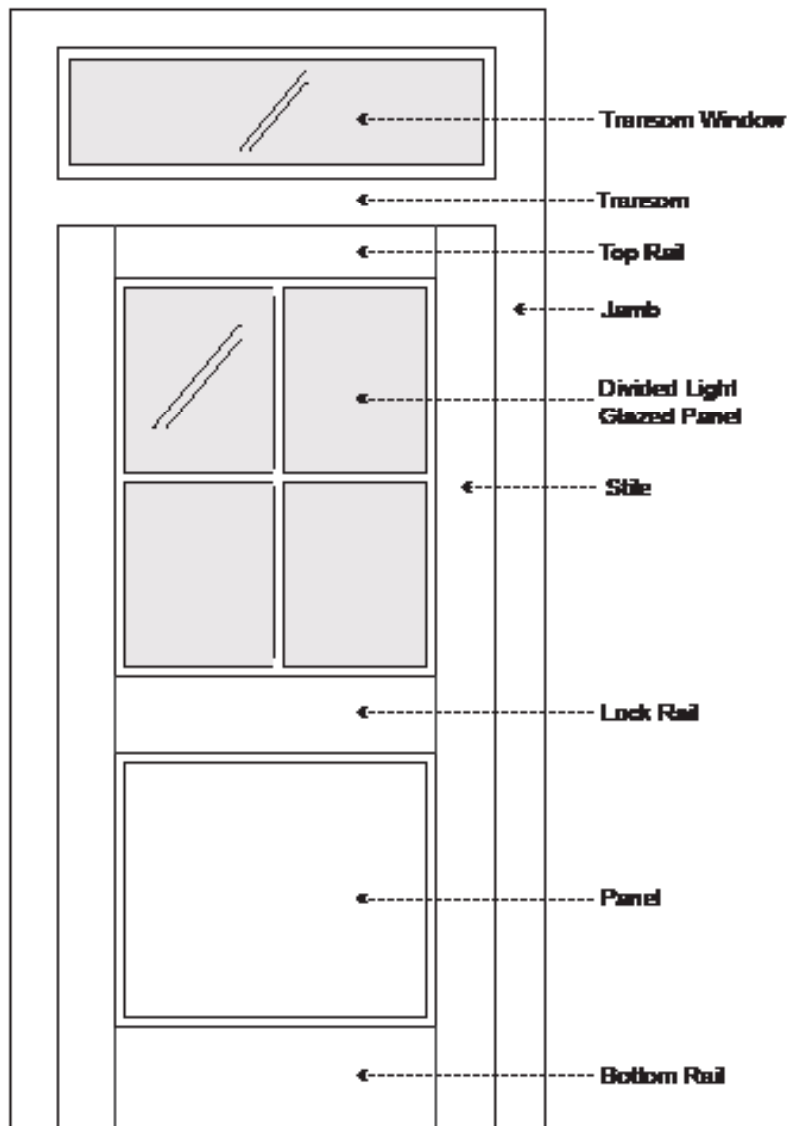
If you have questions regarding the requirements on this application or process please contact a member of the Park City Planning Staff at (435) 615-5060 or visit us online at www.parkcity.org. Updated 10/2014.

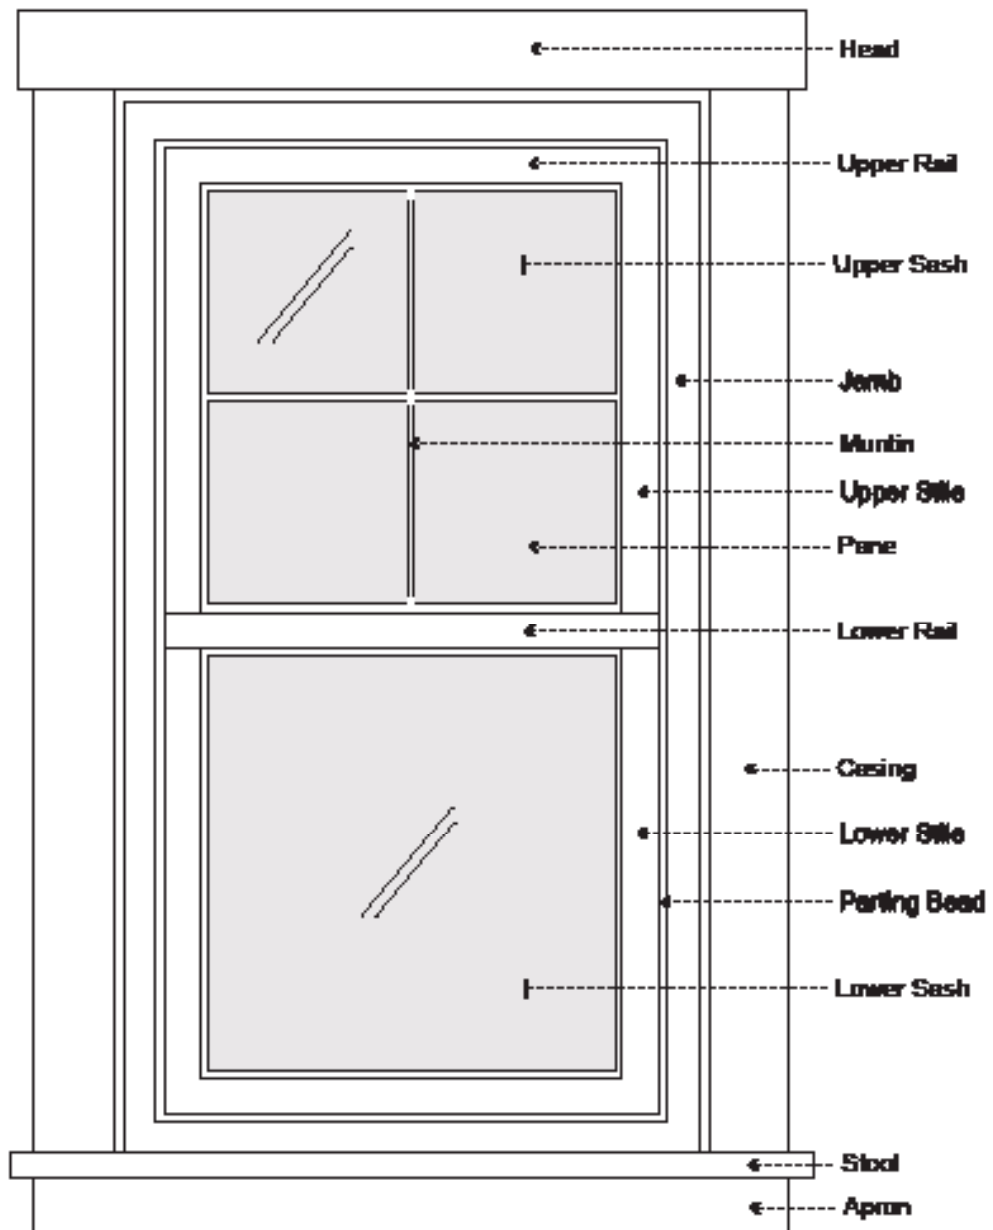
If you have questions regarding the requirements on this application or process please contact a member of the Park City Planning Staff at (435) 615-5060 or visit us online at www.parkcity.org. Updated 10/2014.

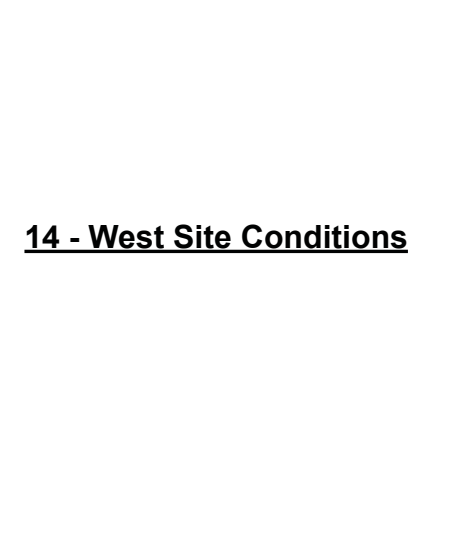
14 - West Site Conditions

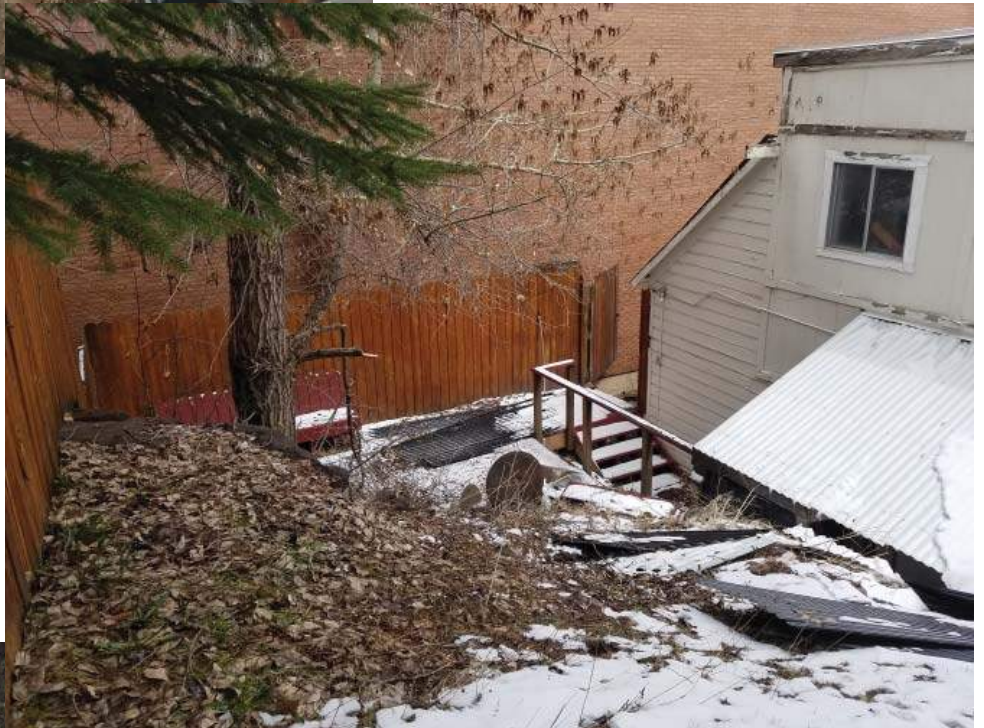
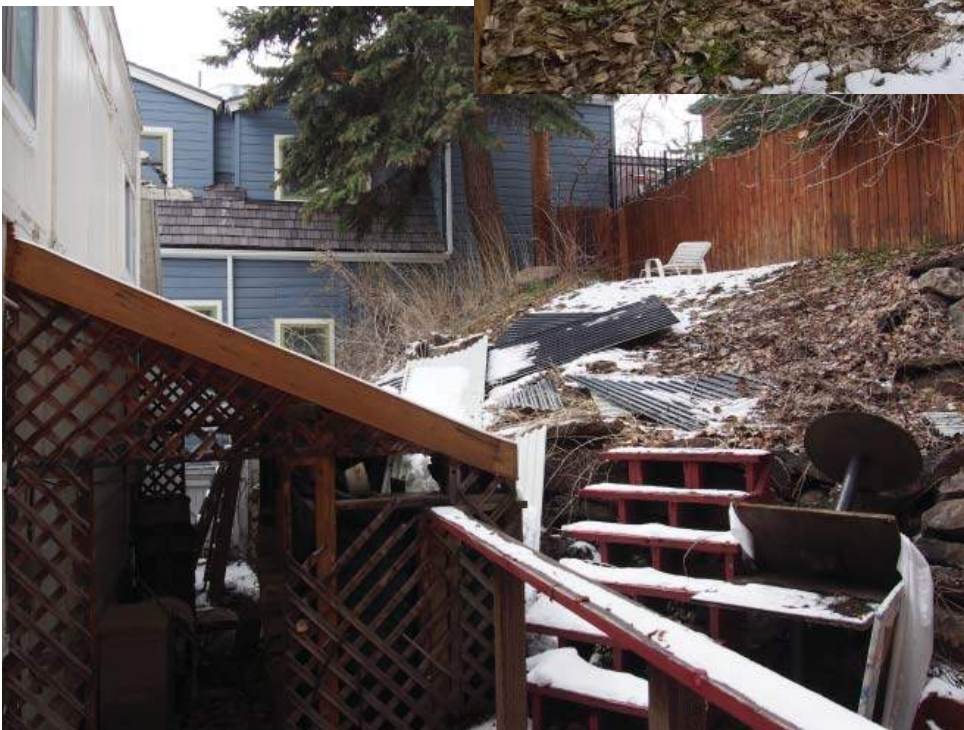
15 - West Site Conditions

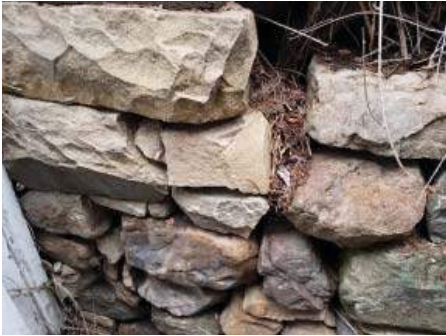
16 - West Retaining Wall Composition

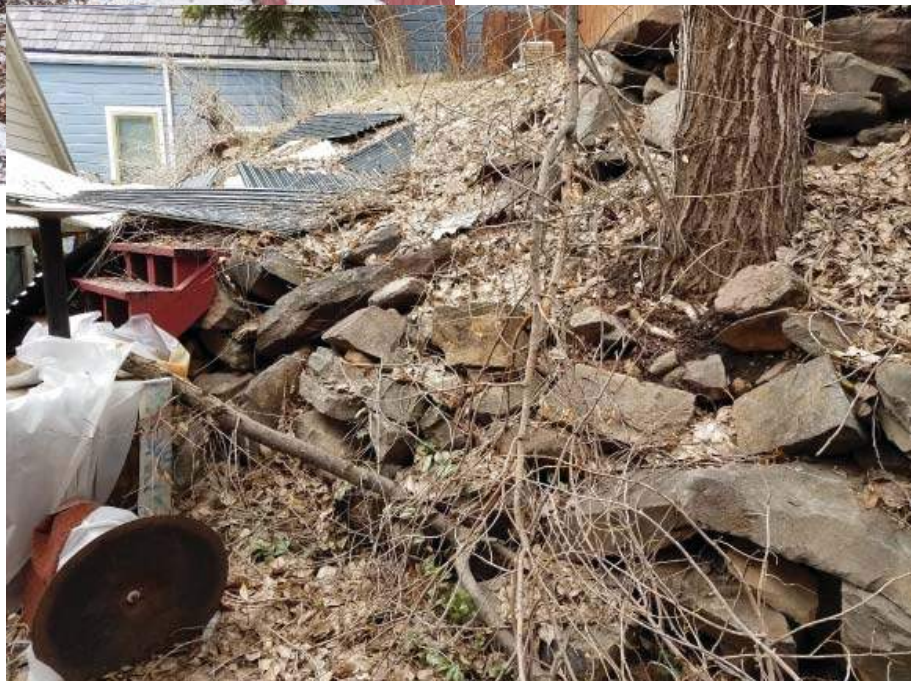
18 - West Site Conditions

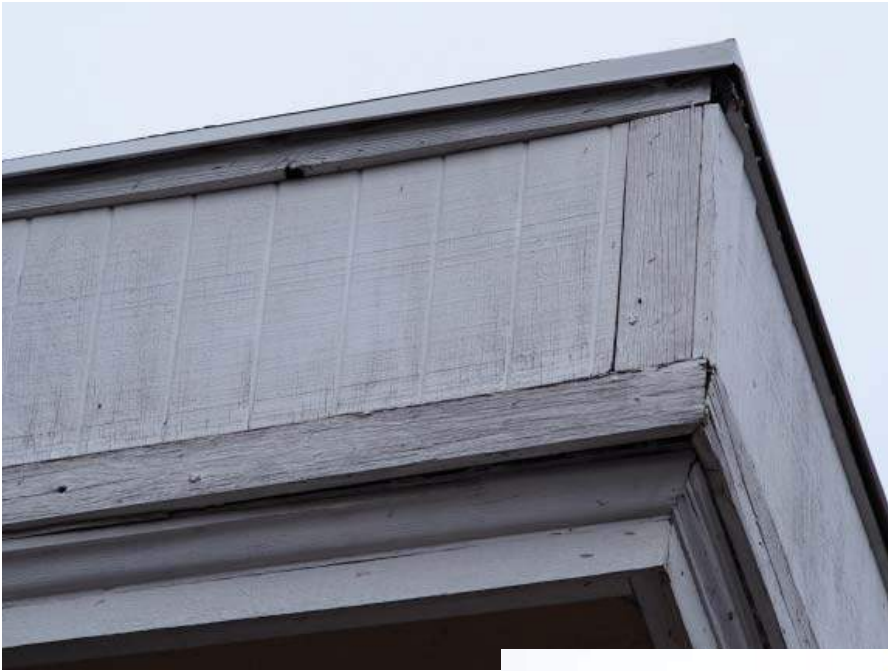
19 - East Eave Detail

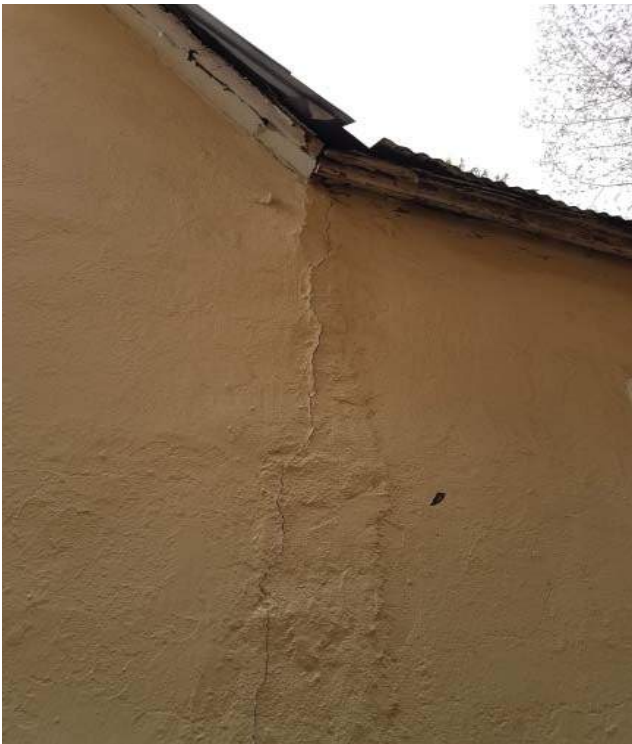
25 - North Water Damage

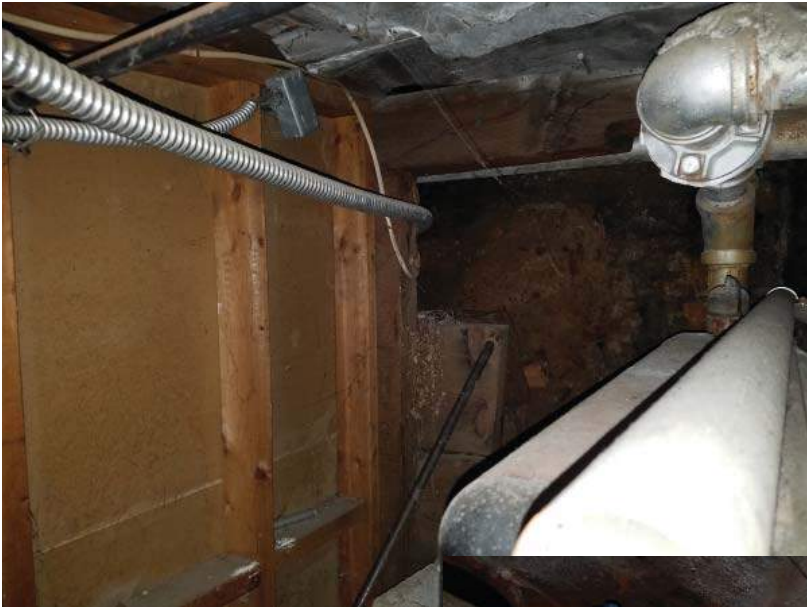
58 - L0 - South Foundation in Mech.

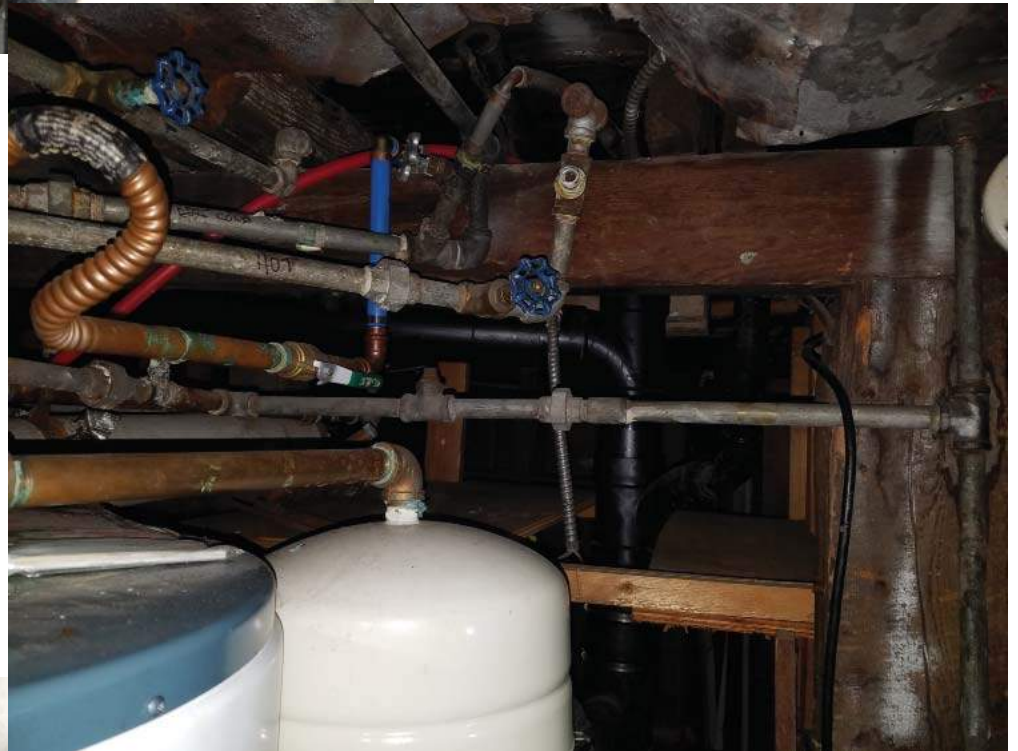
59 - L0 - State of Mech.

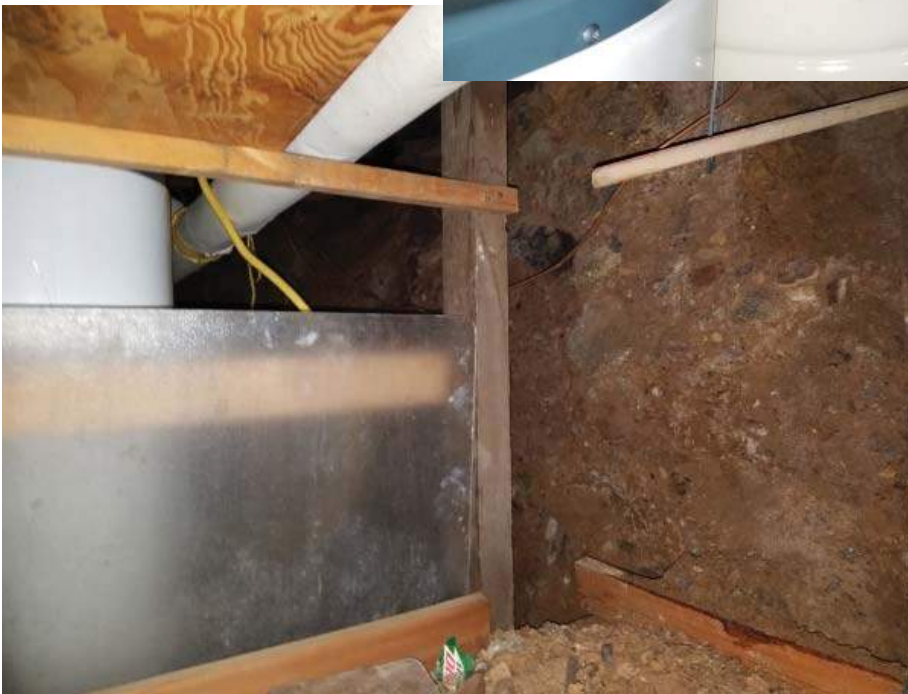
60 - L0 - Dirt Foundation

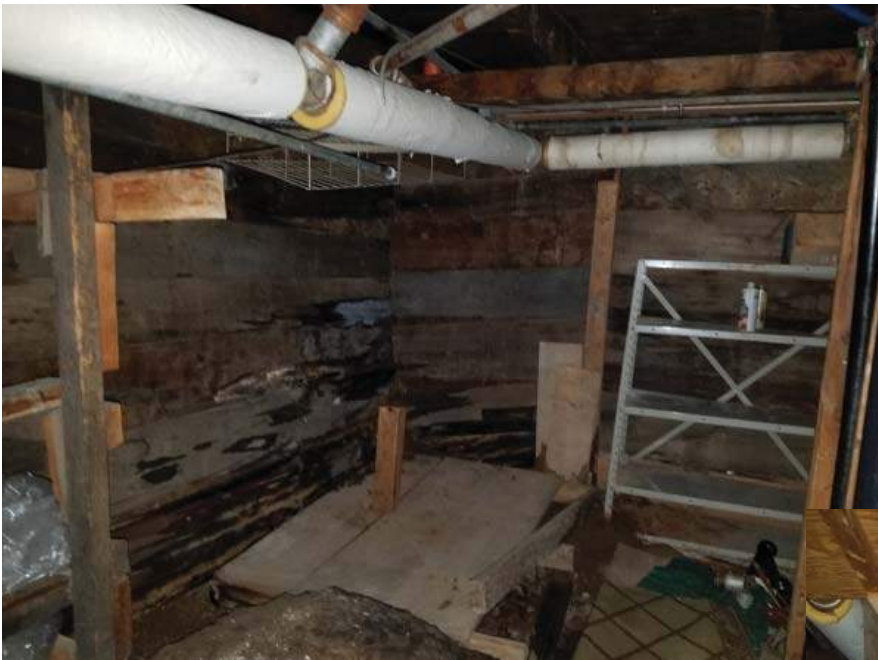
61 - L0 - Wood Shoring

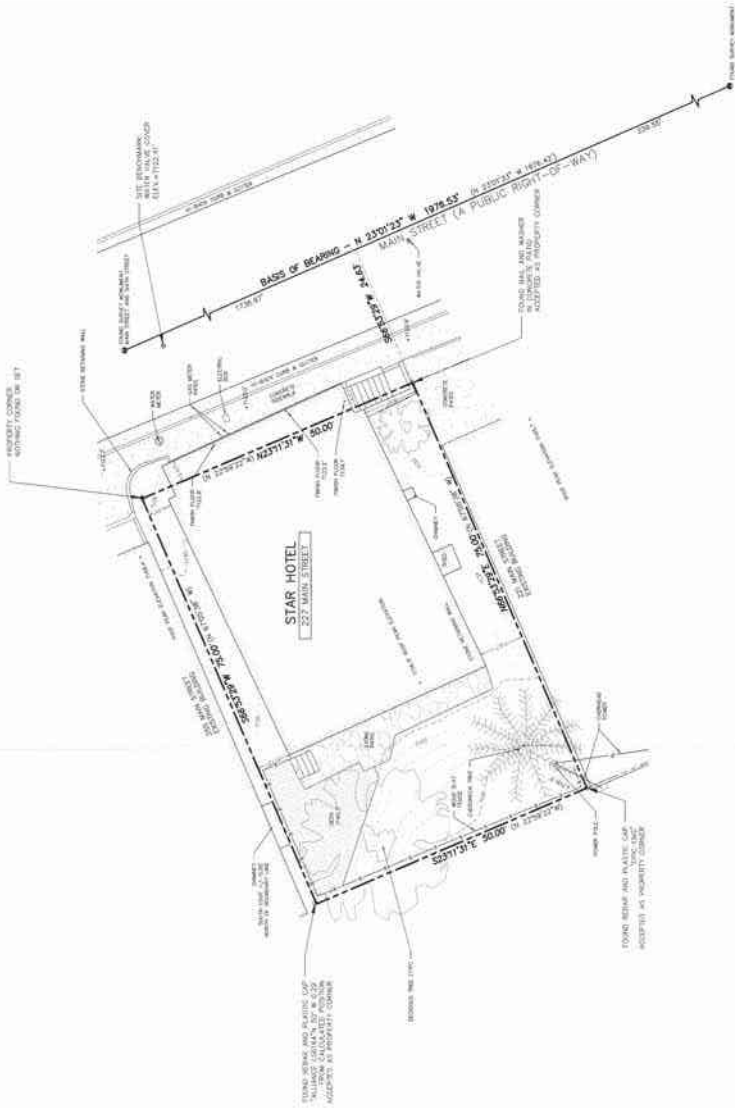
7. Property corners were found as shown.
8. Record bearings and distances were different than measured one shown in subparagraph (1). Record data is from Record of Survey 15-8028.

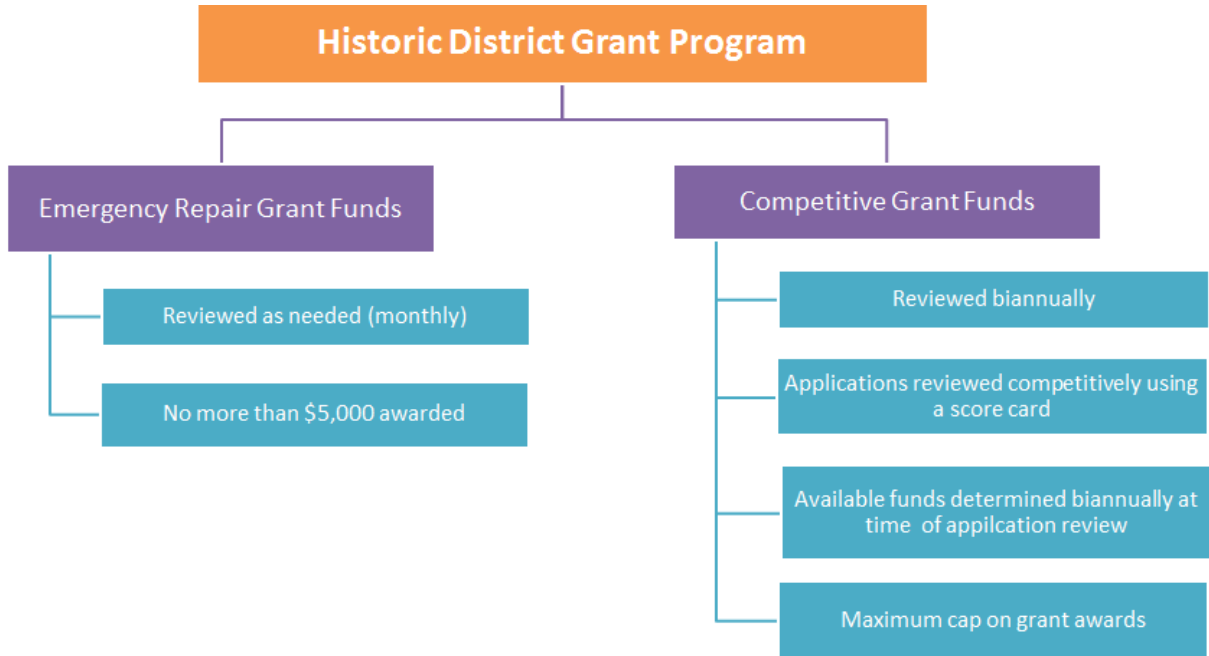
2. Emergency Repair Work

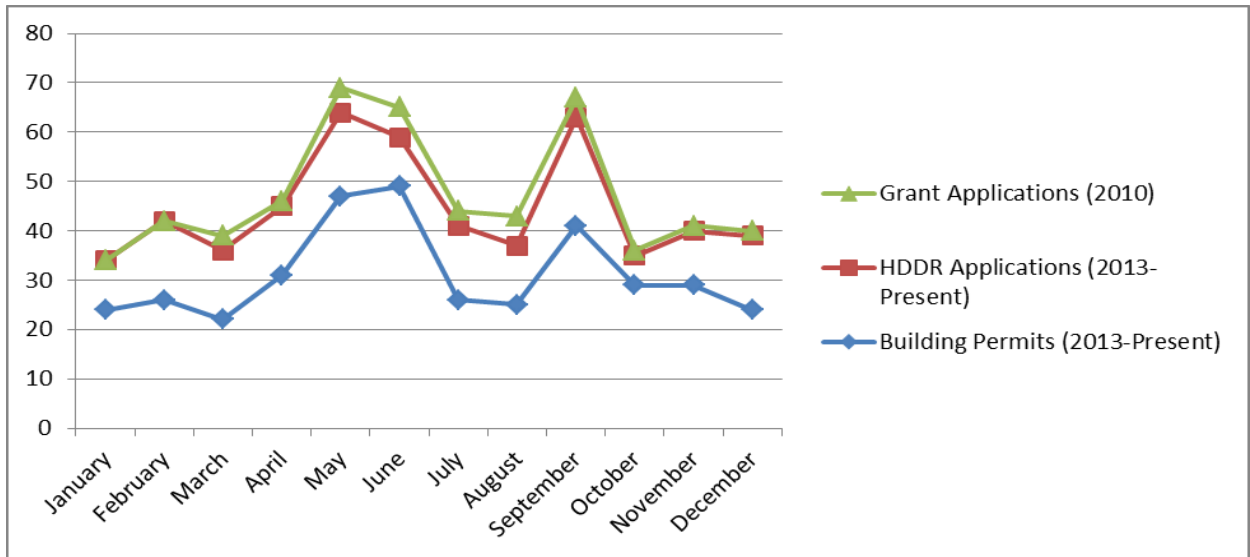
HPB Discussion Requested.
