**PARK CITY MUNICIPAL CORPORATION
HISTORIC PRESERVATION BOARD
CITY COUNCIL CHAMBERS
August 1, 2018**

The originally scheduled meeting of July 18, 2018 has been cancelled. The new meeting date is August 1, 2018.

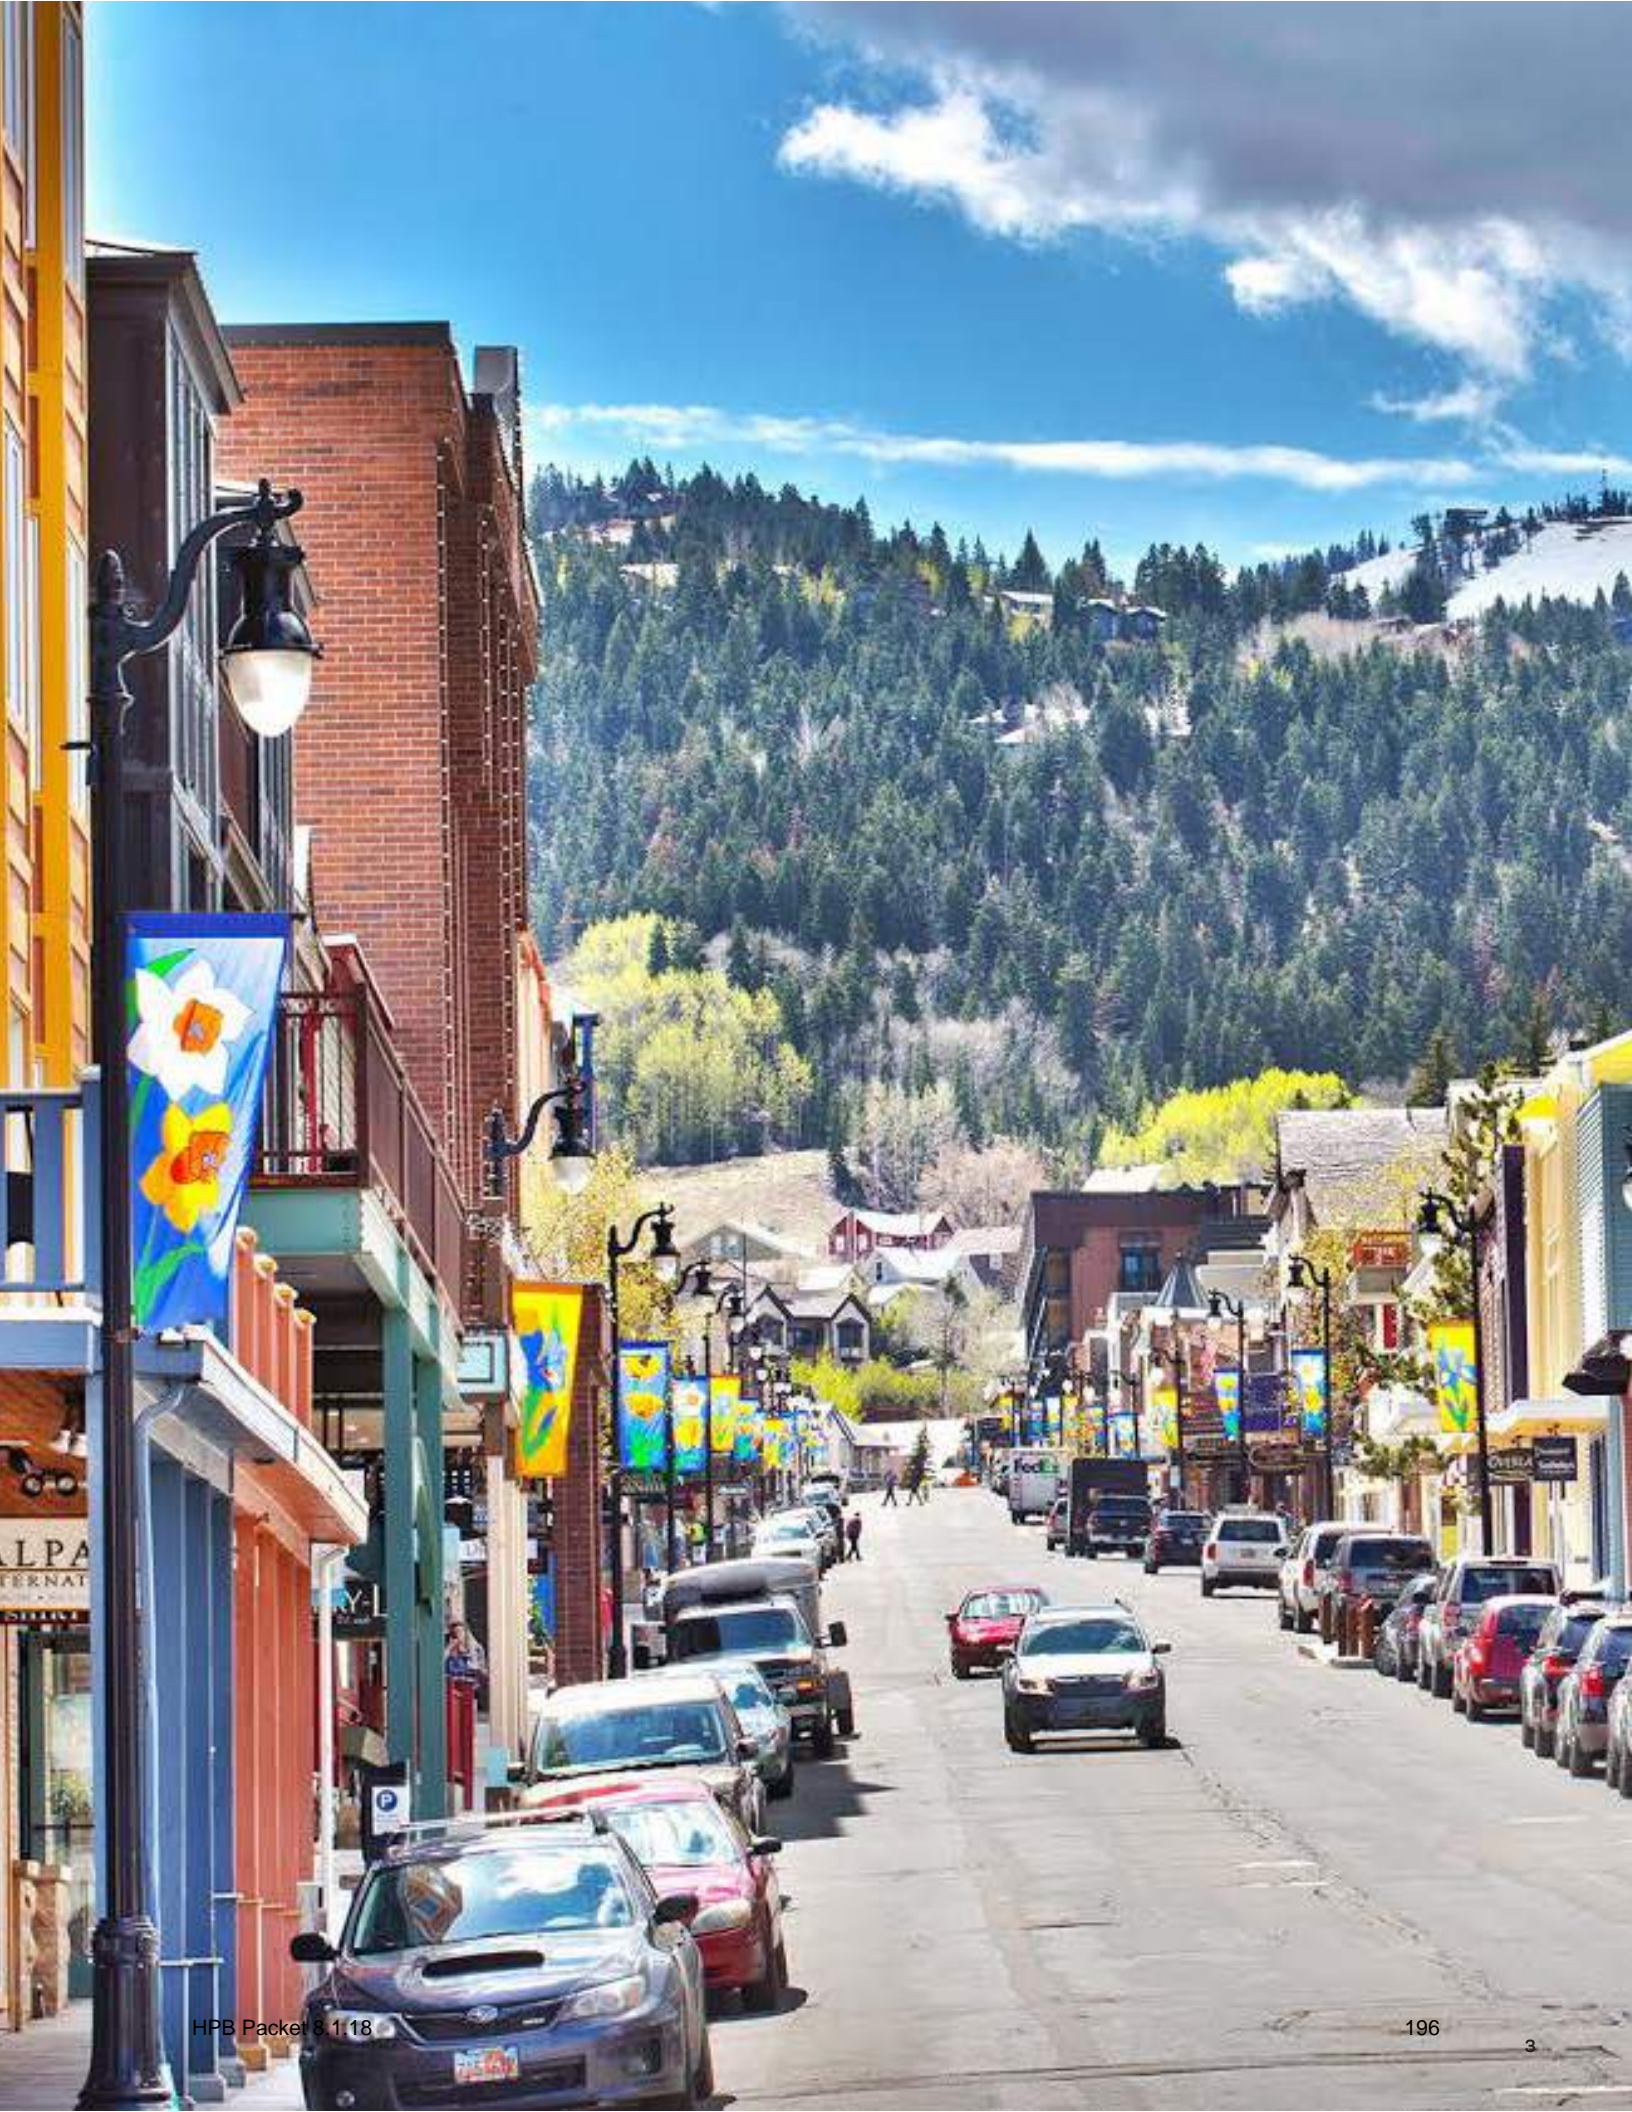
Foreword from the Mayor 5
 Preface 6
 Acknowledgments 7

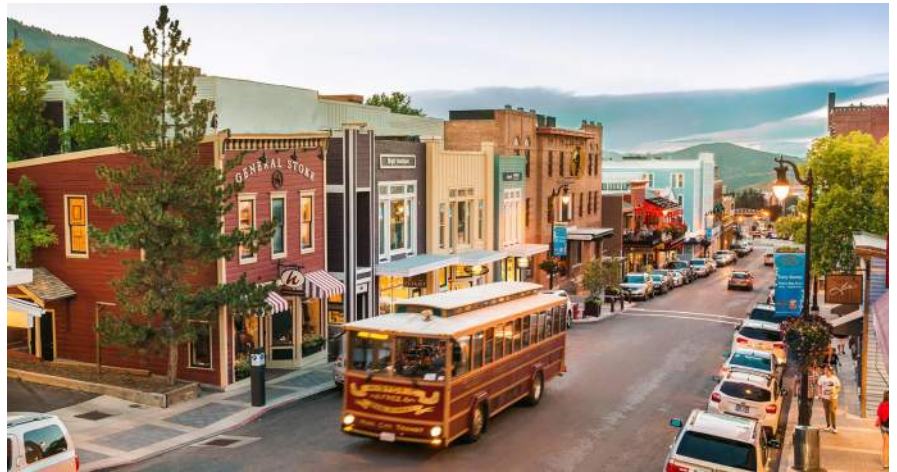
Main Street is home to many unique local businesses and establishments. A sense of authenticity and local flavor is generated as a result of local influence and investment.

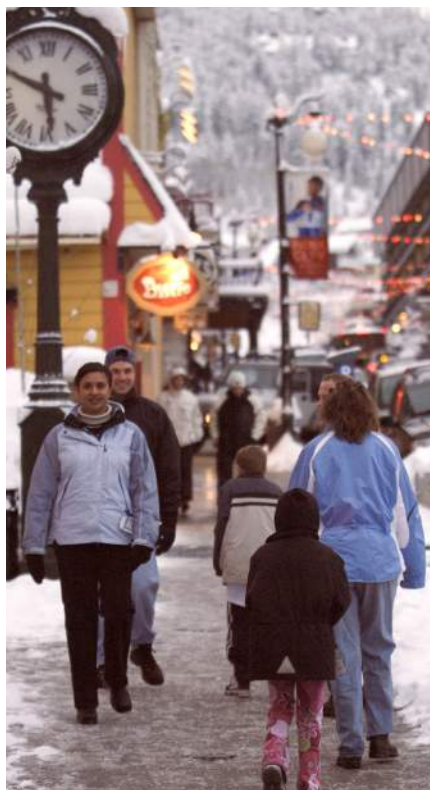
- There is a general sense among interviewees that awarding grants to those who do not need public assistance to make their renovation feasible is not ideal, but there is little consensus about how to address the issue.
- Some interviewees felt that although there may be a perception issue, the grant is not a social program and the real goal is to save and improve historic stock – so who owns the property is a secondary issue that should not drive criteria.
- Other interviewees felt differently, and discussed the possibility of means testing as criteria for eligibility. Some observed that the grant is simply a non-issue in the calculus of a second home buyer who is planning a million-dollar renovation, so perhaps trying to “tune” the grant based on this factor isn’t going to be impactful.

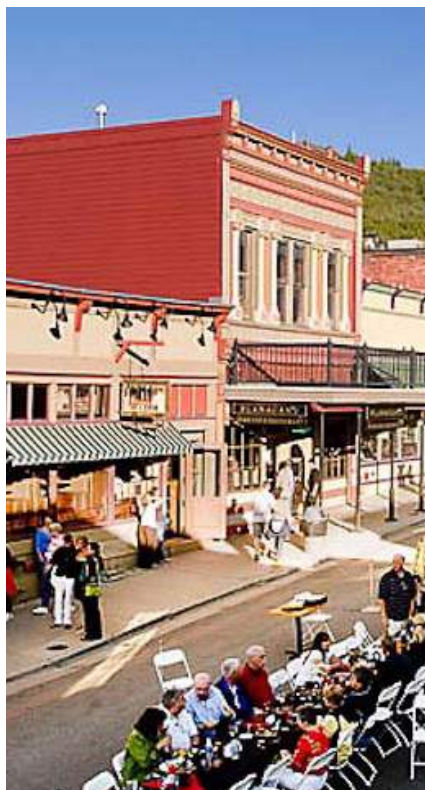
- The City could identify homes that remain to be restored, assess the kind of work they need, and seek to understand why owners are choosing not to do the work. This may help to define criteria, and to design the grant to assist.
- Staff seek clear criteria for eligible types of work. Should the focus be on work that contributes to saving a building like foundation, structural, or roofing? Or the opposite: work that incentivizes above-minimum standard details, like windows and trim? Should tear-downs that are reconstructed be eligible?
- Should the grant privilege primary over secondary owners? Or focus on property restoration, with no preference for characteristics of ownership? It was observed that a lot of locals are moving out of Old Town, and that the community has changed in ways that the grant will not reverse.

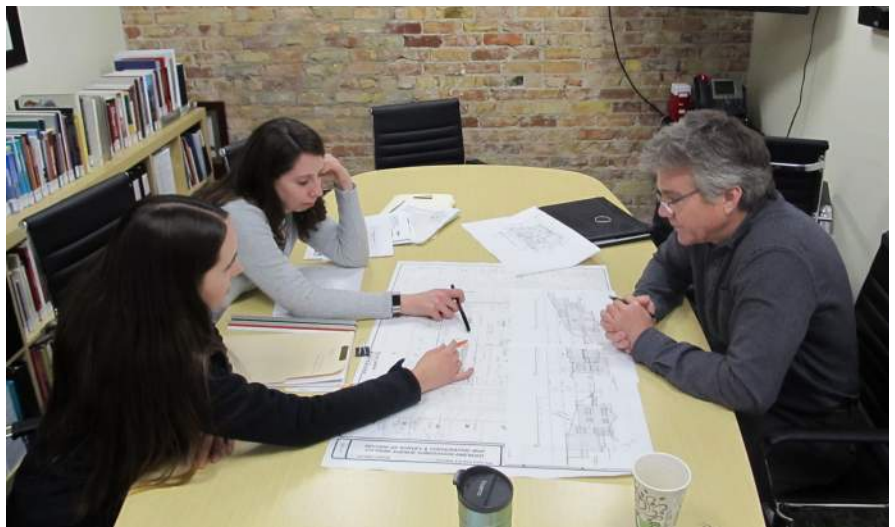
Park City staff provided technical, budgetary, and administrative insights.

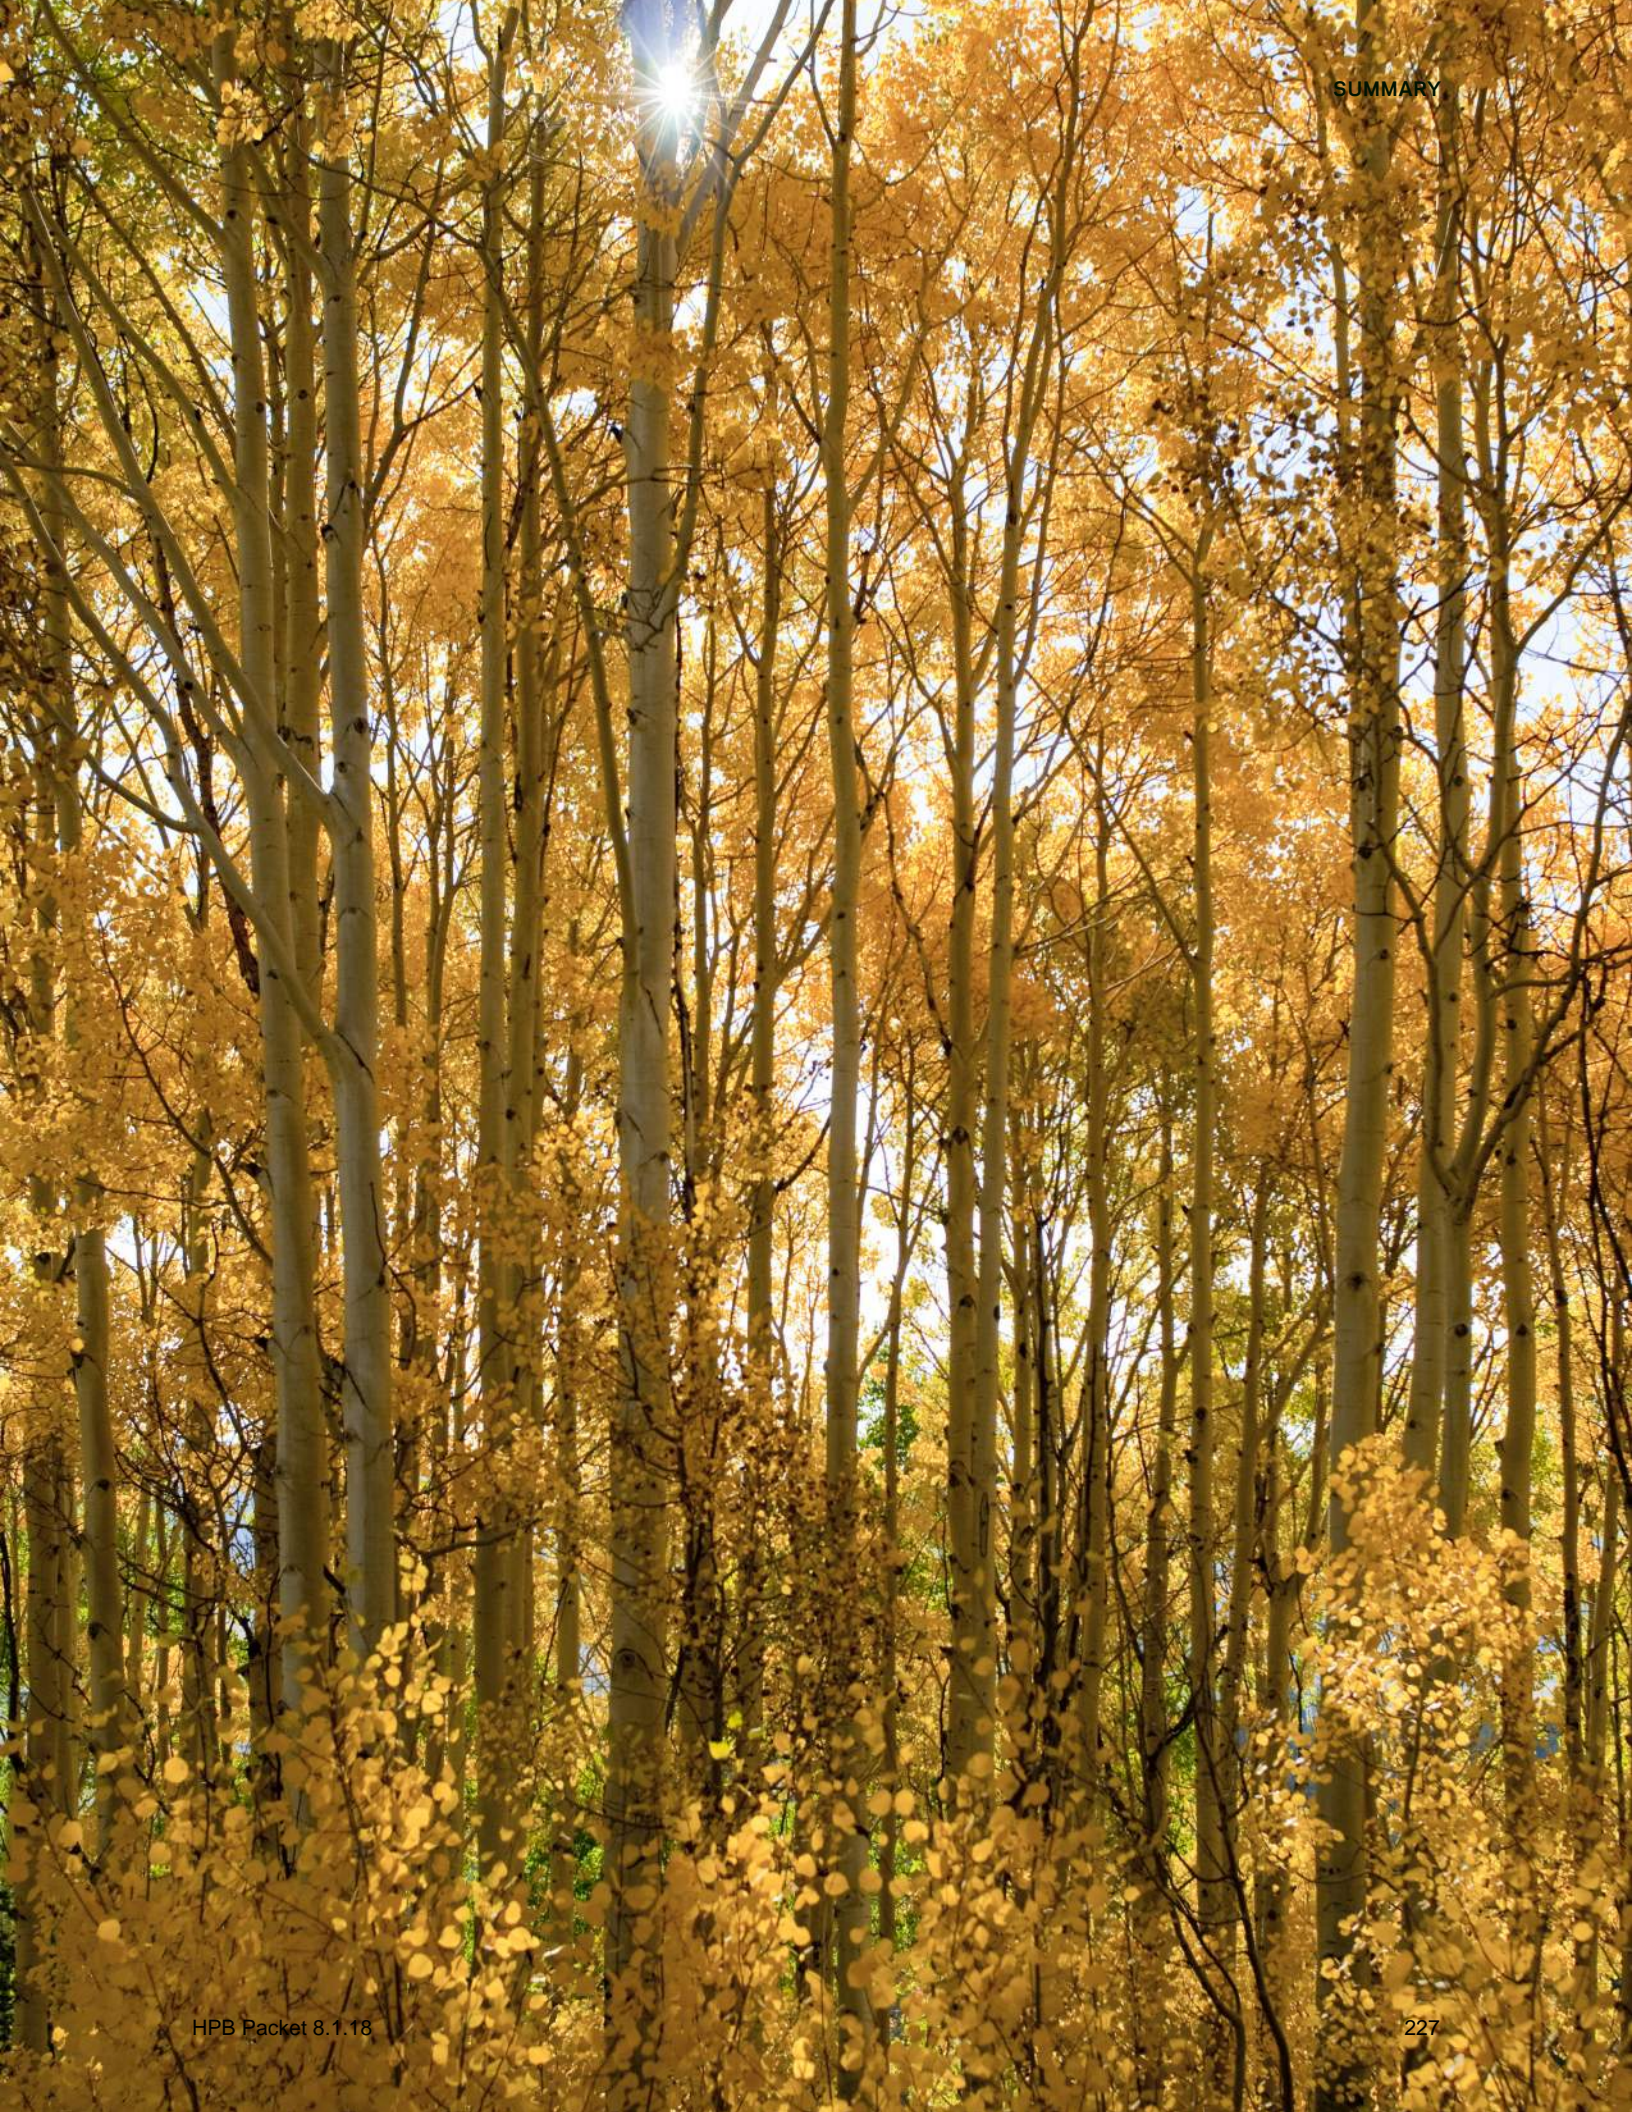
d) Assuming the City introduces a preferred vendor or vendor training program, inform applicants about the City's trained vendor list.
