MEETING CALLED TO ORDER AT 5:00 PM

ADOPTION OF MINUTES OF May 4, 2016

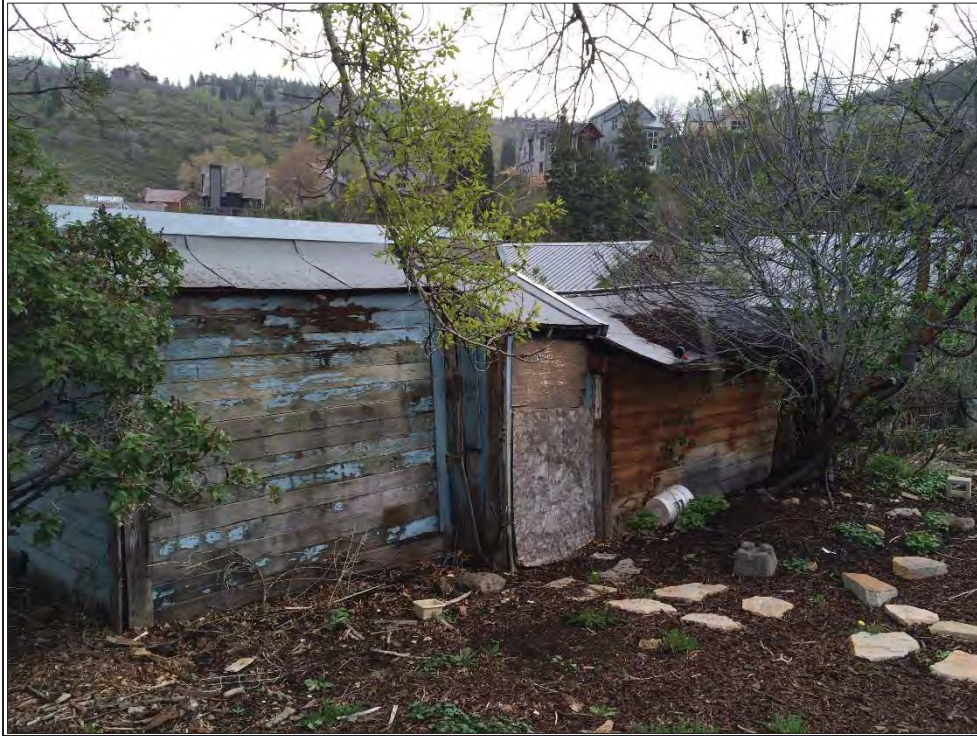
Figure 2. Southwest side of outbuilding in its previous location (facing east); non-historic addition is visible at the right side.

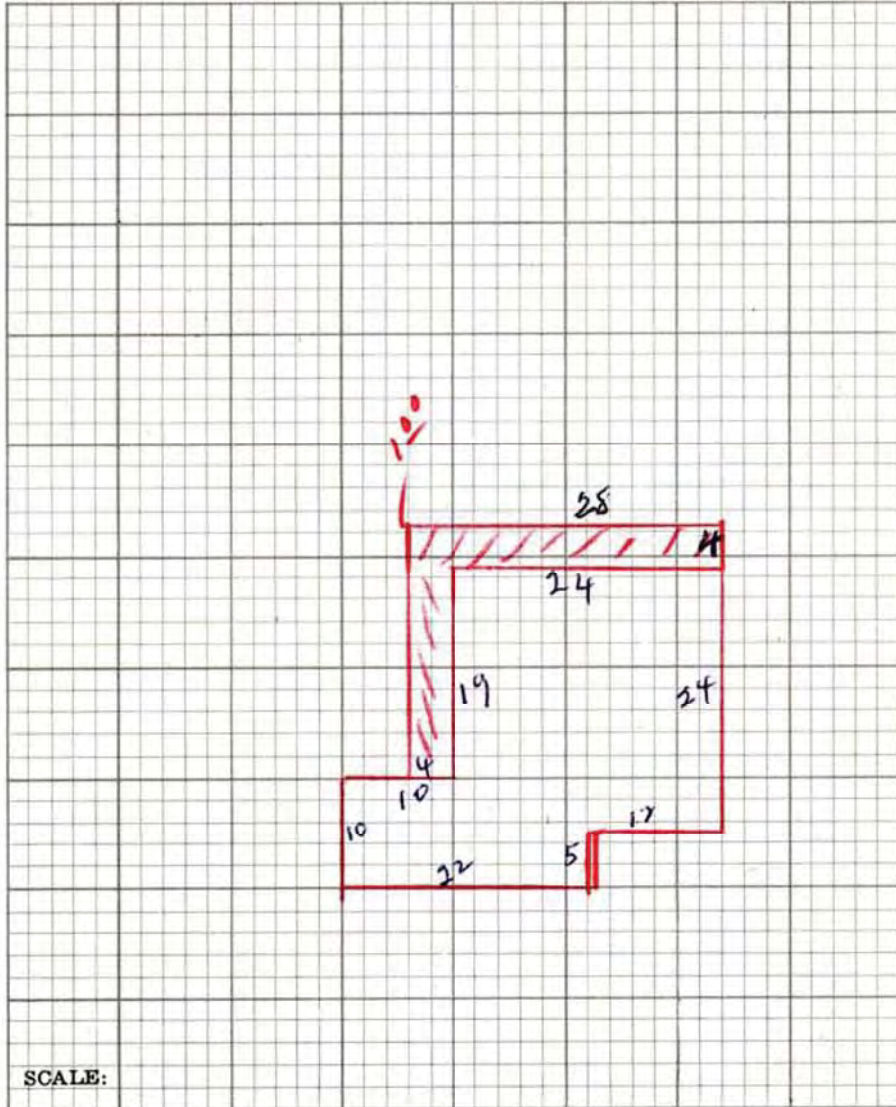
RESIDENTIAL OUT BUILDINGS	Age	Size	Area	Factor	Cost	Conv. Fac.	Adj. Cost	Depr. Value
		x				.47		
		x				.47		
		x				.47		
		x				.47		
		x				.47		
		x				.47

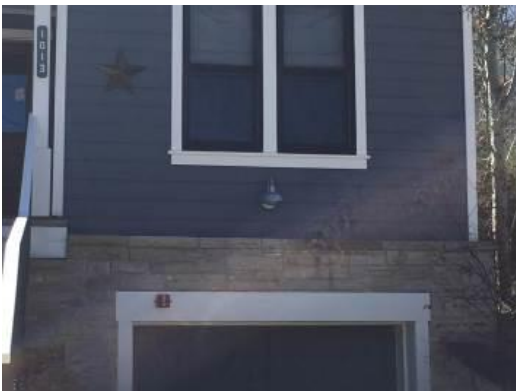
1013 Woodside has no plinth between its baseboard and the new stone foundation.

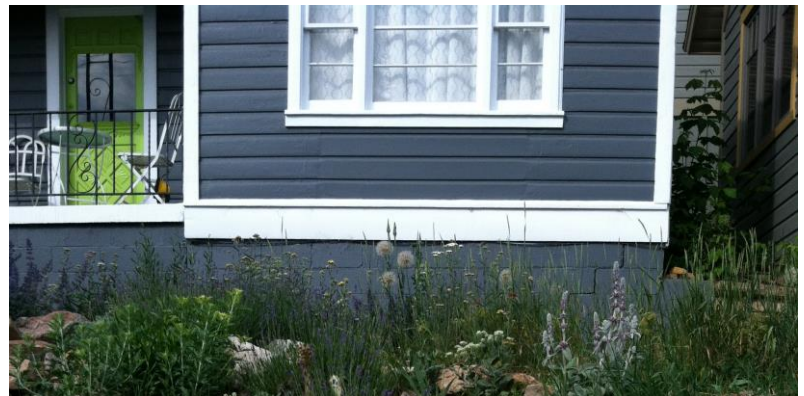
823 Norfolk has a plinth between the wood siding and concrete block foundation which helps anchor the house to the foundation visually.

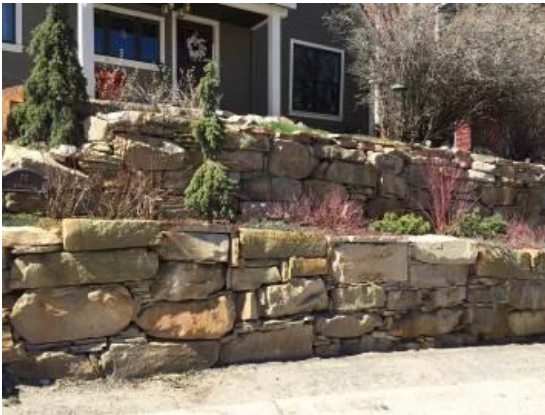
Staff recommends that a sidebar is added which will provide details and recommendations for retaining walls in Old Town. Below are examples of issues that staff finds have arisen as a result of the lack of detail related to retaining walls.

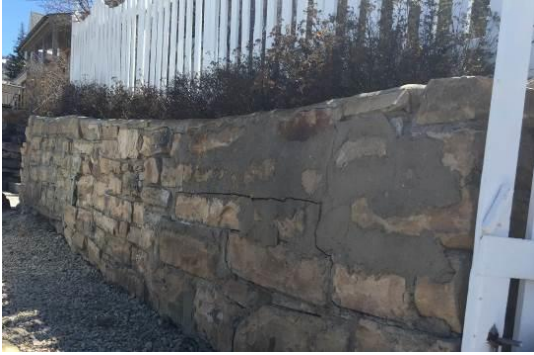
It is important to use stone that is consistent with the types of stone used historically. The color tones of stones are just as important as scale and proportion.

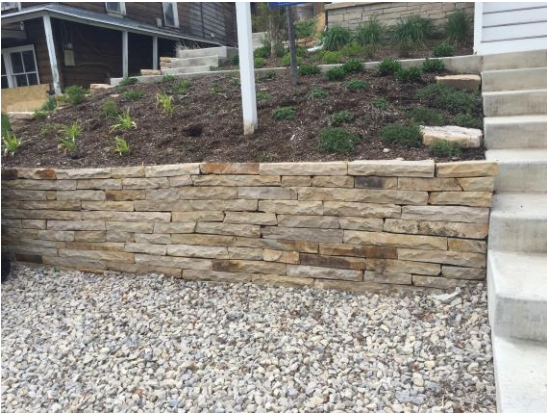
It is important to repair walls using recognized preservation methods. Incompatible repairs can not only damage the historic materials, but will also not appear appropriate.

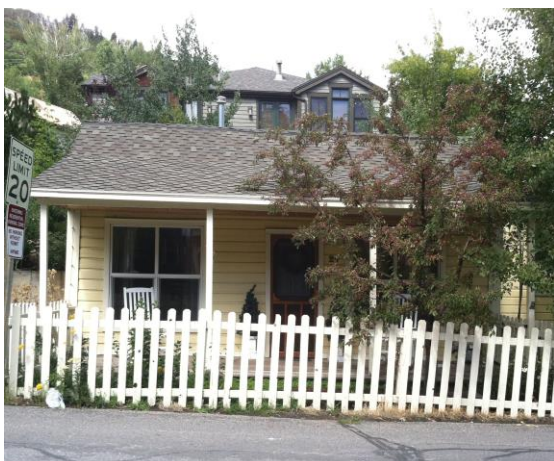
While this fence at 24 Daly Avenue is not historic, it is compatible with the historic house and simple in design.

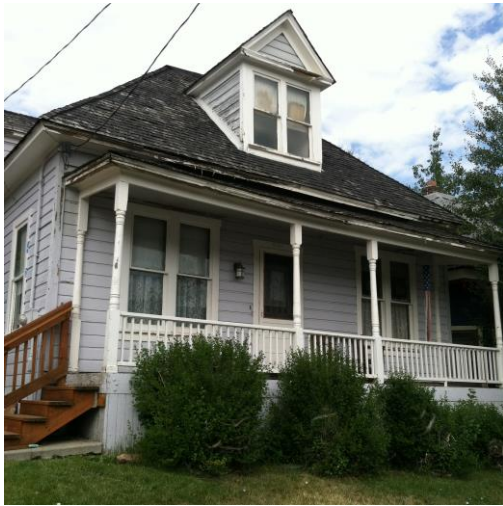
windows. Aesthetically, historic wood windows are generally superior to new vinyl windows. Some examples of this include:

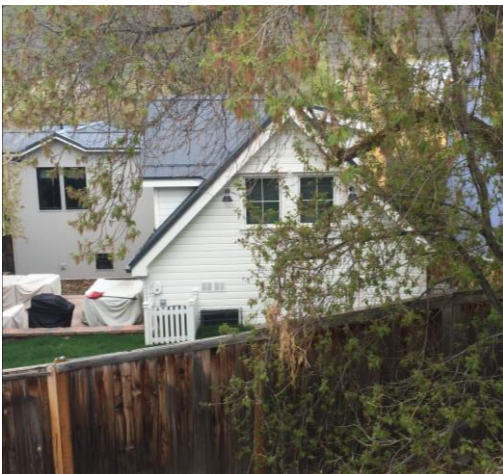
These new windows lack depth. The sash is too thin and does not provide sufficient depth. Compare it to the original wood windows at 945 Norfolk.

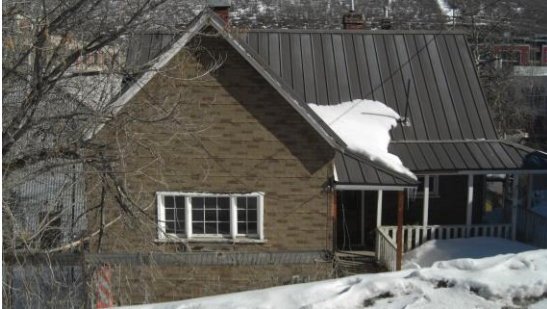
664 Woodside Avenue.

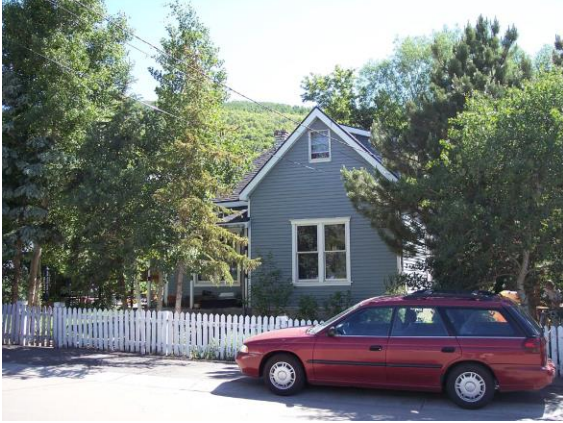
1147 Woodside Avenue

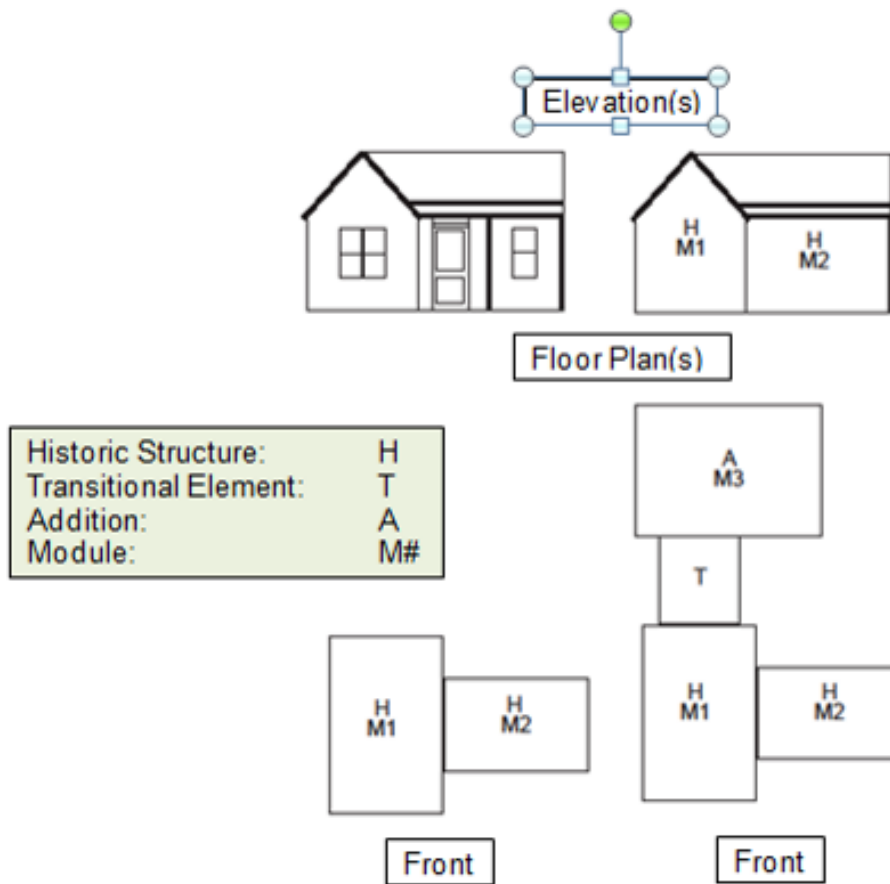
Large additions shall be visually separated from historic structures when viewed from the primary public right-of-way. Where the height of a new addition, site topography (e.g., an uphill addition), or both, the addition shall be set away from the historic structure by a minimum of one-half (1/2) the length of the least-wide historic elevation adjacent to the historic elevation to which the transitional element is attached.

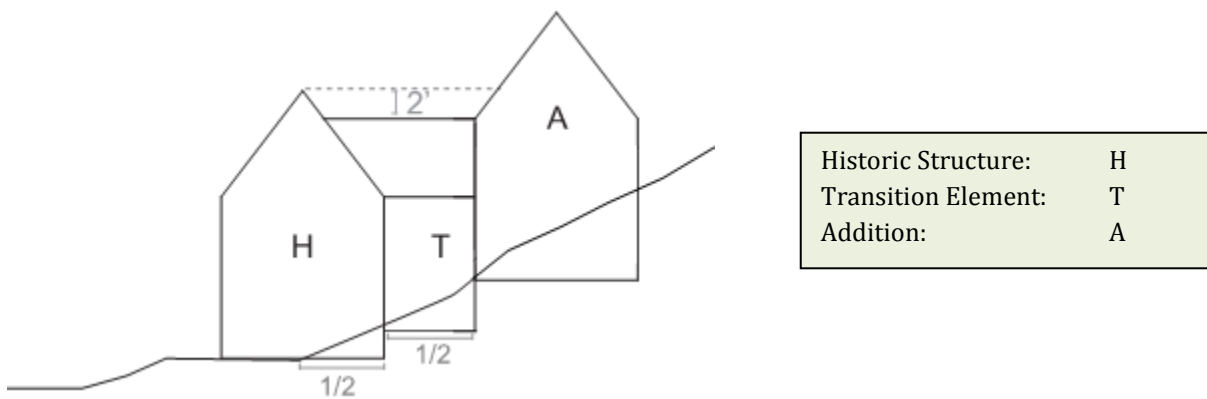
Components and materials used on additions shall be similar in scale and size to those found on the historic structure.
