# HISTORIC SITE FORM - HISTORIC SITES INVENTORY

PARK CITY MUNICIPAL CORPORATION (10-08)

Address: 1109 PARK AVE

Building Type and/or Style: "L" cottage or "T" cottage

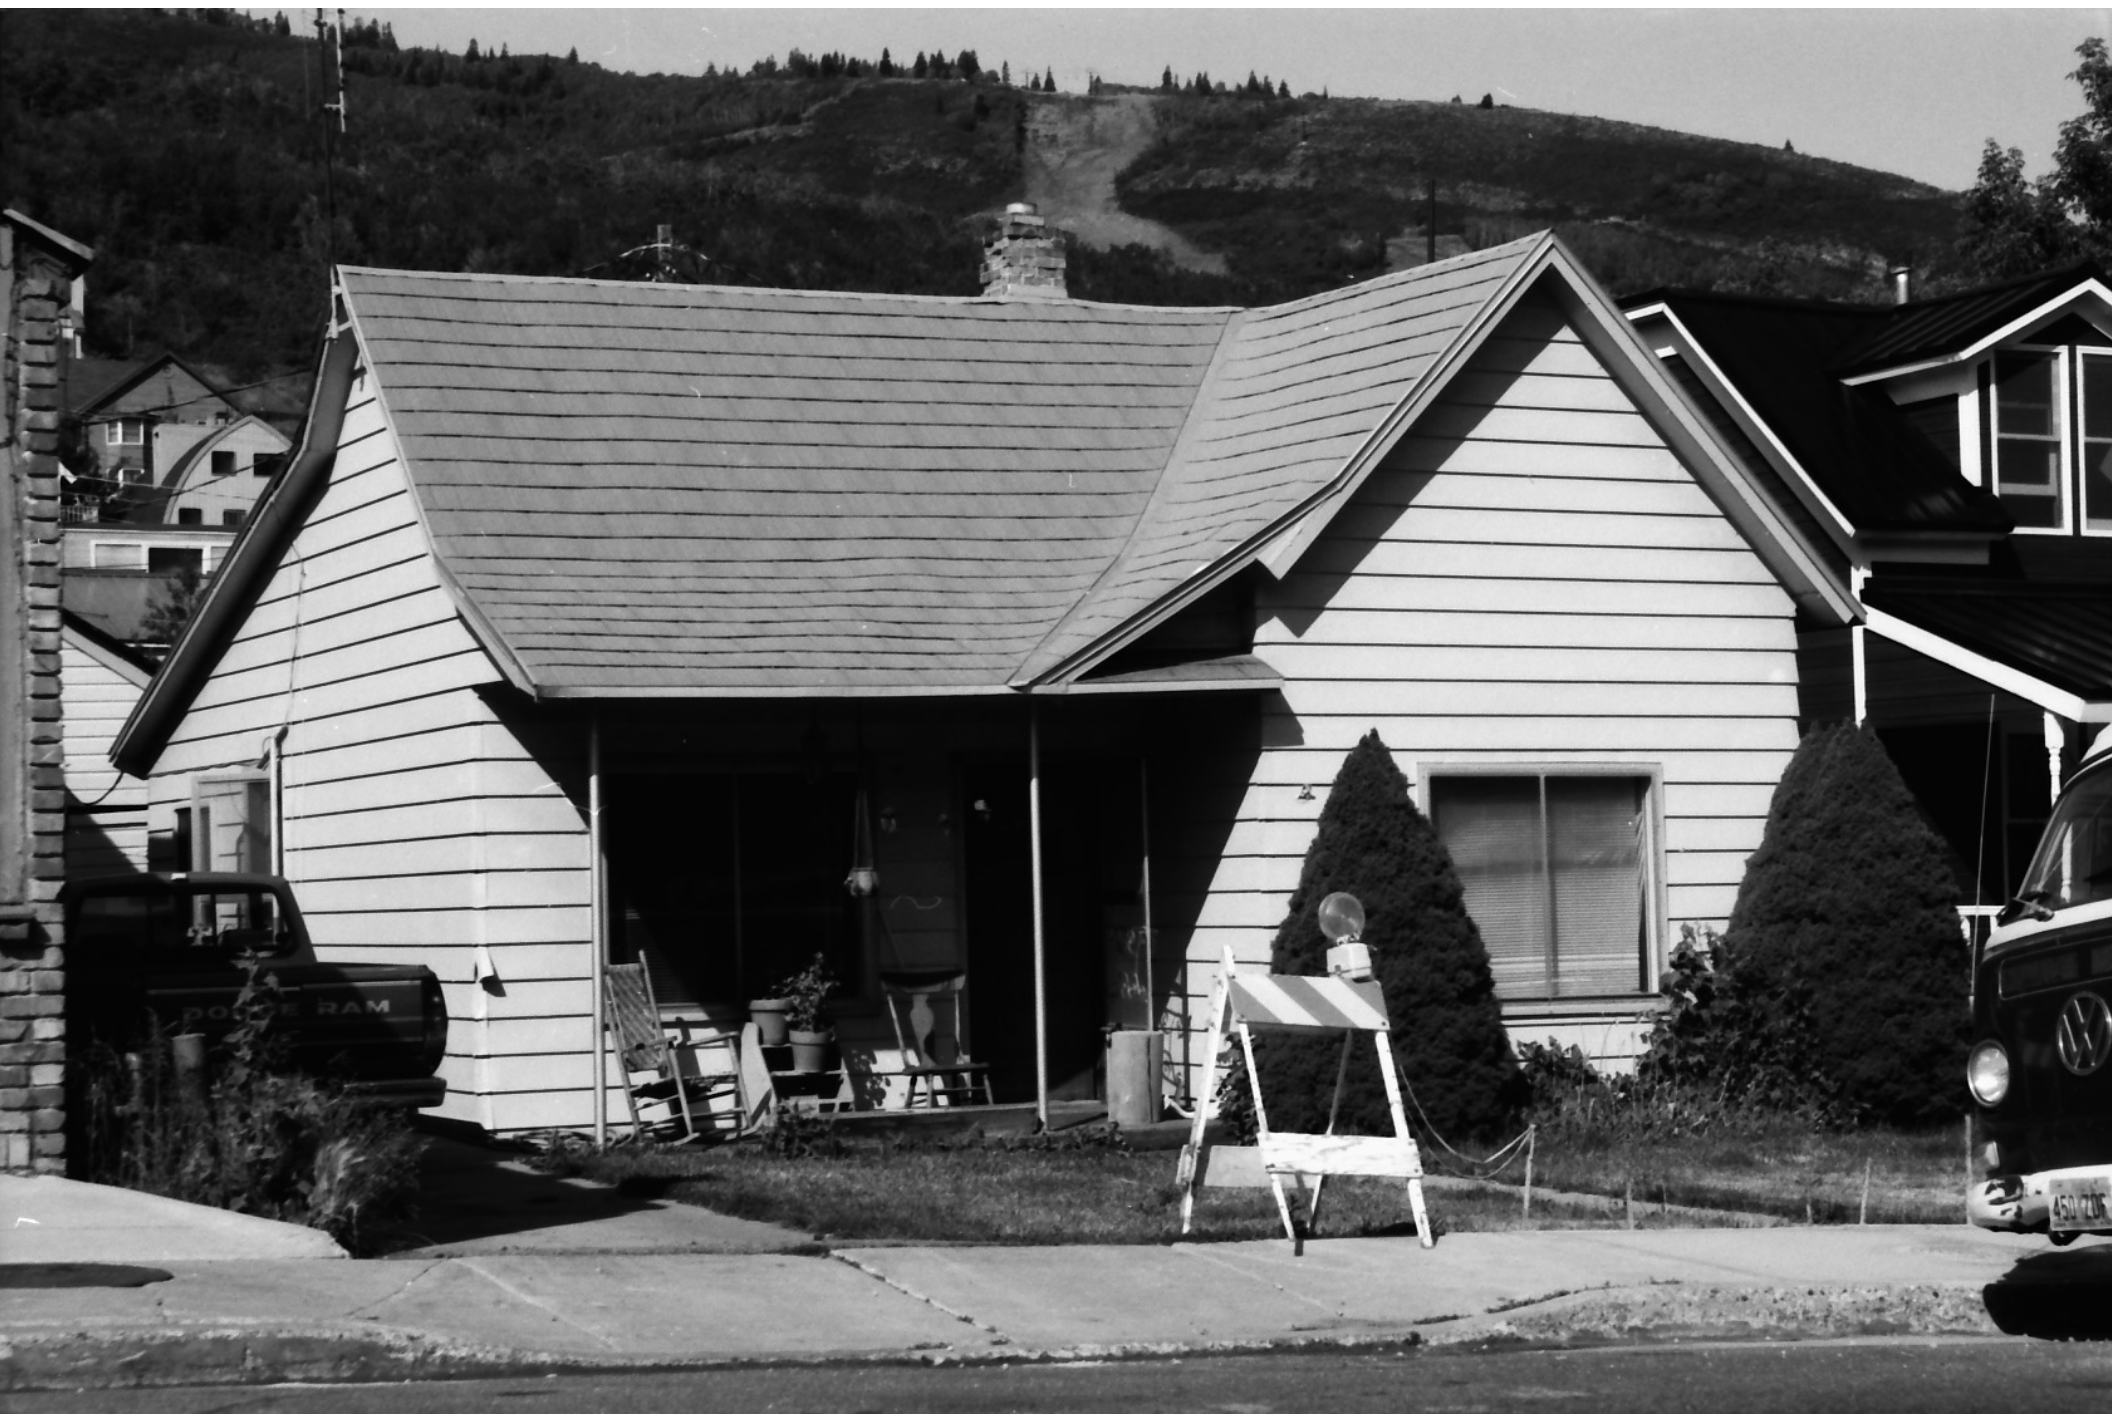
One-story small frame home with a gable roof and entry located on the side. Above the entry is a steep pediment projection with wood post supports. The front has a central entry flanked by two two-over-two double hung frame windows.
