GRANITE VS PRECAST CONCRETE

LifeCycle Cost Comparison

GRANITE AND PRECAST CURBING

Life Cycle Cost Study for Sustainable Hardscape Design - Exterior Stone Paving

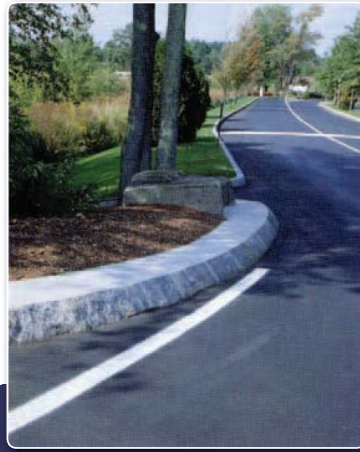
Granite curbing enhances the appearance of every street, highway, and parking lot. Its natural beauty is appreciated for generations.

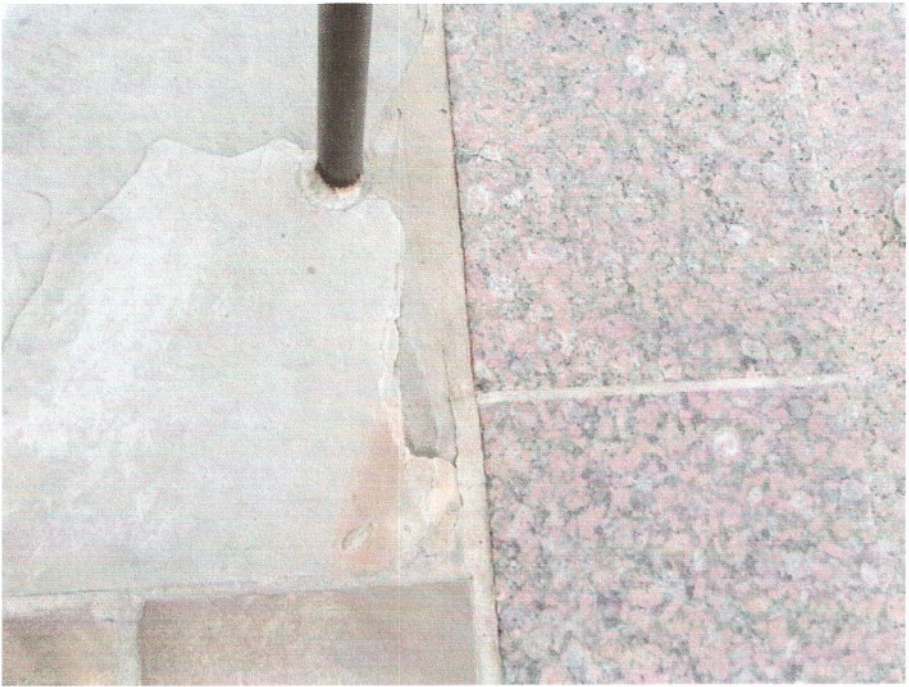
Acid precipitation affects stone primarily in two ways: dissolution and alteration. When sulfurous, sulfuric, and nitric acids in polluted air react with the calcite in marble and limestone, the calcite dissolves. In exposed areas of buildings and statues, we see roughened surfaces, removal of material, and loss of carved details. Stone surface material may be lost all over or only in spots that are more reactive. See Figure 1.3 below for example of limestone paver directly adjacent to granite stair tread. Note the surface loss and condition of stone edges.
