HISTORIC SITE FORM - HISTORIC SITES INVENTORY

Name of Property: **James Cavanaugh House**

Address: 564 Woodside Avenue

3 DOCUMENTATION

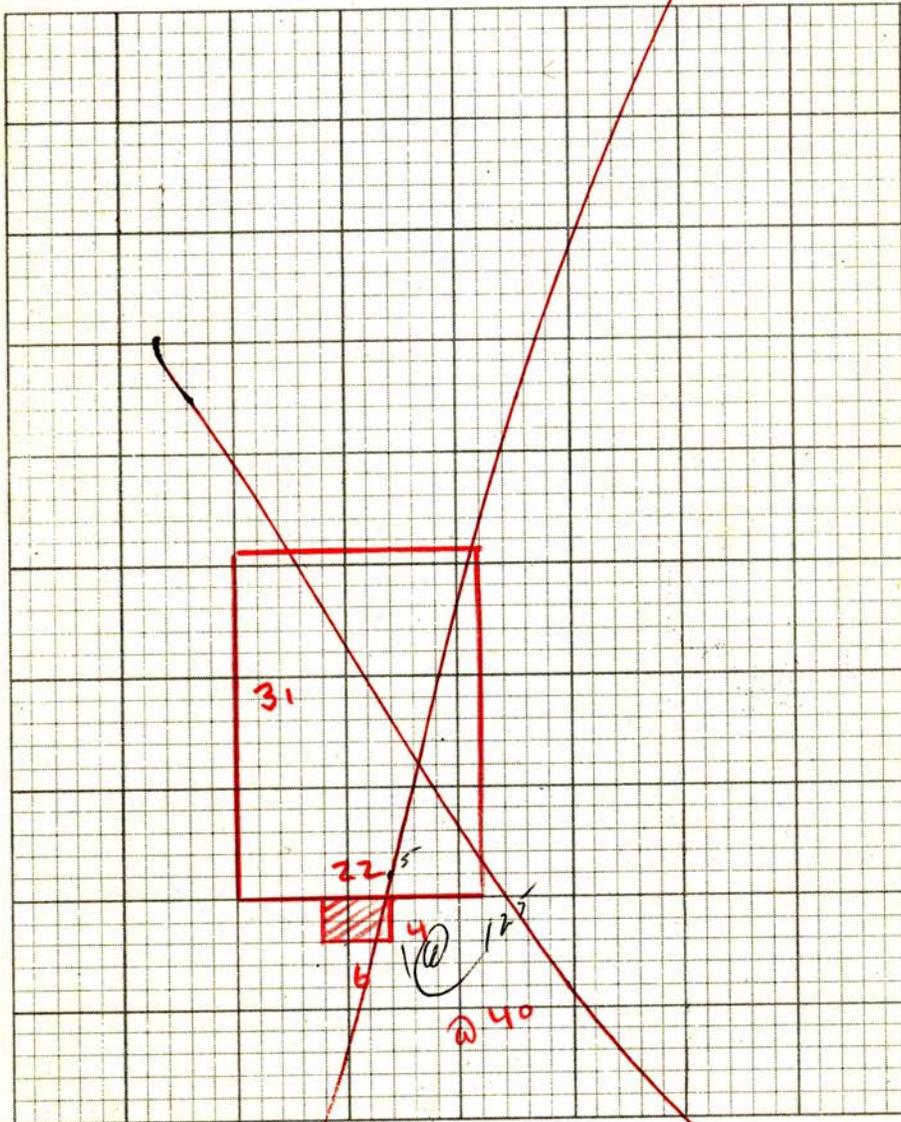
Location _____
 Kind of Bldg. Rgs St. No. 564 Woodside
 Class 3 Type 1 2 3 4 Cost \$ _____ X _____ %
 Stories _____ Dimensions _____ Cu. Ft. _____ Sq. Ft. _____ Factor _____ Totals _____
 1 x x 682 \$ 1397
 x x
 x x
 Gar.—Carport _____ x _____ Flr. _____ Walls _____ Cl. _____

Description of Buildings	Additions	
Foundation—Stone _____ Conc. _____ None <input checked="" type="checkbox"/>		
Ext. Walls _____ <u>Siding</u>		
Insulation—Floors _____ Walls _____ Clgs. _____		
Roof Type _____ <u>dup</u> Mtl. _____ <u>GI</u>		
Dormers—Small _____ Med. _____ Large _____		
Bays—Small _____ Med. _____ Large _____		
Porches—Front _____ <u>24</u> @ _____ <u>40</u> _____ <u>10</u>		
Rear _____ @ _____		
Porch _____ @ _____		
Metal Awnings _____ Mtl. Rail _____		
Basement Entr. _____ @ _____		
Planters _____ @ _____		
Cellar—Bsmt. — $\frac{1}{4}$ $\frac{1}{3}$ $\frac{1}{2}$ $\frac{3}{4}$ Full _____ Floor _____ <u>conc</u> _____ <u>50</u>		
Bsmt. Apt. _____ Rooms Fin. _____ Unfin. _____		
Attic Rooms Fin. _____ Unfin. _____		
Plumbing {	_____	
		Class _____ <u>1</u> Tub _____ <u>1</u> Trays _____
		Basin _____ <u>1</u> Sink _____ <u>1</u> Toilet _____ <u>1</u>
		Wtr. Sfr. _____ Shr. St. _____ O.T. _____

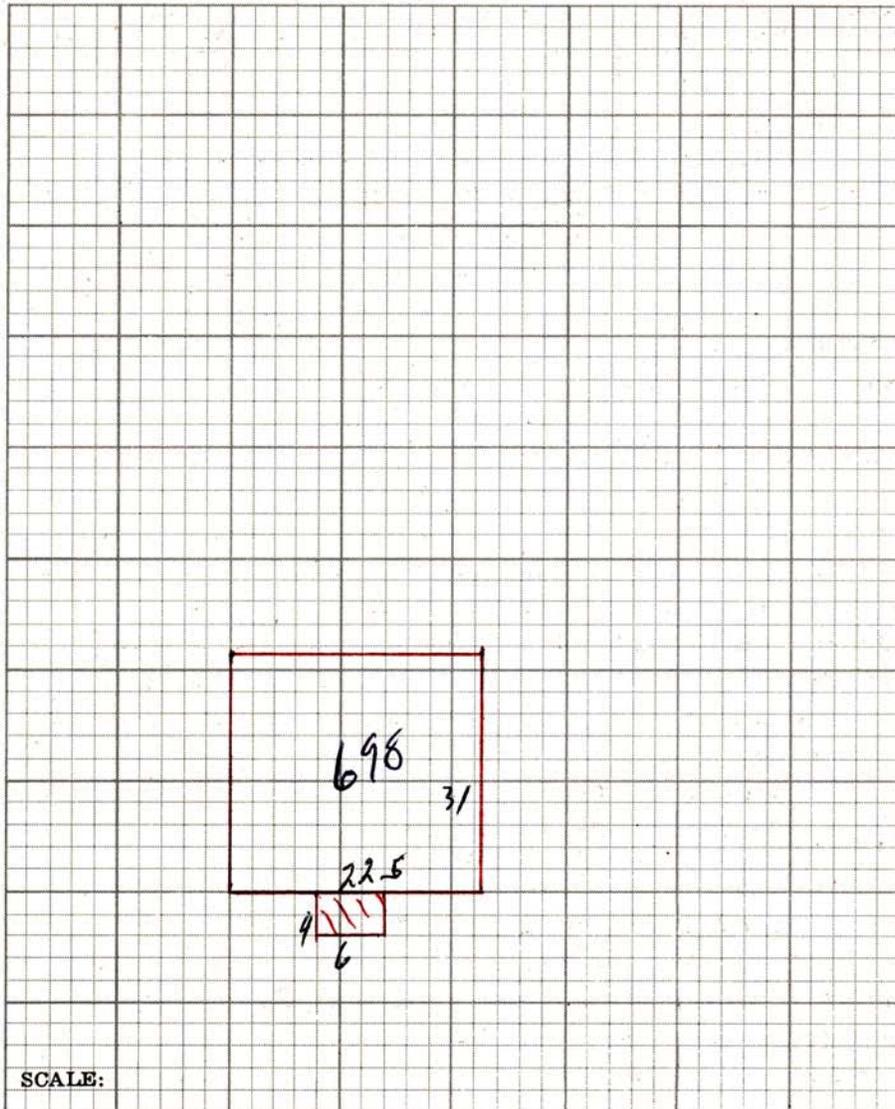
Owners Name _____
 Location _____
 Kind of Bldg. Rm St. No. 564 Woodside
 Class. 3 Type 123 4. Cost \$ _____ X 100 %

Description of Buildings	Additions	Additions
Foundation—Stone _____ Conc. _____ Sills <input checked="" type="checkbox"/>		
Ext. Walls <u>Siding (A)</u>		
Roof Type <u>HIP</u> Mtl. <u>GI</u>		
Dormers—Small _____ Med. _____ Large _____		
Bays—Small _____ Med _____ Large _____		
Porches—Front <u>24' @ 125'</u>	30	
Rear _____ @ _____		
Porch _____ @ _____		
Planters _____ @ _____		
Ext. Base. Entry _____ @ _____		
Cellar Bsmt. — 1/4 1/2 1/2 3/4 Full _____ Floor	80	
Bsmt. Gar. _____		
Basement-Apt. _____ Rms. _____ Fin. Rms. _____		
Attic Rooms Fin. _____ Unfin. _____		
Plumbing	Class <u>1</u> Tub <u>1</u> Trays _____	550
	Basin <u>1</u> Sink <u>1</u> Toilet <u>1</u>	
	Wtr. Sfr. _____ Shr. St. _____ O.T. _____	
	Dishwasher _____ Garbage Disp. _____	
Heat—Stove _____ H.A. _____ FA <input checked="" type="checkbox"/> HW _____ Stkr _____ Elec. _____	318	
Oil _____ Gas <input checked="" type="checkbox"/> Coal _____ Pipeless _____ Radiant _____

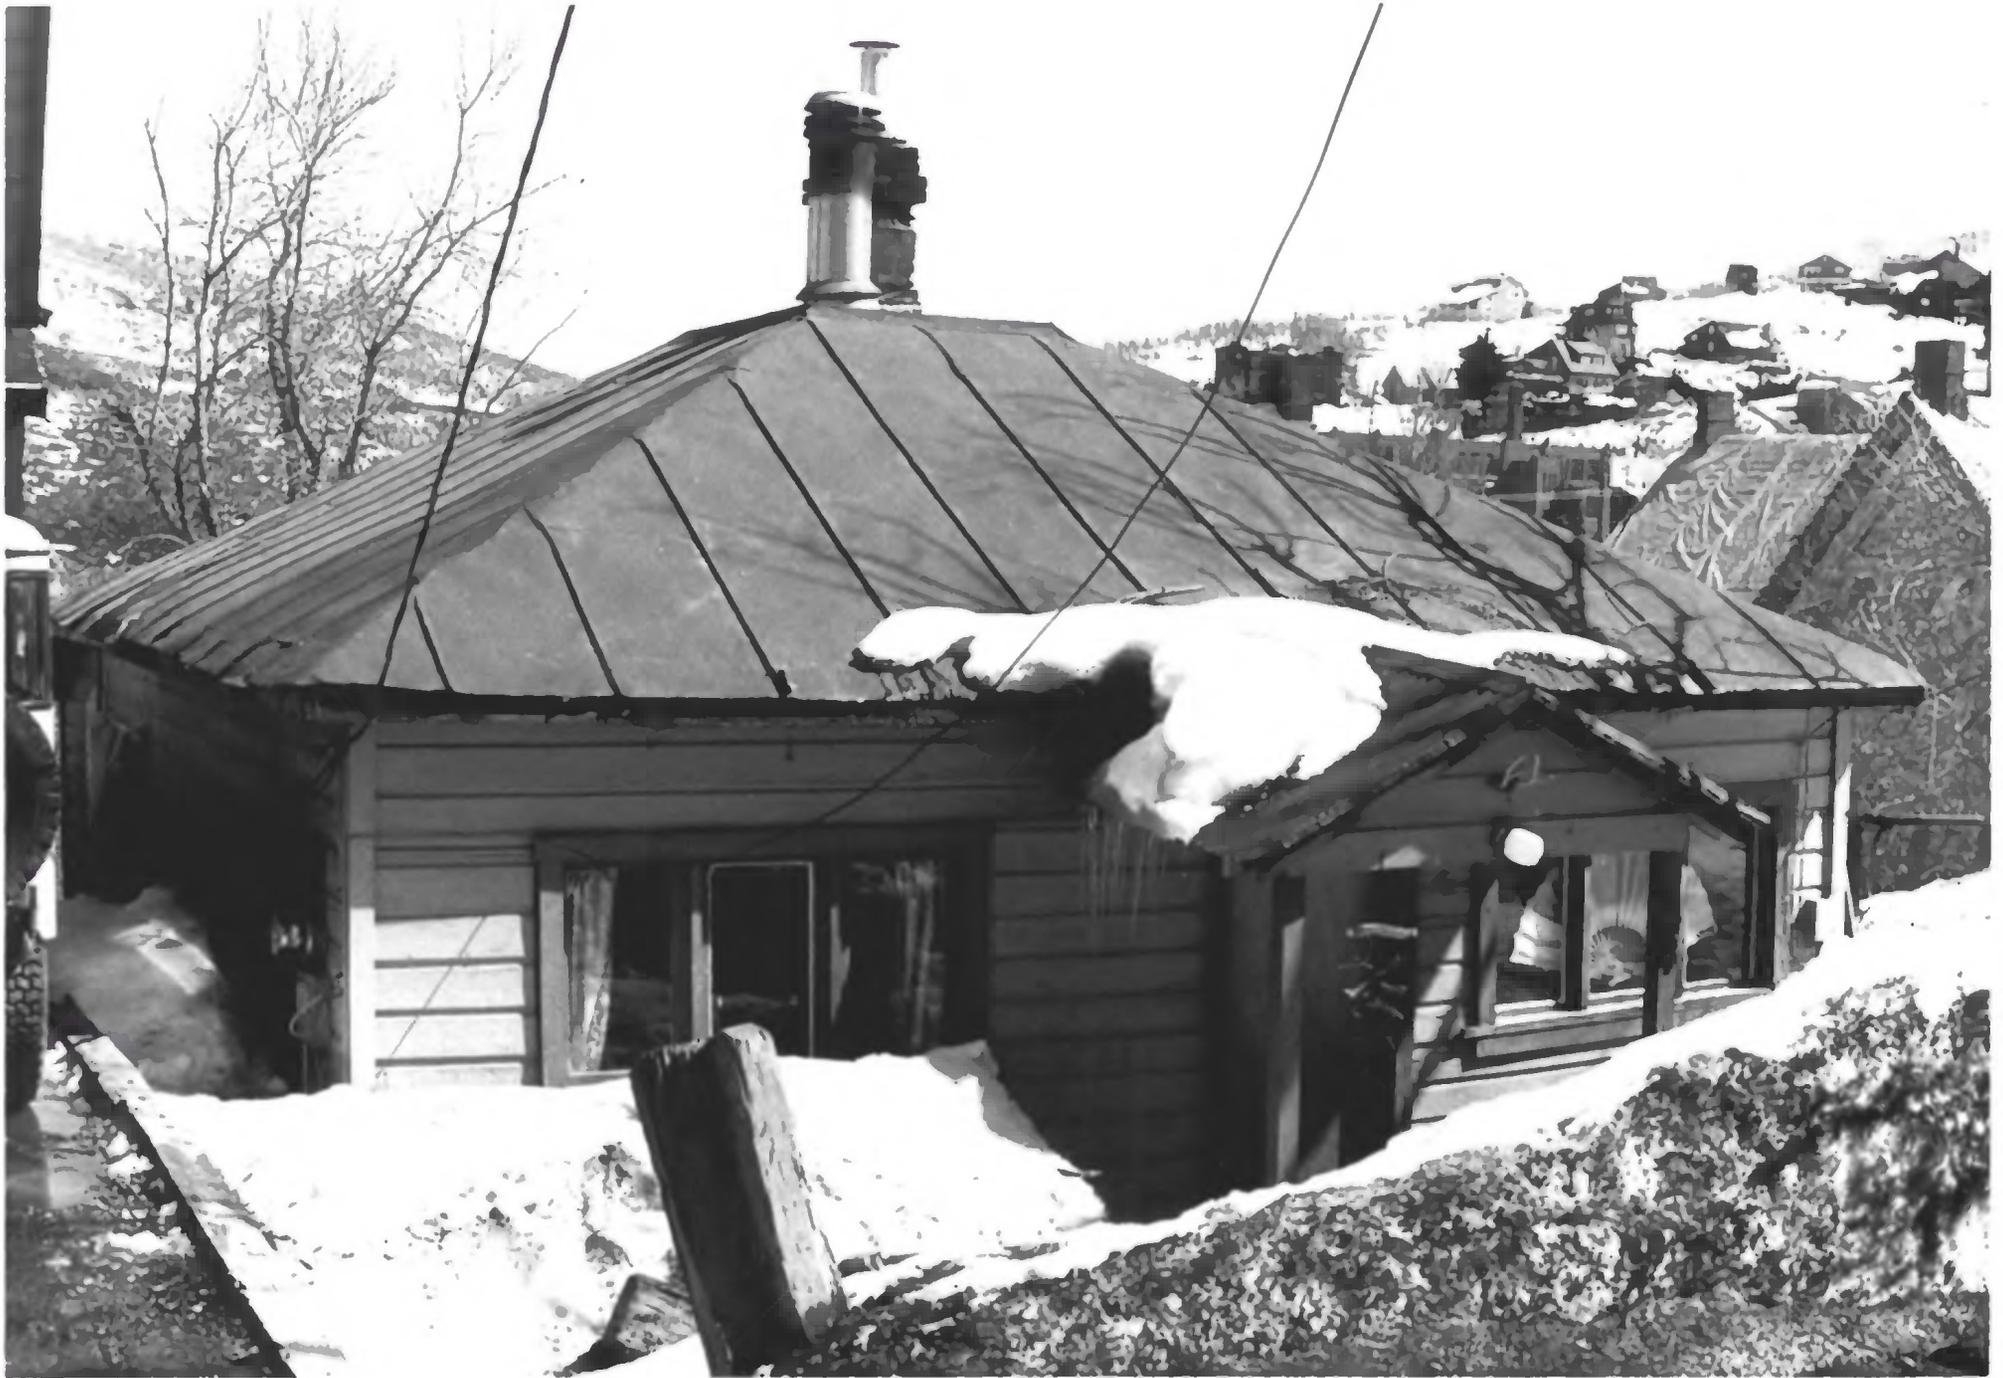
James Cavanaugh House

Northwest corner

Photo by Debbie Temme, March 1983
