HISTORIC SITE FORM - HISTORIC SITES INVENTORY

PARK CITY MUNICIPAL CORPORATION (10-08)

Address: 627 Woodside Avenue

Building Type and/or Style: Variation on a crosswing

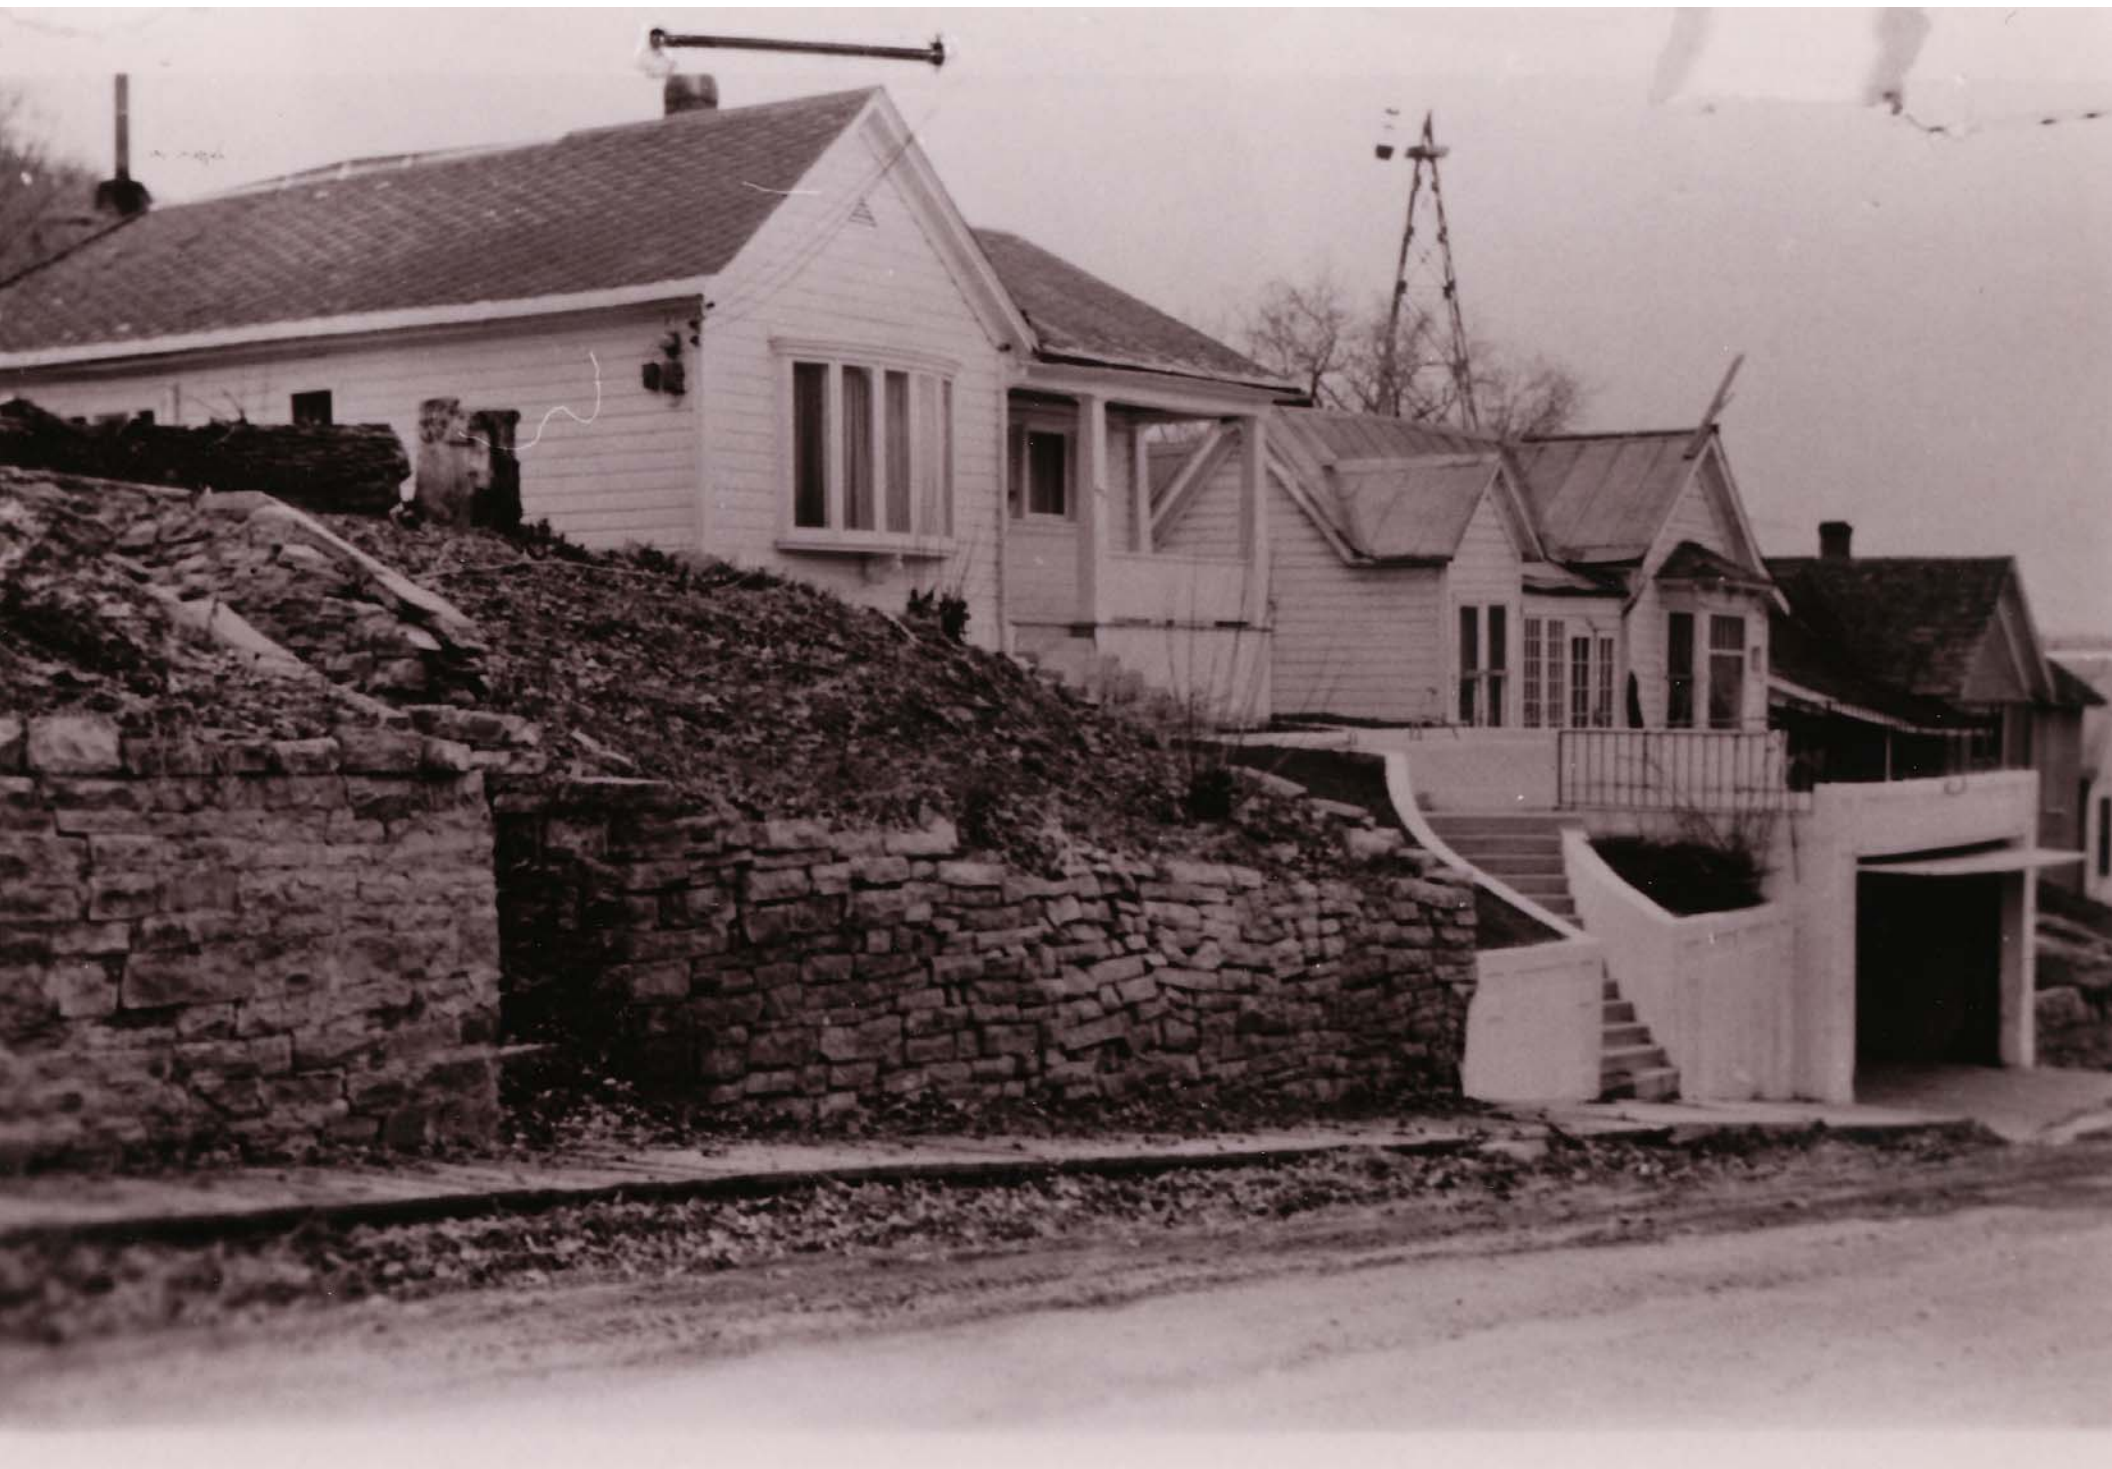
Photo No. 1: East elevation. Camera facing west, 2006.

Site: Terraced front yard to accommodate a garage at the street front and deck/patio above.

Walls: Wood drop siding and vertical wood siding on the lower level. Stone retaining walls.

Roof: Crosswing form sheathed in asphalt shingles.

Windows: Three-part bay has fixed casement windows and the front façade has a band of casement windows with a large center light flanked by narrow lights. Main door is a frame-and-panel door with paired upper lights.

Design (The combination of physical elements that create the form, plan, space, structure, and style. Describe additions and/or alterations from the original design, including dates--known or estimated--when alterations were made): The house and site have been significantly altered. A triangular eyebrow dormer was added to the stem wing roof. Earlier photos--tax and 1995--indicate the three part projecting bay was originally a five-part, half-round bay with a ribbon of five narrow fixed casement windows and a decorative bracket beneath. The house appears raised in the tax photo, but may have been raised higher to accommodate a basement addition. The window openings do not appear to have been greatly altered from what is seen in the tax photo--ribbon of windows with a large center casement flanked by narrow casements. A large gambrel roof addition was constructed after 1968. The overall changes, however, are significant and diminish the site's original character.
