HISTORIC SITE FORM - HISTORIC SITES INVENTORY

PARK CITY MUNICIPAL CORPORATION (10-08)

Address: 905 Woodside Avenue

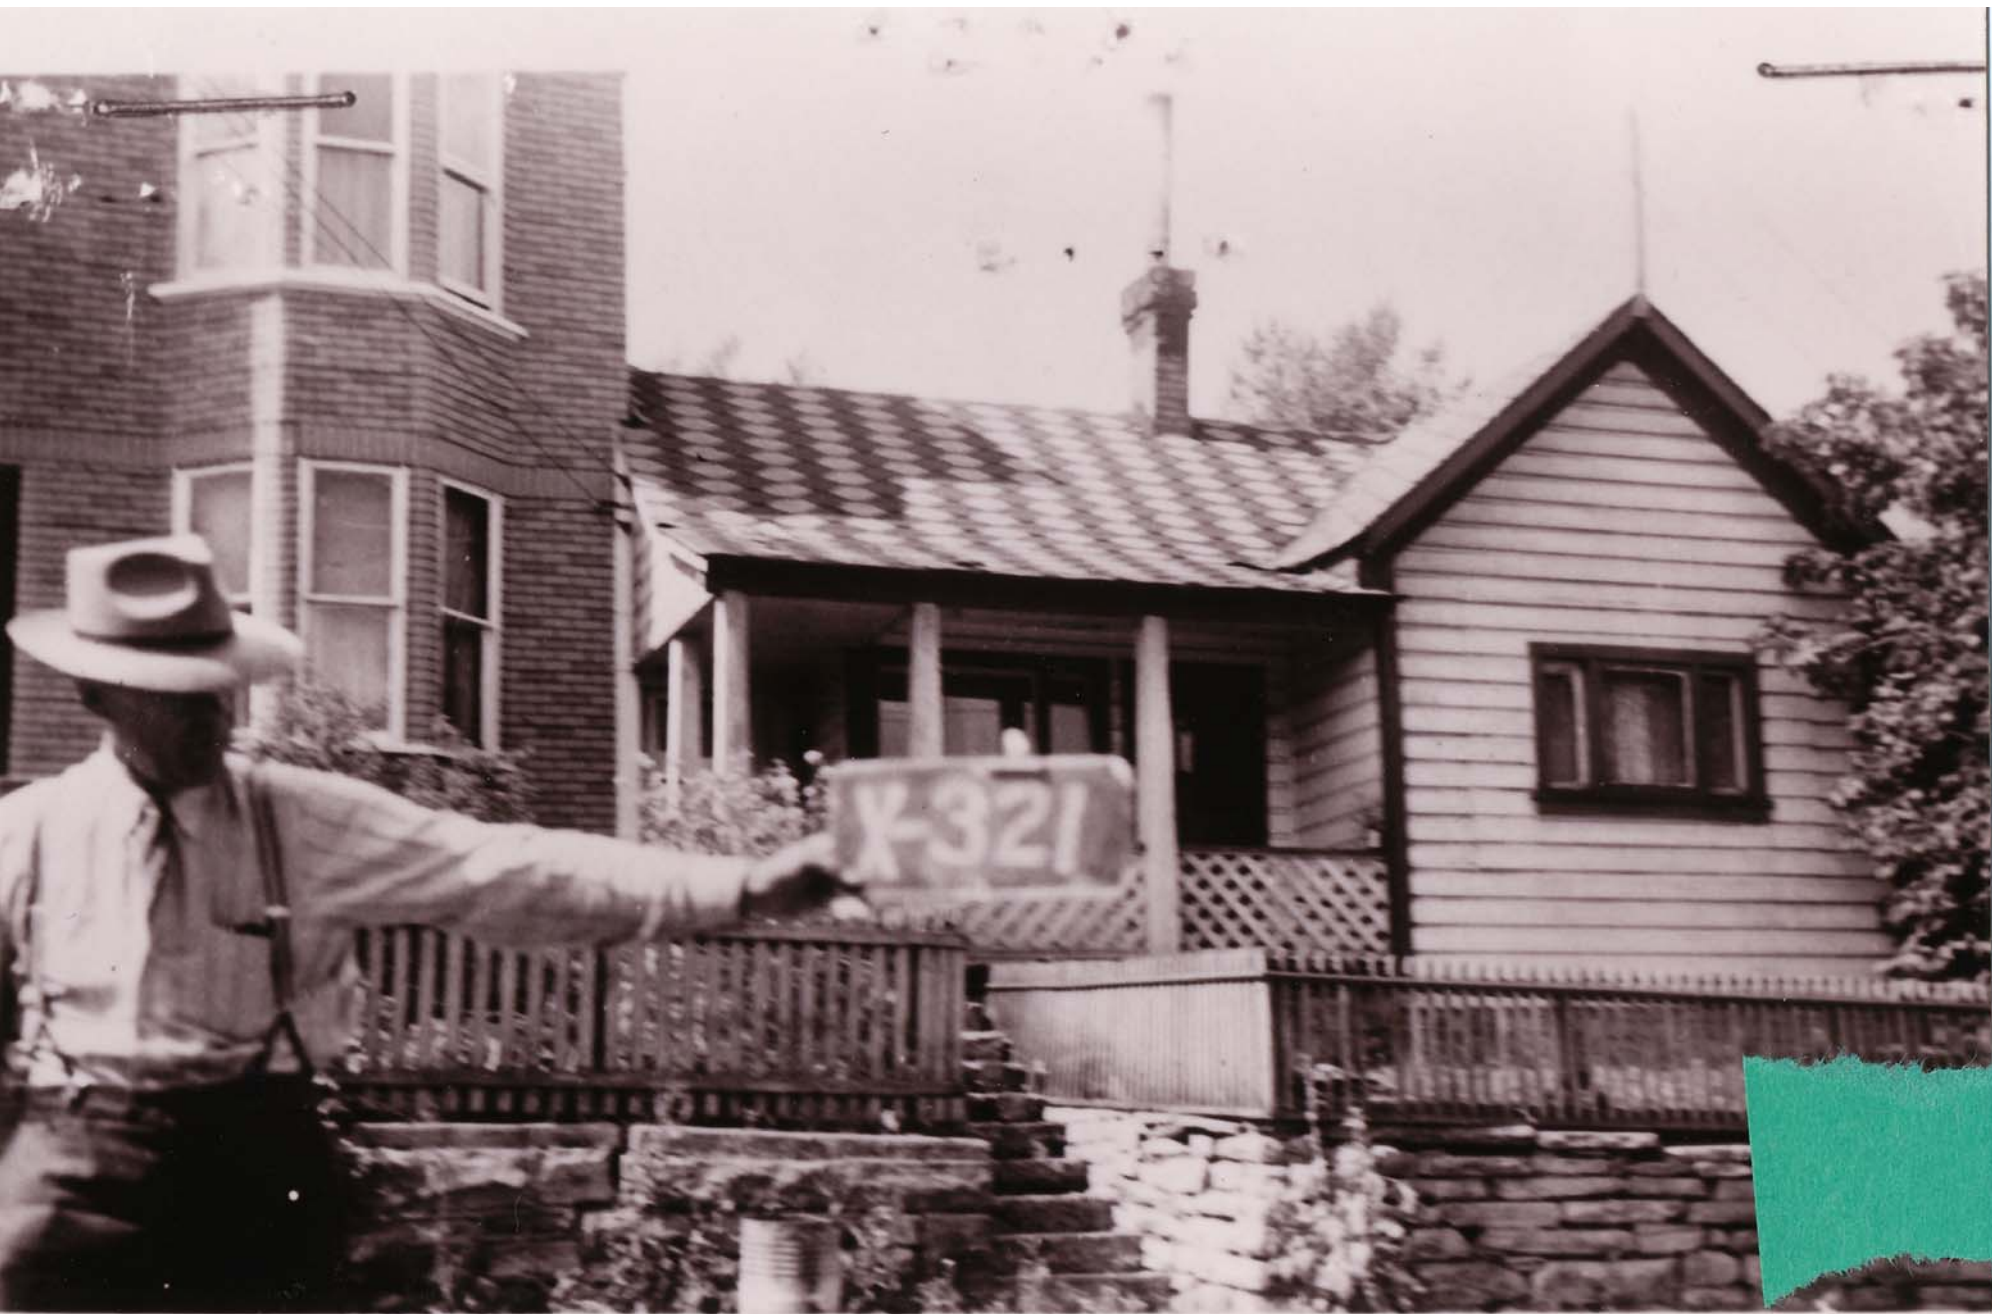
Photo No. 3: East elevation. Camera facing west, tax photo.

Setting (The physical environment--natural or manmade--of a historic site. Describe the setting and how it has changed over time.): The original stone retaining wall, visible in the tax photo, has been replaced by two concrete walls, but the entry steps from the roadway remain as seen in earlier photographs.
