HISTORIC SITE FORM - HISTORIC SITES INVENTORY

Address: 143 NORFOLK AVE

Building Type and/or Style: Crosswing type / Vernacular style

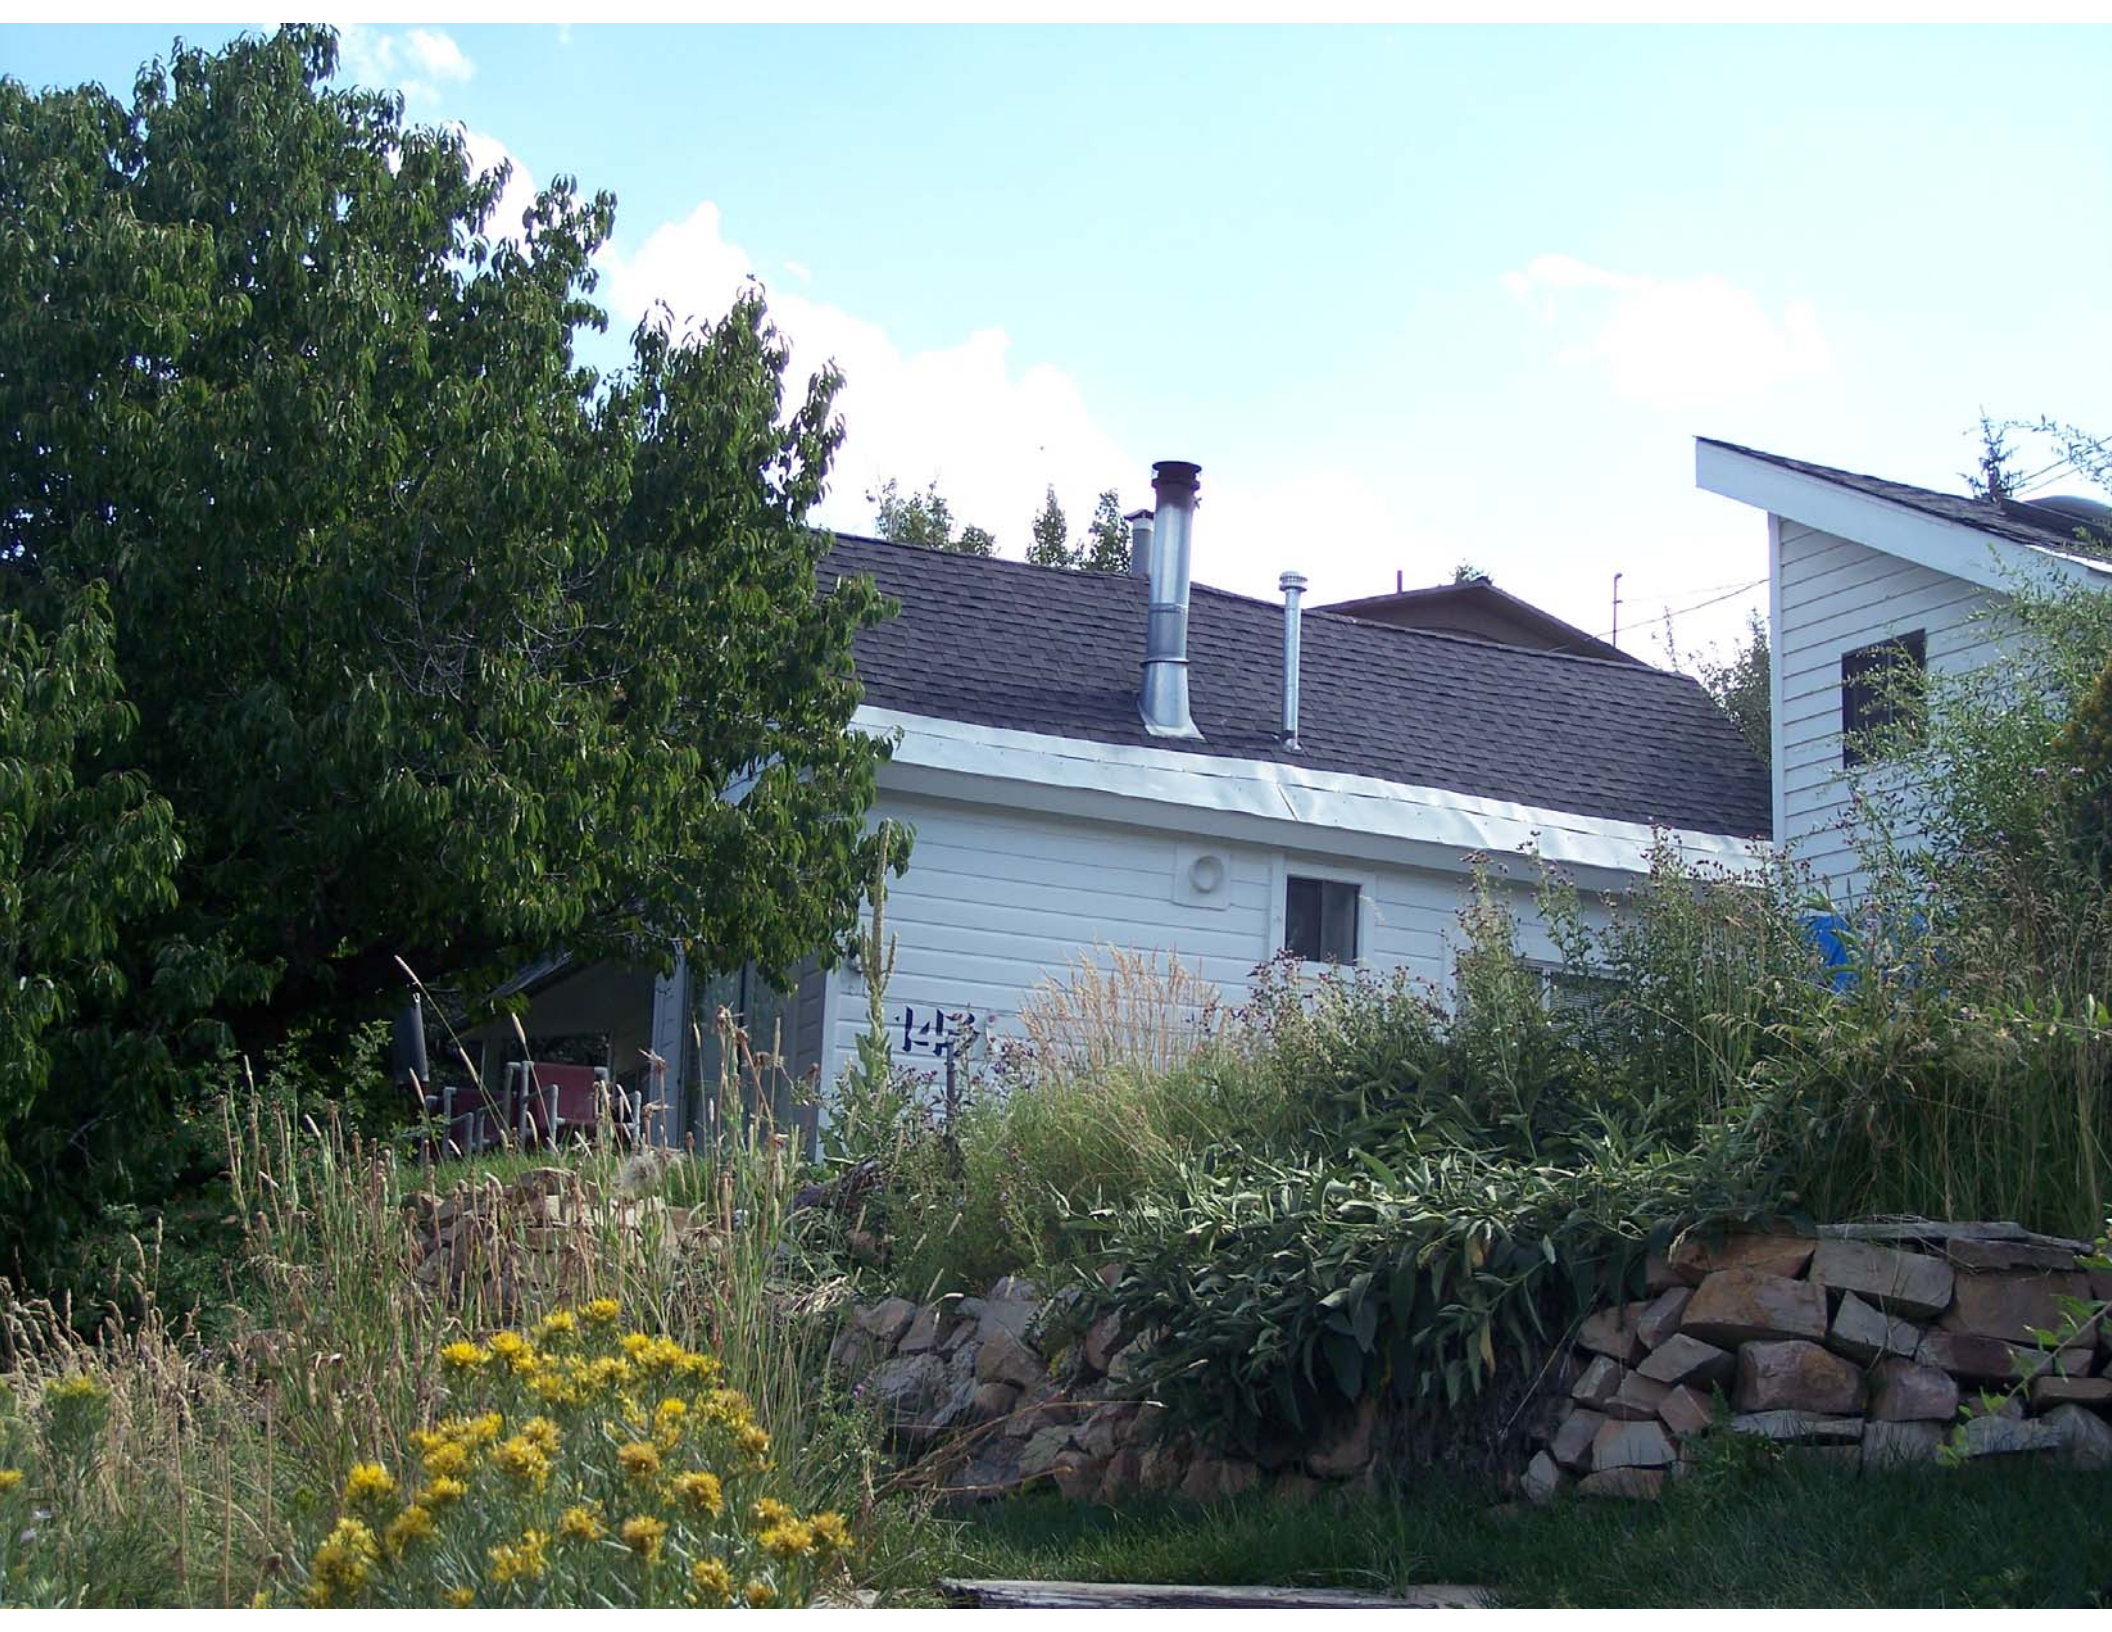
Photo No. 2: West view of roof. Camera facing east, 2006.

Roof: The gabled roof appears to be sheathed with asphalt shingles with metal flashing. The roof of the rear addition is snow-covered in the 2006 photograph and its material cannot be determined.

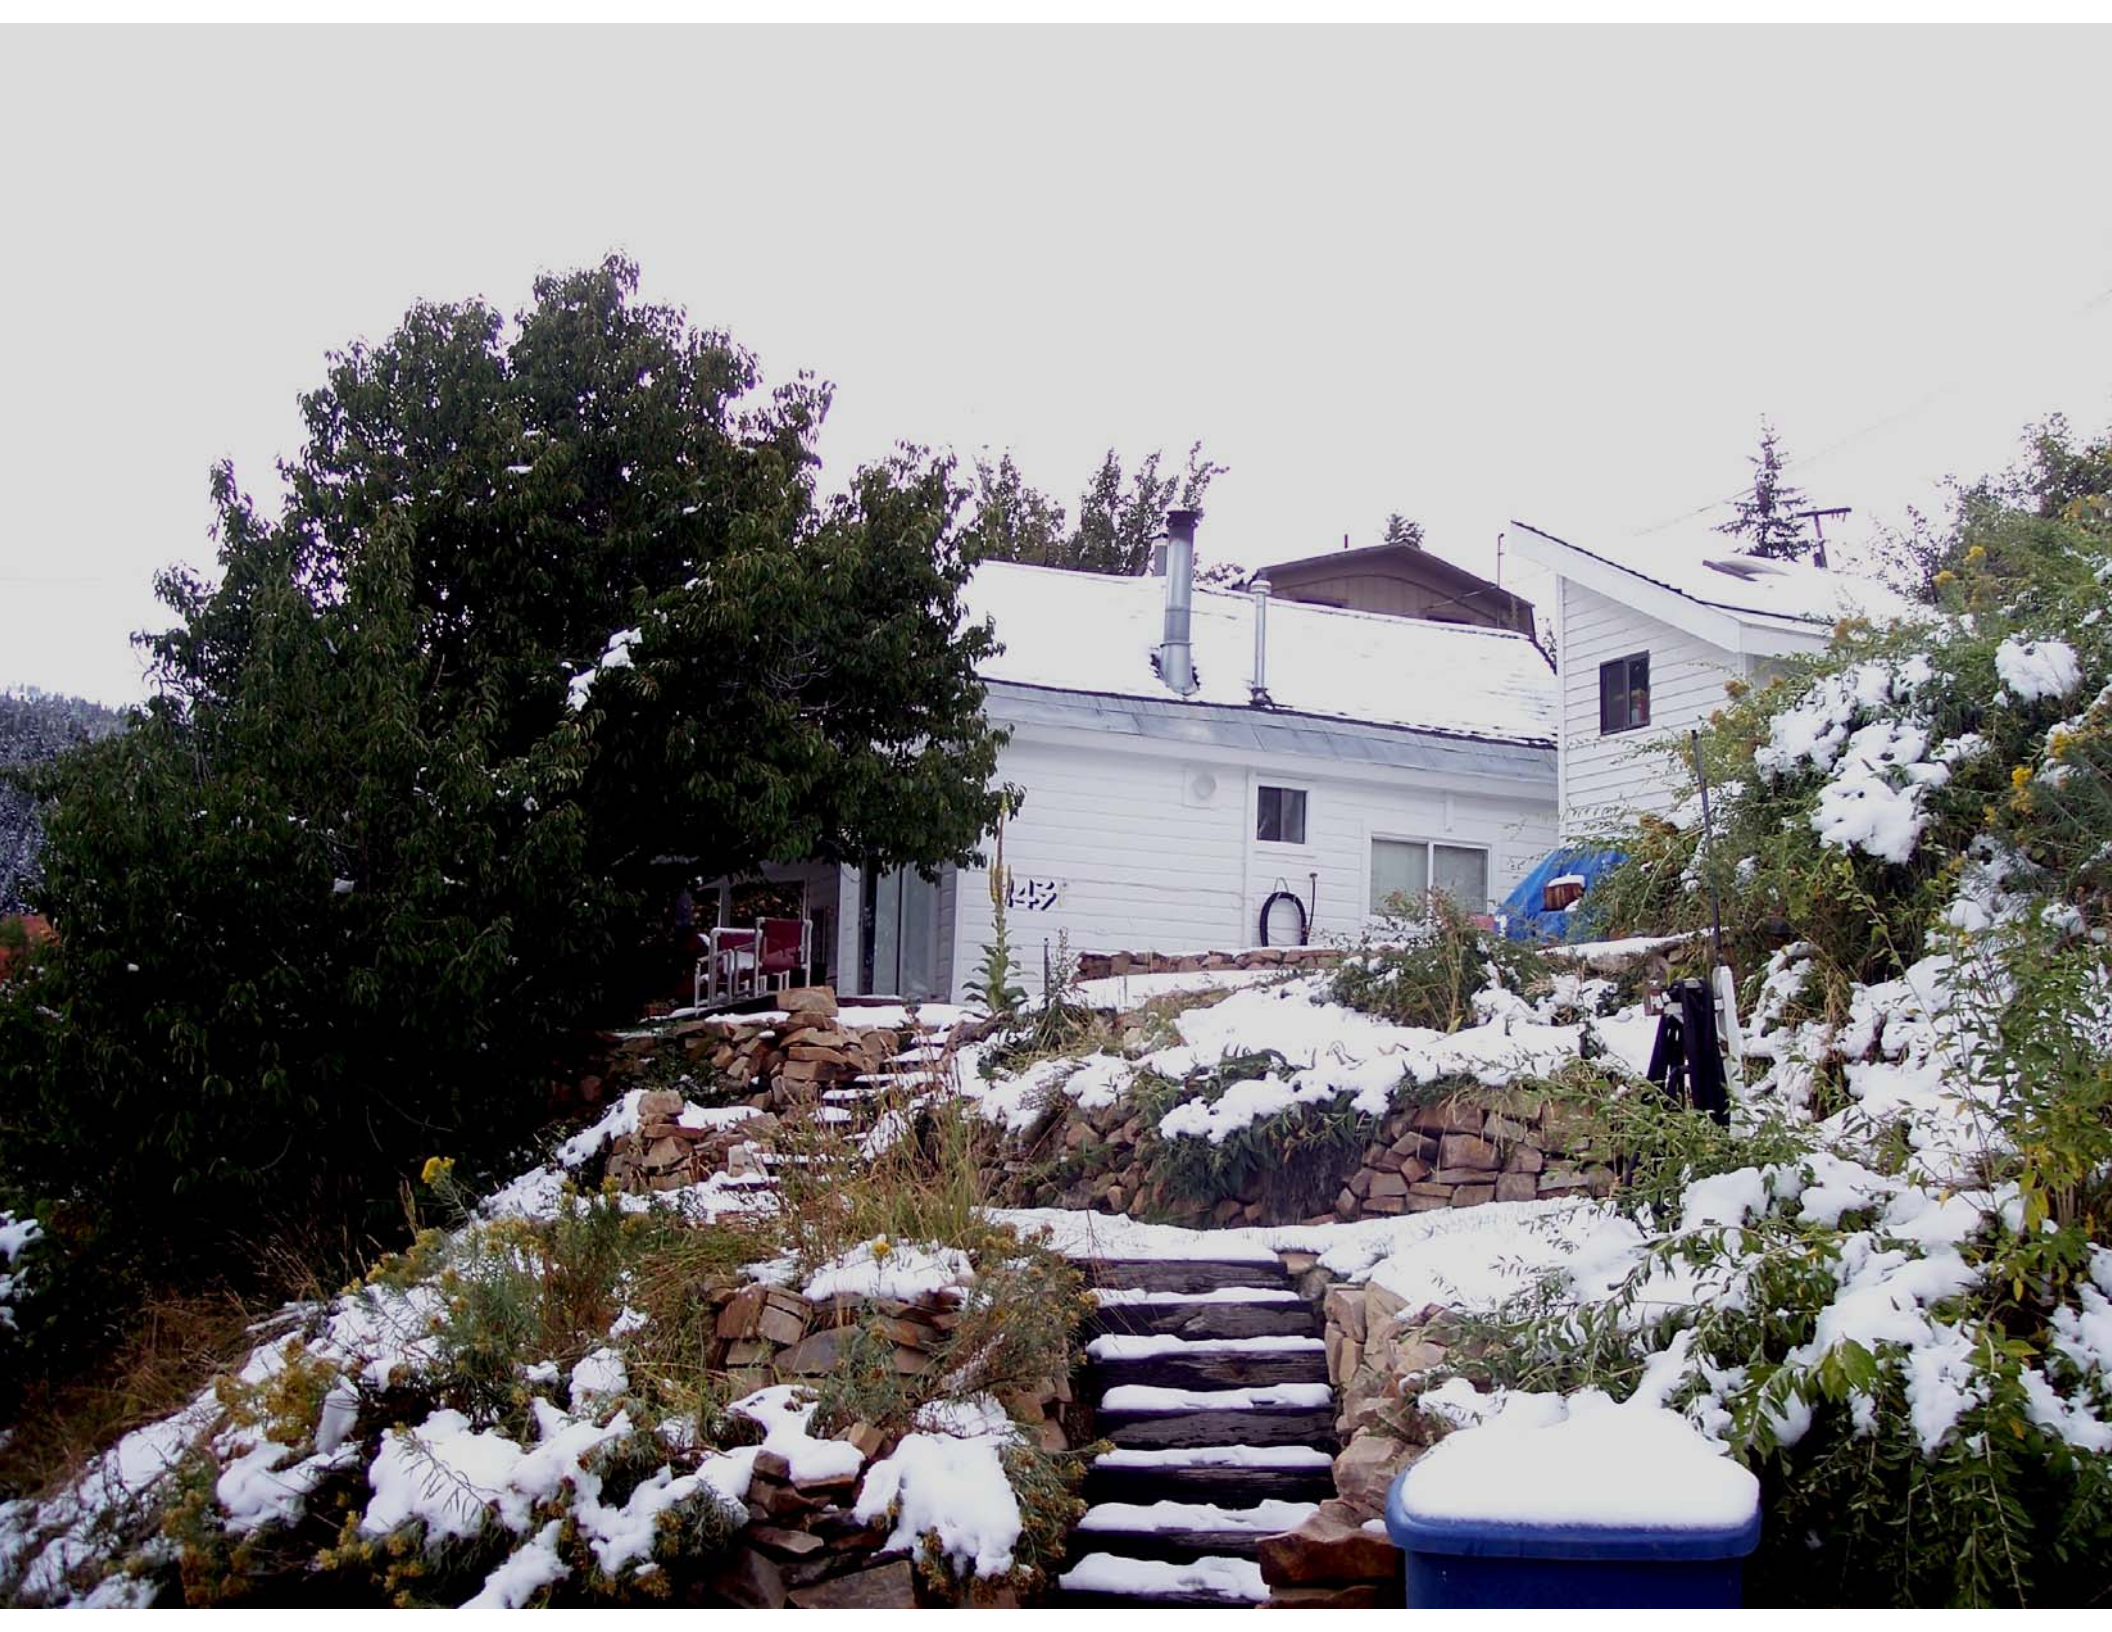
Photo No. 4: Southwest oblique. Camera facing northeast, 1995.

Windows/Doors: Windows visible in the 1995 and 2006 photographs appear to be sliders in openings that are horizontal or square. No doors are visible in any of the available photographs.
