# HISTORIC SITE FORM - HISTORIC SITES INVENTORY

PARK CITY MUNICIPAL CORPORATION (10-08)

Address: 27 HILLSIDE ST

Tax Number: PC-244

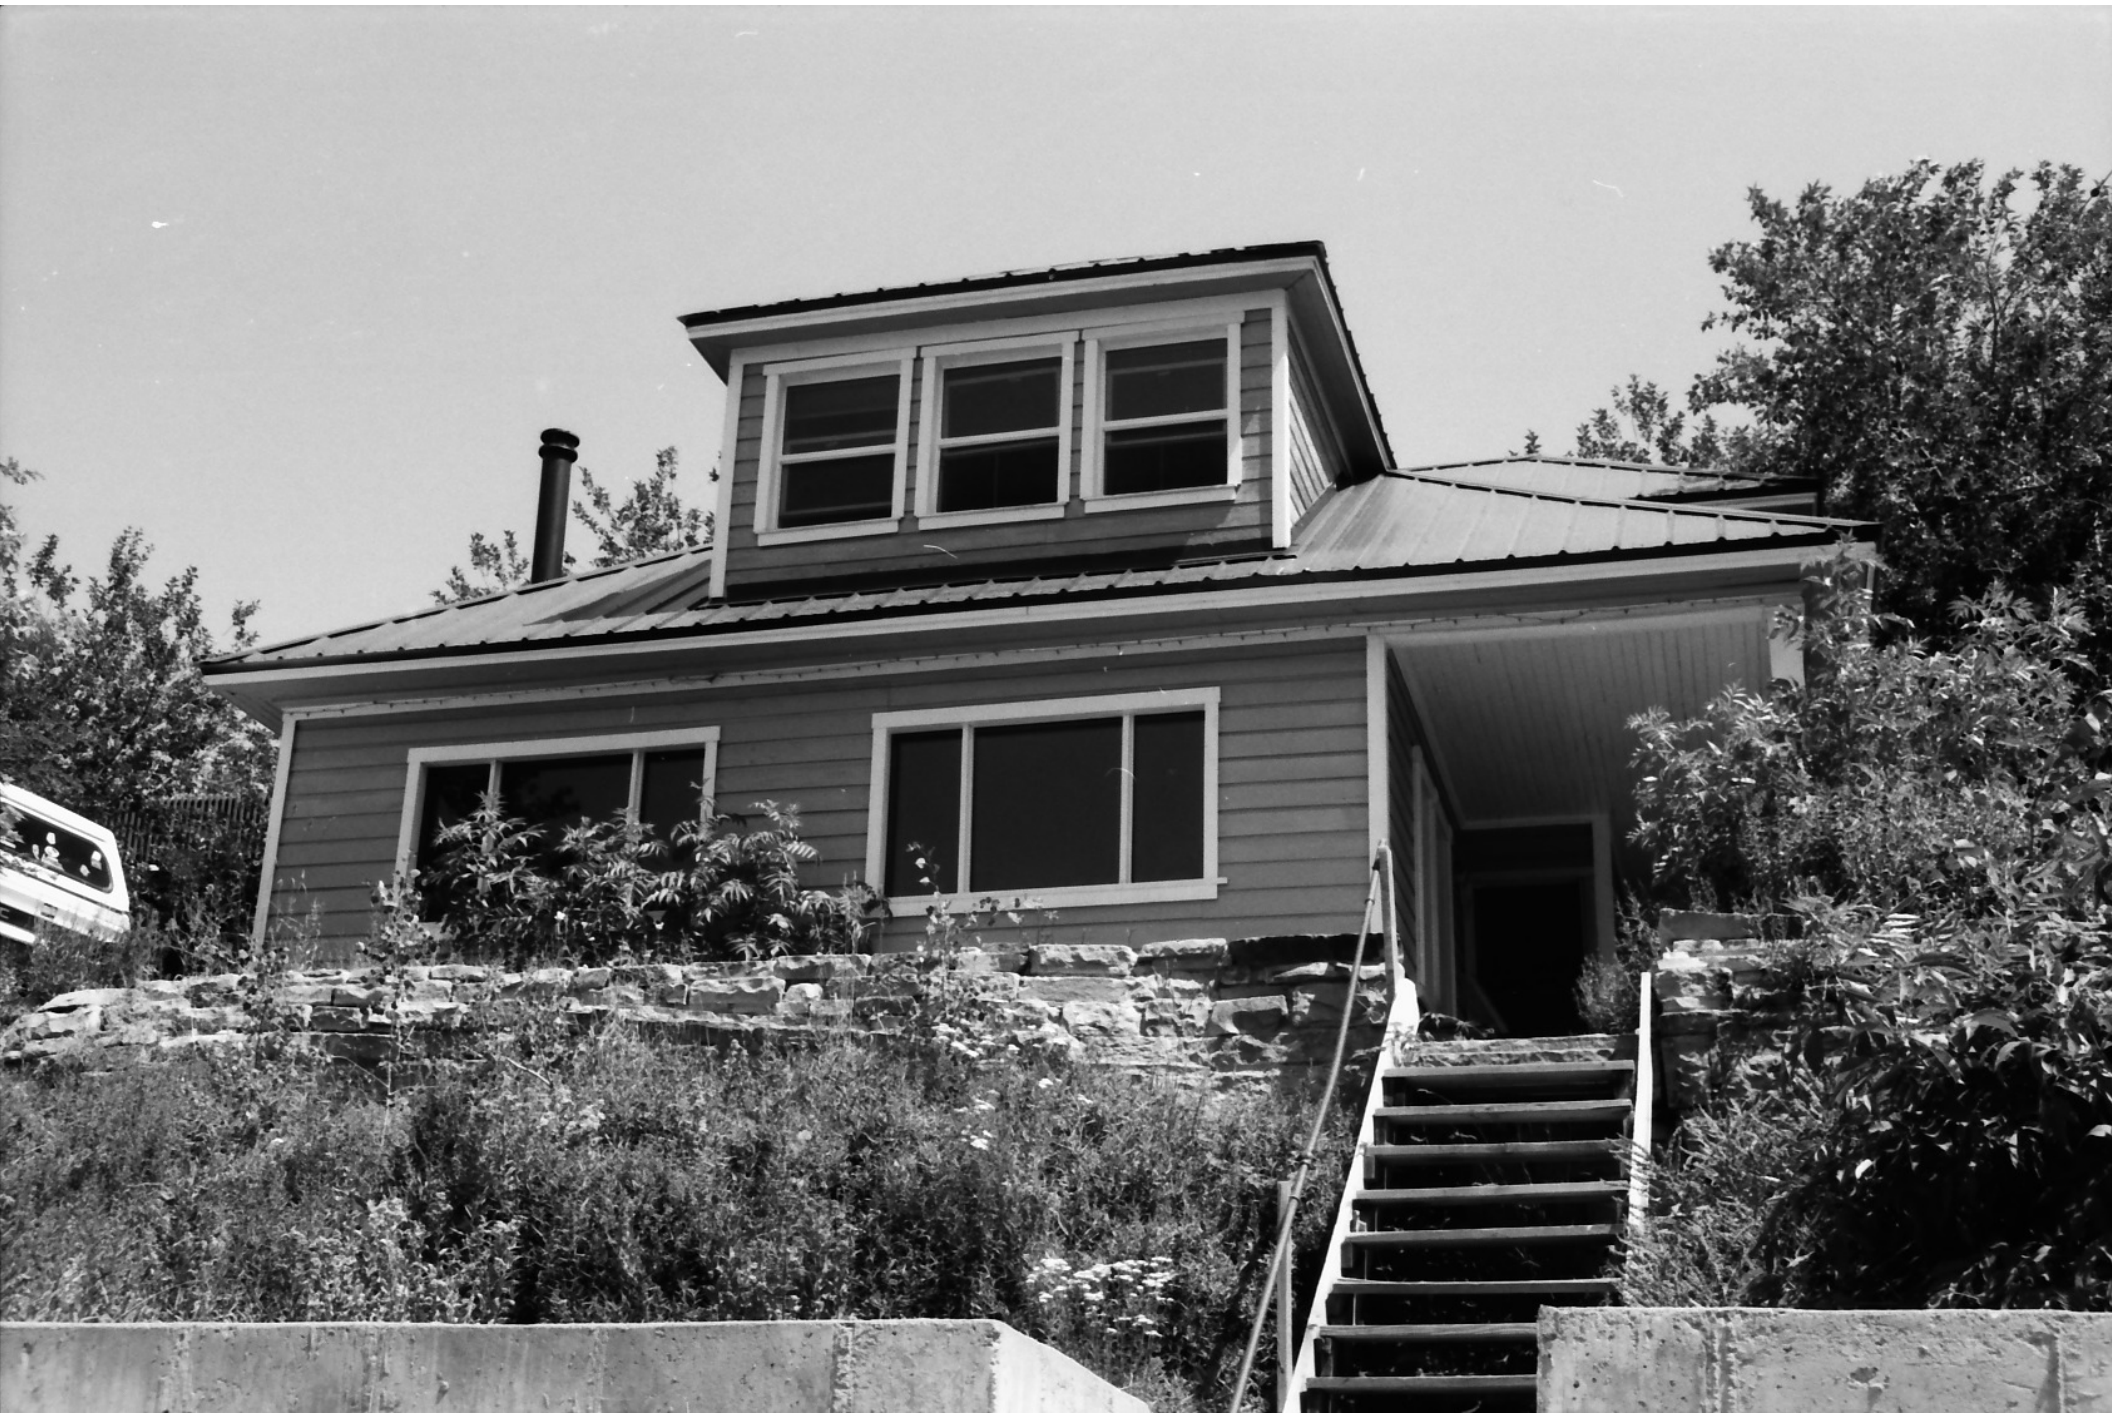
**Photo No. 2:** West elevation. Camera facing east, 1995.

**Roof:** The hipped roof is a standing seam metal roof and visible in the 1995 RLS photo. It was most likely installed between 1968 and 1995. The 1949 and 1957 tax cards indicate a shingled roof and the 1968 tax card a "pat" roof.
