# HISTORIC SITE FORM - HISTORIC SITES INVENTORY

PARK CITY MUNICIPAL CORPORATION (10-08)

Address: 262 GRANT AVE

Building Type and/or Style: Rectangular or "Hall-Parlor" House

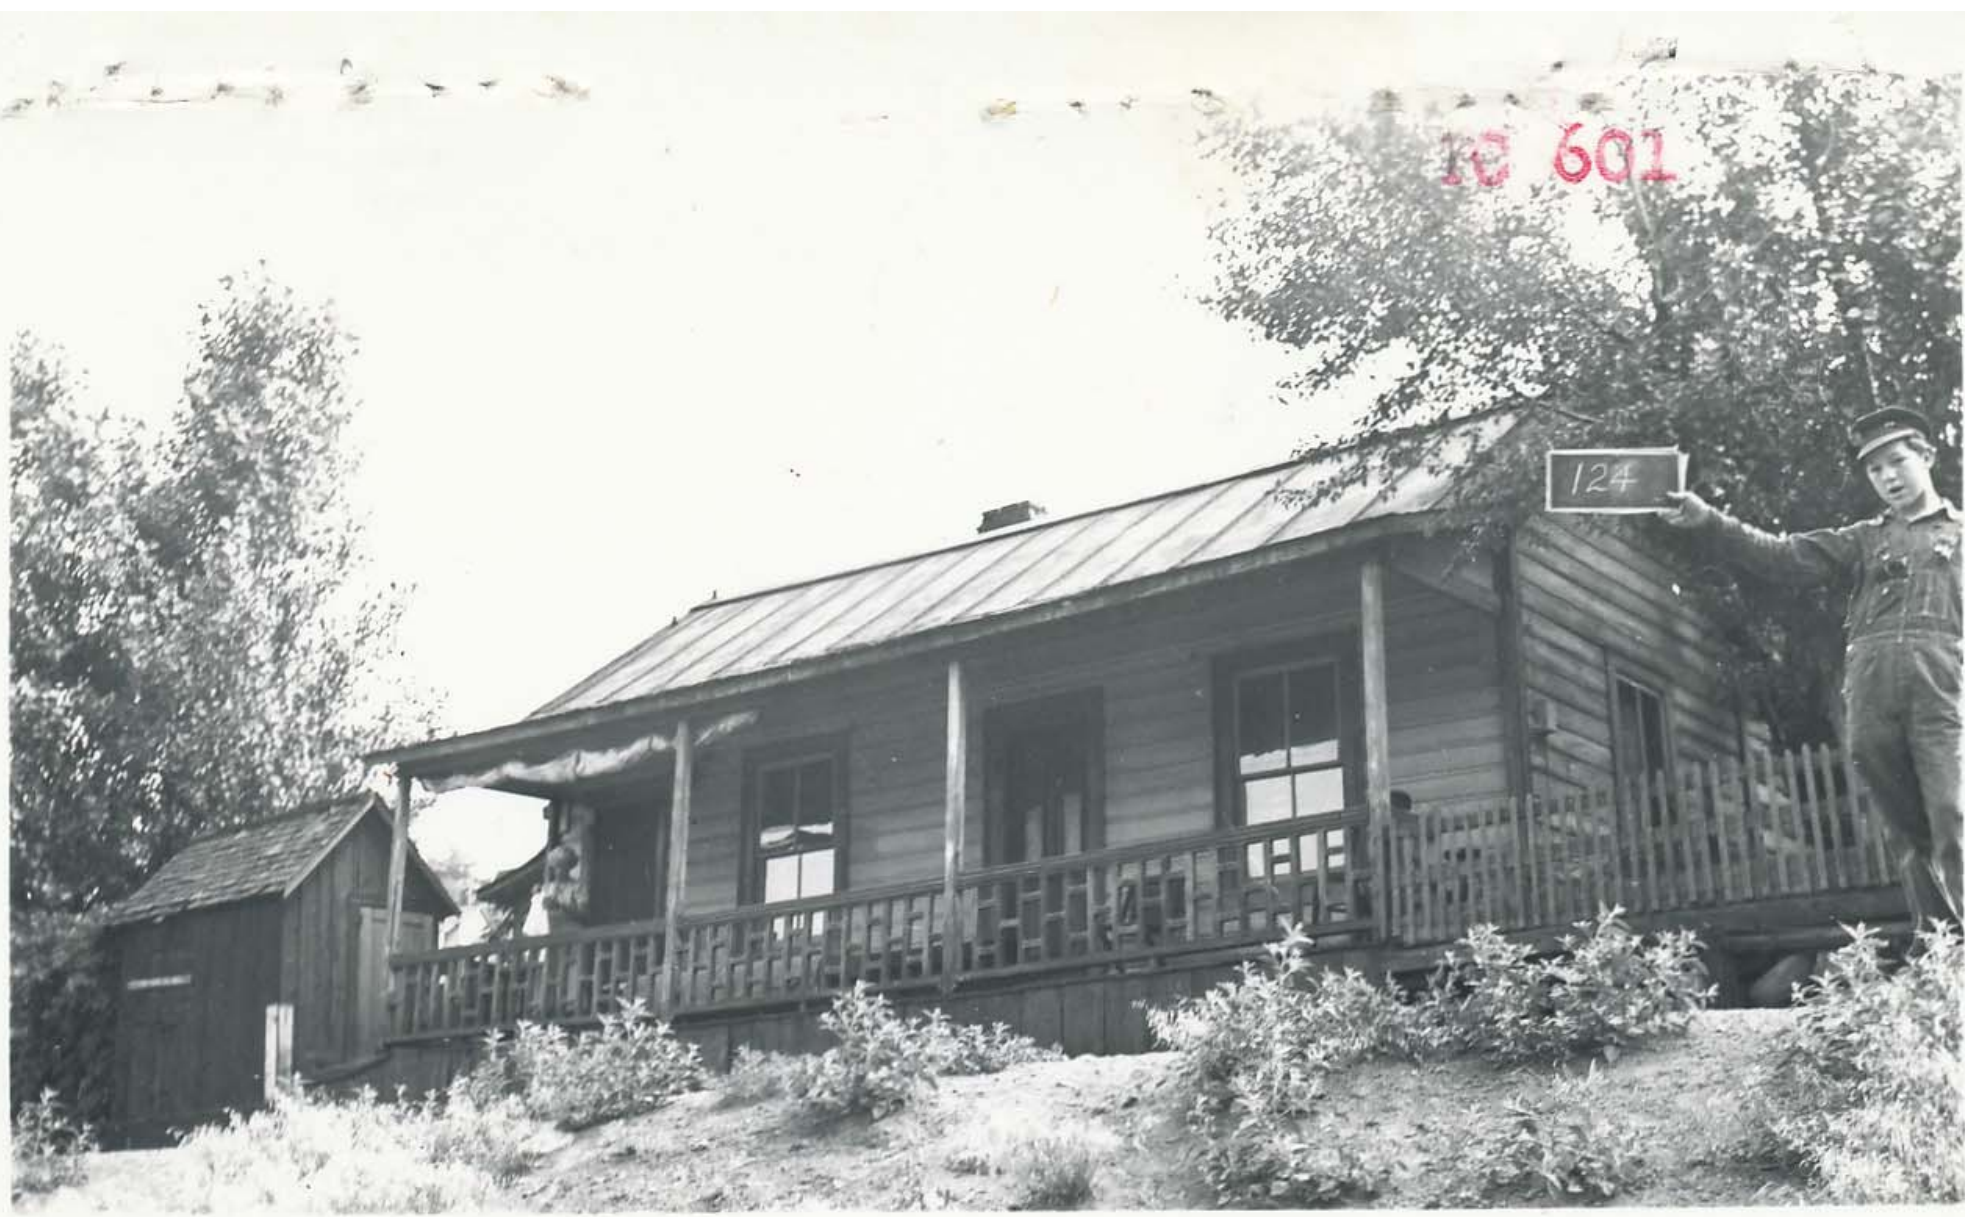
- Photo No. 1:** Southwest oblique. Camera facing northeast, 2006.
- Photo No. 2:** Northwest oblique. Camera facing southeast, 2006.
- Photo No. 3:** Southwest oblique. Camera facing northeast, 1995.
- Photo No. 4:** Southwest oblique. Camera facing northeast, c. 1968
- Photo No. 5:** Southwest oblique. Camera facing northeast, c. 1940 tax photo.

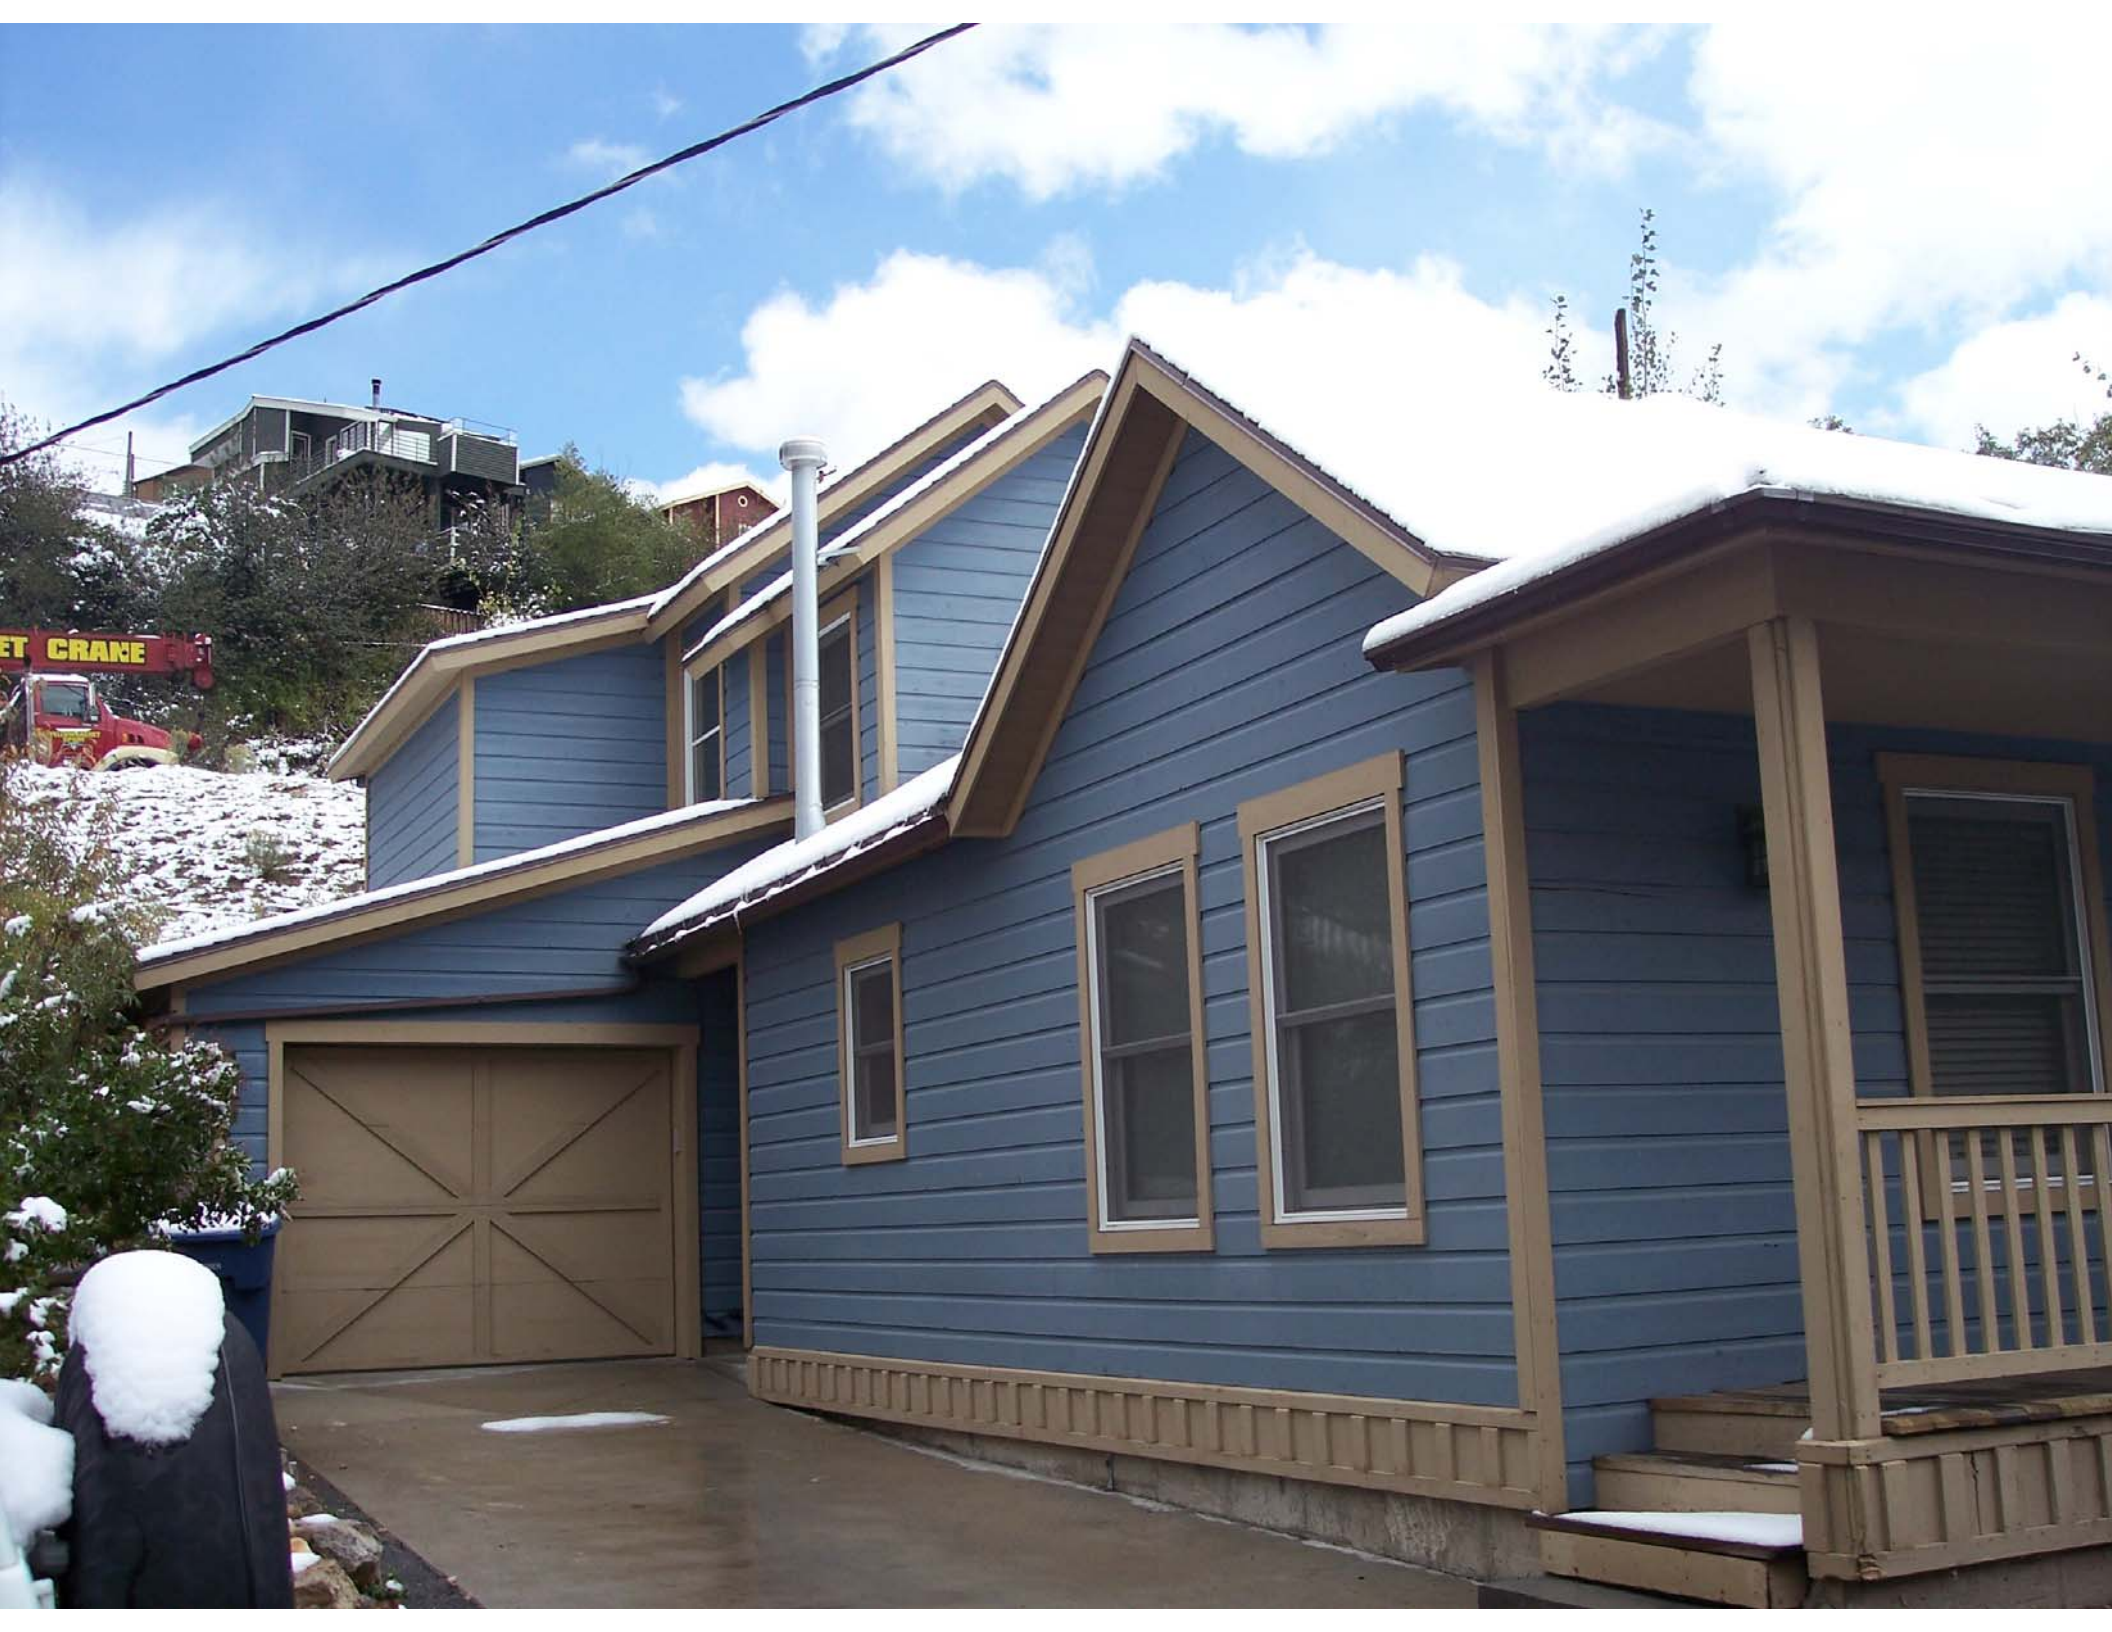
**Setting** (The physical environment--natural or manmade--of a historic site. Describe the setting and how it has changed over time.): Earliest tax photo shows small outbuilding no longer present on property. Narrow building lot has the structure's porch front directly adjacent to roadway. Neighboring residential property structures are similar in size and scale. Removed trees from 1968 photo have since been replanted in areas similar to those in original tax photo.
