# HISTORIC SITE FORM - HISTORIC SITES INVENTORY

PARK CITY MUNICIPAL CORPORATION (10-08)

Address: 844 EMPIRE AVE

Building Type and/or Style: Rectangular or "Hall-Parlor" House

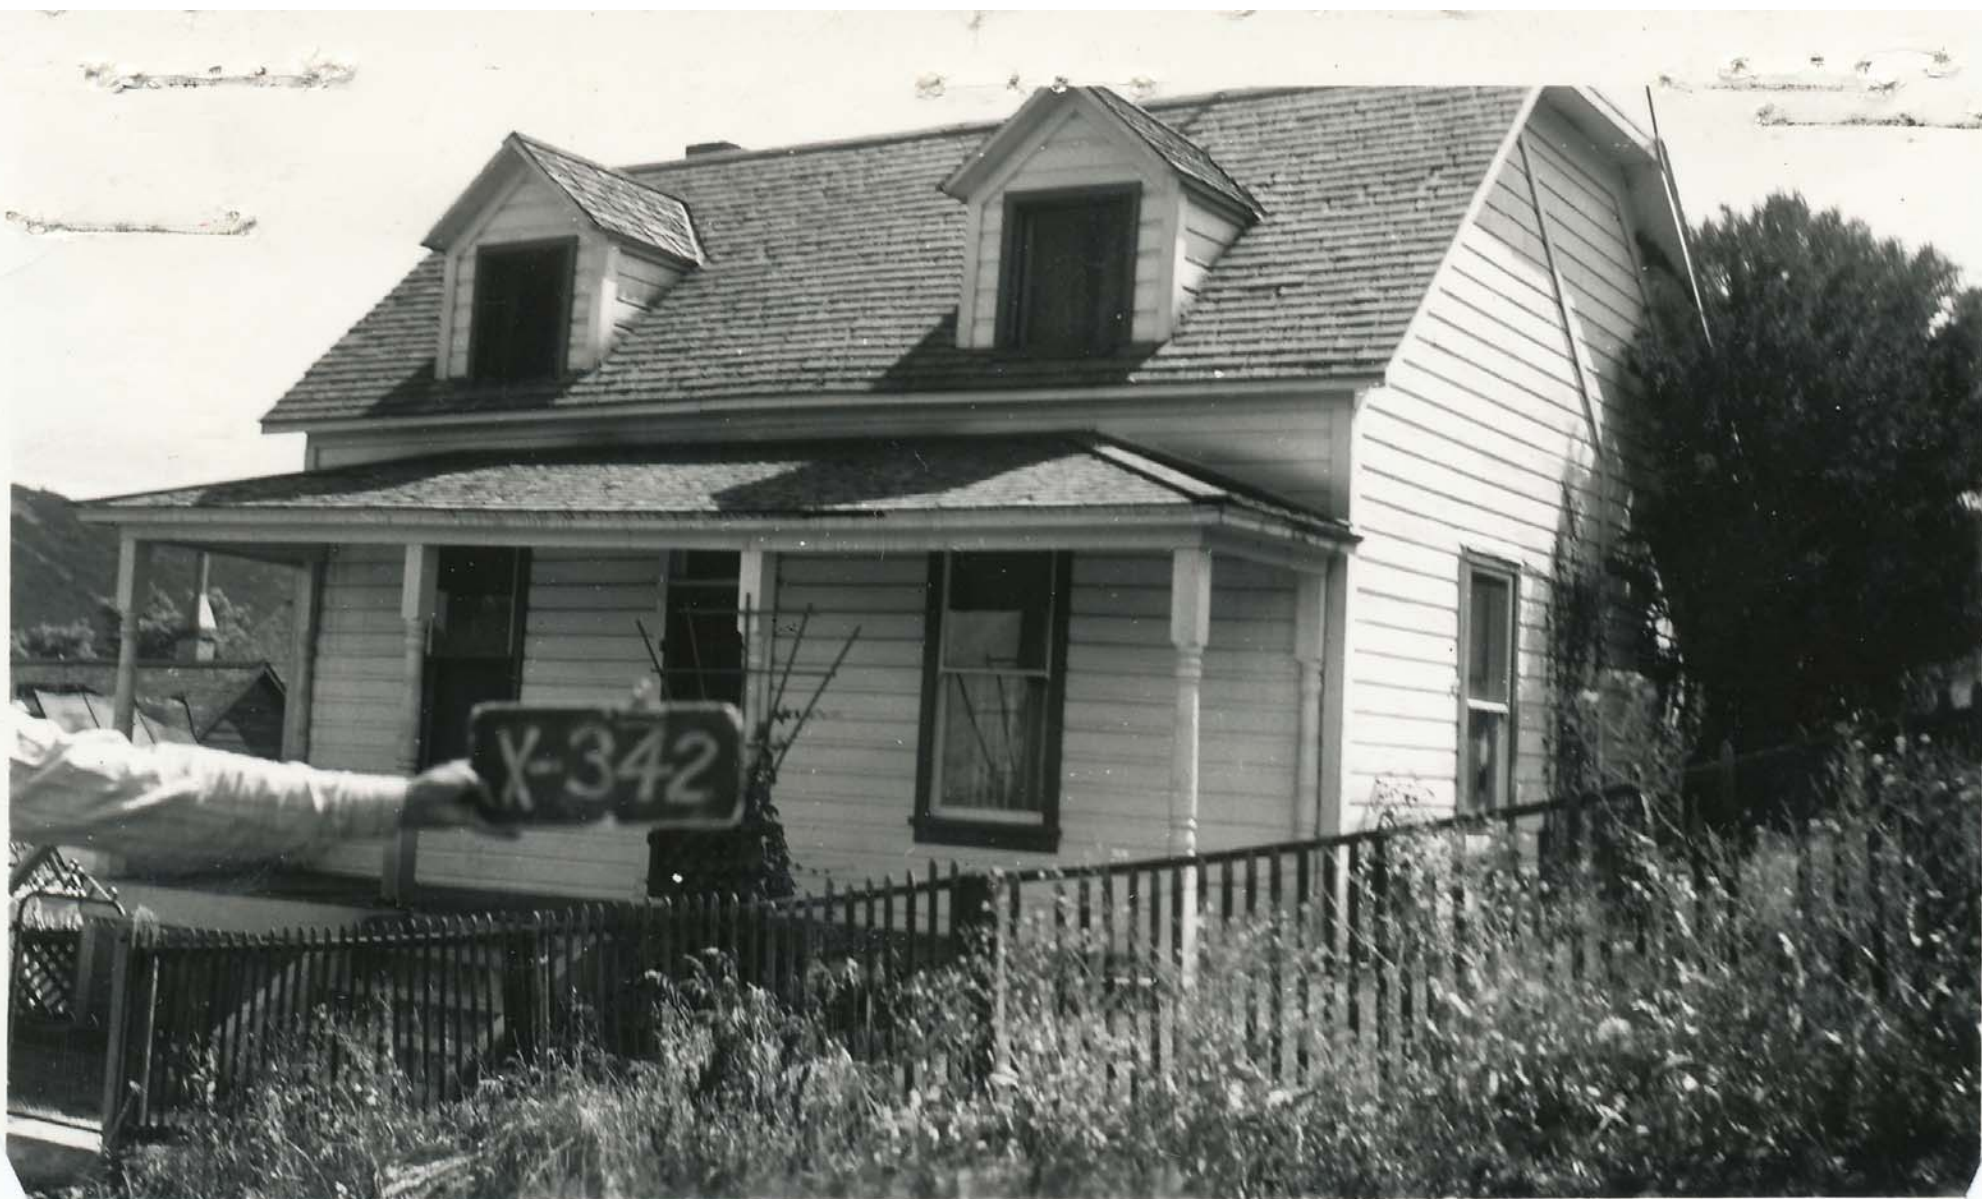
SA 143

Materials and compositional structure of house exterior has been significantly altered from original tax photo.

**Photo No. 4:** South elevation (possibly north façade). Camera facing unknown, c. 1940 tax photo.

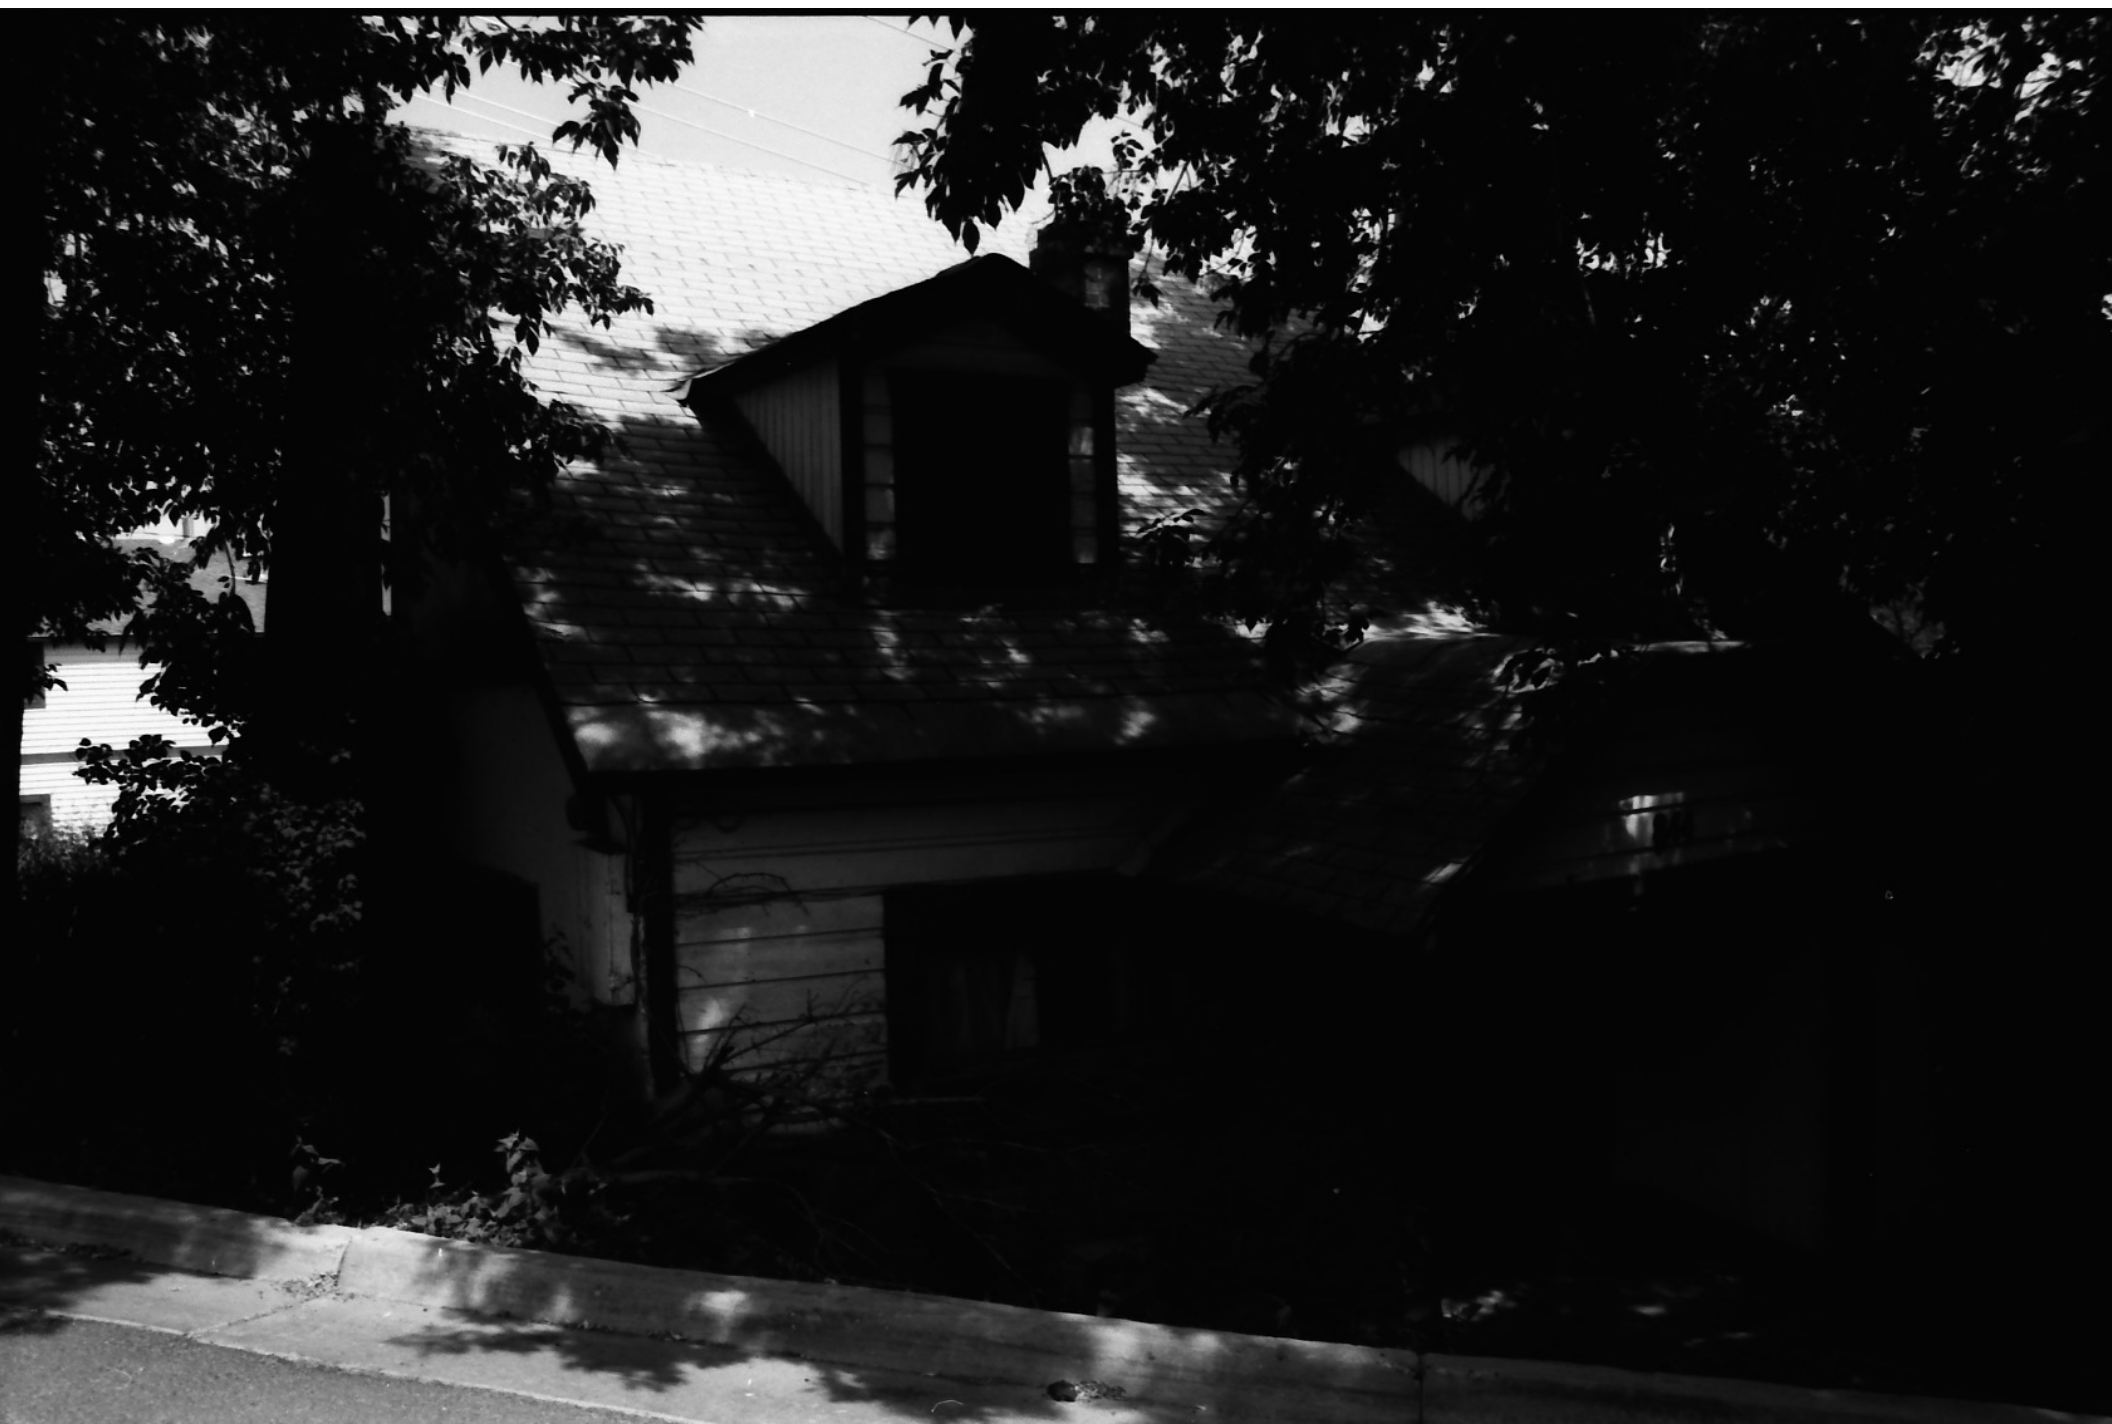
Walls: Vertical wooden board siding, some form of stucco and stone on lower storey, and remnants of drop-novelty siding of which the house fully consisted of based on earliest photos.

Roof: Photos indicate prior use of shingles, but now consists of metal roofing.

Windows: Currently swing or sliding vinyl frame windows.

**Photo No. 1:** North elevation (primary façade). Camera facing south, 2006.

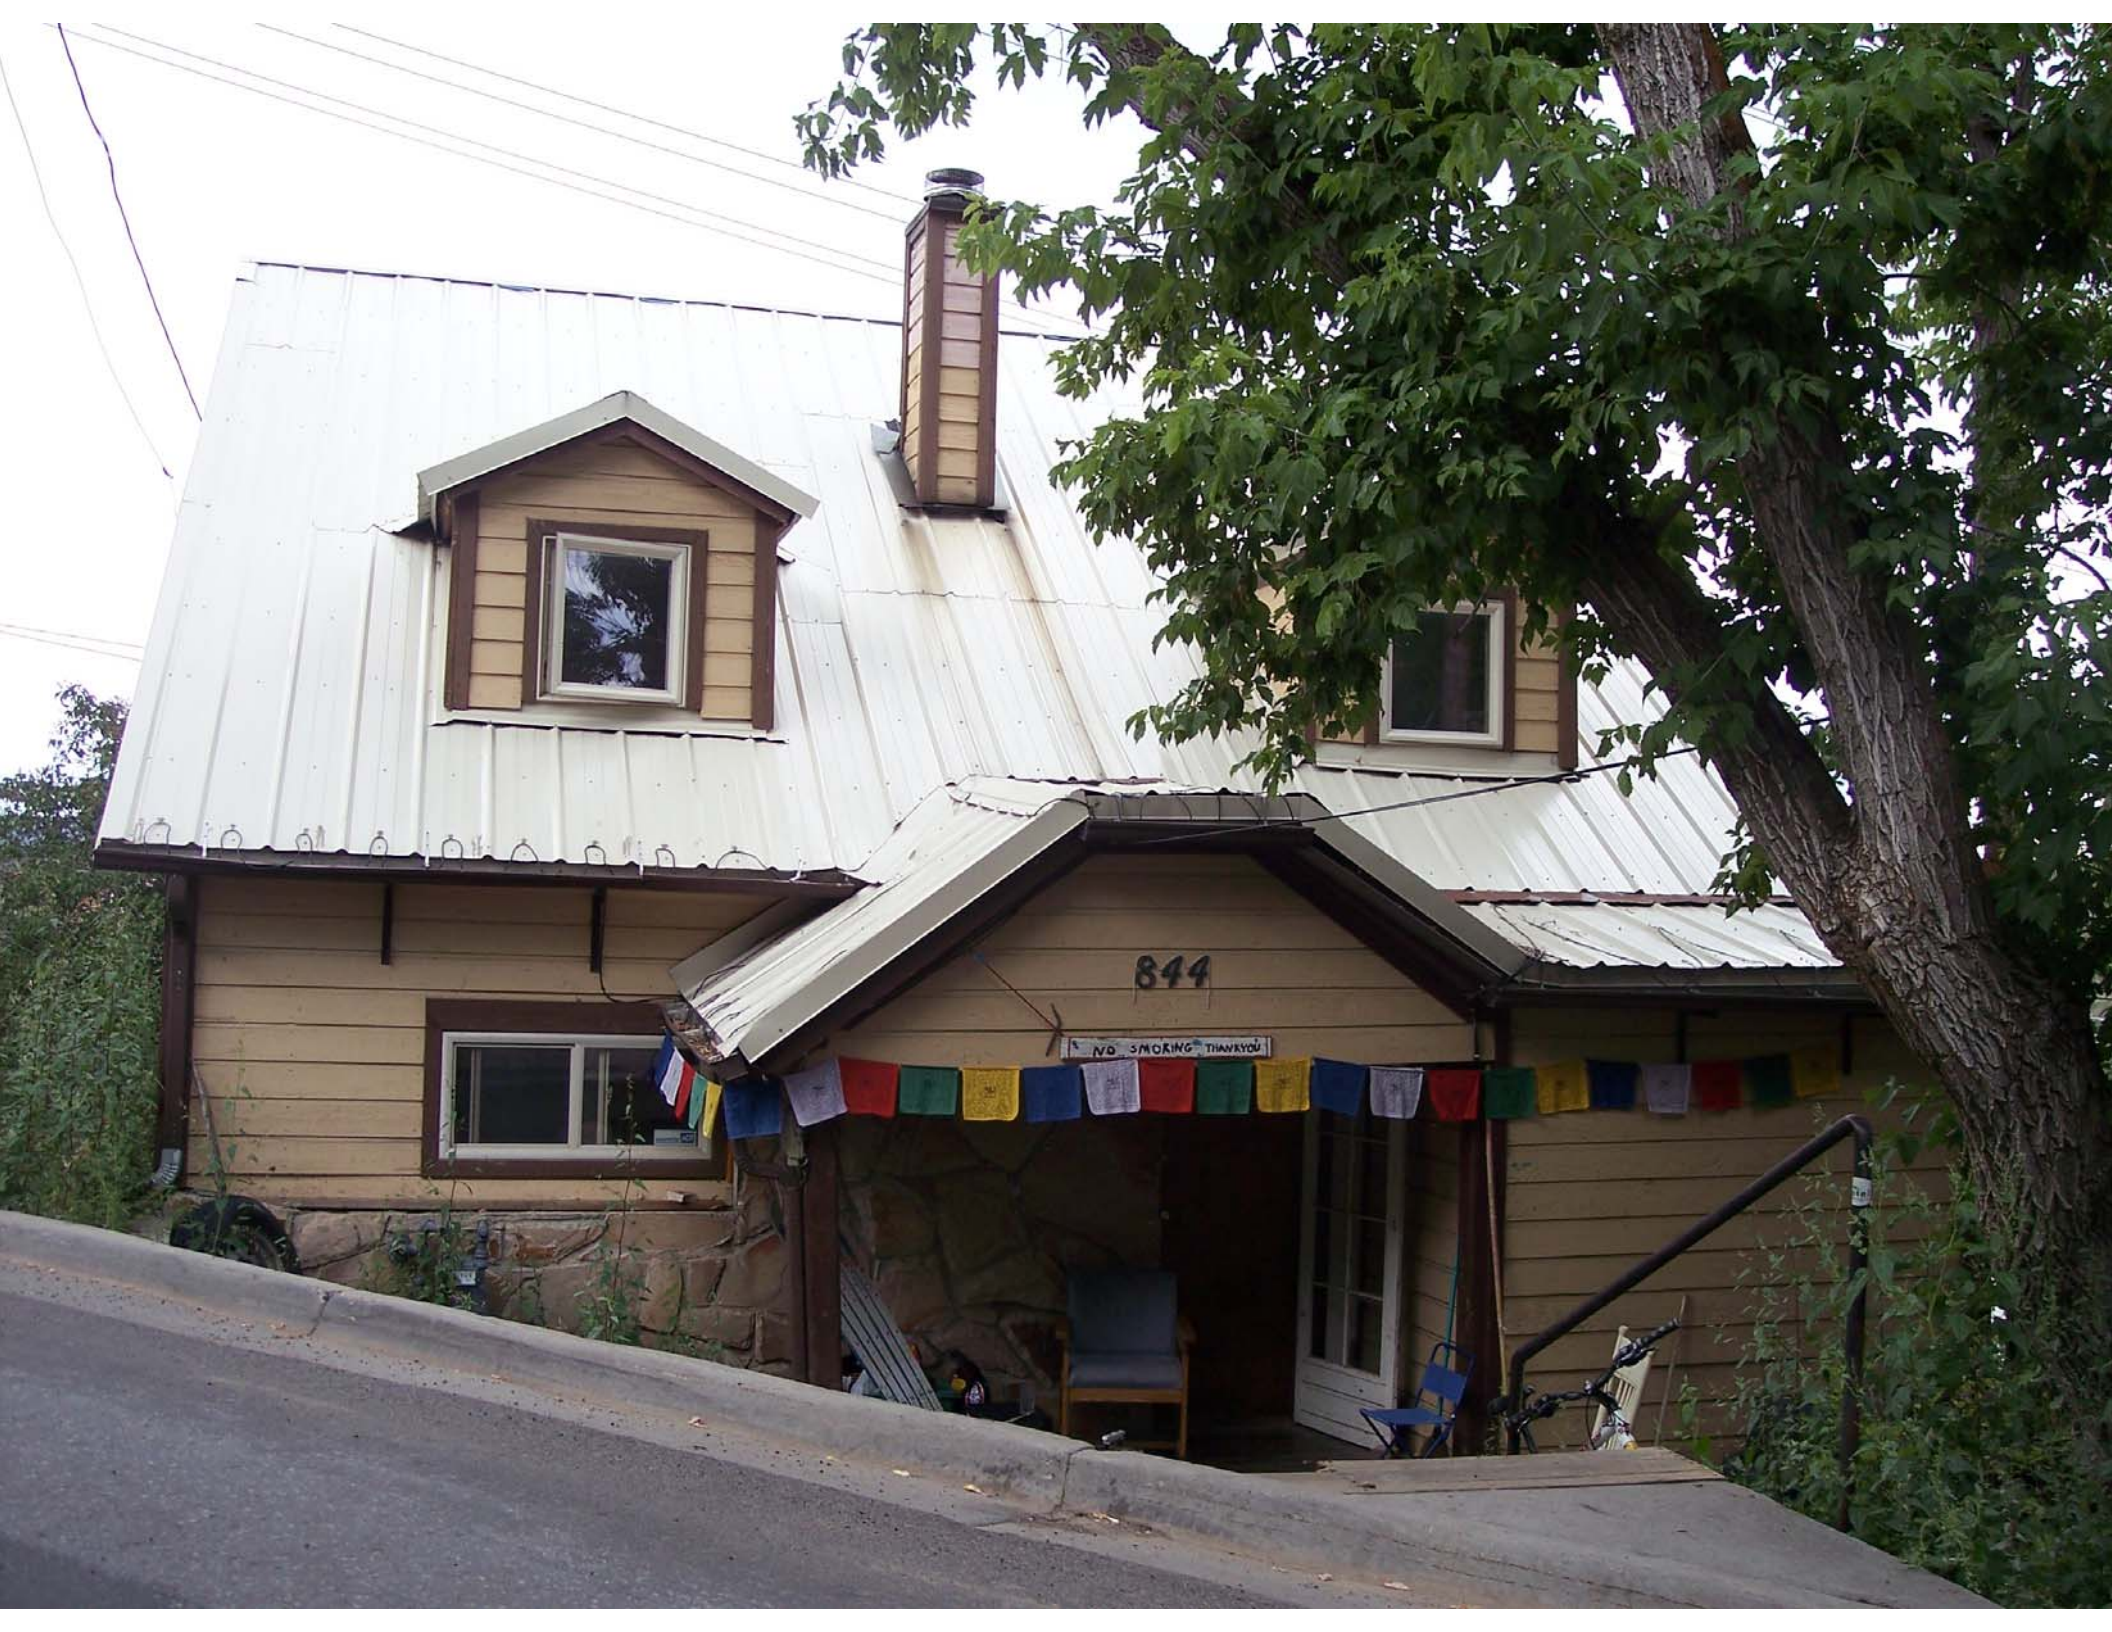
**Design** (The combination of physical elements that create the form, plan, space, structure, and style. Describe additions and/or alterations from the original design, including dates--known or estimated--when alterations were made): Traditional hall-parlor front has been significantly modified; the front full-width shed-roof porch has been replaced with a narrow gabled porch element; exterior wall materials have been significantly altered, yet elements of original drop-novelty siding are still evident in some spots. Also, the roof, which appears to be a gable modified to truncated gable in the tax photo is now simply a steeper gable. Date of this change is unknown. Some evidence--building cards--suggests that the current primary façade is actually the original rear façade. The rear façade is not visible in the tax photos and this cannot be verified. Transition from a shingle roof to a metal roof occurred sometime between 1995 and 2006 photos, as were the significant changes in window materials.

**Photo No. 2:** Northeast oblique. Camera facing southwest, 2006.

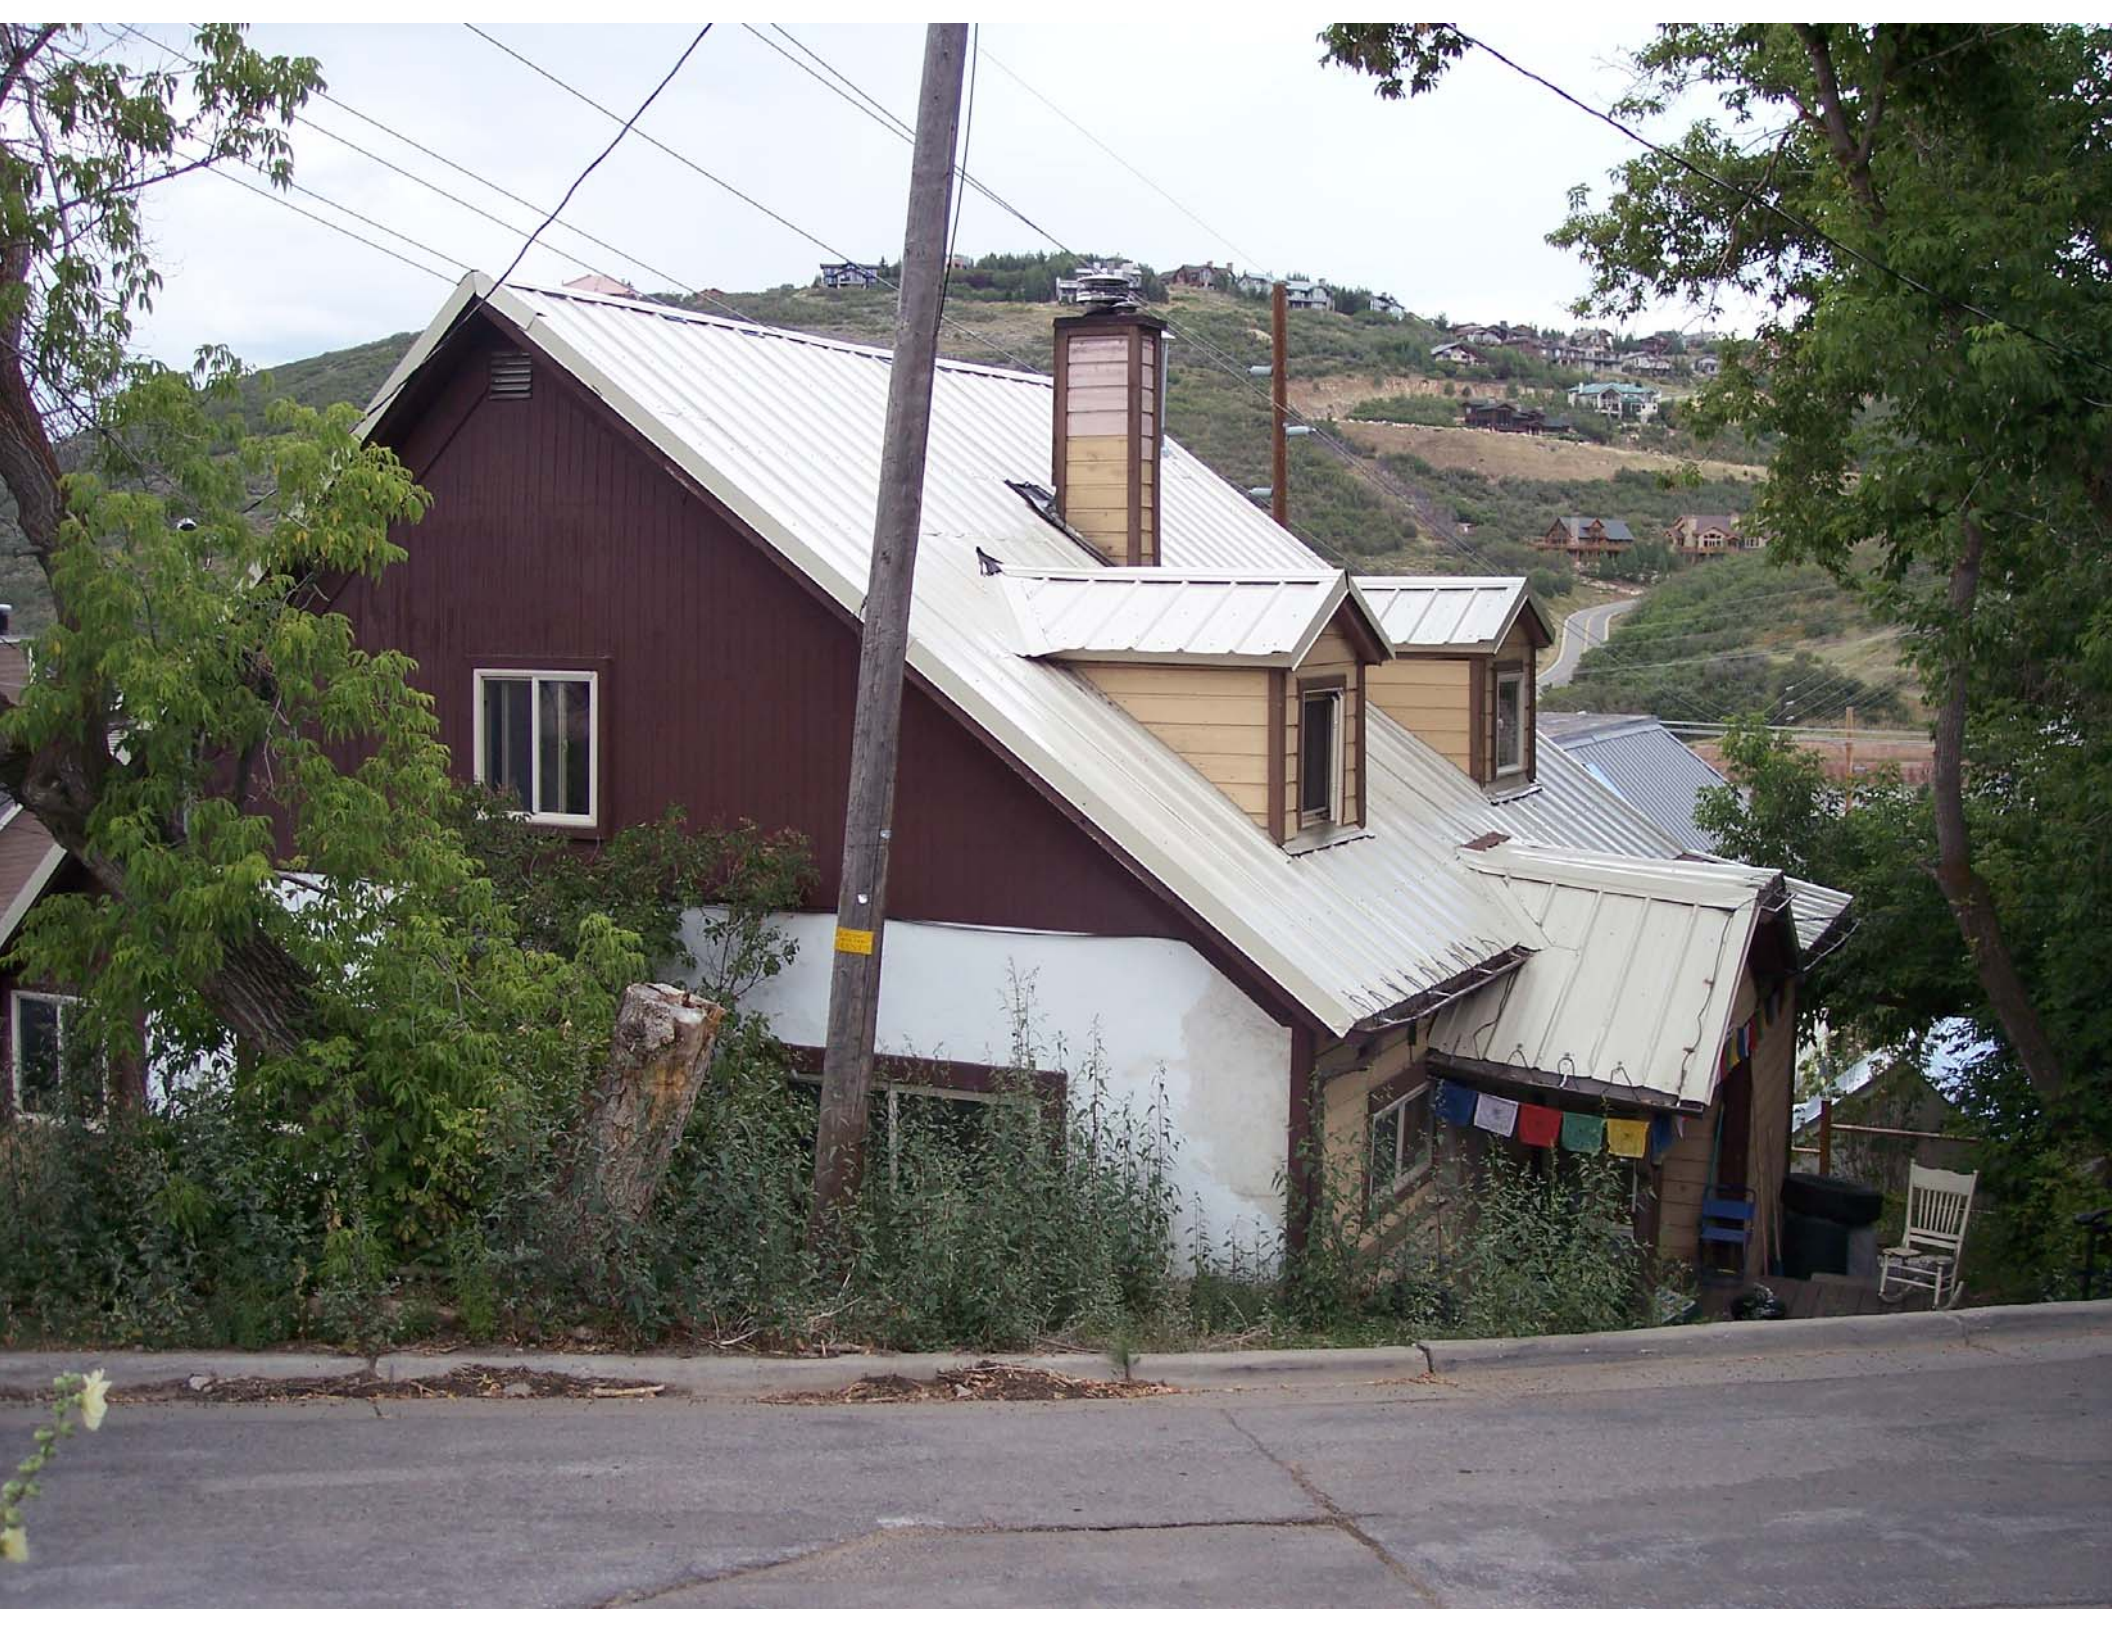
**Setting** (The physical environment--natural or manmade--of a historic site. Describe the setting and how it has changed over time.): Compact building lot on a significant slope. As mentioned earlier, front and back entrances were at some point reversed, and heavy tree landscaping was reduced or scaled back (based on photos) sometime between 1995 and 2006.

**Photo No. 3:** Northeast oblique. Camera facing southwest, 1995.
