HISTORIC SITE FORM - HISTORIC SITES INVENTORY

PARK CITY MUNICIPAL CORPORATION (10-08)

2465 Doc Holliday Drive, Park City, UT, Page 3 of 3

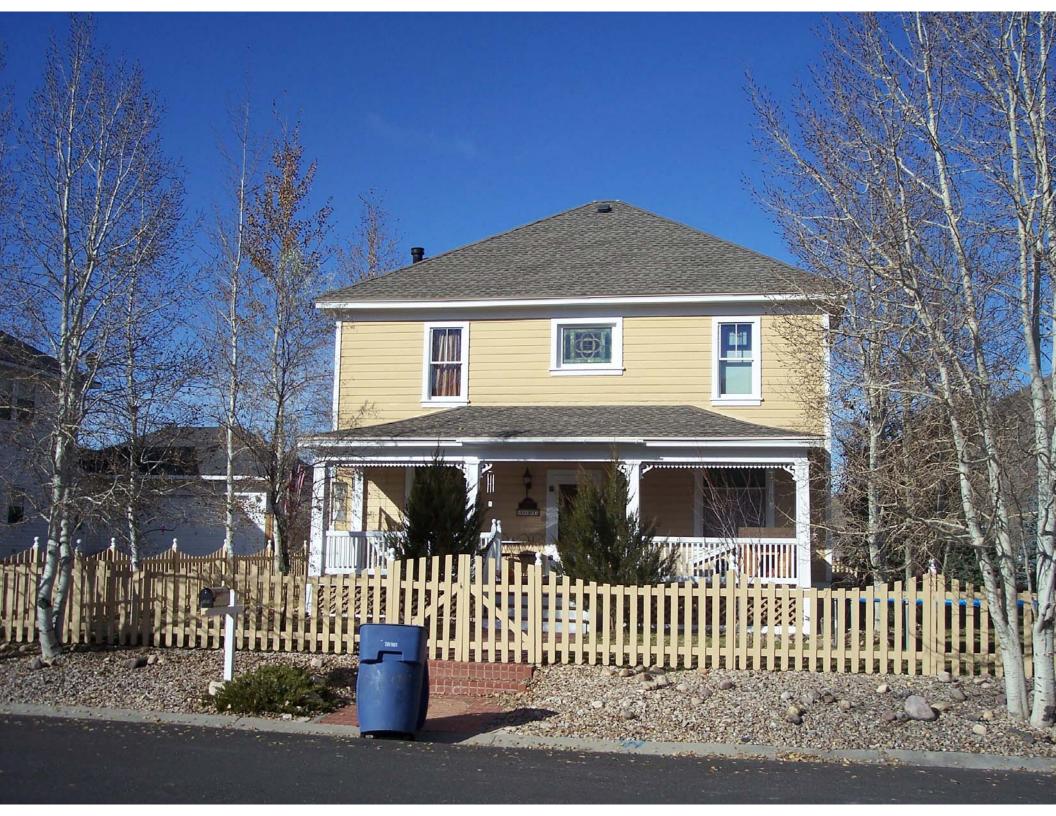
Photo No. 1: Primary façade, 2006.

General Condition of Exterior Materials:
☑ Good (Well maintained with no serious problems apparent.)
☐ Fair (Some problems are apparent. Describe the problems.):
☐ Poor (Major problems are apparent and constitute an imminent threat. Describe the problems.):
☐ Uninhabitable/Ruin
Materials (The physical elements that were combined or deposited during a particular period of time in a particular pattern or configuration. Describe the materials.): Foundation: Not verified, assumed to be concrete.
Walls: Horizontal wood siding
Roof: Hipped roof form sheathed in asphalt shingles.
Windows: Two-over-one double-hung sash type and large fixed casement with fixed transom windows.
Essential Historical Form: ☑ Retains ☐ Does Not Retain, due to:
Location: ☐ Original Location ☐ Moved (dateunknown) Original Location: Coalville
Design (The combination of physical elements that create the form, plan, space, structure, and style. Describe additions and/or alterations from the original design, including datesknown or estimatedwhen alterations were made): The 2-story frame foursquare exhibits many of the typical design elements of the style and period; square plan, low-pitched hipped roof, two-story massing, one-story hipped roof porch that spans the façade, and symmetrically placed openings on the primary façade. This house was moved to this site from Coalville, but retains the physical elements critical to its design as an American foursquare house.
