HISTORIC SITE FORM - HISTORIC SITES INVENTORY

PARK CITY MUNICIPAL CORPORATION (10-08)

Address: 255 DALY AVE

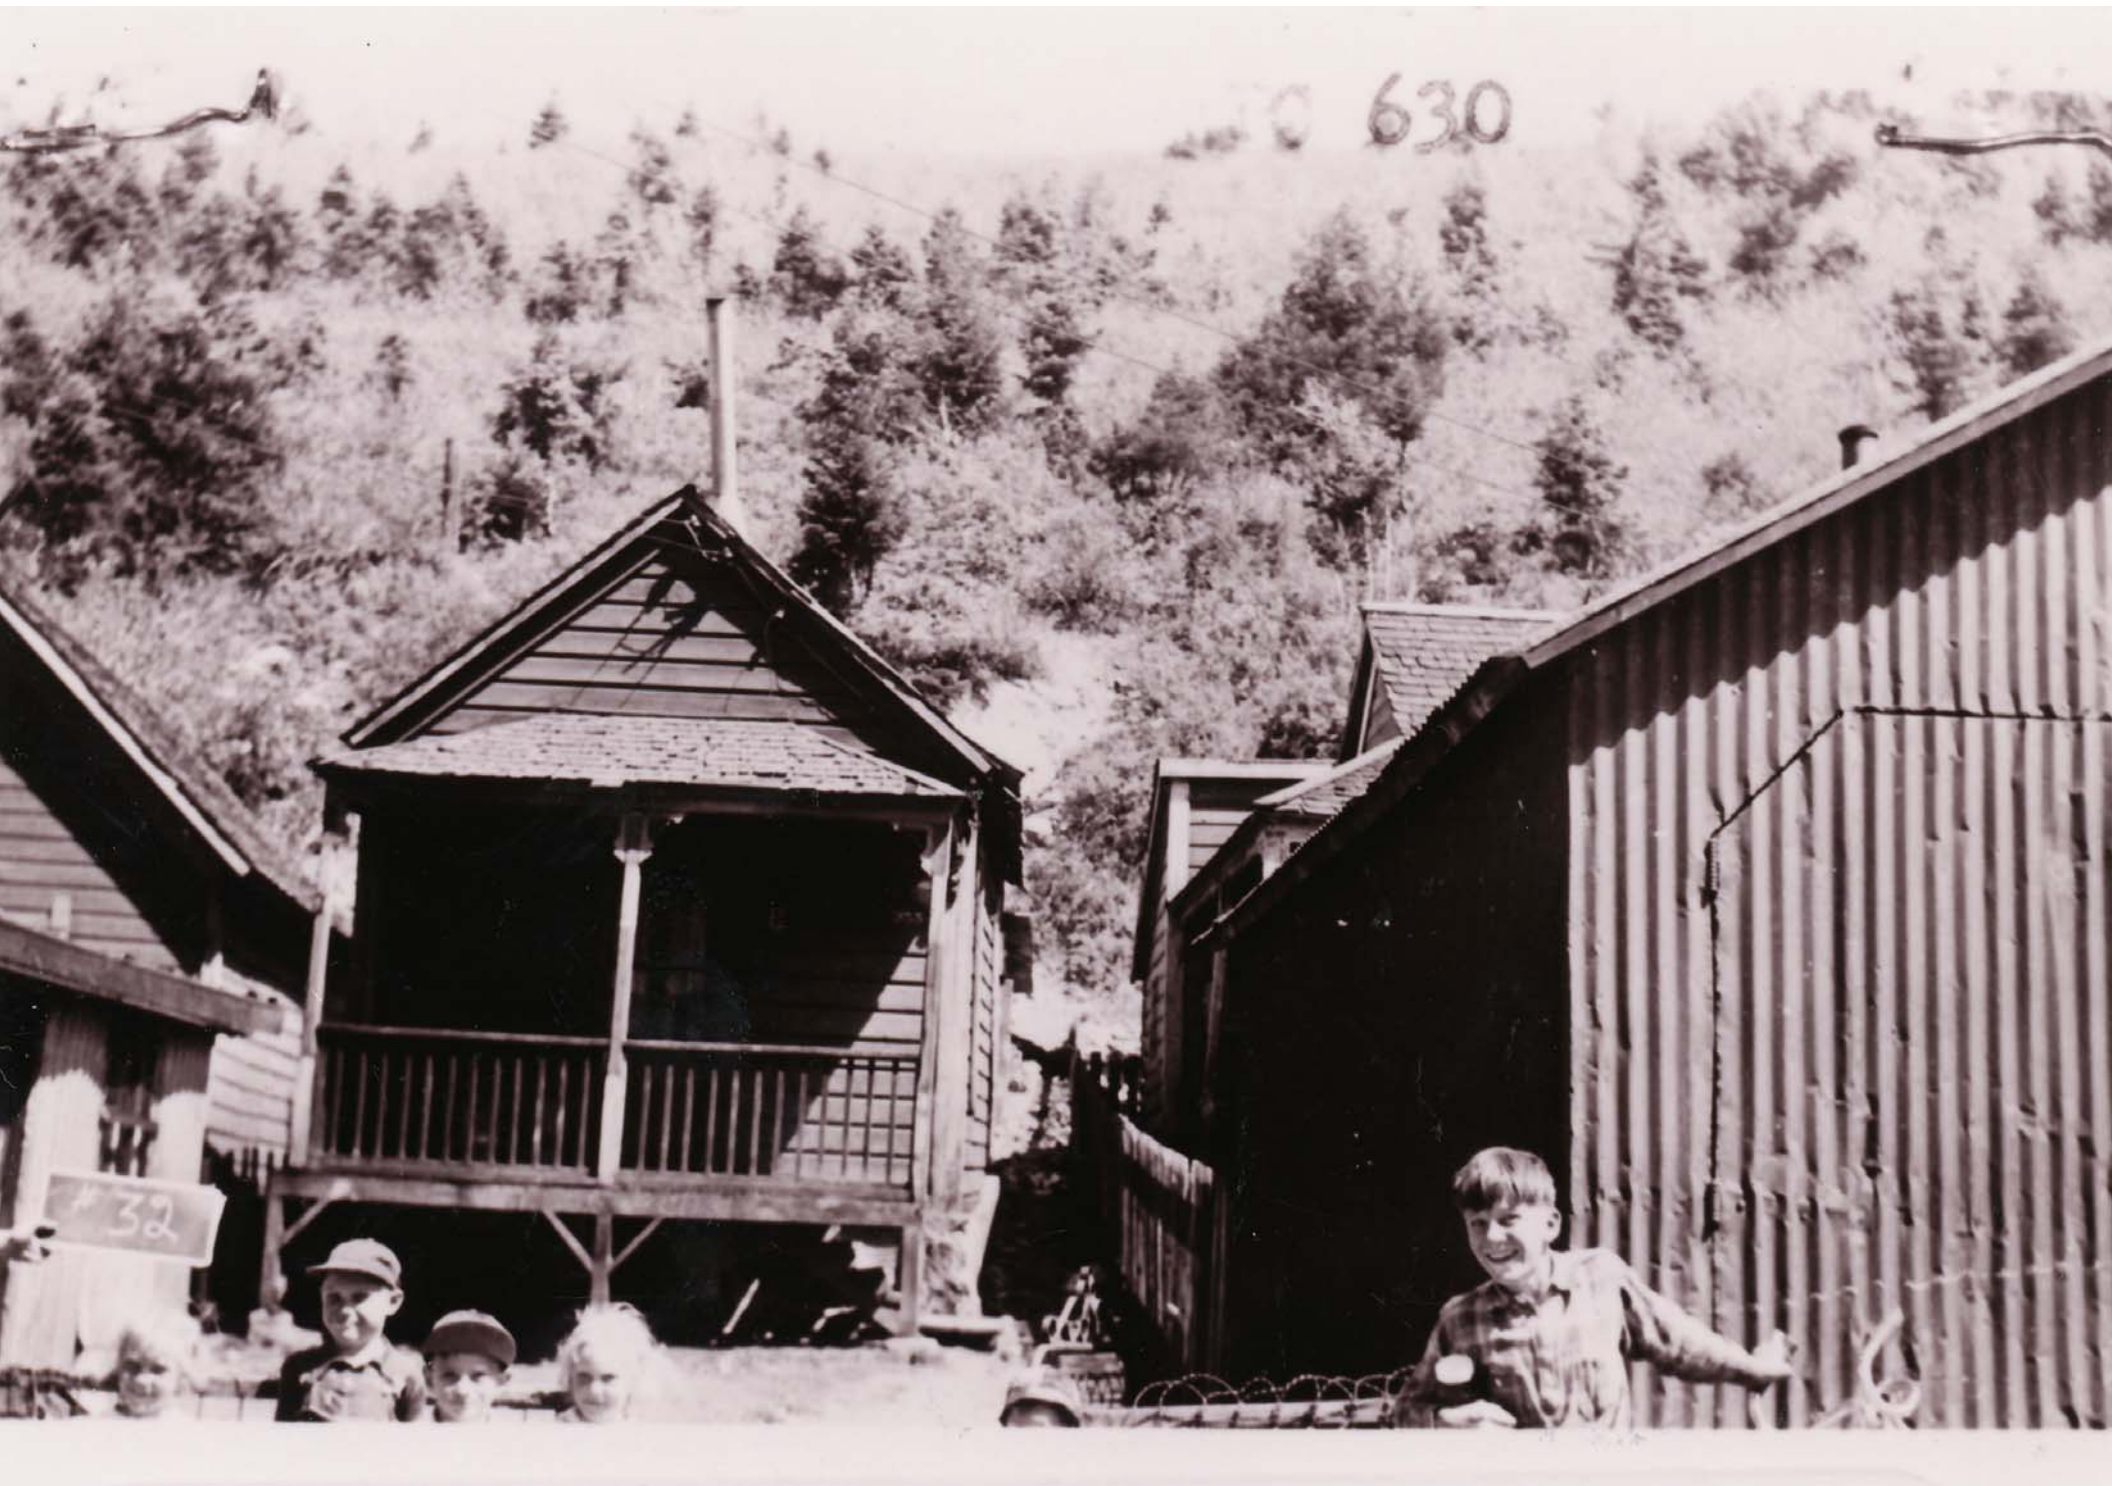
- Photo No. 1:** West elevation (primary façade). Camera facing east, 2006.
- Photo No. 2:** West elevation (primary façade). Camera facing east, 1995.
- Photo No. 3:** West elevation (primary façade). Camera facing east, tax photo.
