# HISTORIC SITE FORM - HISTORIC SITES INVENTORY

PARK CITY MUNICIPAL CORPORATION (10-08)

Address: 60 Sampson Avenue

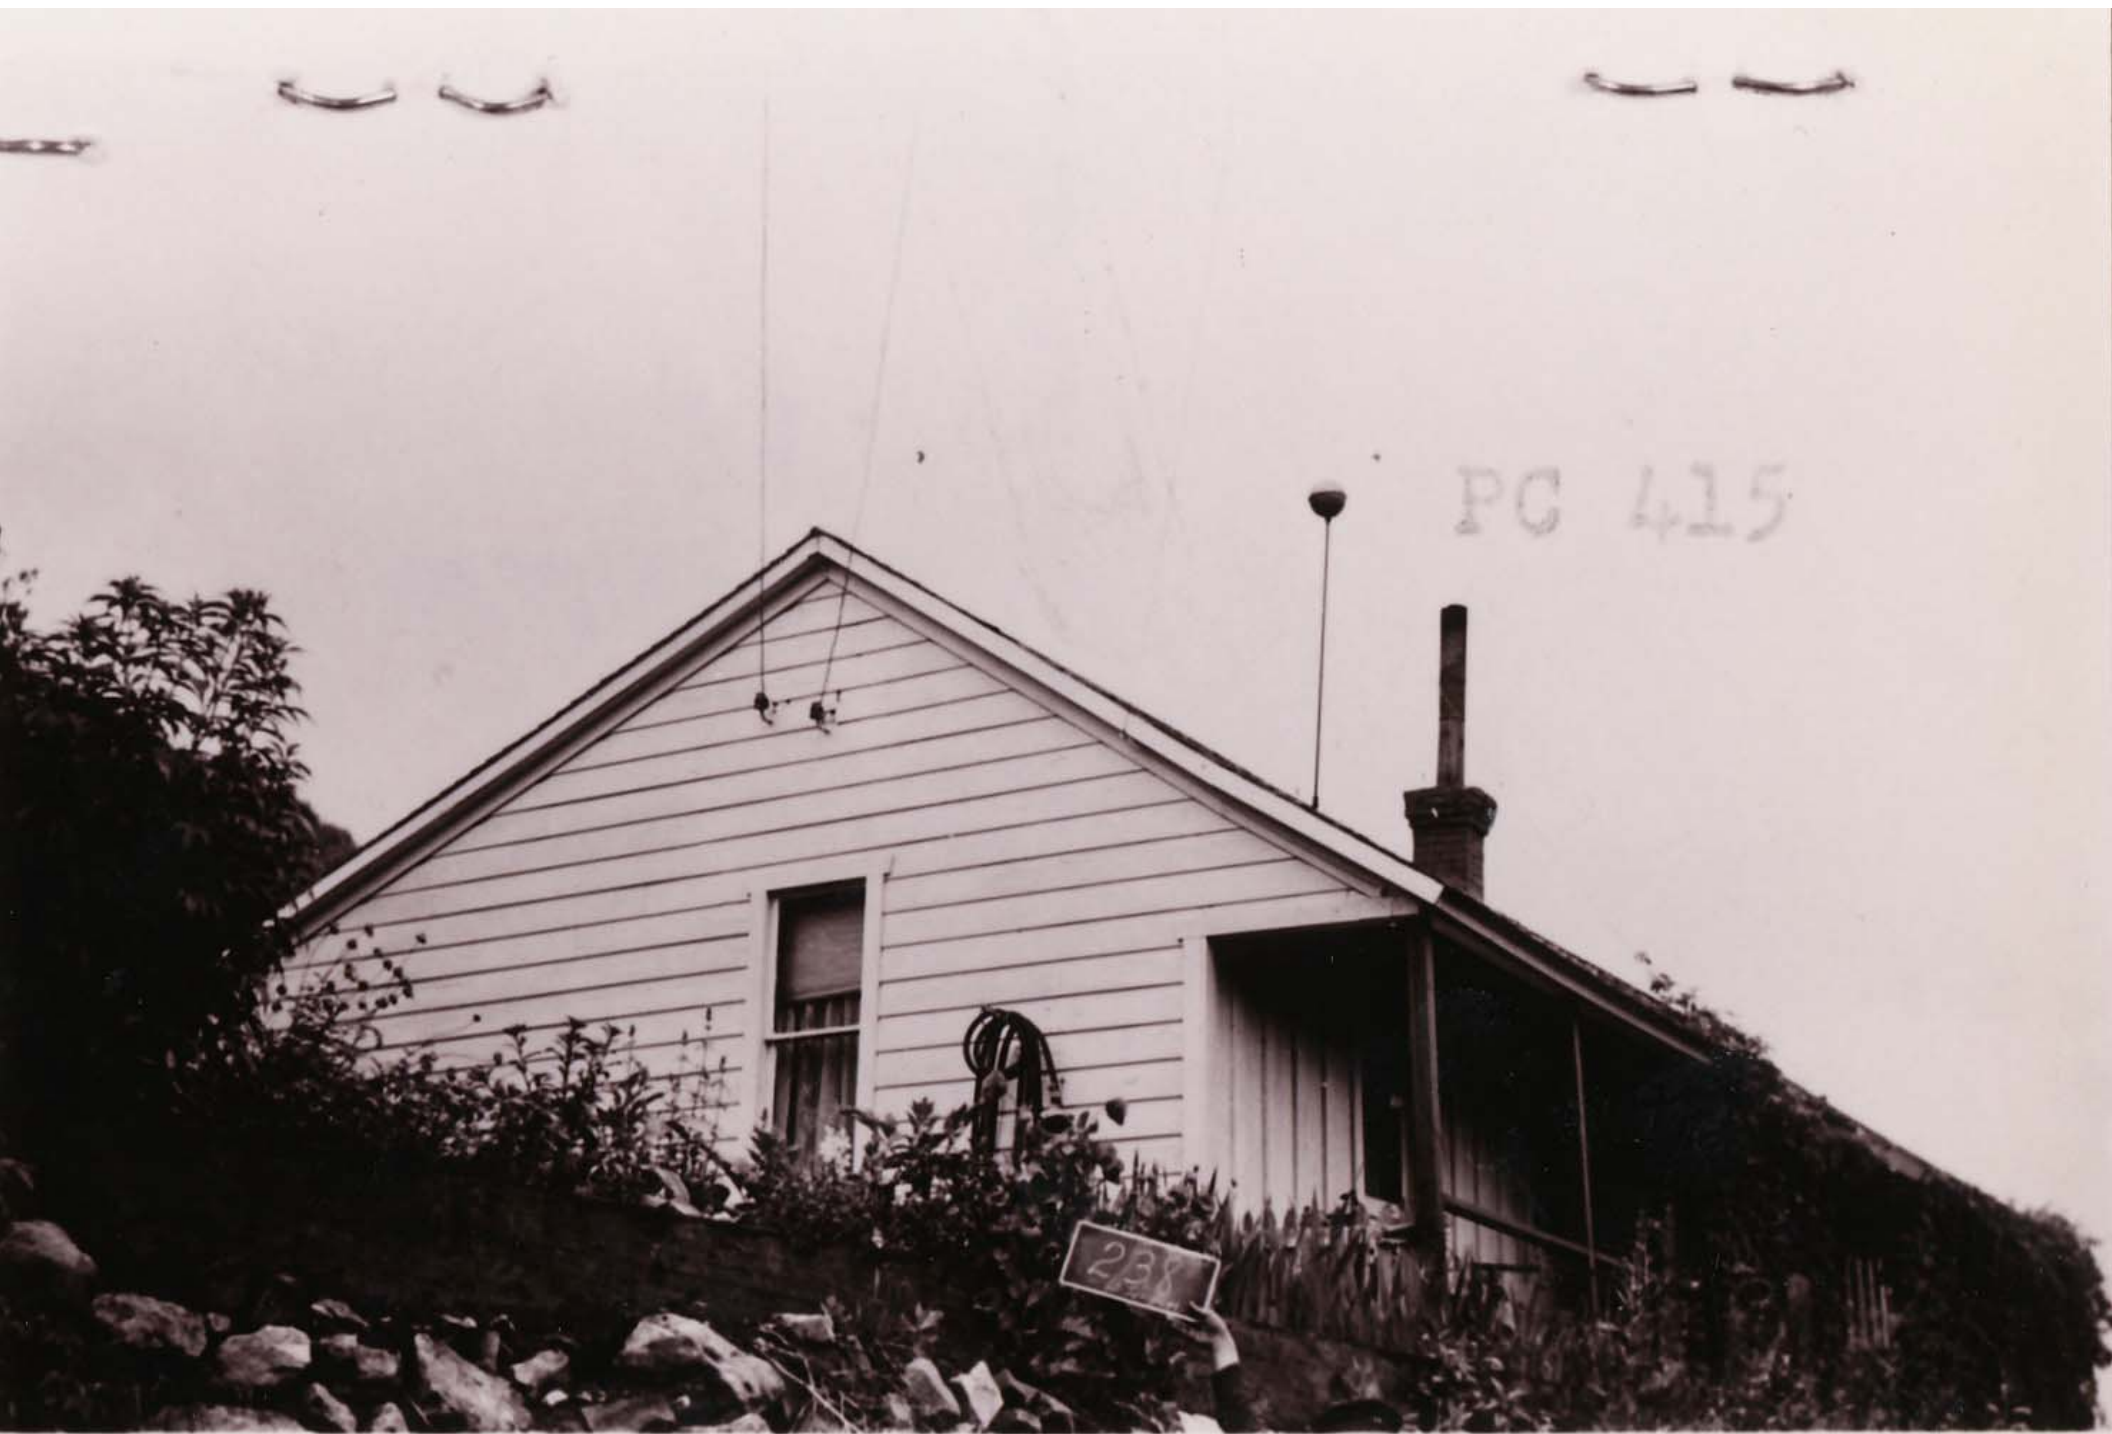
**Photo No. 6:** Southeast oblique. Camera facing northwest, tax photo.

**Design** (The combination of physical elements that create the form, plan, space, structure, and style. Describe additions and/or alterations from the original design, including dates--known or estimated--when alterations were made): The one-story frame house appears to have had major alterations. The tax photo suggests the full-width porch was recessed under the principal roof, but now reflects an extended shed roof. It is not clear if this is a conjectural change or based on physical evidence discovered during rehabilitation. A low pediment was added to the eave above the main entry door. A large basement addition and garage have been constructed with access from the short end of the house. The window openings on the side elevation have been altered from a single double-hung sash type to multiple double-hung sash types. The board & batten siding is seen in the tax photo, but only on the primary façade; the side façade shows drop siding. The rear roof form appears as it does in the tax photo. A rear addition was constructed after 1995, but is not visible from the primary right-of-way. The changes are significant and diminish the site's original character.

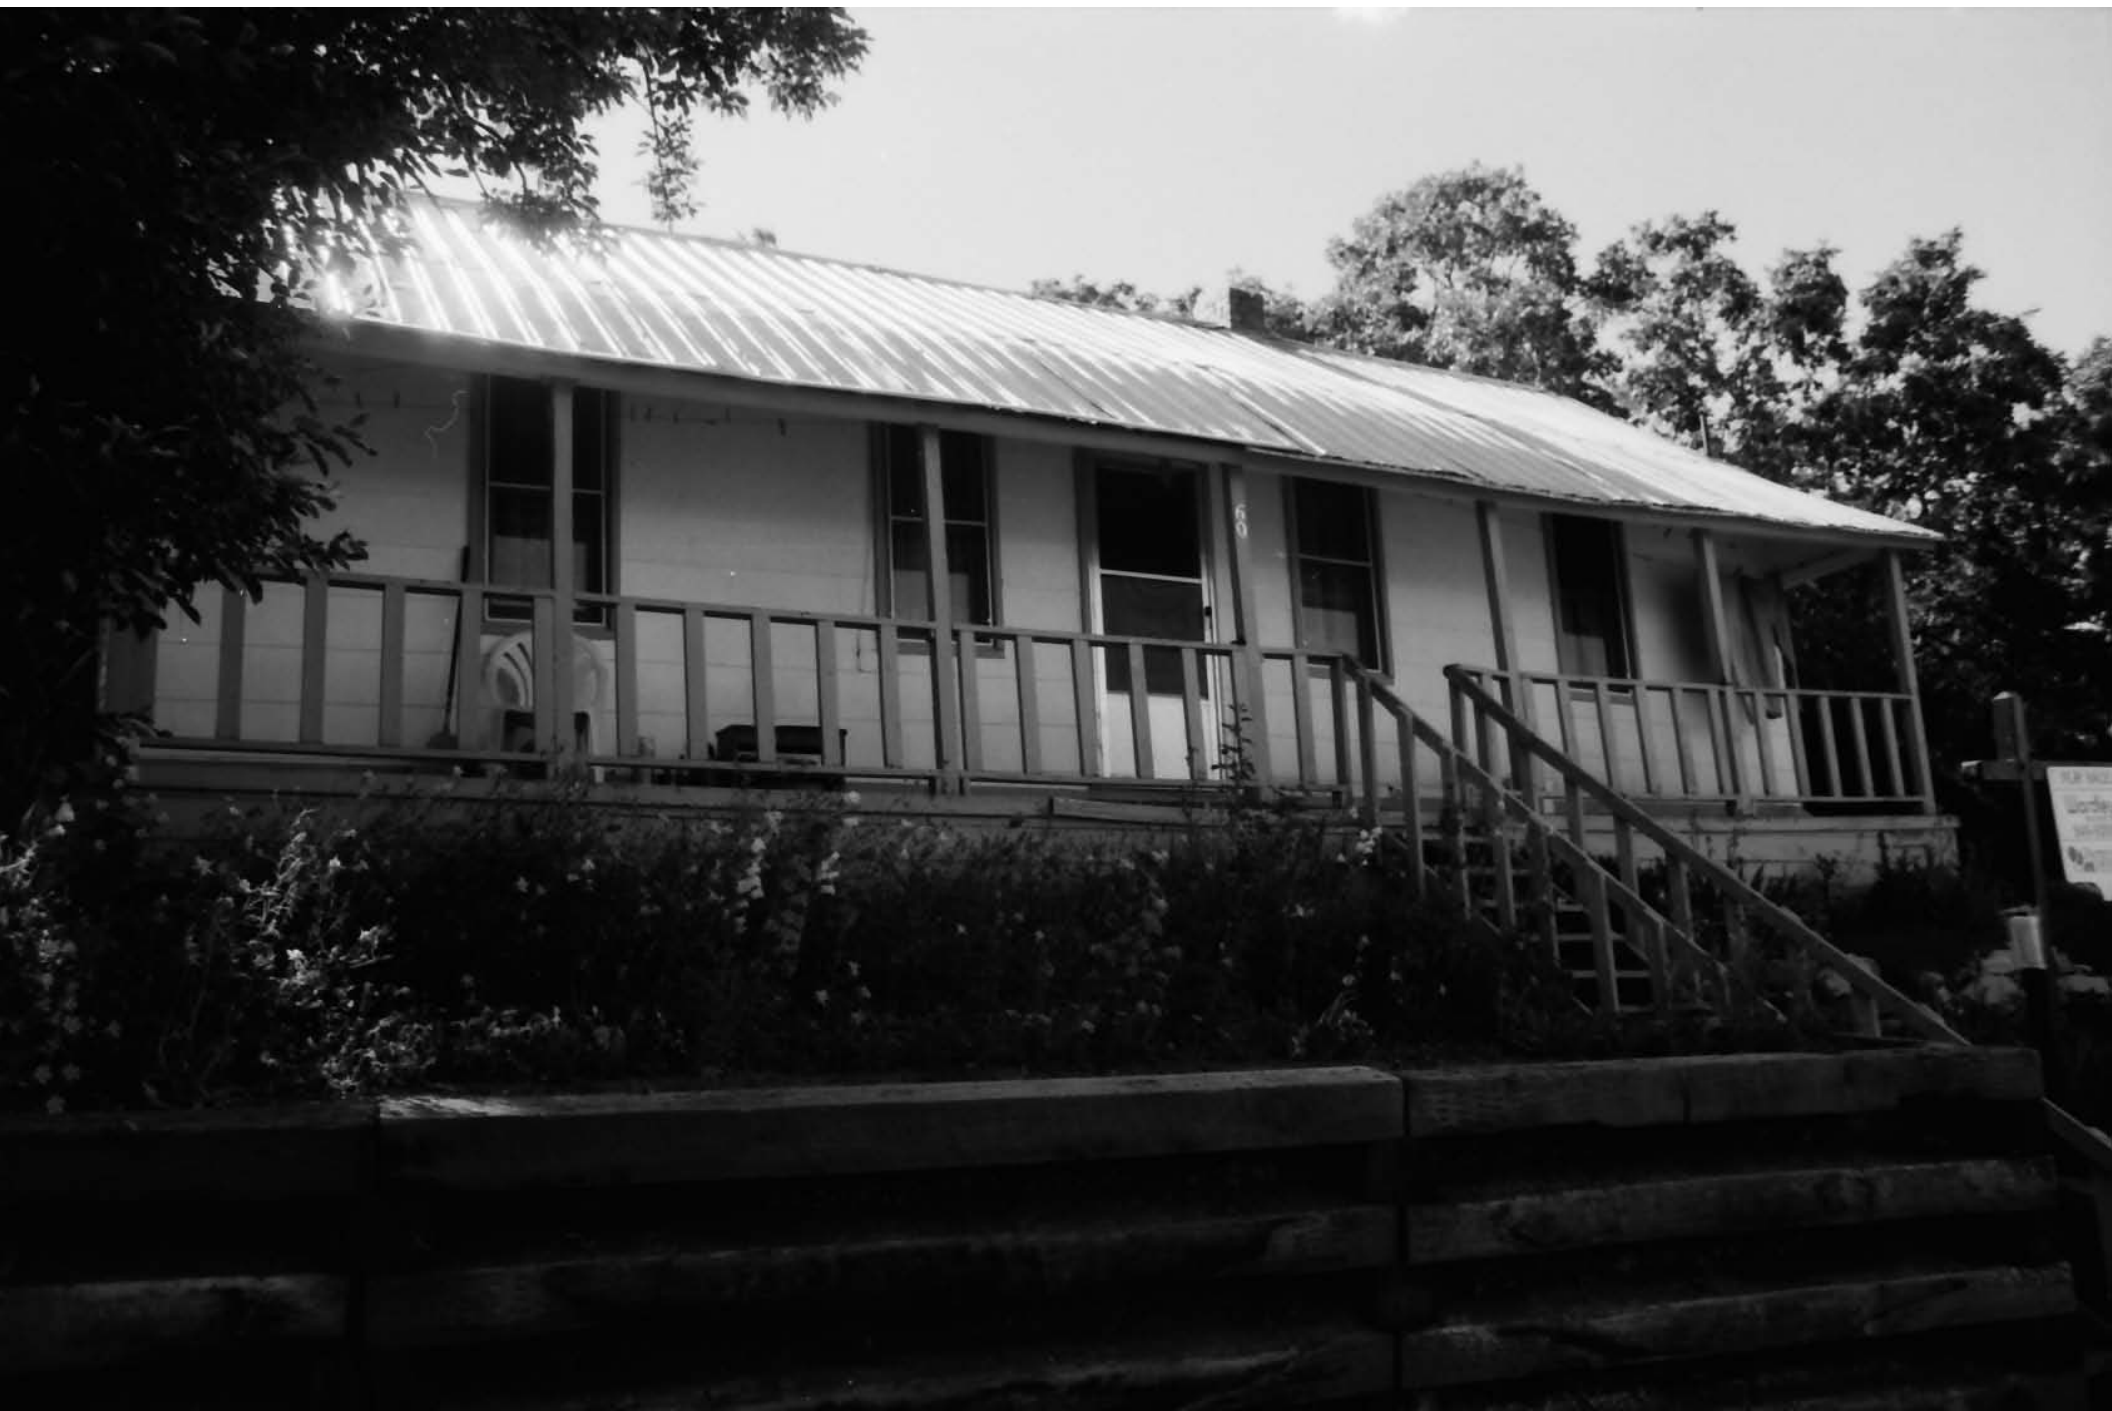
**Photo No. 5:** East elevation (primary façade). Camera facing west, 1995.

**Setting** (The physical environment--natural or manmade--of a historic site. Describe the setting and how it has changed over time.): The setting has been altered by the excavation done to accommodate access to a garage. However, the setting as viewed in front of the house remains as it is seen in the tax photo and 1995 photo.
