HISTORIC SITE FORM - HISTORIC SITES INVENTORY

PARK CITY MUNICIPAL CORPORATION (10-08)

Name of Property: **Matilda M. Stromberg House**

Address: 222 Sandridge Road

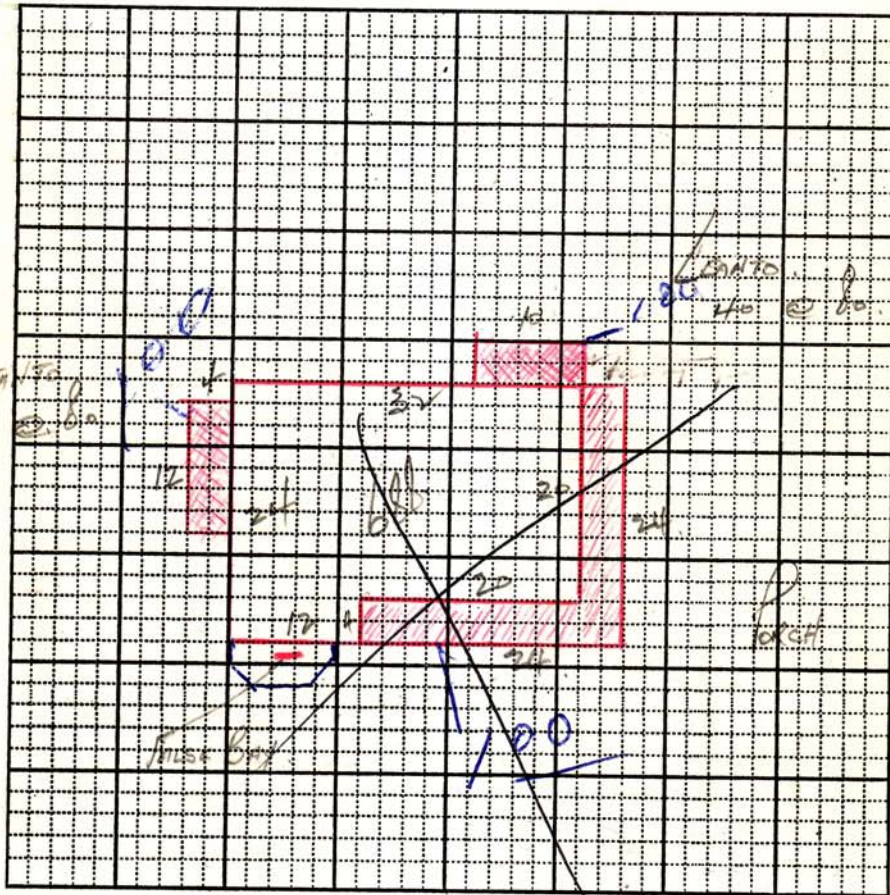
Description of Building	Add	Deduct
56 x 2 x 100 Foundation—Stone Conc. None <input checked="" type="checkbox"/>		112
Ext. Walls <u>ASBESTOS SHG.</u>		
Insulated—Floors Walls Clgs.		
Roof—Type <u>GAB.</u> Mat. <u>PAT. SHG.</u>		
Dormers—Small Med. Lg.		
Bays—Small <u>FALSE</u> Med. Lg.	18	
Porches—Front <u>176 @ .80</u>	140	
Rear @		
Cellar—Basem't— $\frac{1}{4}$ $\frac{1}{2}$ $\frac{3}{4}$ full-floor <u>DIRT</u>		
Basement Apts.—Rooms Fin.		
Attic Rooms Fin. Unfin.		
Plumbing— Class <u>1</u> Tub <u>1</u> Trays <u>1</u> Basin <u>1</u> Sink <u>1</u> Toilet <u>1</u> Urns <u>1</u> Ftns. <u>1</u> Shr. <u>1</u> Dishwasher <u>1</u> Garbage Disp. <u>1</u>	315	
Heat—Stove <input checked="" type="checkbox"/> H. A. <input checked="" type="checkbox"/> Steam <u>S.</u> Blr. <u>1</u> Oil <input checked="" type="checkbox"/> Gas <input checked="" type="checkbox"/> Coal <input checked="" type="checkbox"/>		
Air Conditioned <input type="checkbox"/> Incinerators <input type="checkbox"/>
