# HISTORIC SITE FORM - HISTORIC SITES INVENTORY

PARK CITY MUNICIPAL CORPORATION (10-08)

Address: 351 Park Ave

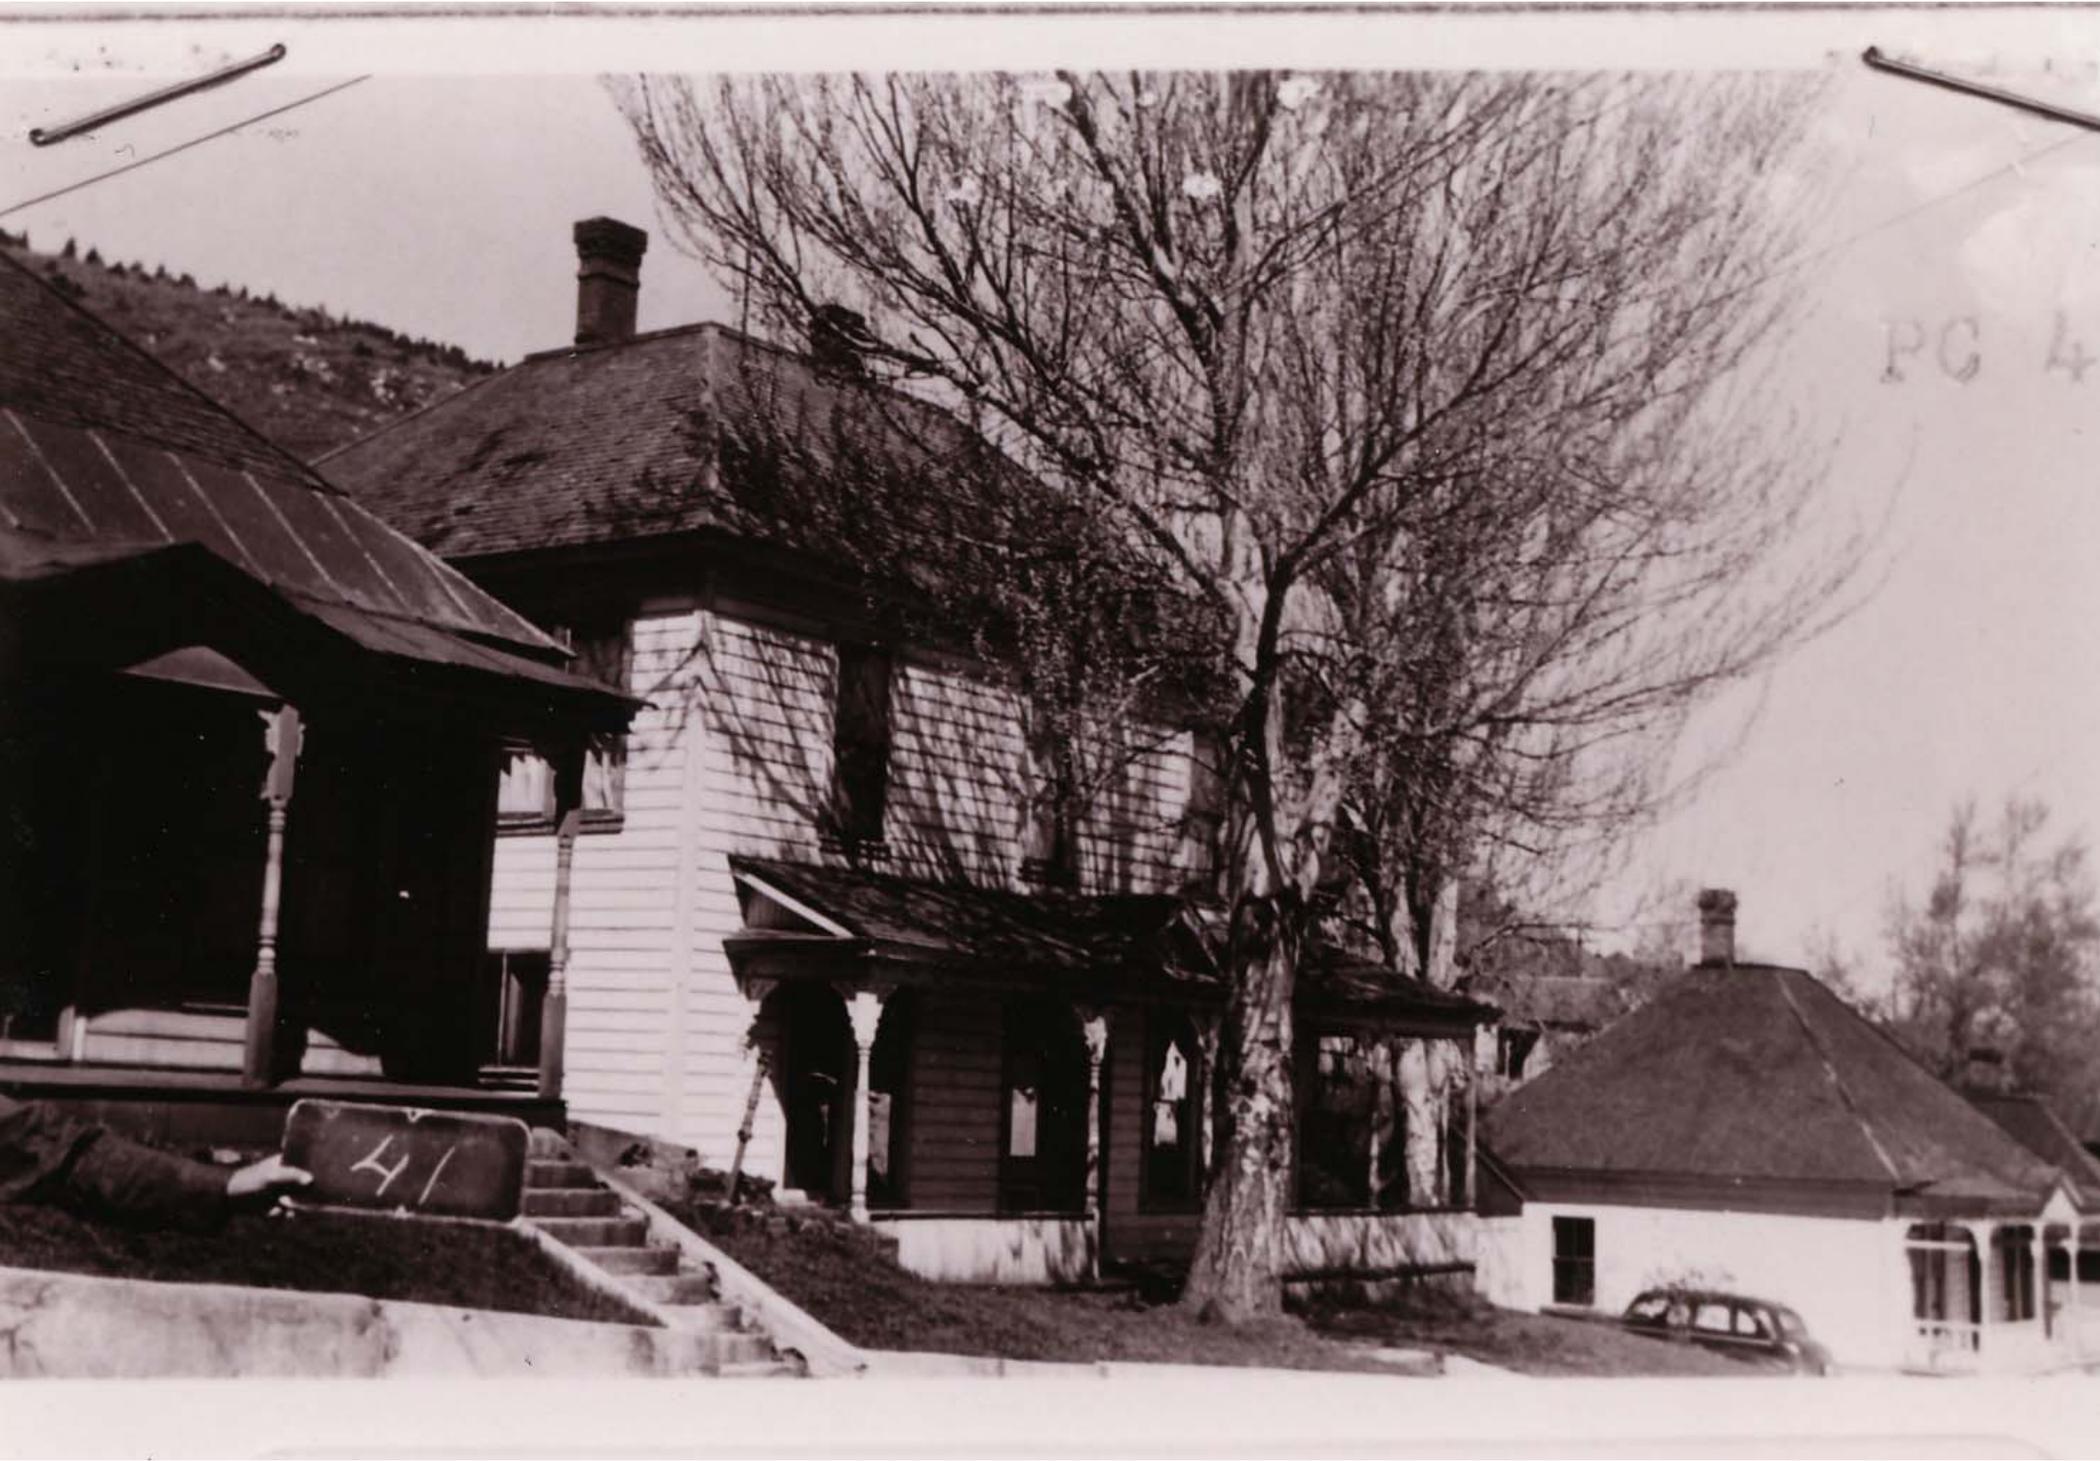
**Photo No. 1:** East elevation (primary façade). Camera facing west, 2006.

**Walls:** The exterior walls are clad in wooden drop/novelty siding.

**Roof:** The roof appears to be sheathed in metal shingles in the 2006 photograph. The two corbelled brick chimneys visible in the c.1940 tax photo had been removed by the time of the 1995 photograph.

**Windows/Doors:** The visible windows are one-over-one double-hung sash with simple casing and slightly protruding sills. The second floor façade has three windows, symmetrically placed. The first floor has two pairs of windows, set in two vertical openings flanking the entry door. The door is wooden paneled with a large single light.
