# HISTORIC SITE FORM - HISTORIC SITES INVENTORY

PARK CITY MUNICIPAL CORPORATION (10-08)

Address: 557 Park Ave

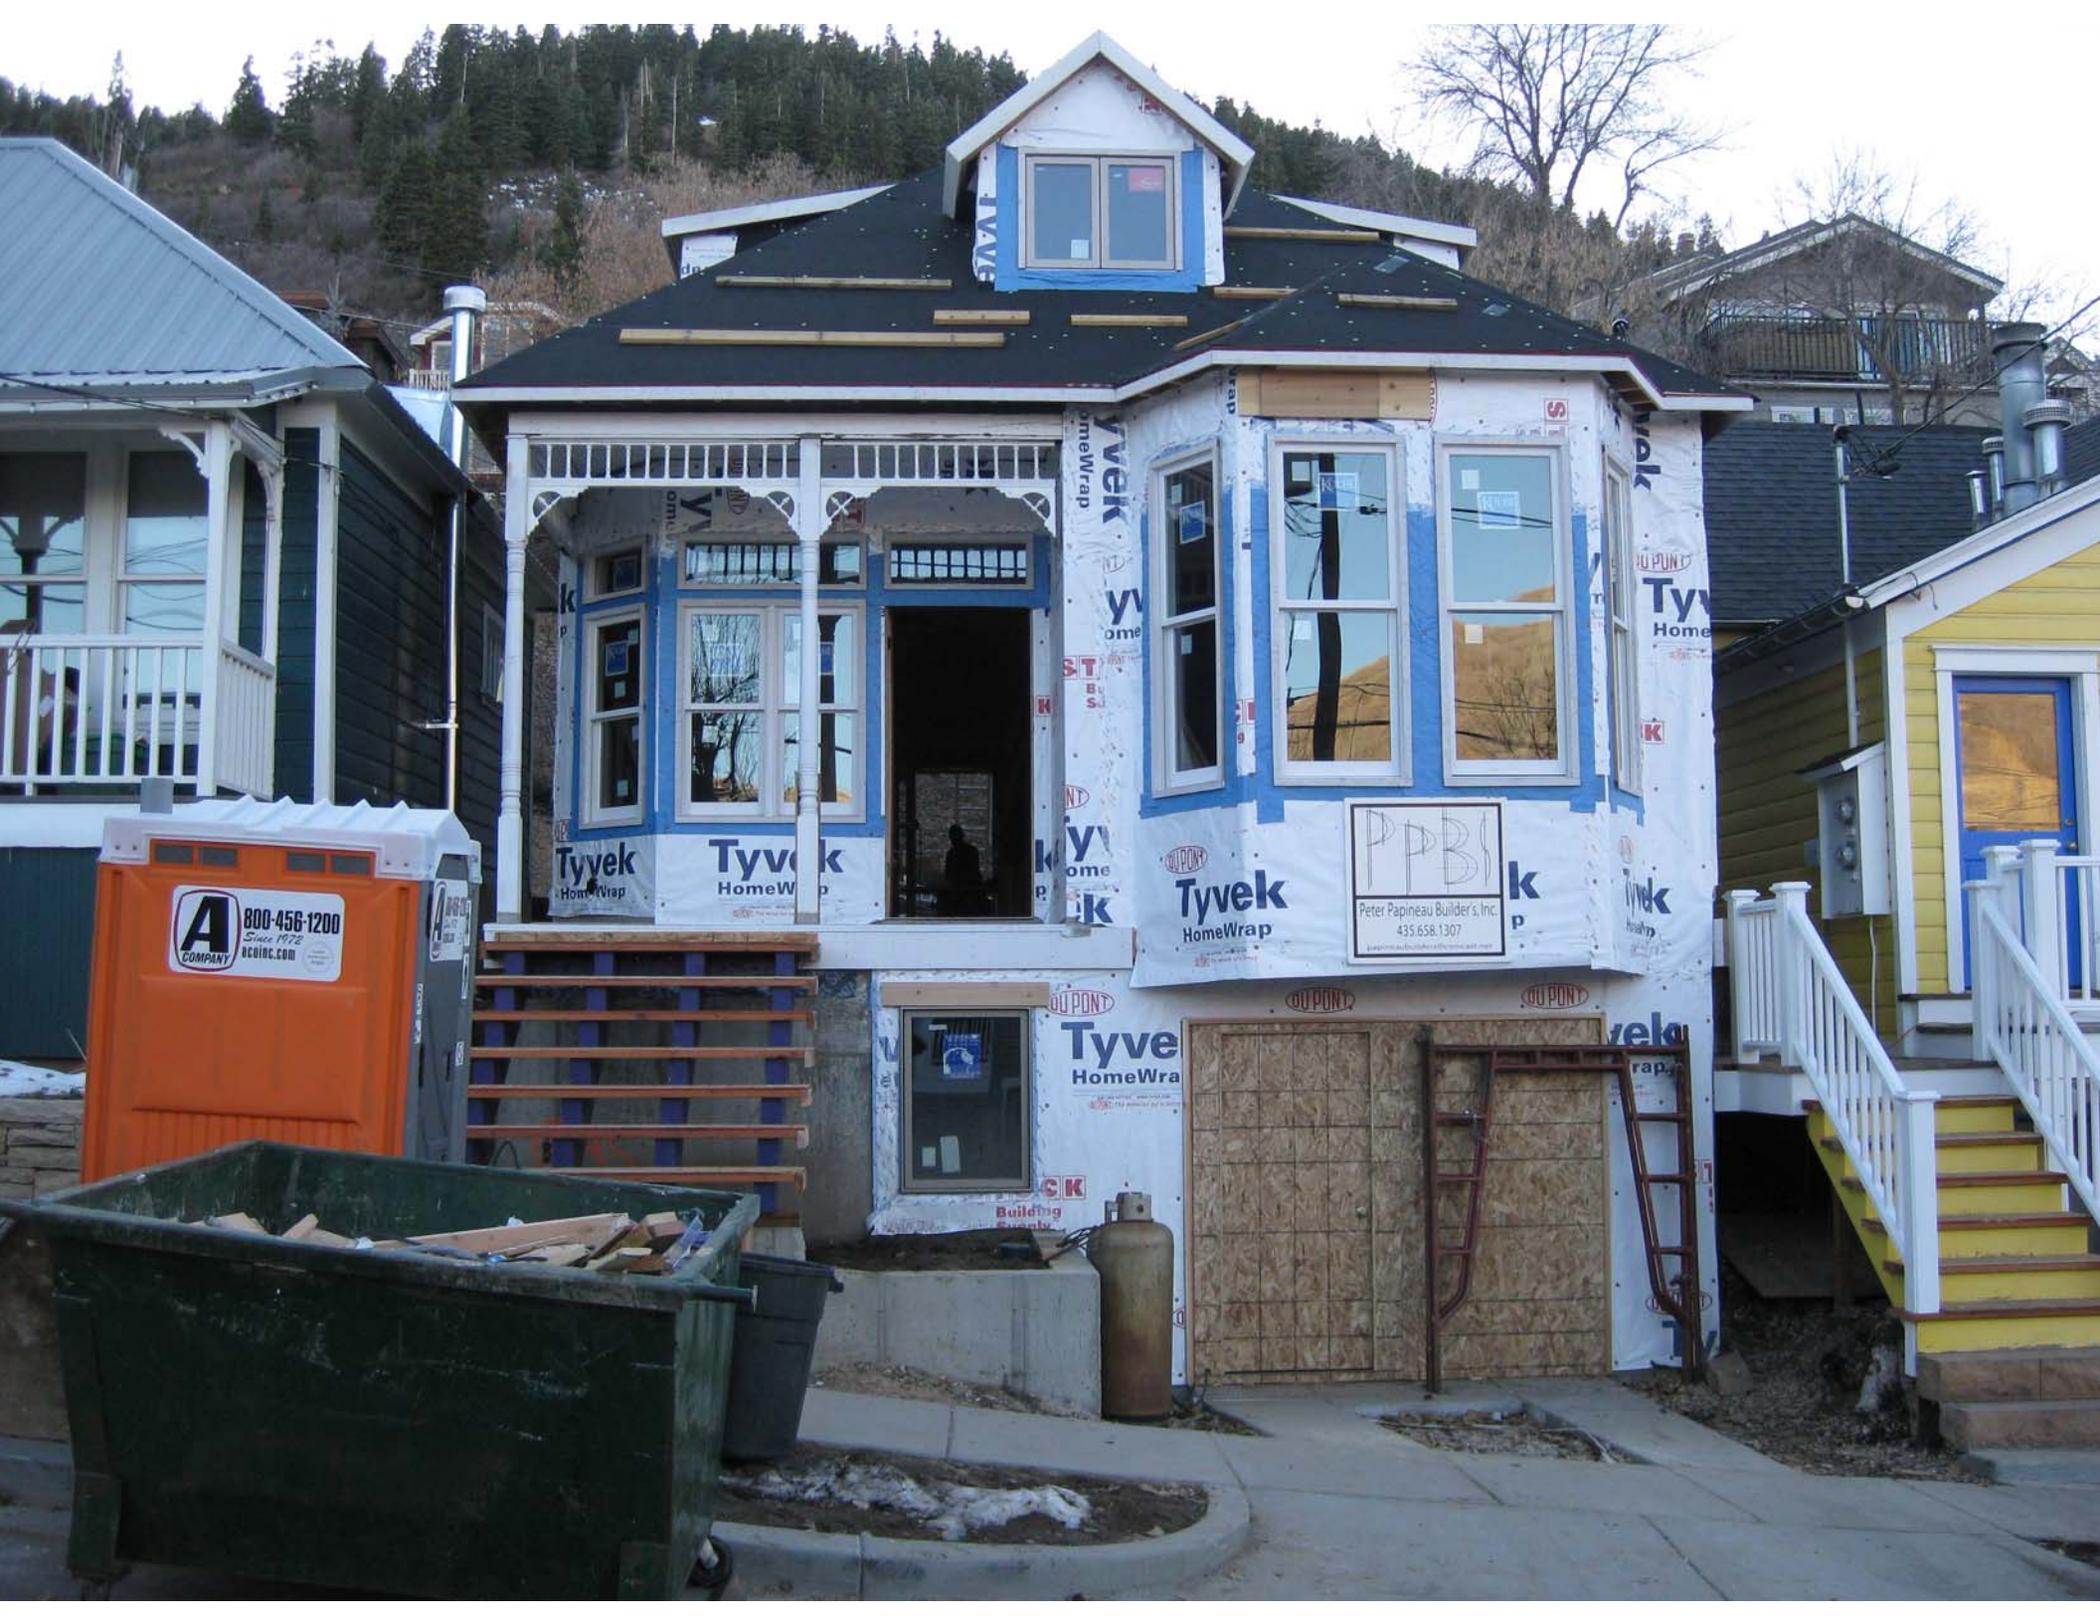
Walls: The exterior walls were clad in Tyvek, awaiting the final siding, as of the 2008 photographs.

Roof: The roof had not received its final materials as of the 2008 photographs.

Windows/Doors: The windows are one-over-one, double-hung sash with simple casing. The entry door had not been installed as of the 2008 photographs.
