HISTORIC SITE FORM - HISTORIC SITES INVENTORY

PARK CITY MUNICIPAL CORPORATION (10-08)

Address: 614 Park Ave

Utah State Historical Society
Historic Preservation Research Office
Structure/Site Information Form

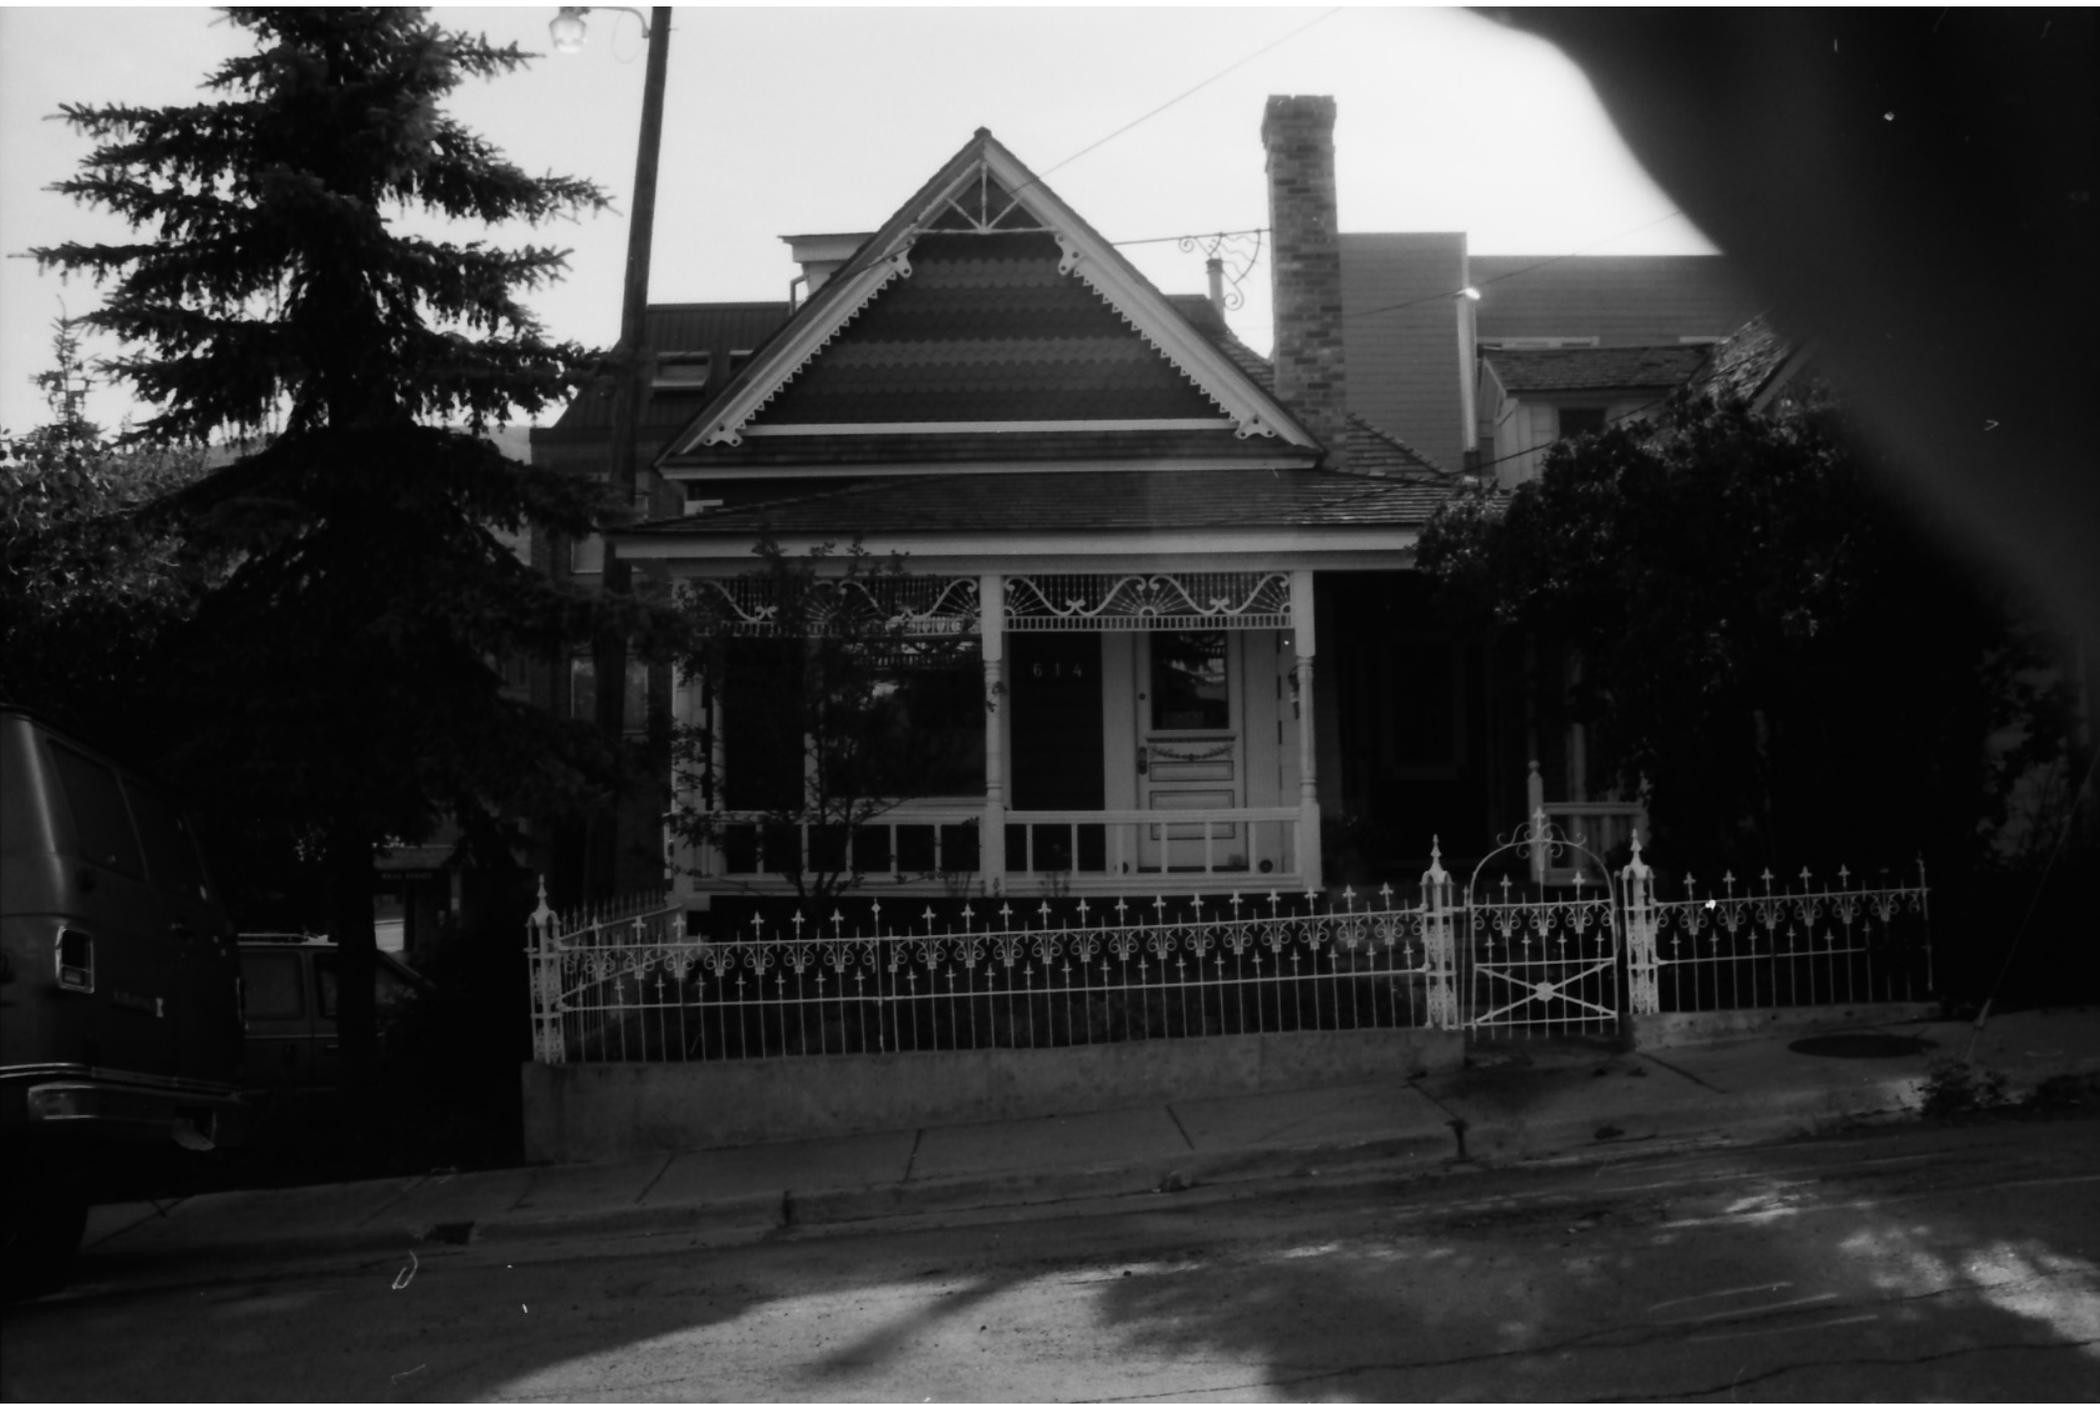
- Photo No. 1:** West elevation (primary façade). Camera facing east, 2006.
Photo No. 2: West elevation (primary façade). Camera facing east, 1995.
Photo No. 3: West elevation (primary façade). Camera facing east, tax photo.
