HISTORIC SITE FORM - HISTORIC SITES INVENTORY

PARK CITY MUNICIPAL CORPORATION (10-08)

Address: 1015 PARK AVE

Utah State Historical Society
Historic Preservation Research Office
Structure/Site Information Form

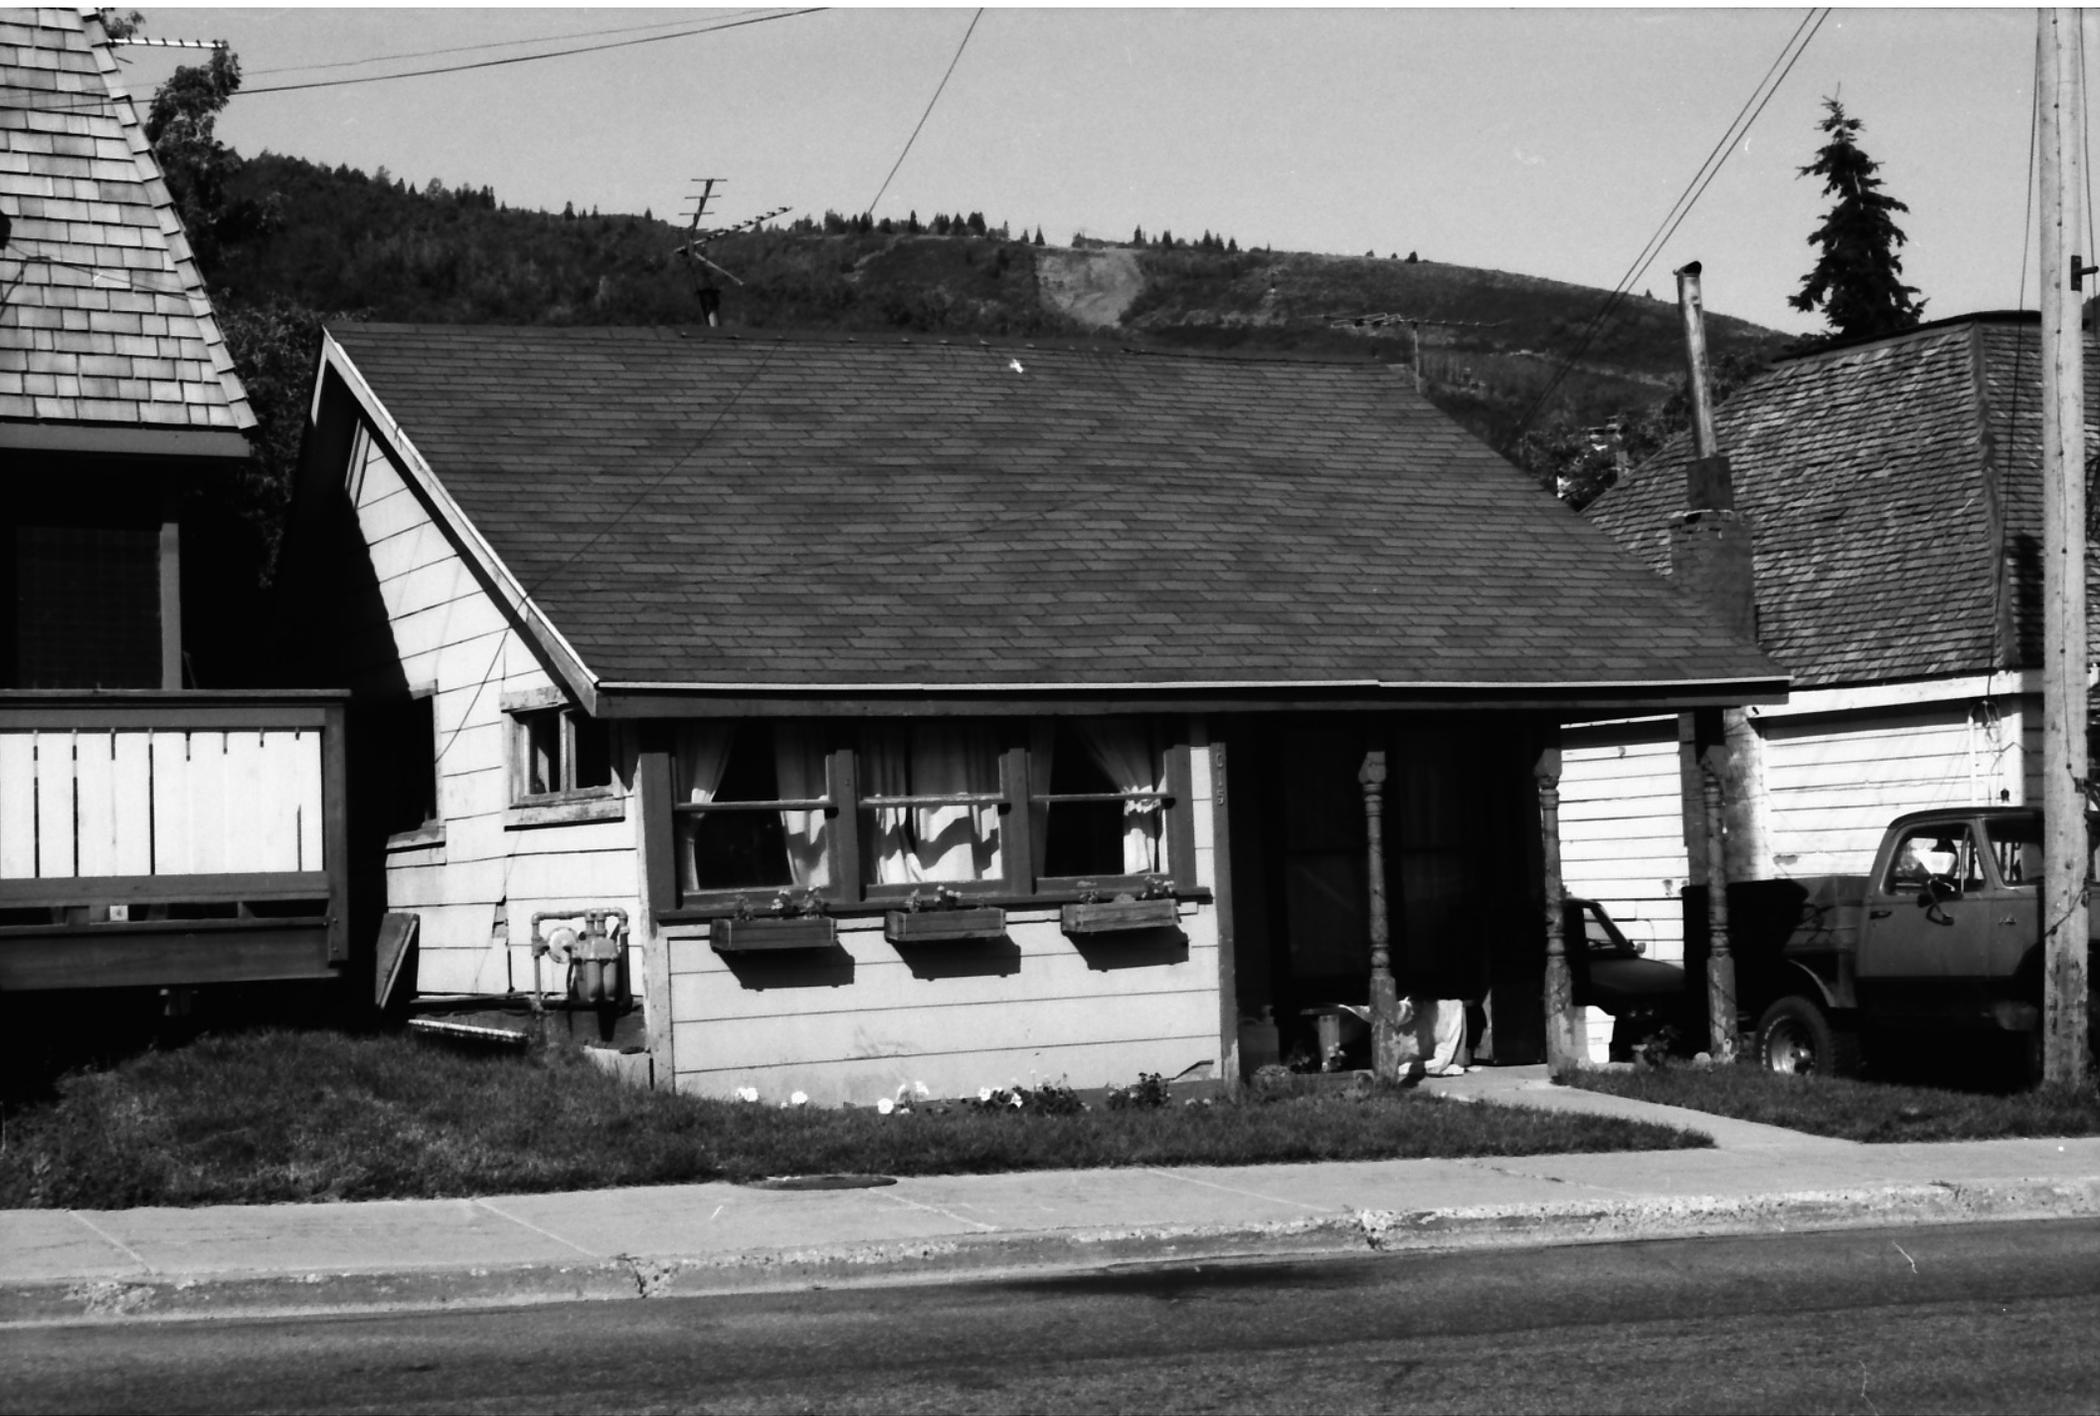
Photo No. 1: East elevation (primary façade). Camera facing west, 2006.

Design (The combination of physical elements that create the form, plan, space, structure, and style. Describe additions and/or alterations from the original design, including dates--known or estimated--when alterations were made): An interesting modification of a "hall-parlor" form. Only indication of this original form is found in the 1907 Sanborn map showing a typical "hall-parlor" porch front at this address. By the 1949 building card sketch, the structure's front elevation has built in the left portion of the original porch for interior space, and left the right portion as the porch entryway. The roof pitch has also been apparently adjusted to accommodate this infill. Some subsequent additions are indicated by the 1968 sketches on the building card towards the rear of the structure (unseen in available photos), and the structure has remained as such since this time. Asbestos siding is not original to the structure, and the cornice edge of the front elevation roof shingles show increasing wear in the 2006 photo. The changes are significant and diminish the site's historic character.

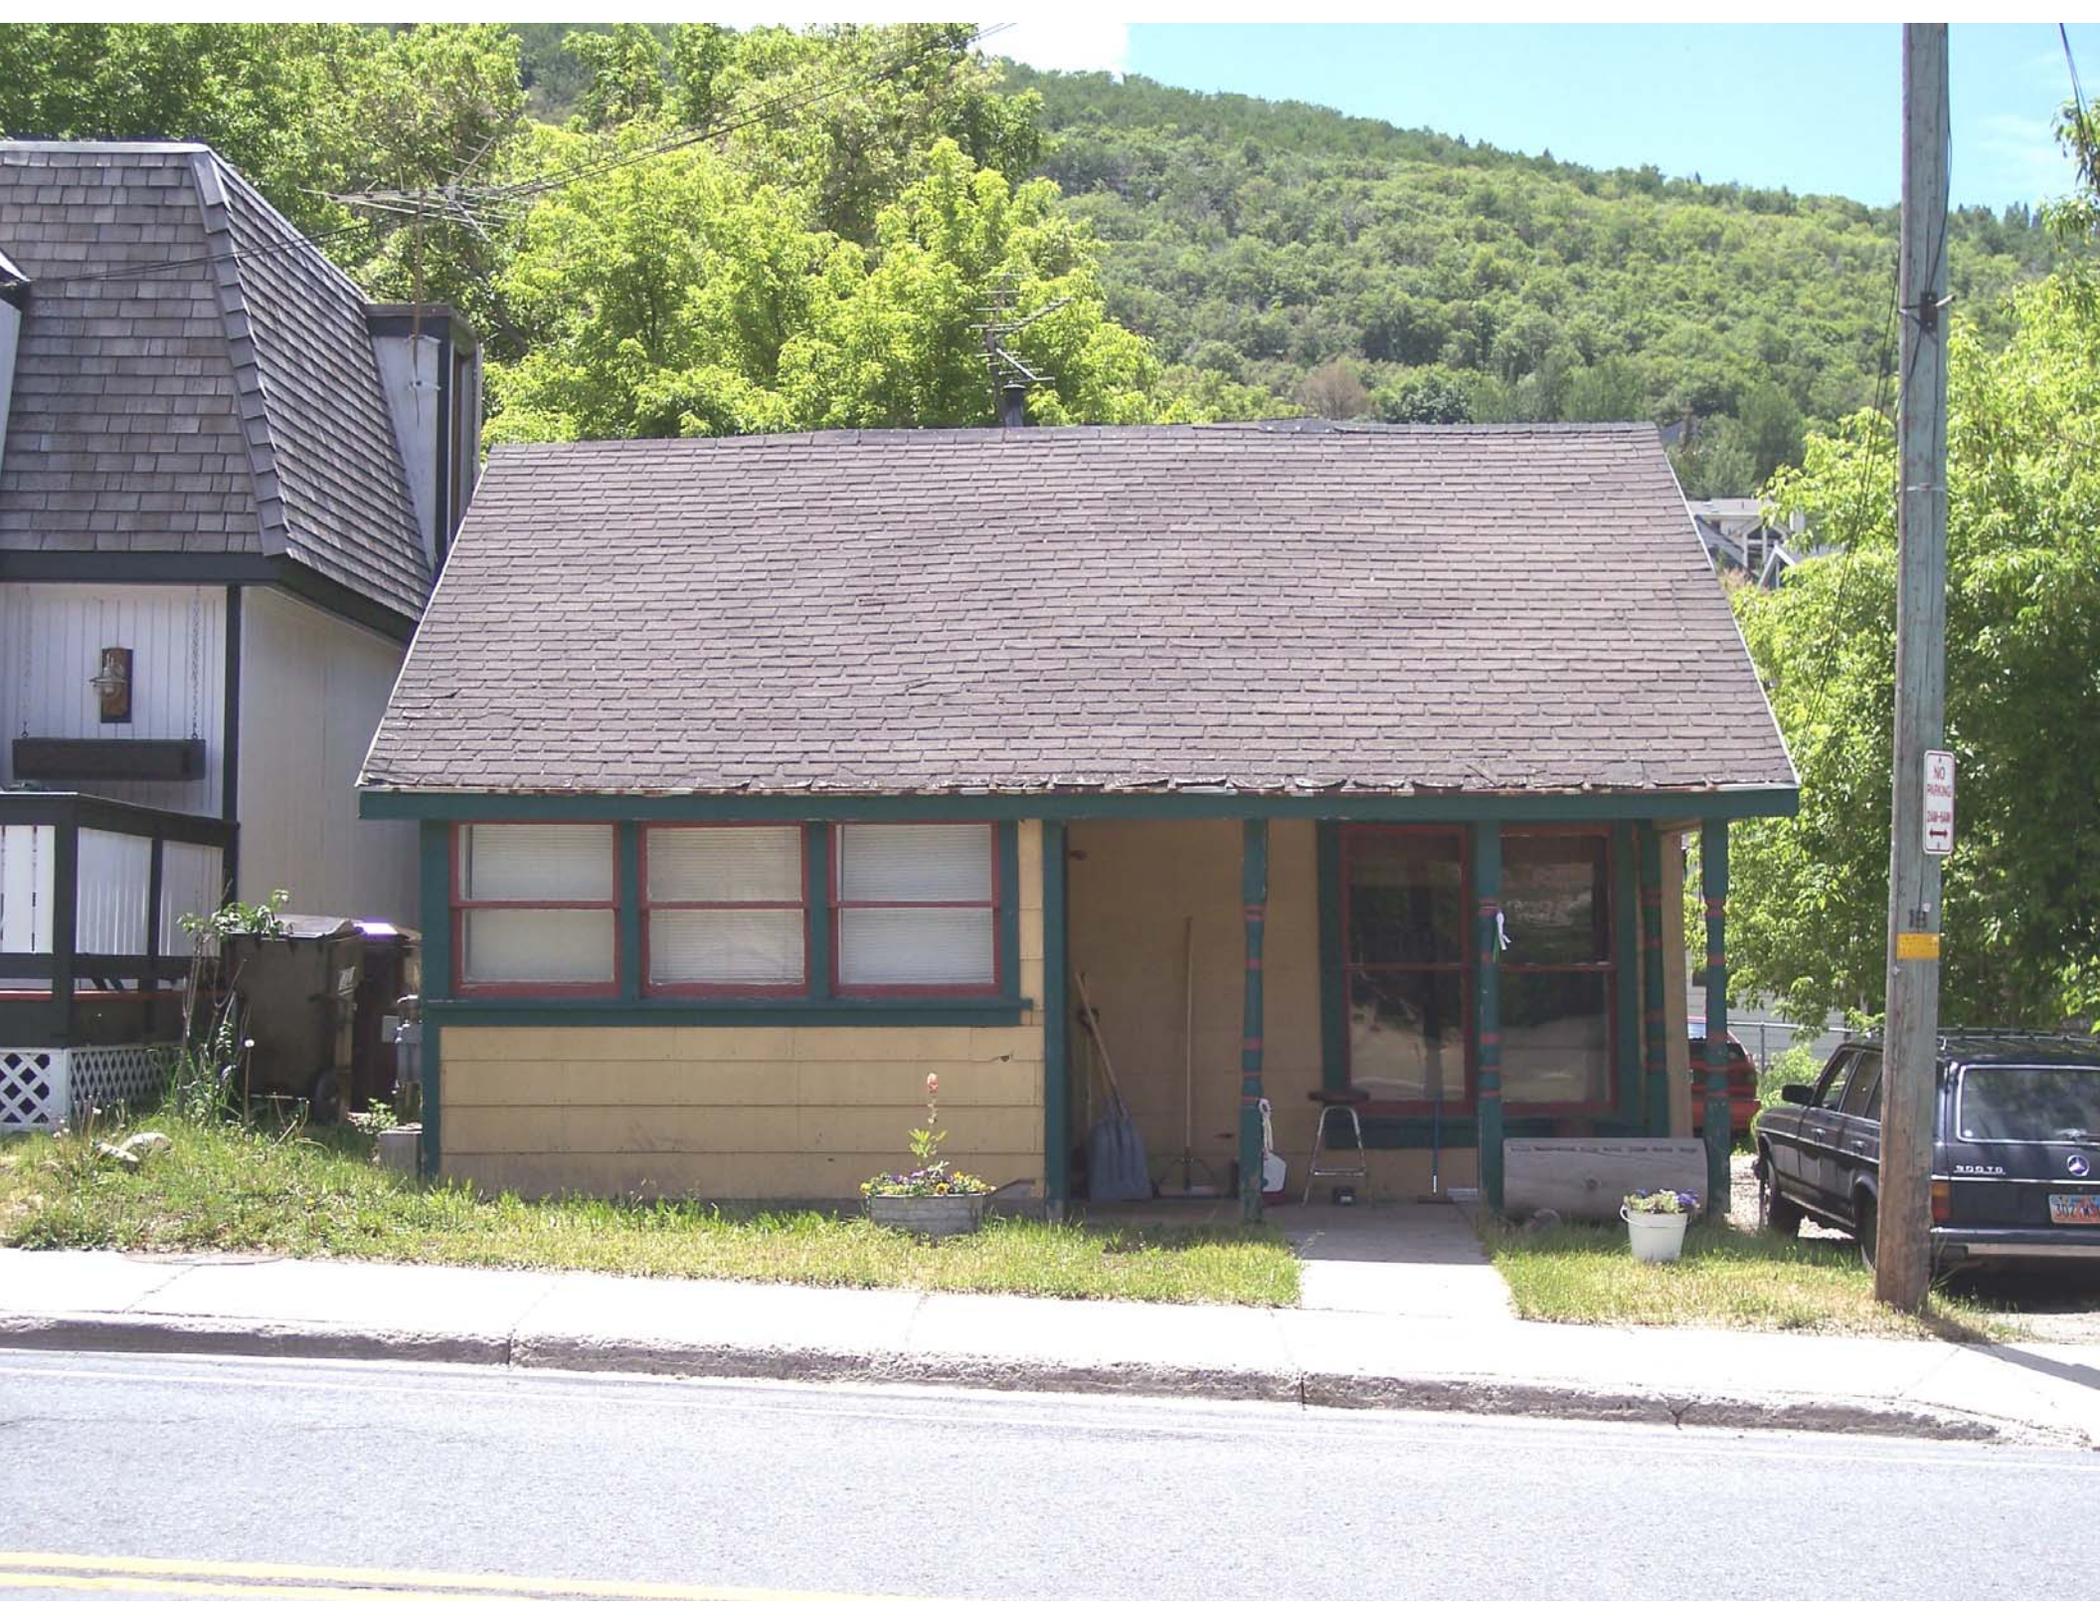
Photo No. 2: Southeast oblique. Camera facing northwest, 1995.

One-story frame structure, @1895 with a gable roof. The entry is on the side, as opposed to the gable end; and a projection to the rear may have been a later addition, @ 1900-1907. The porch has been altered, possibly in its original state having extended along the entire front of the building, instead of only half as at present. Siding (Wood) has been added.

Porch also added sometime between 1900 and 1907, see Sanborn Maps. False diagonal canes have been added to the upper sashes, which are not appropriate to the period. Front porch window, and porch, altered.
