# HISTORIC SITE FORM - HISTORIC SITES INVENTORY

PARK CITY MUNICIPAL CORPORATION (10-08)

Address: 1101 PARK AVE

Researcher/Organization: Preservation Solutions/Park City Municipal Corporation Date: 12-2008

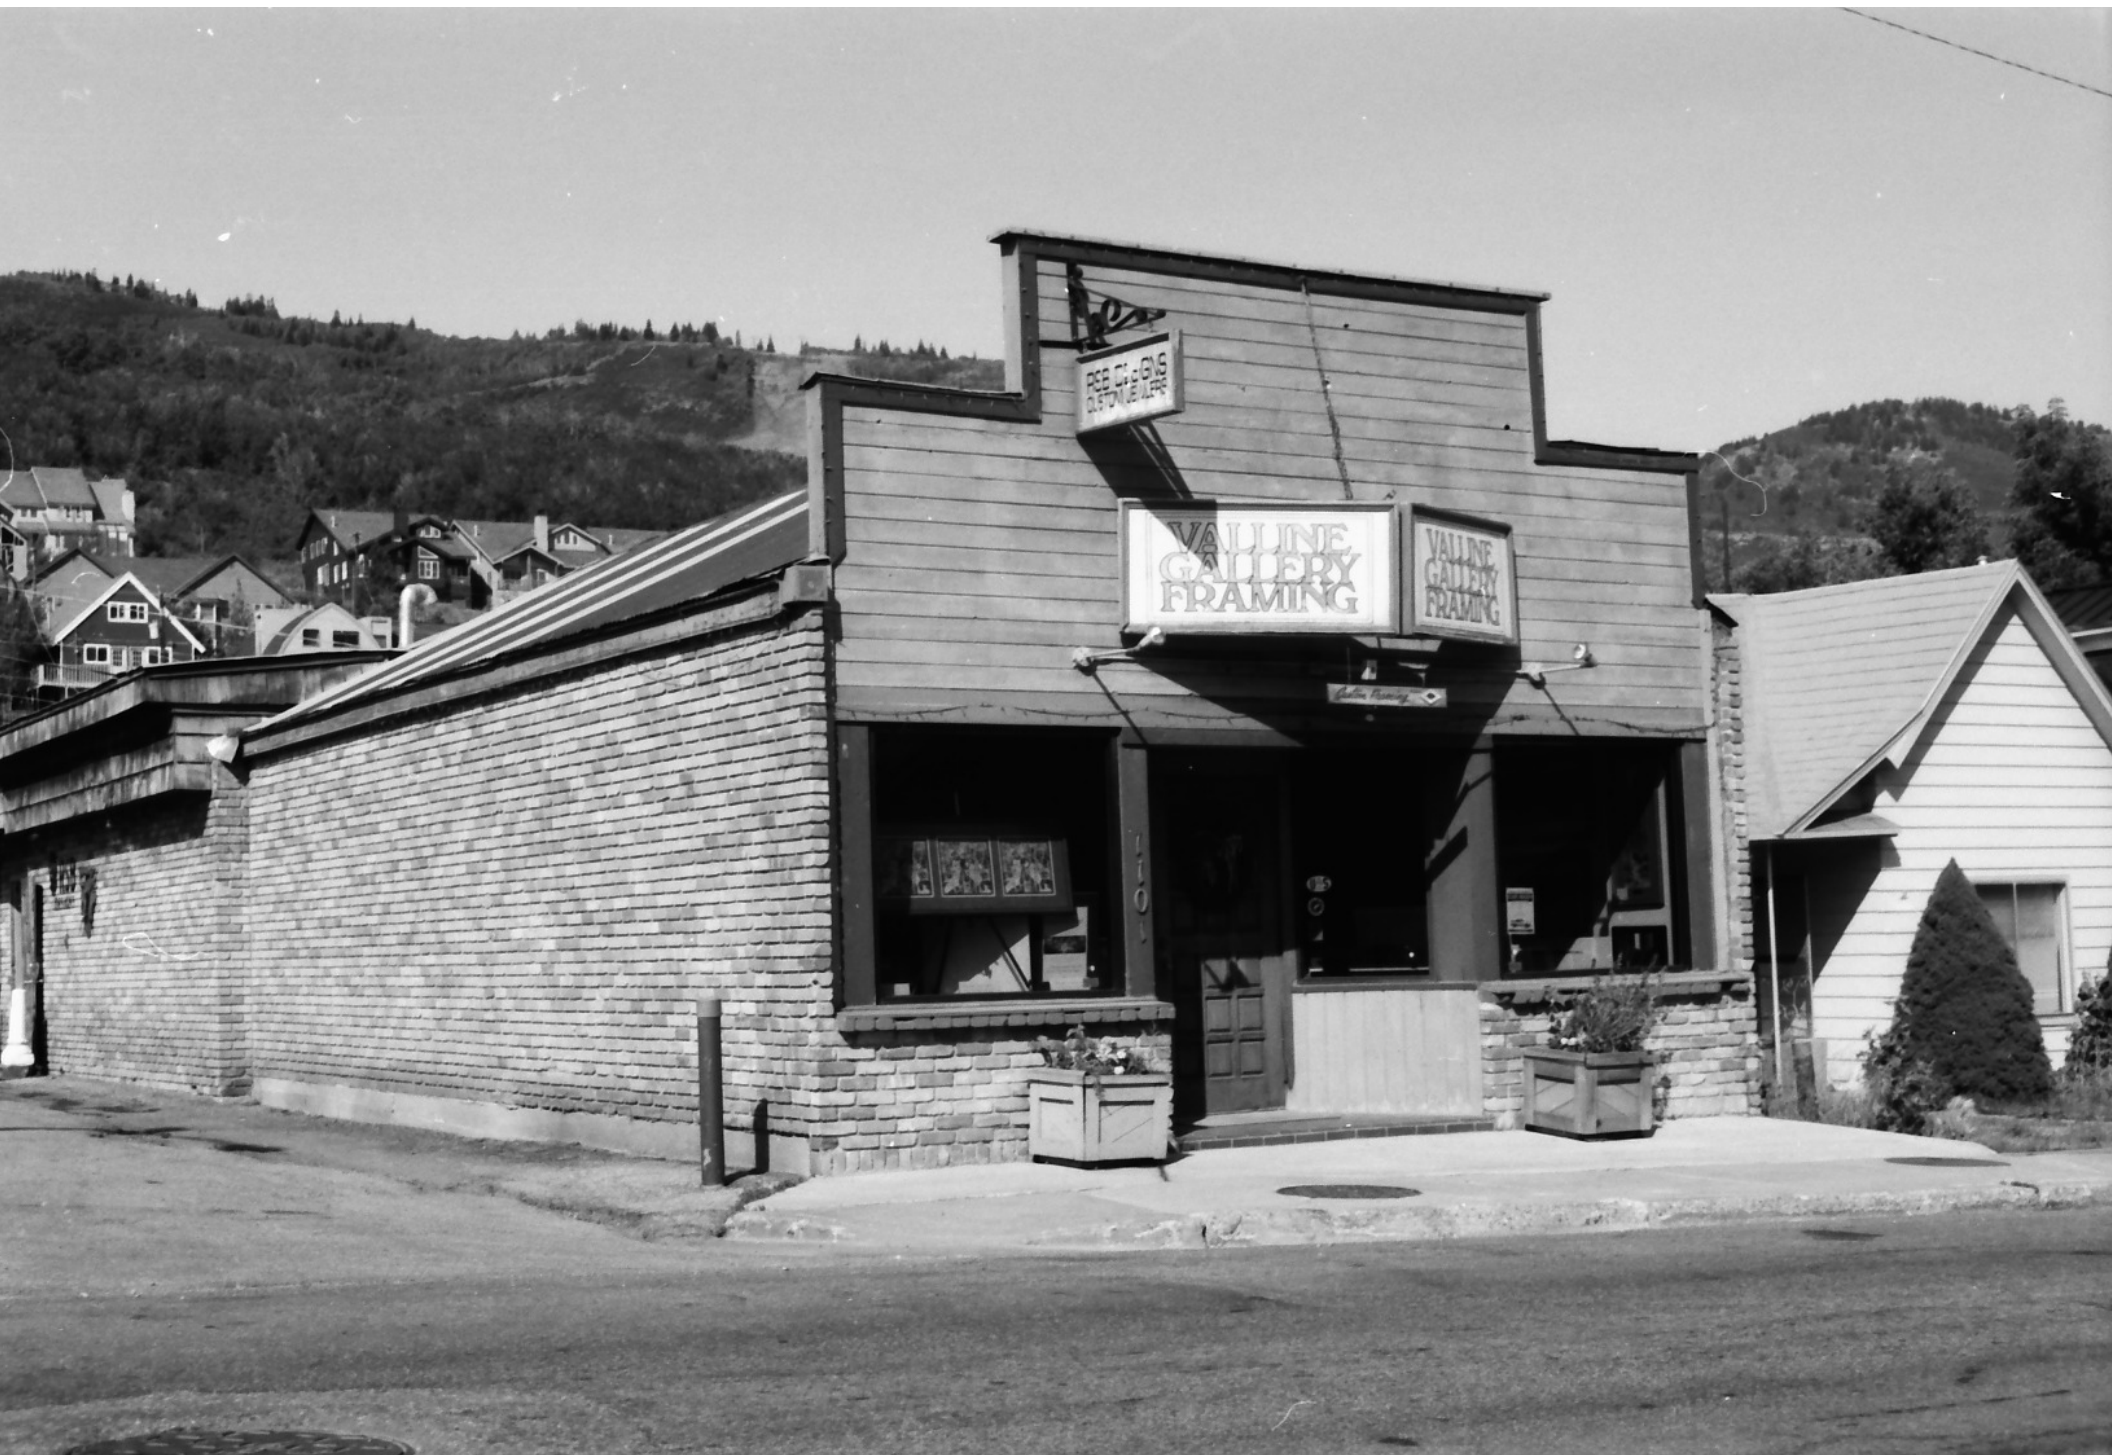
**Photo No. 1:** East elevation. Camera facing west, 2006.

**Design** (The combination of physical elements that create the form, plan, space, structure, and style. Describe additions and/or alterations from the original design, including dates--known or estimated--when alterations were made): The one-story frame on-part block has been significantly altered over the years. The structure does not appear on the 1907 Sanborn Insurance map and the 1929 map was not consulted for this report. The tax card suggests the structure was built c. 1929. The tax photo shows a one-story false front commercial block clad in narrow siding (typically used in the 1920s). The building had large storefront display windows that flanked a center recessed entry door. The tax cards indicate the rear of the building was extended 10 feet in 1946. By 1968, according to the tax card, the building nearly doubled in size with a large rear addition. The exterior materials appear to have been altered between 1957 and 1968. The 1957 tax card indicates the original square footage and exterior wall materials are listed as siding. By 1968 when the building was expanded, the exterior materials noted on the tax card are pressed brick and concrete block. The changes were made outside the period of historic significance and diminish the site's original design integrity.
