## Historic Preservation Board Staff Report

**Author:** Hannah Turpen, Planner  
**Subject:** Material Deconstruction Review  
**Address:** 3000 N. Highway 224 (McPolin Barn)  
**Project Number:** PL-16-03117  
**Date:** April 6, 2016  
**Type of Item:** Administrative – Material Deconstruction

**MCPOLIN BARN  
STRUCTURAL UPGRADE**

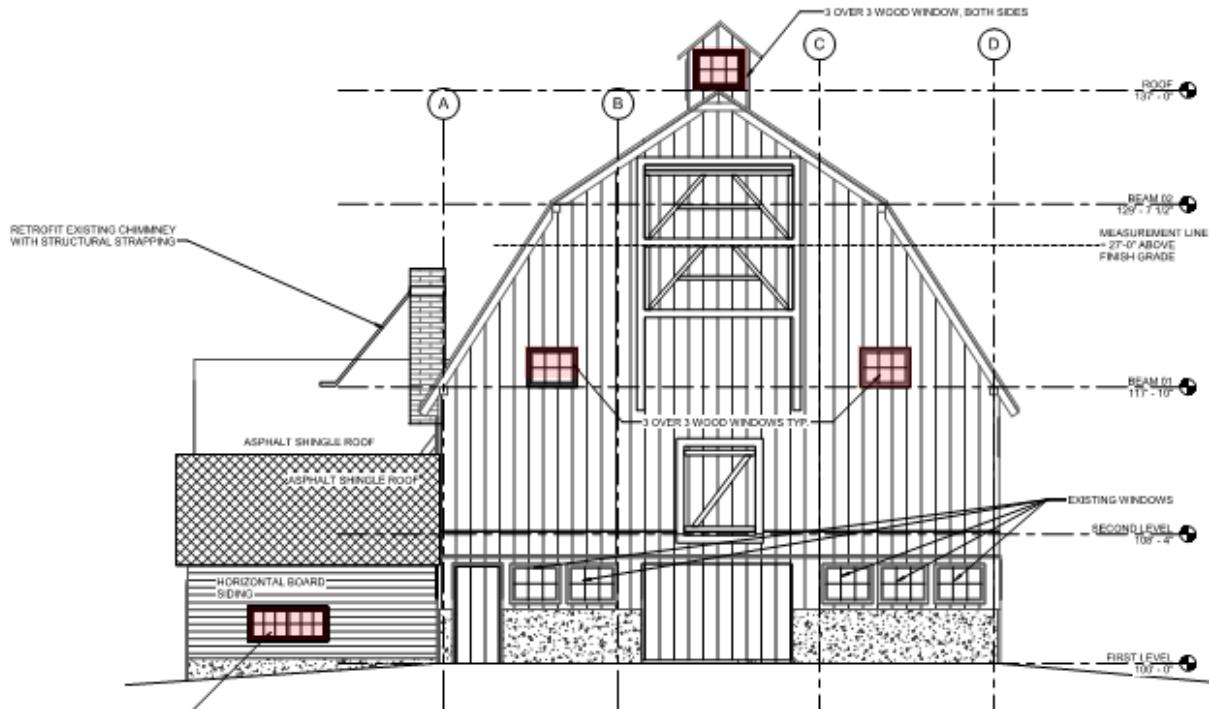
**Figure 6a:** The non-historic plywood boards (painted black) that are to be removed from the historic window openings of the McPolin Barn and its additions (shaded red). South Elevation.

Staff finds that the removal of the non-historic plywood boards covering the historic window openings of the McPolin Barn and its additions is appropriate. The removal of the non-historic plywood boards will result in replacement with historically accurate windows.

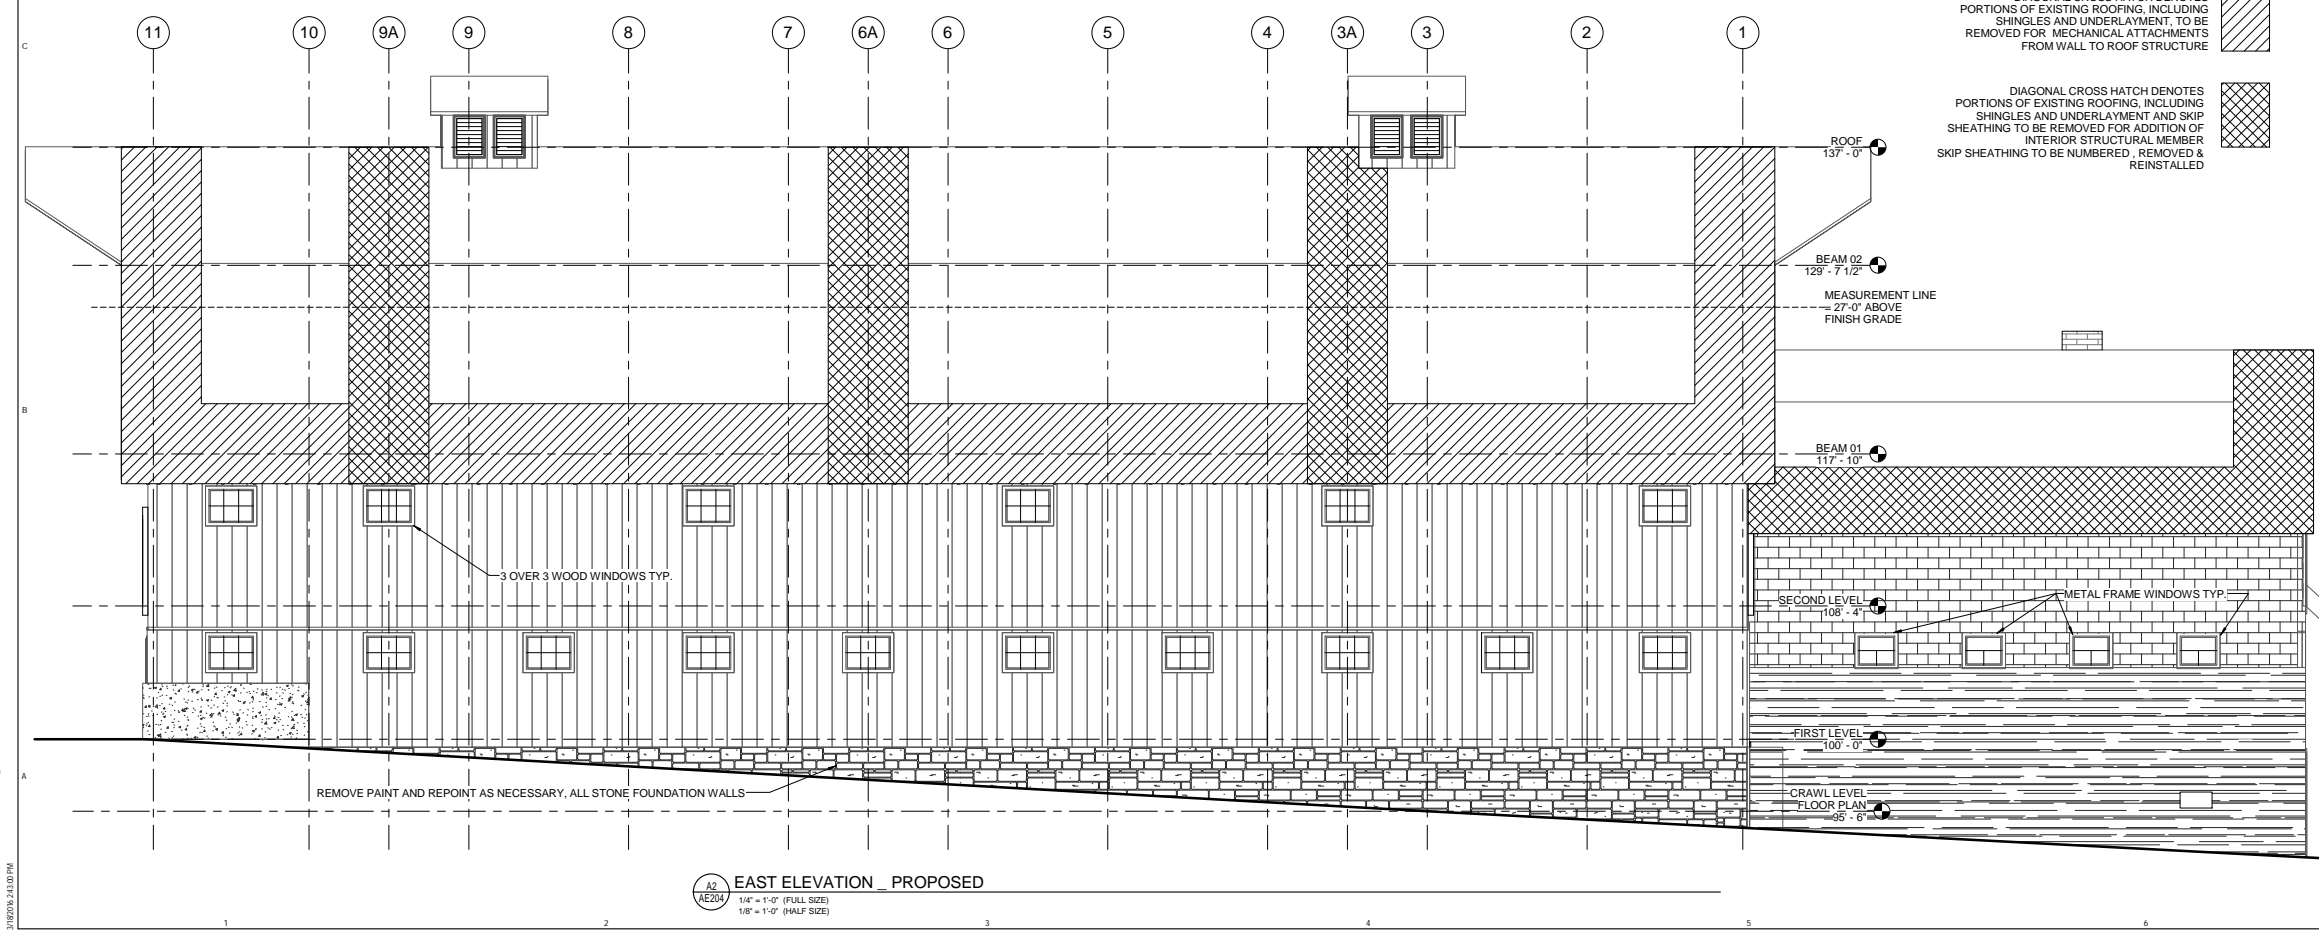
**EAST ELEVATION \_ PROPOSED**  
 1/8" = 1'-0" (FULL SIZE)  
 1/8" = 1'-0" (HALF SIZE)

DIAGONAL CROSS HATCH DENOTES PORTIONS OF EXISTING ROOFING, INCLUDING SHINGLES AND UNDERLAYMENT AND SKIP SHEATHING TO BE REMOVED FOR ADDITION OF INTERIOR STRUCTURAL MEMBER. SKIP SHEATHING TO BE NUMBERED, REMOVED & REINSTALLED

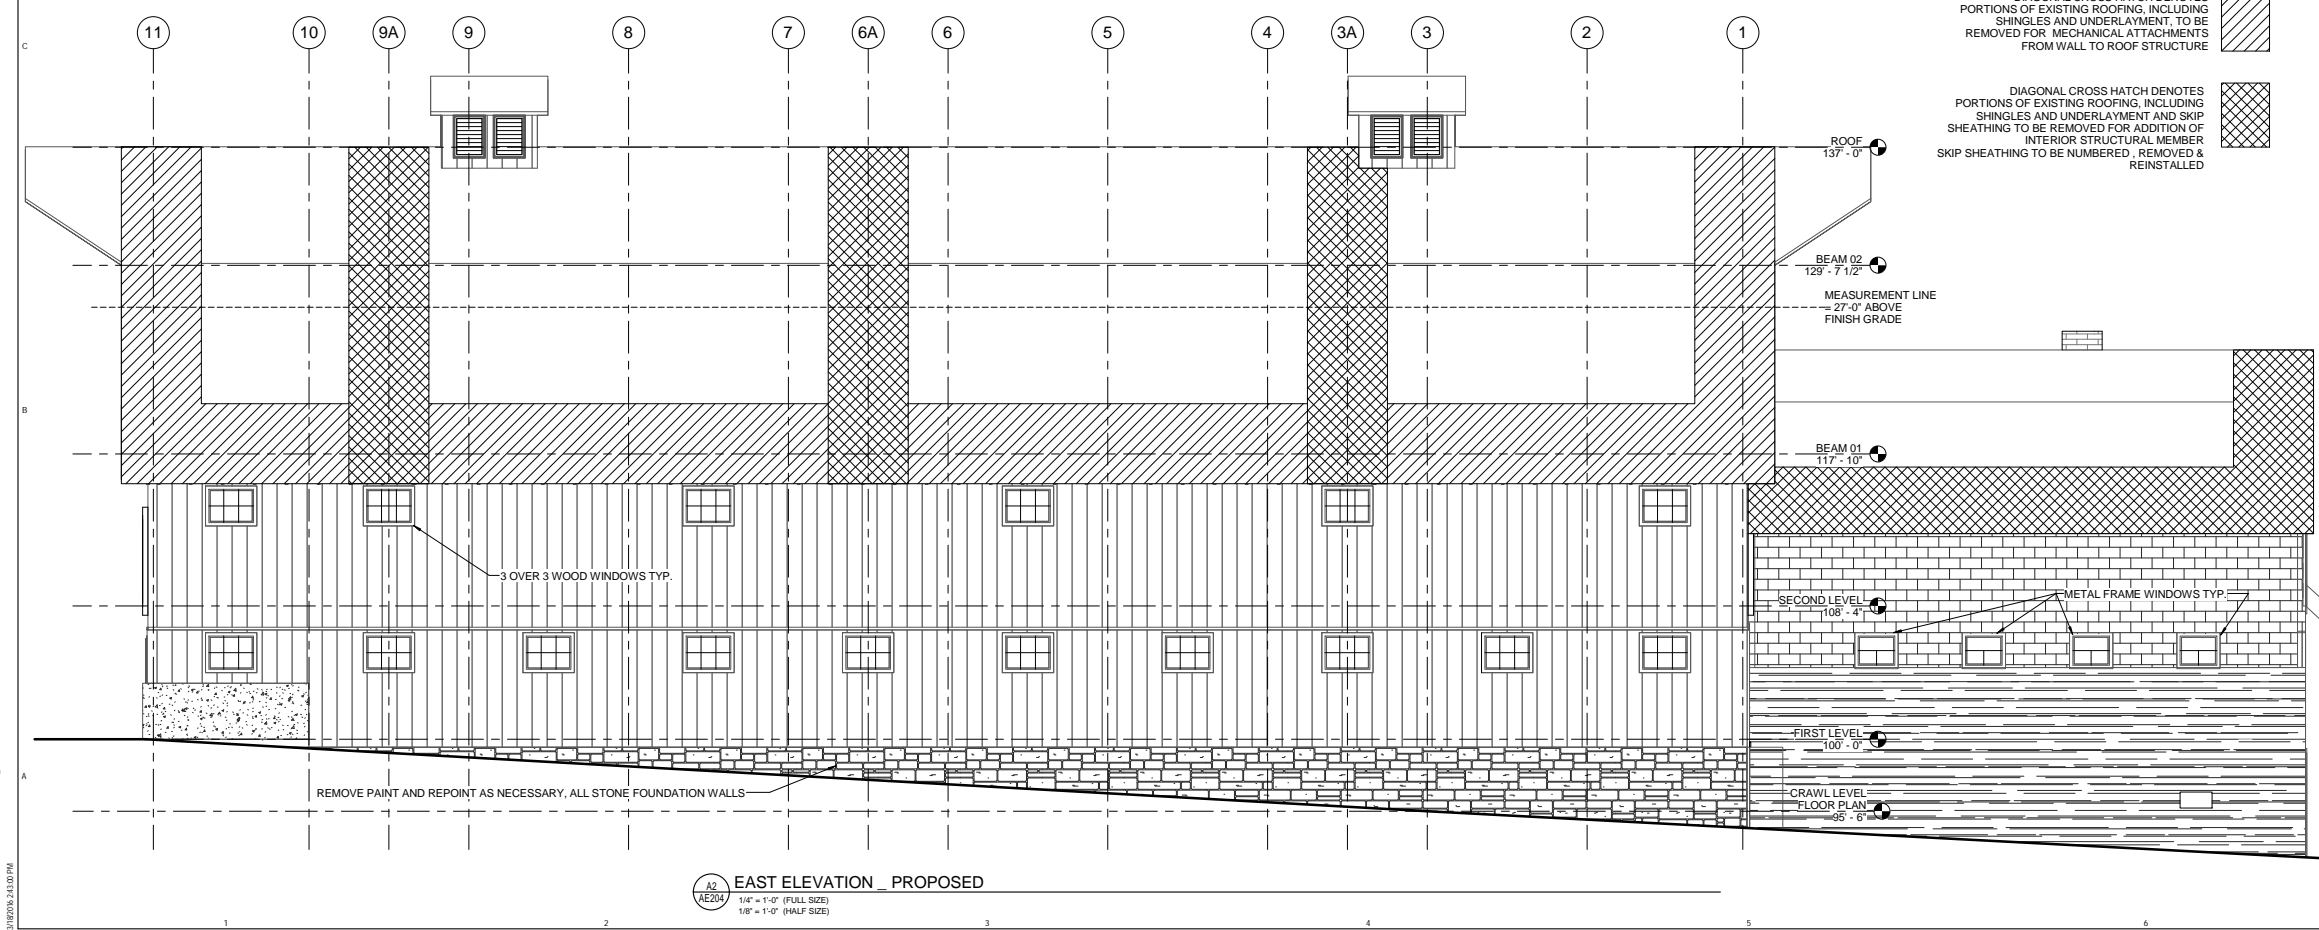
**EAST ELEVATION \_ PROPOSED**  
 1/8" = 1'-0" (FULL SIZE)  
 1/8" = 1'-0" (HALF SIZE)

DIAGONAL CROSS HATCH DENOTES PORTIONS OF EXISTING ROOFING, INCLUDING SHINGLES AND UNDERLAYMENT AND SKIP SHEATHING TO BE REMOVED FOR ADDITION OF INTERIOR STRUCTURAL MEMBER. SKIP SHEATHING TO BE NUMBERED, REMOVED & REINSTALLED

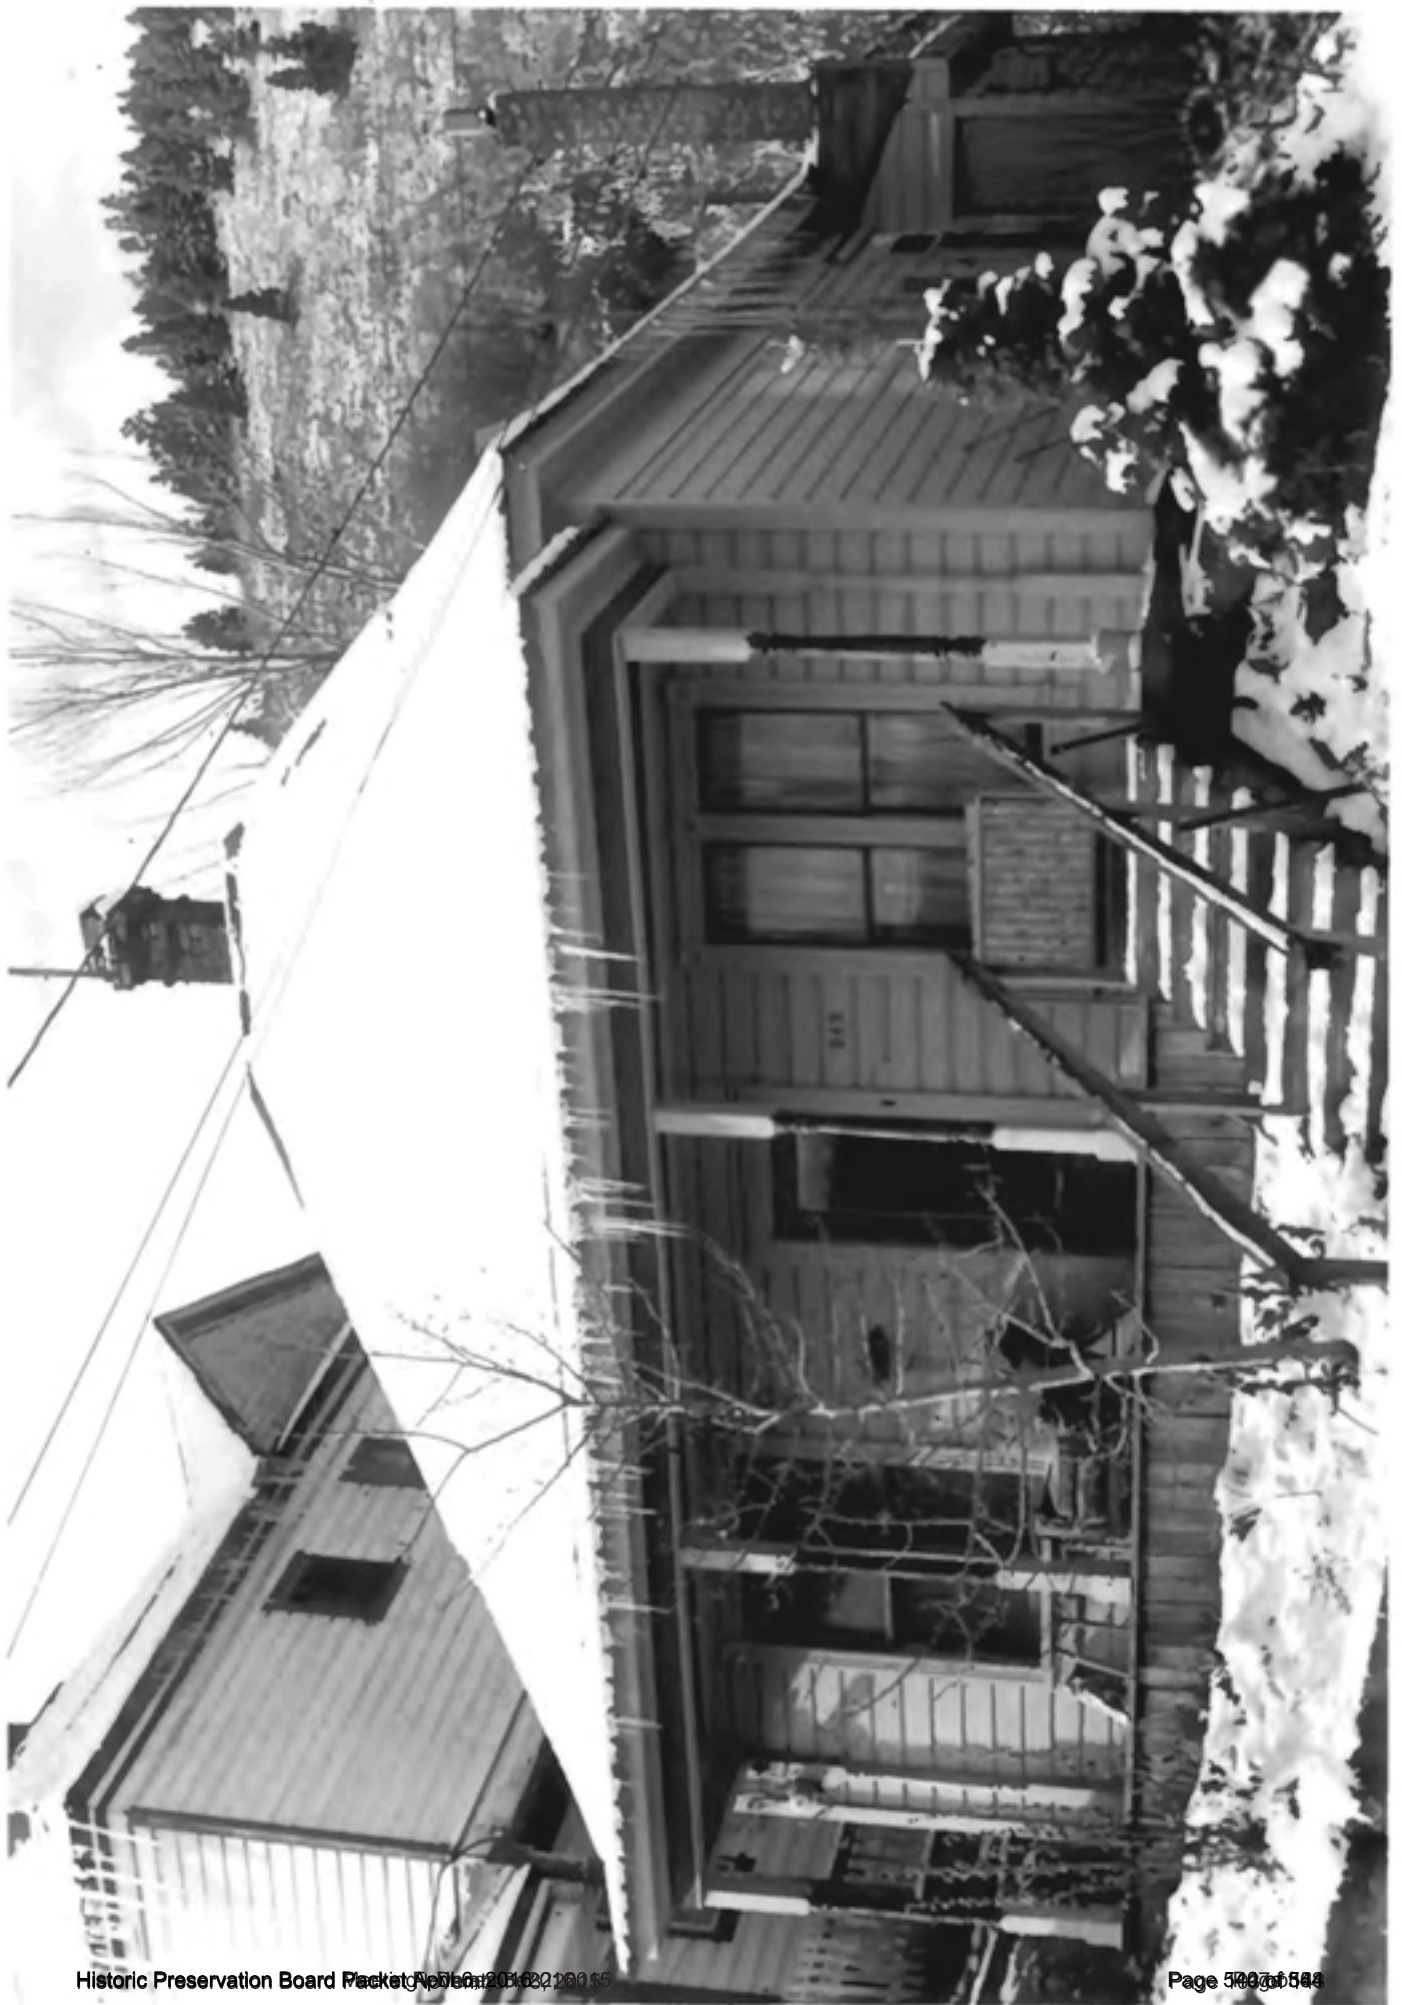
House at 343 Park  
Park City, Summit County, Utah

View from Northeast corner

Photo by Roger Roper, October 1983  
Negative: Utah State Historical Society

This house was built by at least 1900, as indicated by the Sanborn Insurance Maps, having probably been built c.1898 as investment property by Walter and Ann W. Wilcocks, who lived down the block at 363 Park. William Scoble, Ann Wilcocks' brother, sold them the property in 1888, at which time there was a different house located there. That house was probably destroyed in the fire of 1898, which burned many of the houses in town, including some along this the west side of Park Avenue.<sup>1</sup> Ann Wilcocks, widowed in 1900, probably rented out this house until selling it in 1905 to her 21 year old nephew, William J. Scoble (a son of William Scoble). The 1900 census records indicate that at that time this house was probably occupied by William Boyd, a druggist, and his family. William J. Scoble, who had previously lived with the Wilcocks in their neighboring house, owned this house until 1924, although it is unclear whether or not he ever lived here. Other owners of the house include Willard R. Jones (1924-26), Henry and Corina Tuggle (1926-49), and Robert W. Thielke (1949-c.1980).
