**PARK CITY MUNICIPAL CORPORATION  
HISTORIC PRESERVATION BOARD  
CITY COUNCIL CHAMBERS  
July 20, 2016**

1057 Woodside Avenue – Historic District Design Review - Material Deconstruction (House) of the Historic north addition and partial chimney of the Landmark Single-Family Dwelling to restore the ca. 1918 Period of Historic Significance and Historic Form.

1057 Woodside Avenue – Historic District Design Review - Disassembly and Reassembly (Panelization) of the Historic Single-Car Garage on the Landmark Site. Relocation of the Historic Single-Car Garage on the Landmark Site.

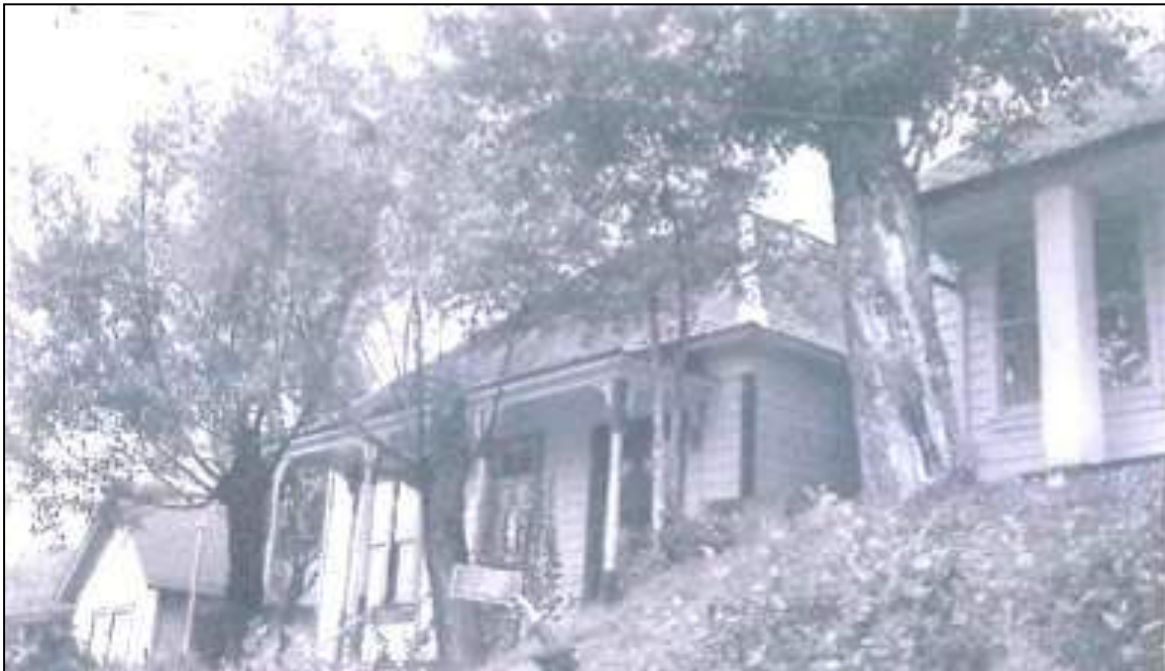
The ca. 1940 tax photograph shows that the house had features typical of pyramid-type houses in Park City (see Figure 2). These features include a truncated hip roof (clipped pyramid roof) with cedar shakes, a generally symmetrical façade including two (2) pairs of double hung windows on either side of the slightly off-centered front door with a transom window above, and a partial-width front porch with a centered low pitch hip roof. In addition, the ca. 1940 tax photograph shows the two (2) trees located in the front yard on either side of the front door, which are still present today (see Figure 5a for a current photograph of the trees).

**Figure 2:** Circa 1940 tax photograph of 416 Ontario Avenue. Facing northeast.

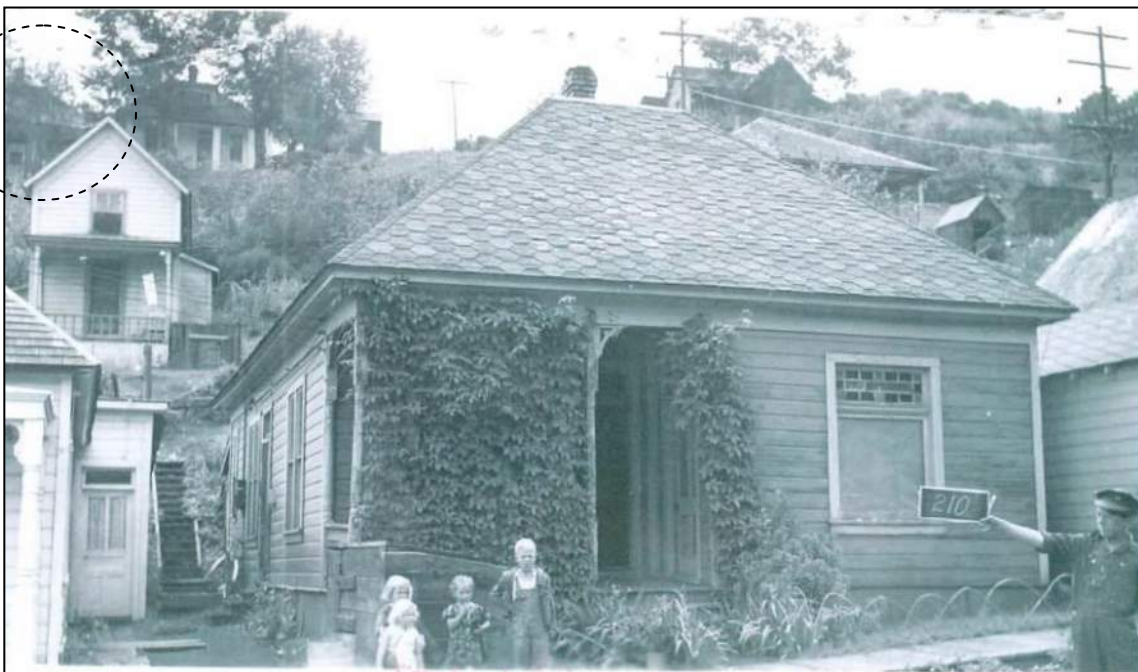
**Figure 3:** Circa 1940 tax photograph of 412 Marsac Avenue. Facing northeast.

Based on information found in the 1949 and 1958 tax appraisal cards (Exhibit A), the house was documented with a total of 624 square feet. Based on known measurements of the house, it can be estimated that the square footage of the core of the house in 1907, 1929, and 1941 was still 624 square feet. The small northeast addition (present in all Sanborn Maps) was approximately 60 square feet at the time and was likely not included in the tax assessment square footage calculations because it was possibly a simple storage-shed addition.

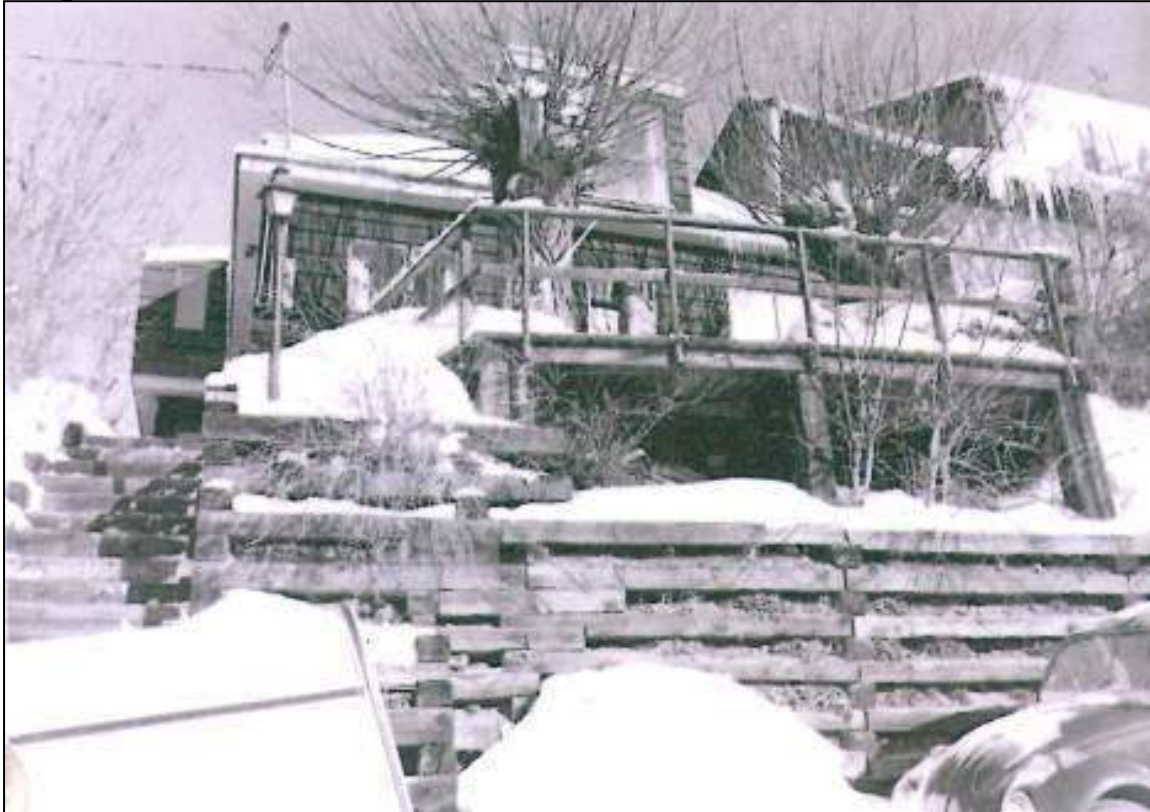
**Figure 4:** 1983 Reconnaissance Level Survey Site Photograph. February 1982, facing east.

Though it is clear that out-of-period alterations have occurred, no formal permit documentation of such can be found. The only Building Permits on file include a reroof in 1995 and the installation of a floor heater in 2011. Figure 5a and 5b show the current conditions of the house. Note the expansion of the west dormer addition, the new north dormer, upgrades to the northeast addition, and the new metal roof. The pair of double hung windows, front door, and transom window configuration still remains.

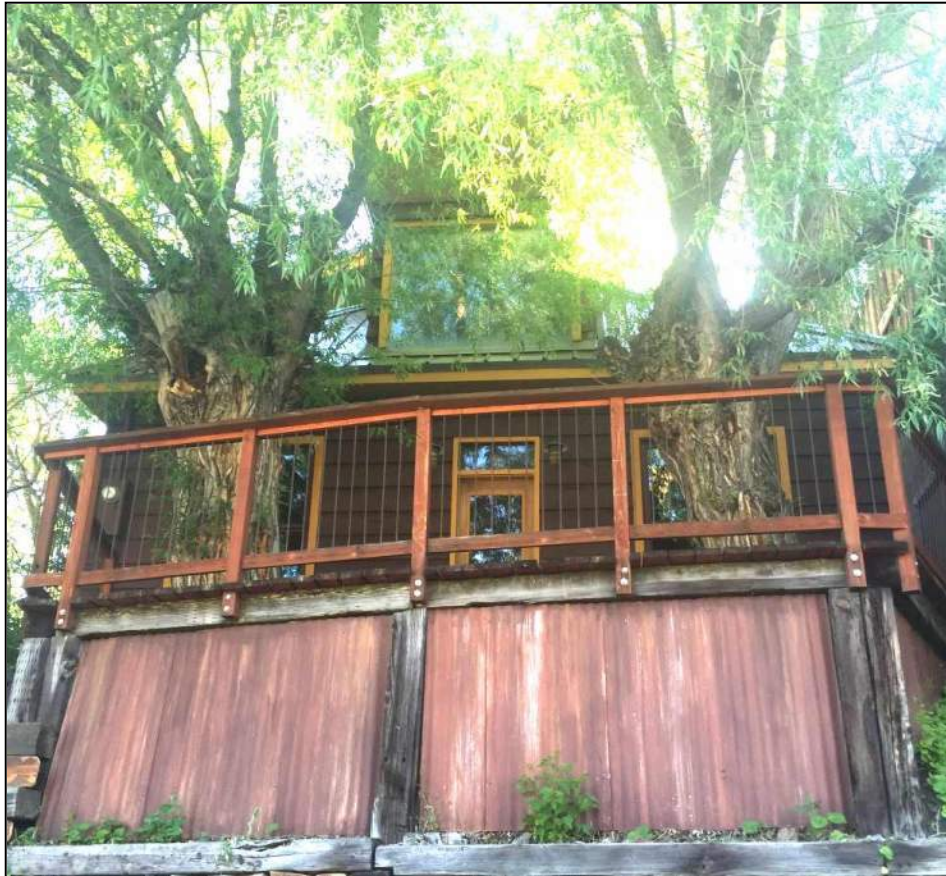
**Figure 5a:** 416 Ontario Avenue, 2016. Camera facing east.

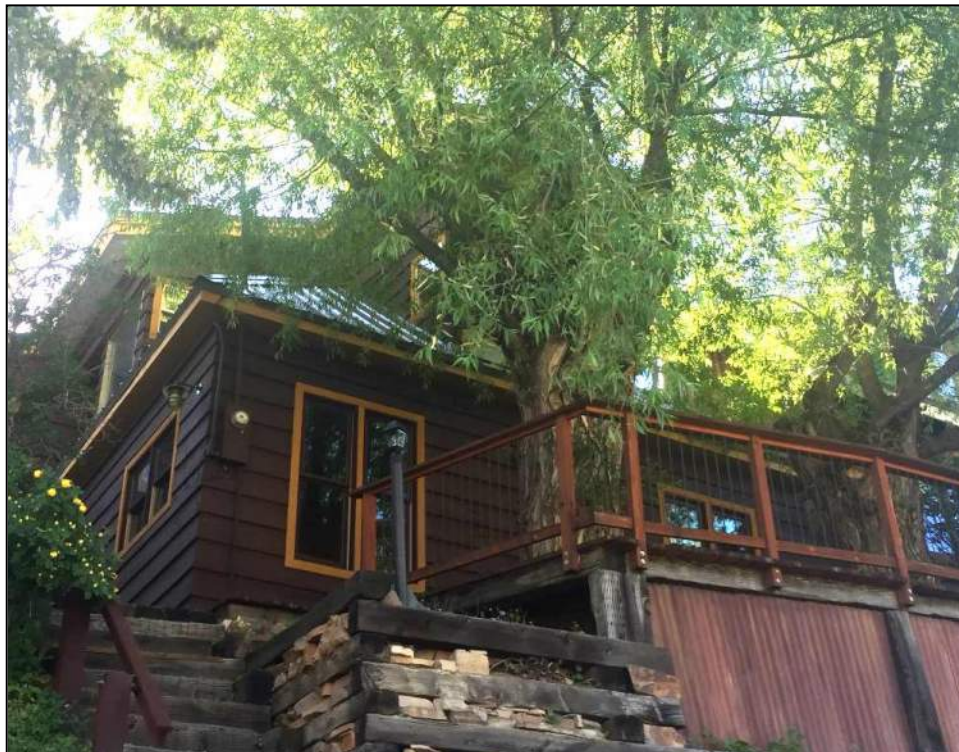
**Figure 5b:** 416 Ontario Avenue, 2016. Camera facing southeast.

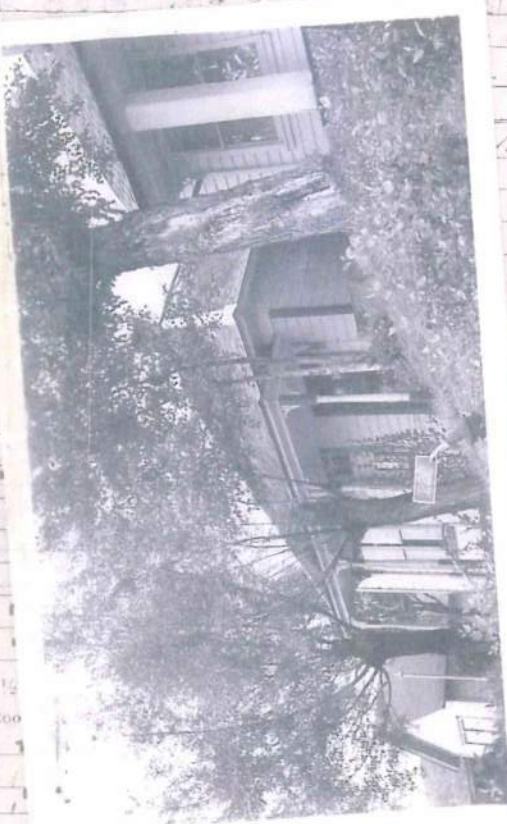
Location Block 529, Lot 14 (2nd Hill)  
 Kind of Bldg. 2nd  
 Class X 100%  
 Stories 1 3/5  
 Dime Total  
 Gar.—Carport \_\_\_\_\_  
 Foundation—Stone \_\_\_\_\_  
 Ext. Walls \_\_\_\_\_  
 Insulation—Floors \_\_\_\_\_  
 Roof Type \_\_\_\_\_  
 Dormers—Small \_\_\_\_\_  
 Bays—Small \_\_\_\_\_  
 Porches—Front \_\_\_\_\_  
 Rear \_\_\_\_\_  
 Porch \_\_\_\_\_  
 Metal Awnings \_\_\_\_\_  
 Basement Entr. \_\_\_\_\_  
 Planters \_\_\_\_\_  
 Cellar-Bsmt. — 1/4 1/2 1/2 \_\_\_\_\_  
 Bsmt. Apt. — Roo \_\_\_\_\_  
 Attic Rooms Fin. \_\_\_\_\_  
 Plumbing { Class \_\_\_\_\_  
 Basin \_\_\_\_\_  
 Wtr. Sfr. \_\_\_\_\_  
 Dishwasher \_\_\_\_\_ Garbage Disp. 350

Built-in-Appliances \_\_\_\_\_  
 Heat—Stove  H.A. \_\_\_\_\_ Steam \_\_\_\_\_ Stkr. \_\_\_\_\_ Blr. \_\_\_\_\_  
 Oil \_\_\_\_\_ Gas \_\_\_\_\_ Coal  Pipeless \_\_\_\_\_ Radiant \_\_\_\_\_  
 Air Cond. \_\_\_\_\_  
 Finish—Fir  Hd. Wd. \_\_\_\_\_  
 Floor—Fir \_\_\_\_\_ Hd. Wd. \_\_\_\_\_ Other \_\_\_\_\_  
 Cabinets \_\_\_\_\_ Mantels \_\_\_\_\_  
 Tile—Walls \_\_\_\_\_ Wainscot \_\_\_\_\_ Floors \_\_\_\_\_  
 Storm Sash—Wood D. \_\_\_\_\_ S. \_\_\_\_\_; Metal D. \_\_\_\_\_ S. \_\_\_\_\_  
 Total Additions 532 532

Year Built _____	Avg. _____	Reproduction Value	\$ 1847
<u>Acc App 1949-46</u>	Age <u>54</u>	Obsol. or Rem.	%
Inf. by { Owner - Tenant - Neighbor - Record - Est.		Bldg. Value	
		Depr. Col. 1 2 3 4 5 6	<u>33</u> %
Remodel Year _____	Est. Cost _____	Repr. Val. Minus Depr.	\$ 609
Garage—Class _____	Depr. 2% 3%	Carport—Factor _____	
Cars _____	Floor _____	Walls _____	Roof _____
Size—x _____	Age _____	Cost _____	x _____ %
Other _____			
Total Building Value			\$

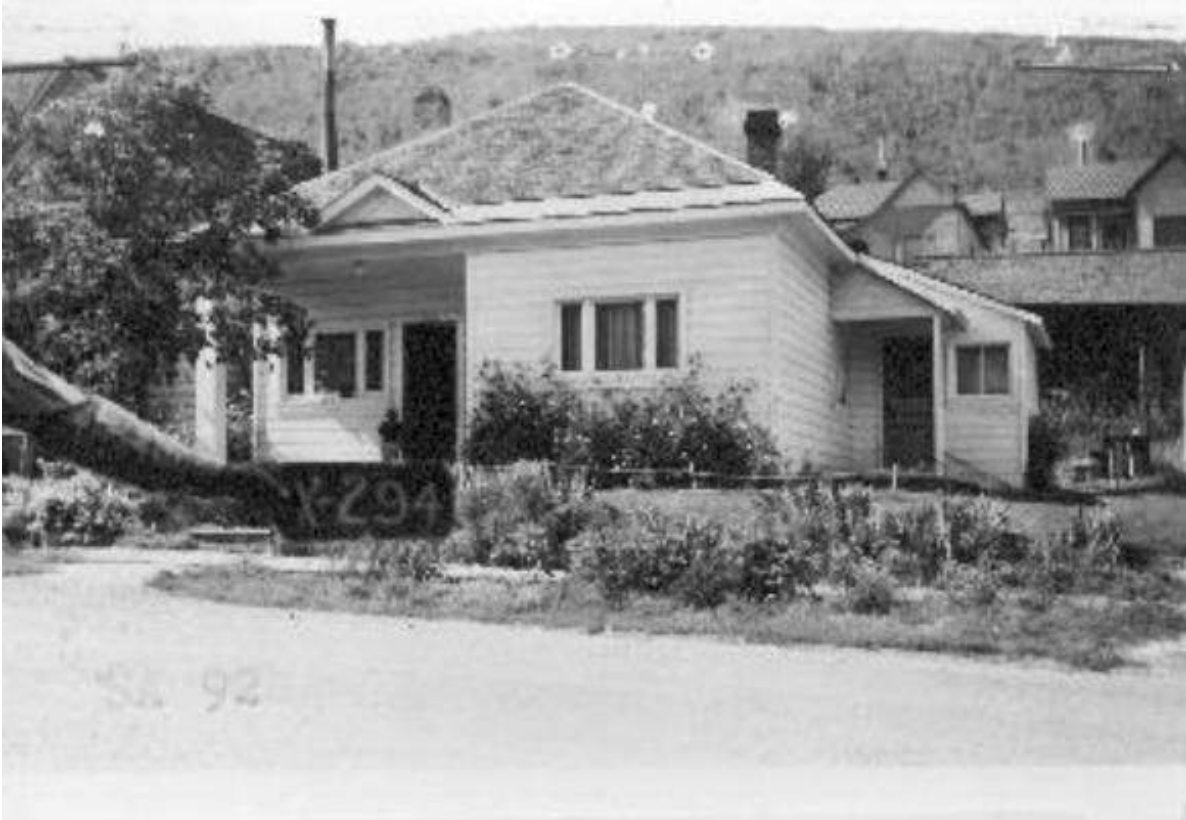
The ca. 1940 tax photo of 1103 Woodside Avenue, which is the property on the north side of Crescent Street, provides a better view of the two (2) outbuildings (Figure 8). The white-painted, board and batten building with a wood-shingled roof is clearly the single-car garage in the same location on the property today.

**Figure 8:** 1103 Woodside Avenue ca. 1940 tax photo. Visible in this photo is the single-car garage with its white-painted, board and batten siding and wood-shingled roof.

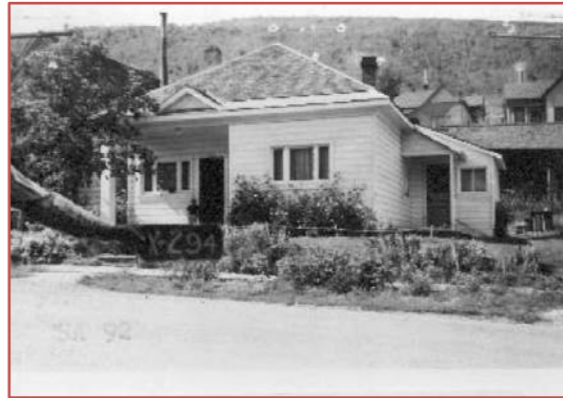
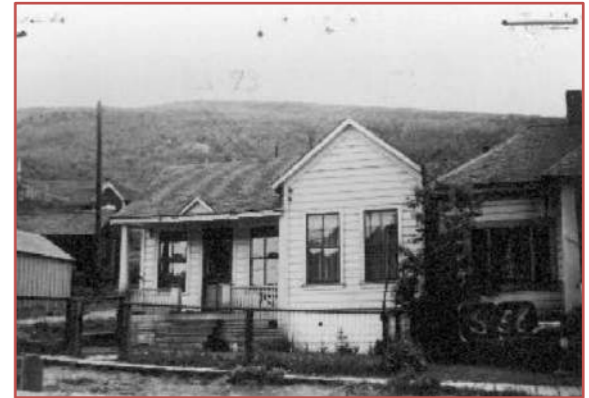
**1940**  
The tax photo of 1057 Woodside Avenue (left) documents a shed-roofed addition with a door, window, and covered stoop has been made to the north side of the house. The tax photo of 1103 Woodside Avenue (right), which is the property on the north side of Crescent, provides a better view of the two outbuildings.

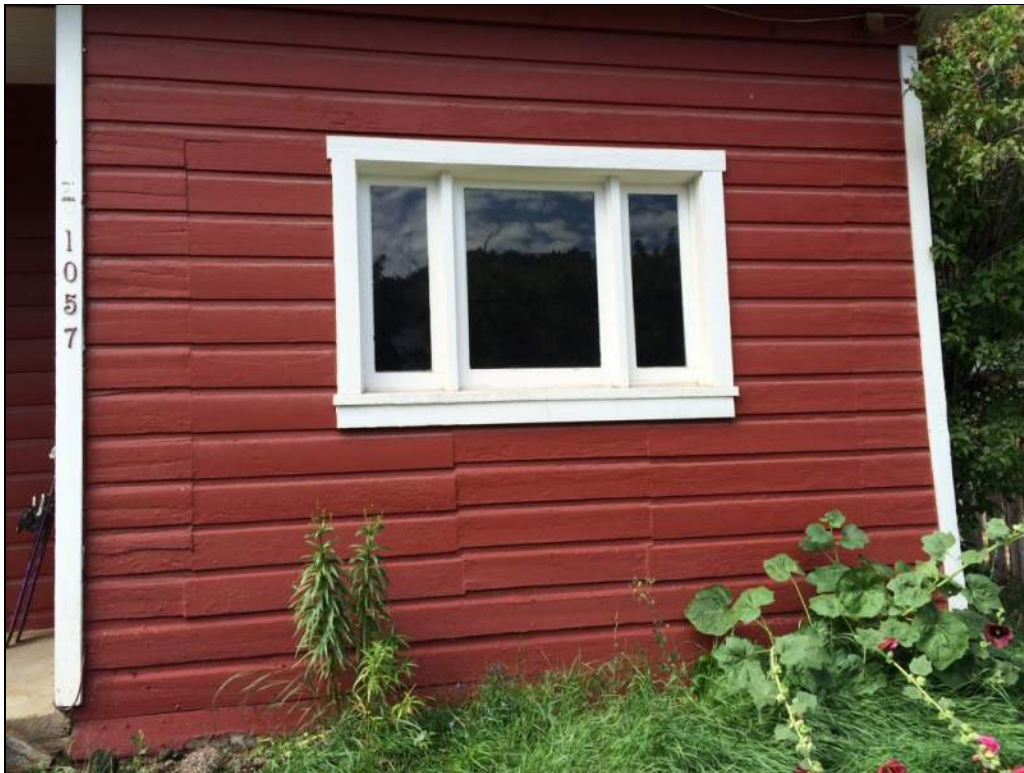
**Figure 2.** Detail of east façade of house, with original window locations visible in siding.

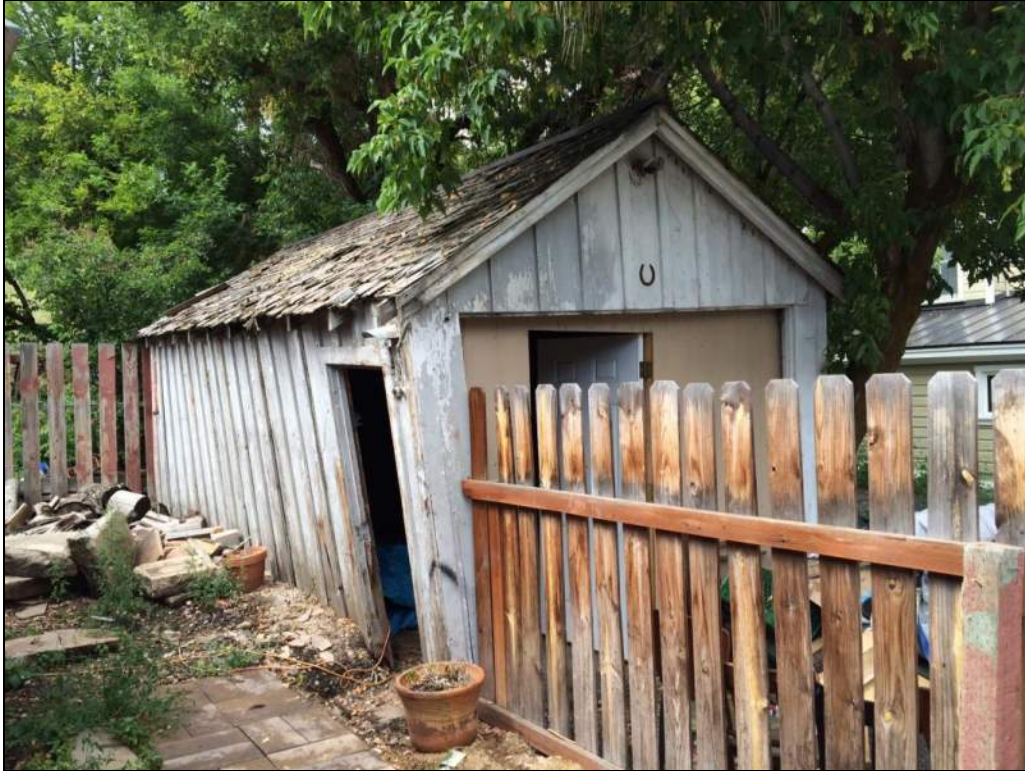
The front-gabled garage is north of the residence and faces Woodside Avenue to the east; it is set back from the street and aligns with the east face of the addition on the north side of the house (Figures 1-4). The building has no visible foundation, although channeled iron bars have been used to create a sill for the doorway in the east end of the south wall. The walls are of wood-framed, single-wall construction, with posts measuring 4" x 5" and lighter framing members and roof joists measuring 1¾" x 3½" (Figure 5). These are true dimensions that predate industry standards for dimensional lumber enacted in 1963.<sup>1</sup> The framing is finished on the exterior side with vertical boards and battens, measuring about 11¾" and 3¾" wide respectively, which have been painted white several times. The original vehicle entrance was located on the east façade, and extant hardware indicates that it was fitted with a pair of side-hinged doors. This opening has recently been infilled with wood-veneer panels fitted with a modern paneled door. The opening at the east end of the south wall was for a person door, but the door has been removed. The wood-shingled roof has open eaves with exposed rafter tails, and is finished by a metal ridge with spherical end caps.

**Figure 3.** General view of garage, facing northwest.

The garage and storage shed are considered contributing features to a landmark property. As such, all efforts should be made to preserve them. A formal condition assessment was not conducted, but the shed appears to be in fair condition while the garage appears to be in poor condition; the latter may be difficult to repair without partially or fully reconstructing it. It is recommended that a formal Condition

Assessment and Preservation Plan be developed for both outbuildings to document their deficiencies and develop appropriate plans for their repair and/or replacement.

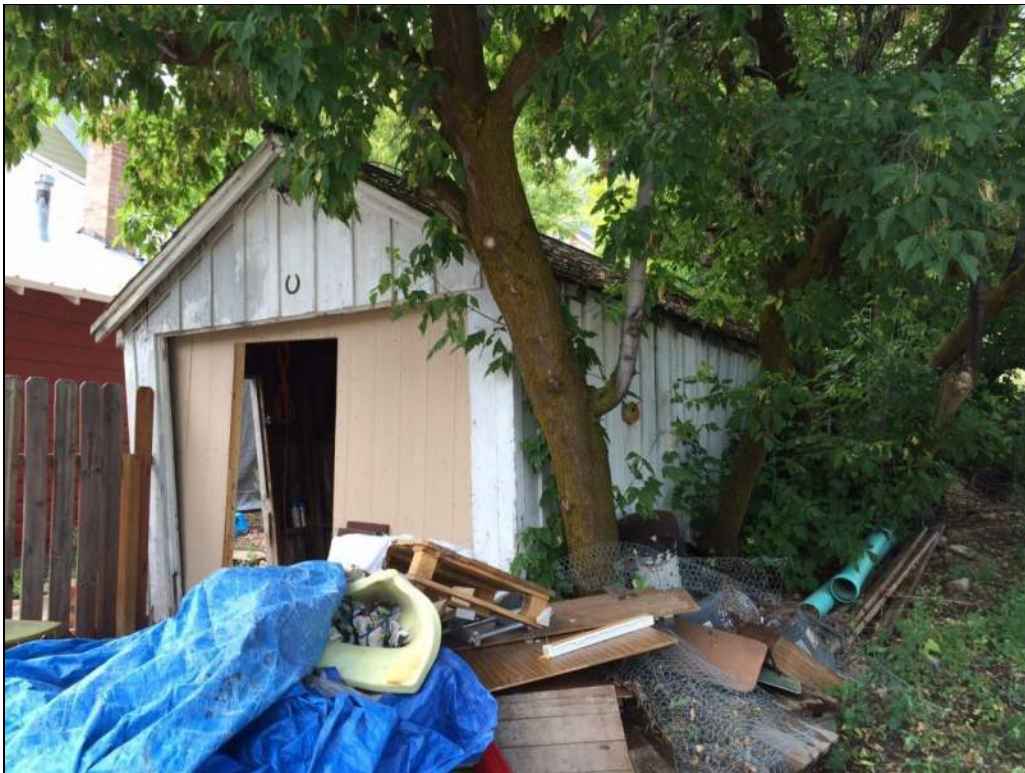
**Figure 4.** General view of garage, facing southwest.

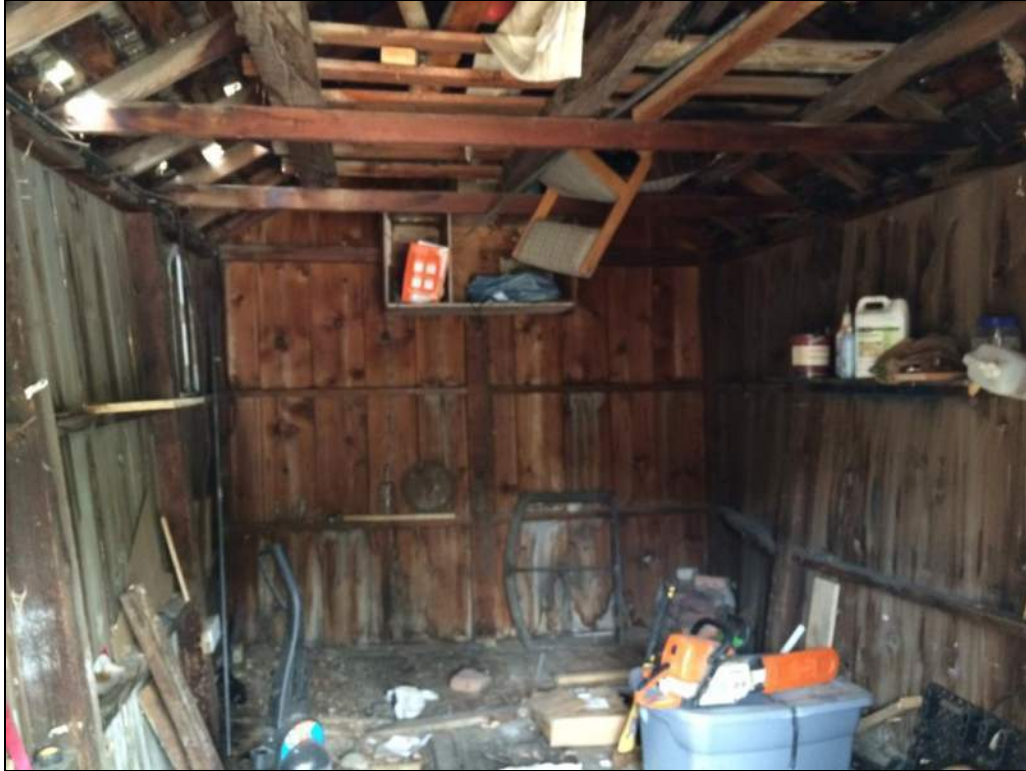
**Figure 5.** General view of garage interior, facing west.

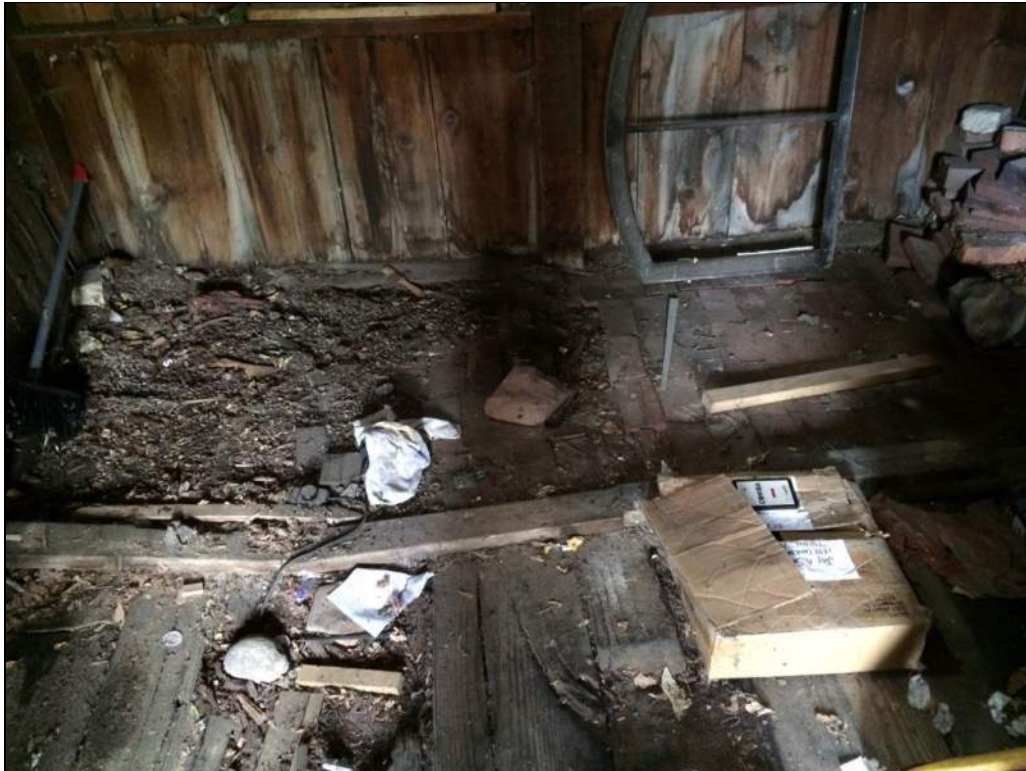
On the interior, the floor is finished with bricks at the west end and with heavy planks elsewhere (Figure 6). The walls and ceiling are unfinished. Knob and tube electrical wiring is surface-mounted on the interior and exterior walls, and early or original light fixtures and switches are present on the exterior (Figure 7).

**Figure 6.** Garage floor, showing brickwork at west end and wood planks covering remainder of floor, facing west.

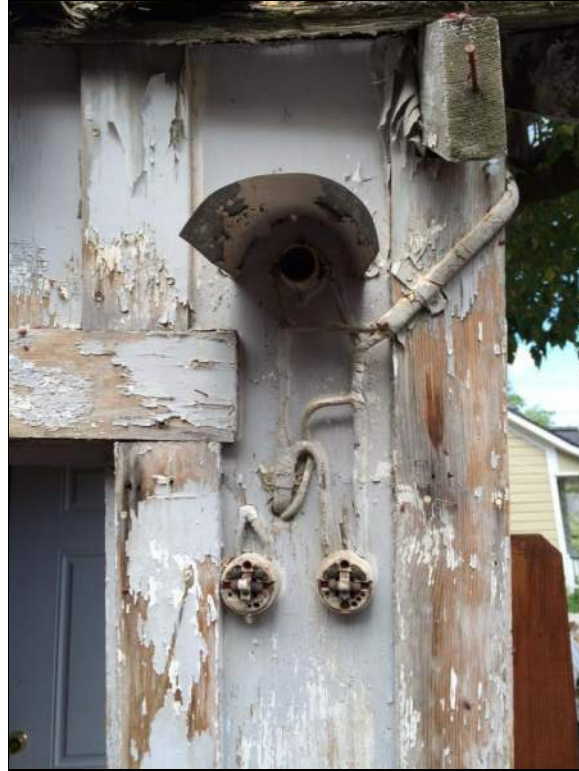
**Figure 7.** Light fixture and electrical switches on south side of garage, facing north.

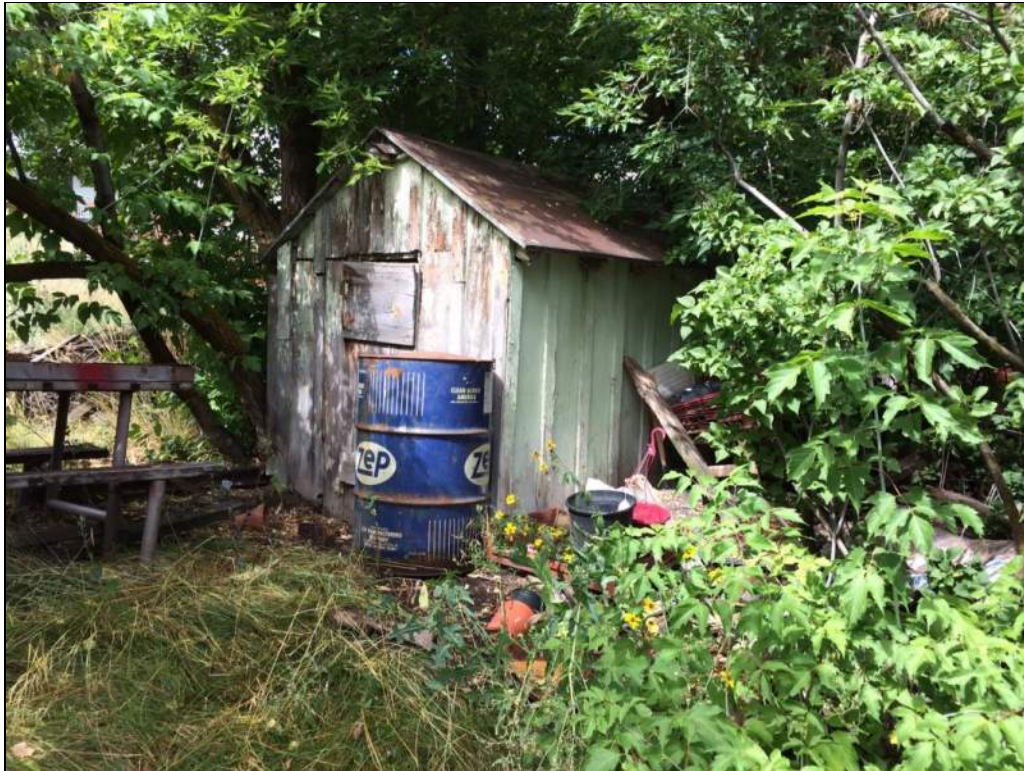
The front-gabled, board and batten storage shed is west of the garage and utility pole, in the northwest corner of the lot, and faces south into the rear yard of the property (Figures 8 and 9). On the exterior, it is nearly identical in construction to the garage and retains the same early or original light fixture above the single door on the south side. In contrast to the garage, the roof is finished with sheet metal. The interior of the shed was not accessed and its original use is unclear, although it was likely built to store gardening and yard equipment. The PCMC Historic Site Form doesn't note the presence of the shed in 2008 because the rear of property was not accessed at that time.<sup>2</sup>

**Figure 8.** General view of storage shed, facing northwest.

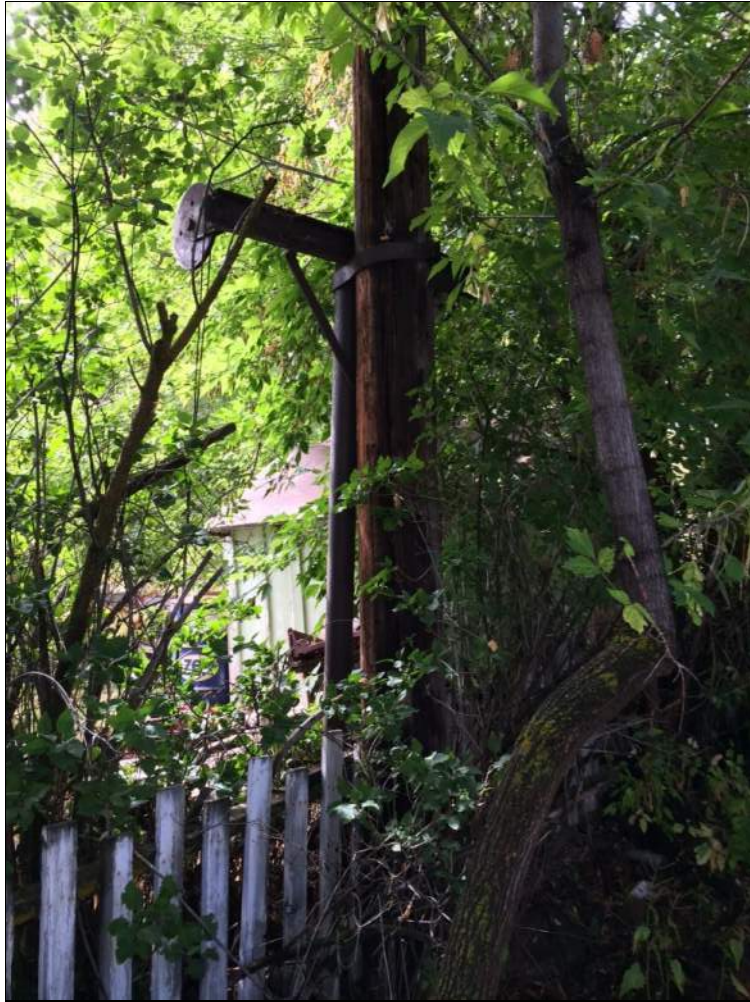
**Figure 9.** View of east side of storage shed in relation to utility pole and fenced property line, facing southwest.

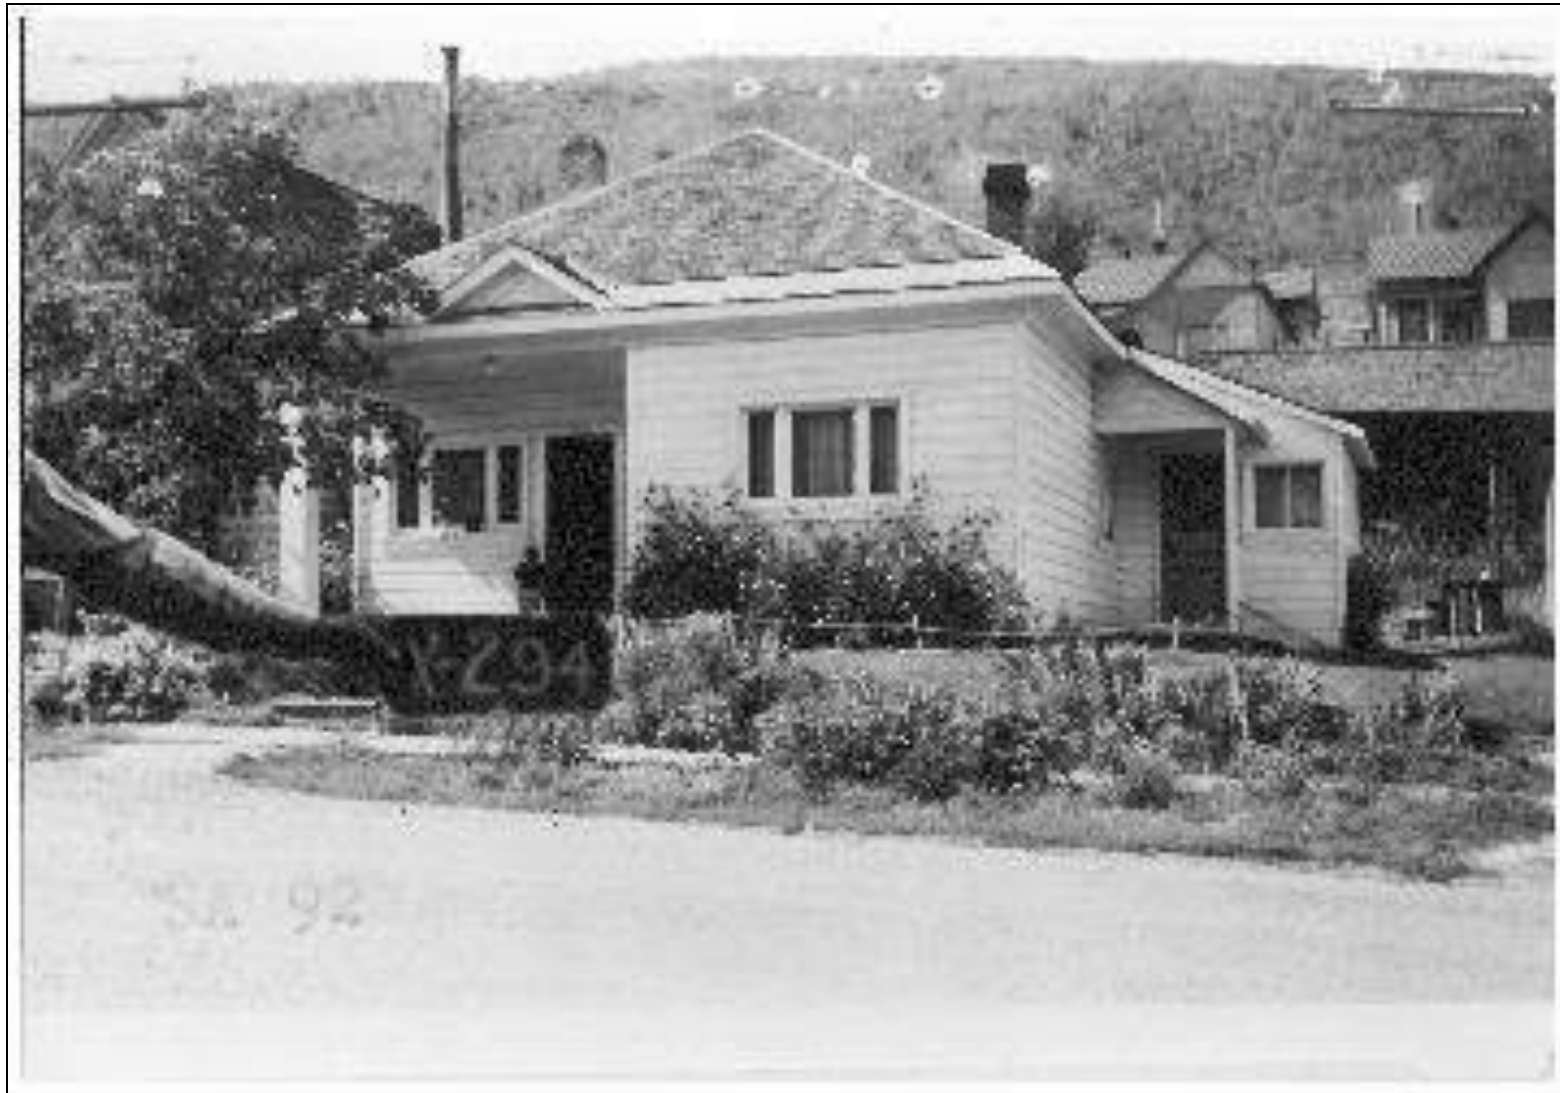
**Figure 14.** Tax assessment photograph of 1057 Woodside Ave, ca. 1940-41 (from Park City Municipal Corporation Historic Site Form).

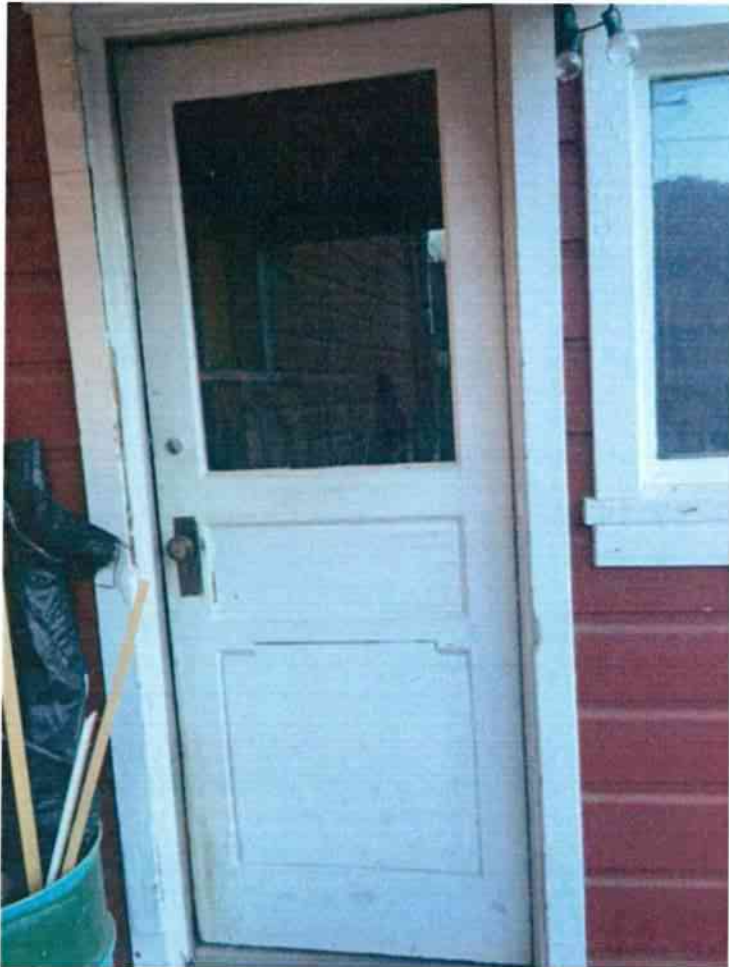
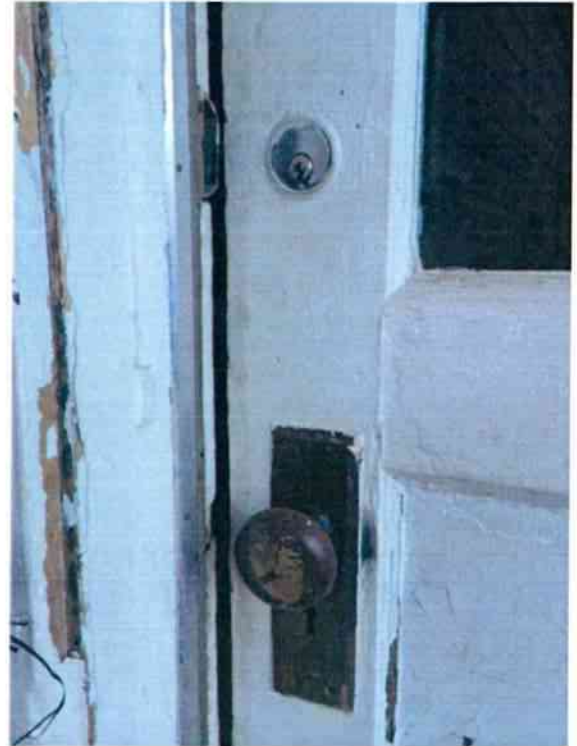
Detail of Door #1

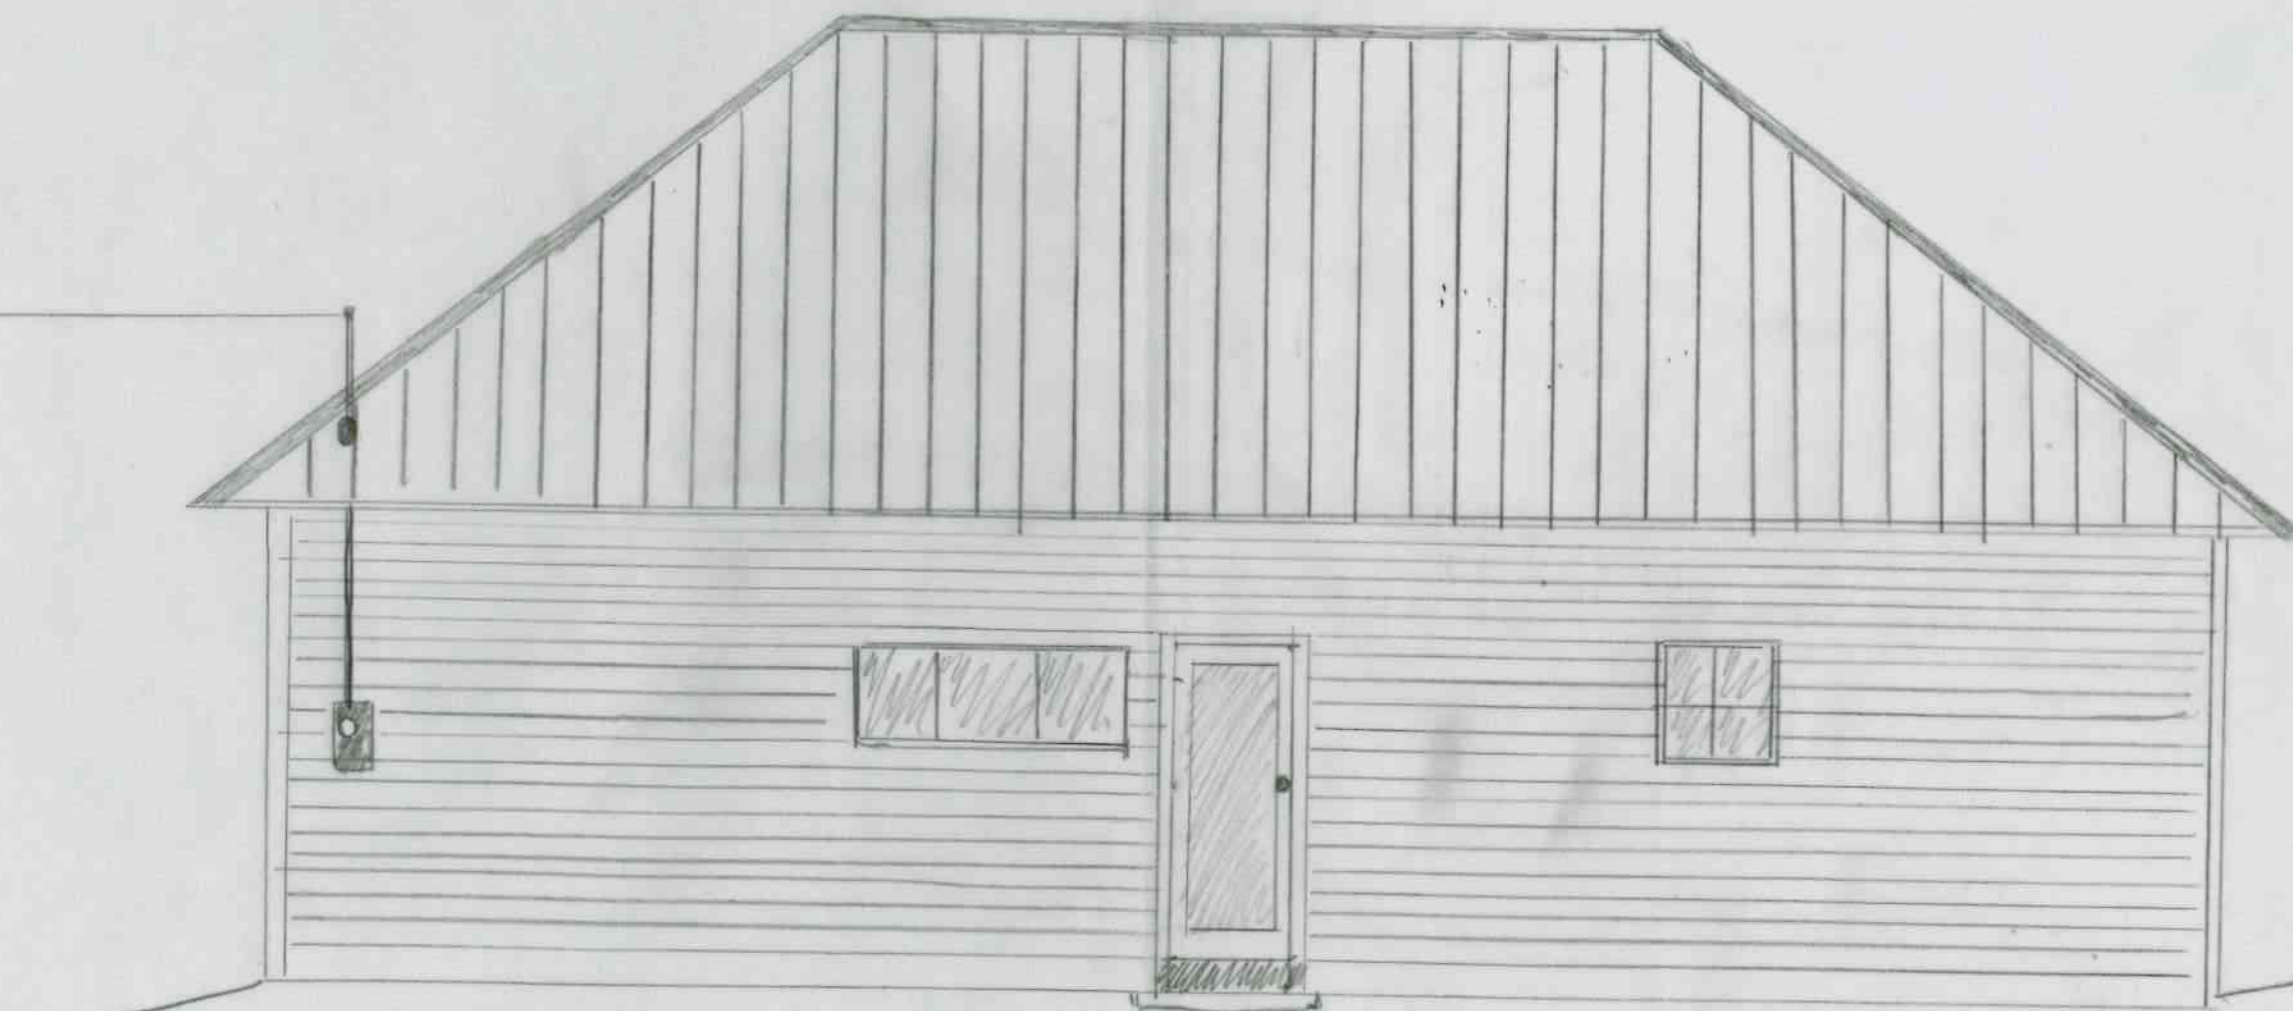
- ↳ USE EXISTING SIDING TO MATCH HISTORIC HOME SIDING.
- USE METAL ROOFING MATERIAL TO MATCH EXISTING ROOF.
- WOODEN SIDE DIBB EXISTING.
- FINISH GRADE TO EXISTING GRADE, CONCRETE SLP TO GRASS TRANSITION

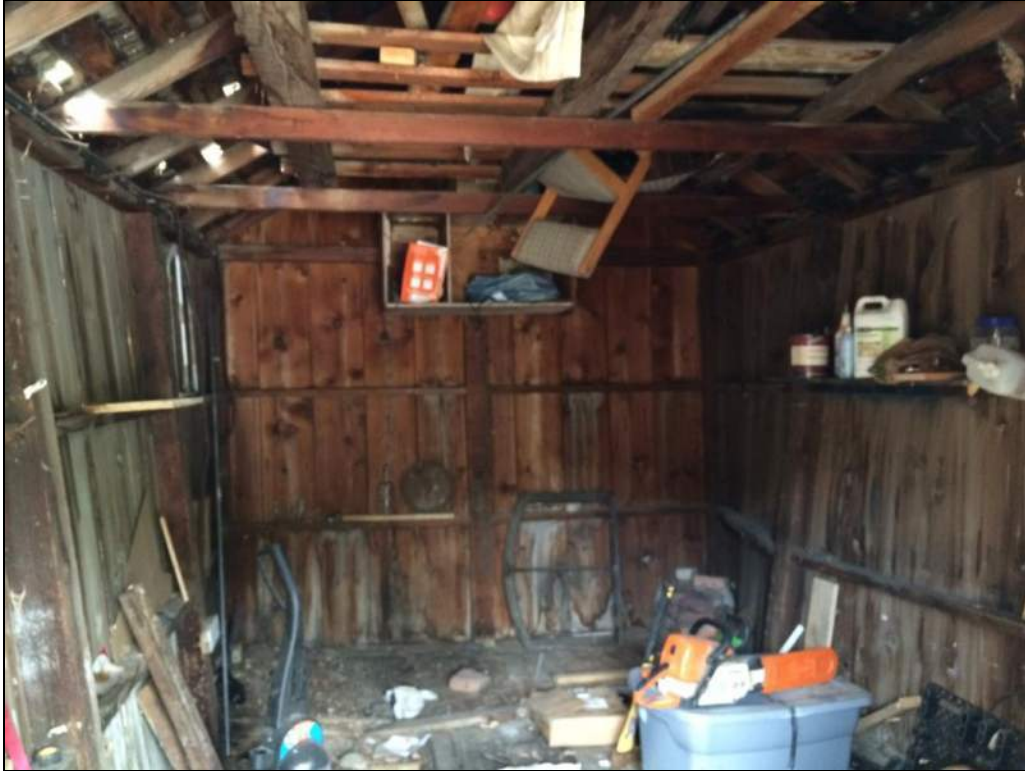
**Figure 5.** General view of garage interior, facing west.

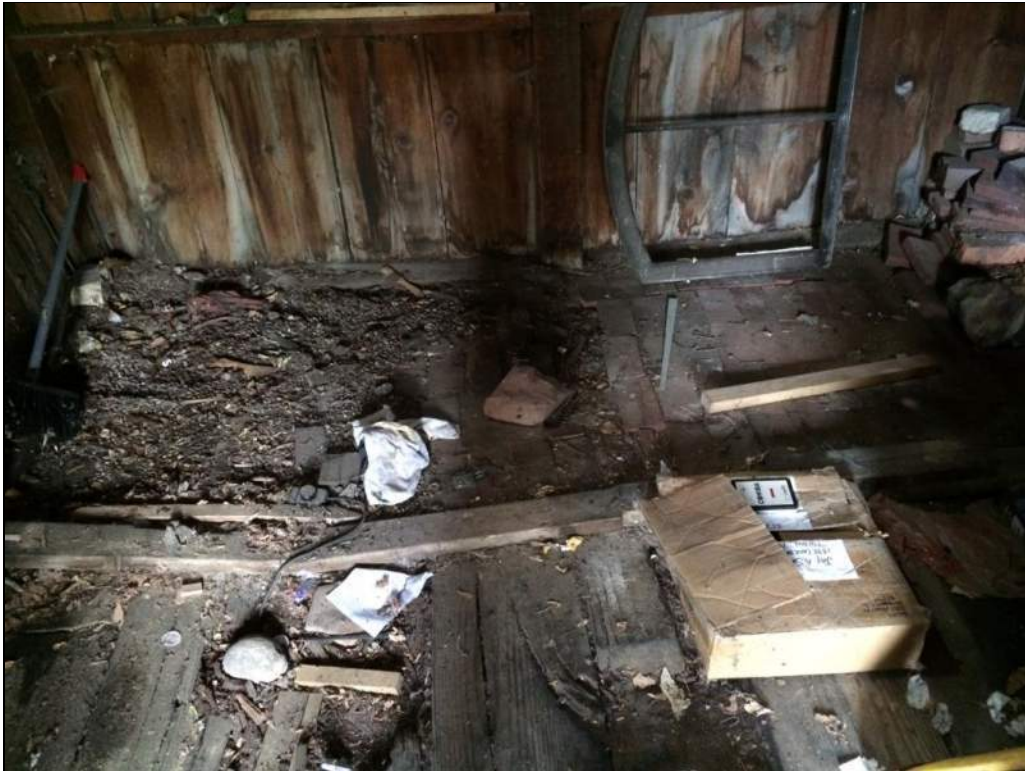
**Figure 6.** Garage floor, showing brickwork at west end and wood planks covering remainder of floor, facing west.

On the interior, the floor is finished with bricks at the west end and with heavy planks elsewhere (Figure 6). The walls and ceiling are unfinished. Knob and tube electrical wiring is surface-mounted on the interior and exterior walls, and early or original light fixtures and switches are present on the exterior (Figure 7).

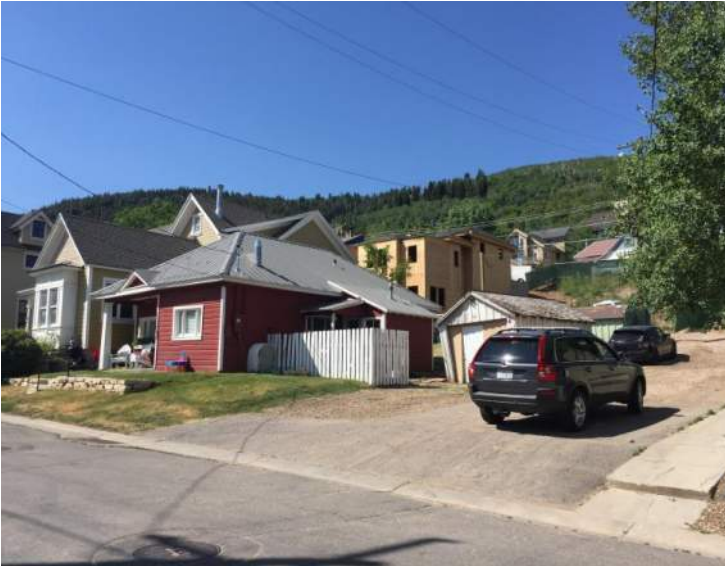
1057 Woodside Avenue (centered), Platted 11 Street (right), and 1053 Woodside Avenue (left). Note the relationship between the single-family dwelling and its outbuilding(s). Camera facing southwest

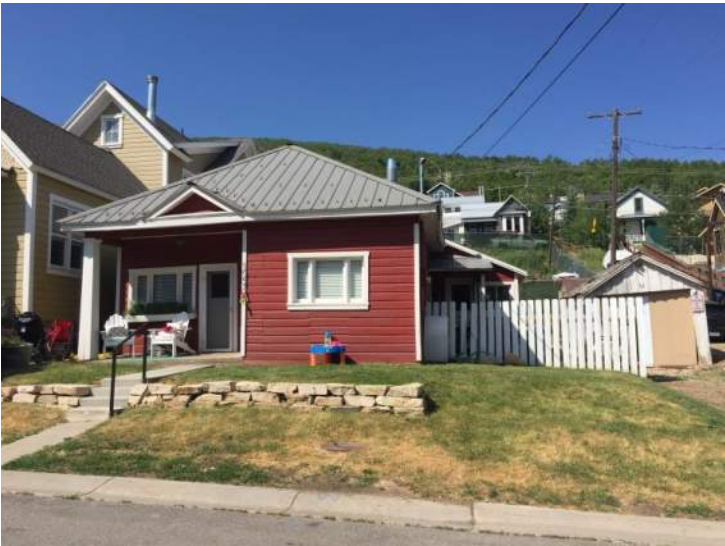
1057 Woodside Avenue (centered). Note the relationship between the single-family dwelling and its outbuilding(s). Camera facing west.

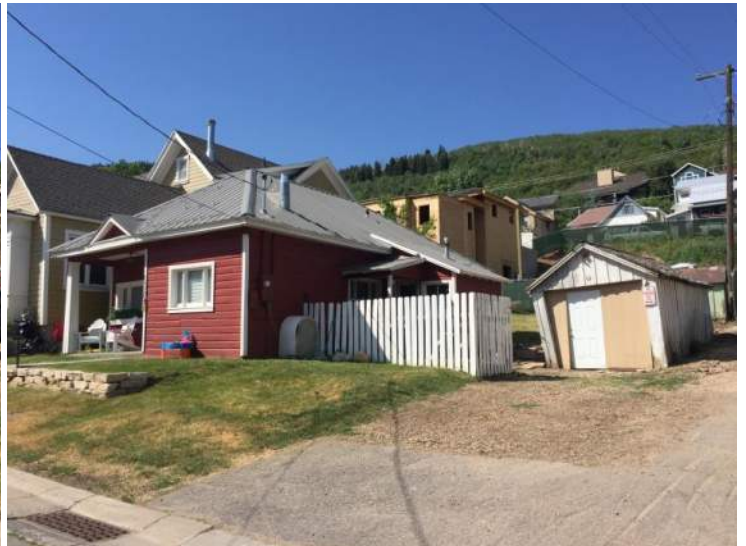
1057 Woodside Avenue (centered). Note the relationship between the single-family dwelling and its outbuilding(s). Camera facing southwest.

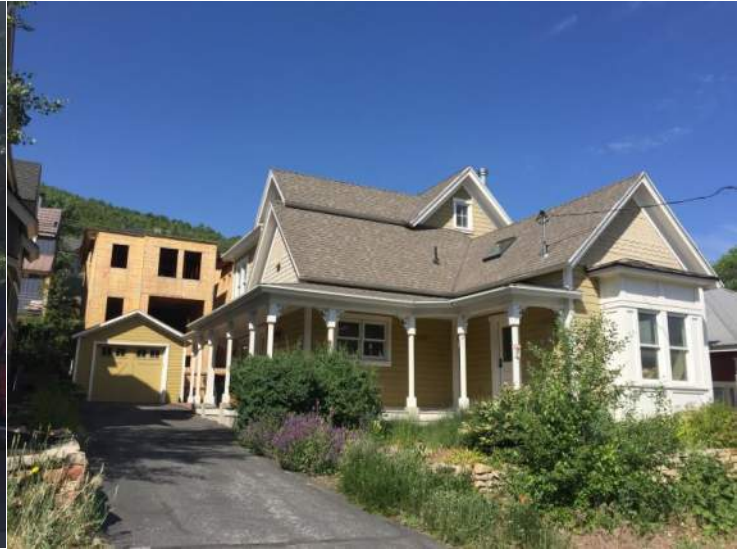
1053 Woodside Avenue located just south of 1057 Woodside Avenue. Note the garage located in the rear yard, yard space, separation between structures. Camera facing northwest.
