**PARK CITY MUNICIPAL CORPORATION  
 HISTORIC PRESERVATION BOARD  
 CITY COUNCIL CHAMBERS  
 November 2, 2016**

**Physical Conditions Report  
Internal Demolition Report  
227 Main Street - Star Hotel  
Submitted by Westlake Land, LLC**

**NOTICE AND ORDER TO REPAIR**

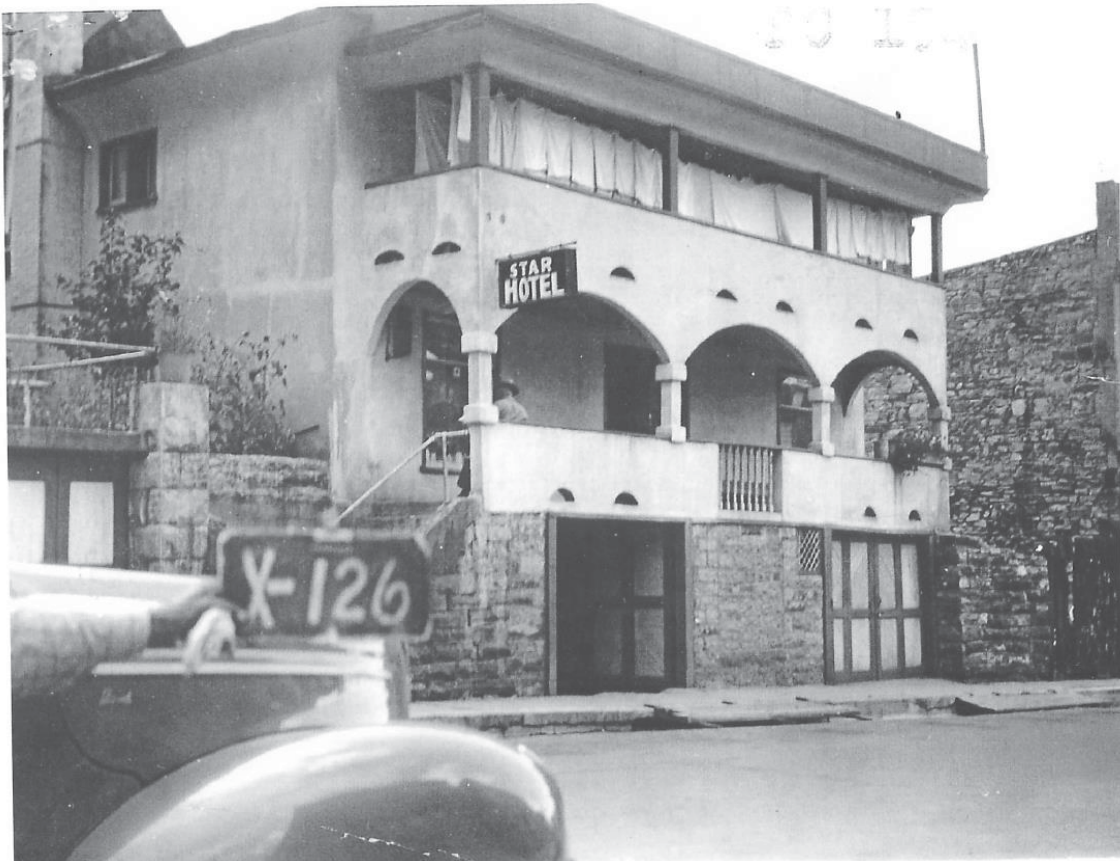
*C.1940 Tax Photograph of the Star Hotel at 227 Main Street*

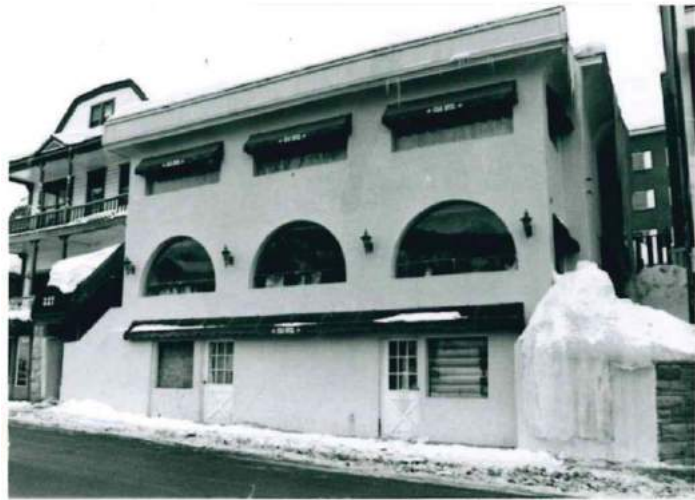
*c. 1982 Architectural Survey photo*

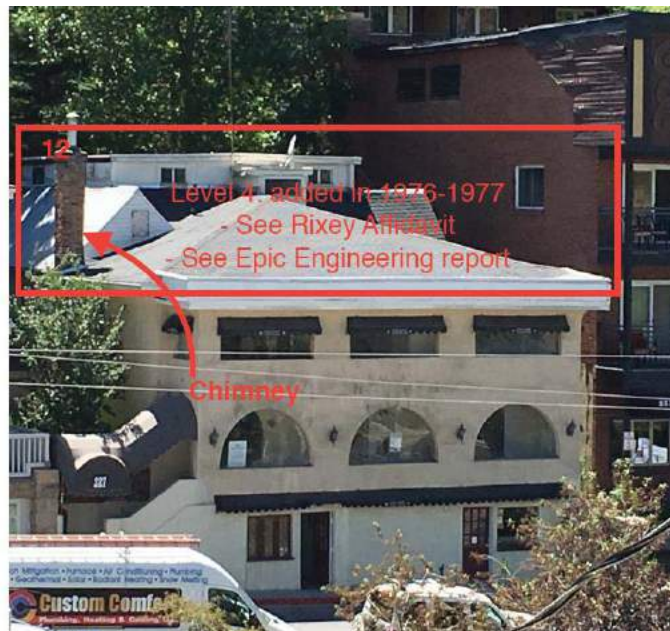
The Rixies also constructed a fourth floor addition above the original cross-wing between 1976 and 1977. This addition is wood framed and sits atop the ridge of the cross-wing house with a single dormer extending over the ridge. Their son Bill also remembers modifying window openings, door openings, and building materials. As previously noted, the Rixies also replaced awnings in 1994, made a temporary roof repair in 2005, and completed stucco repair in 2007.

*Applicant submitted this rooftop view of the Star Hotel, showing the rear addition that was added by the Rixies 1976-1977.*

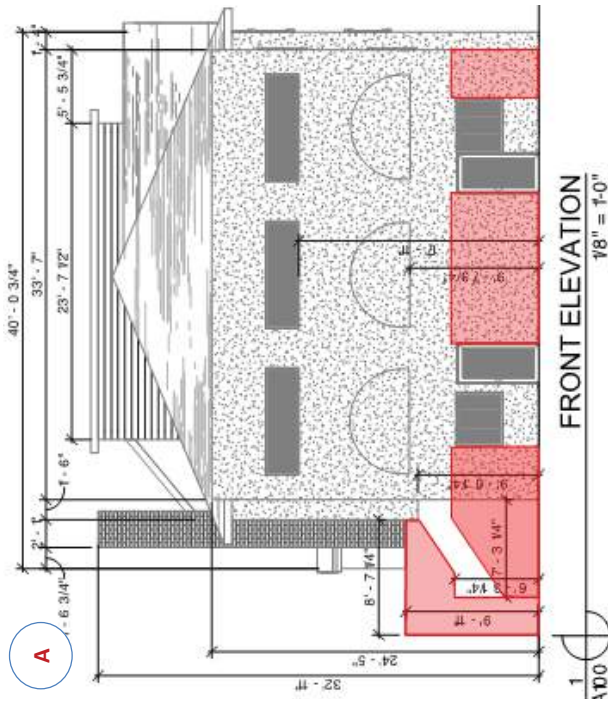
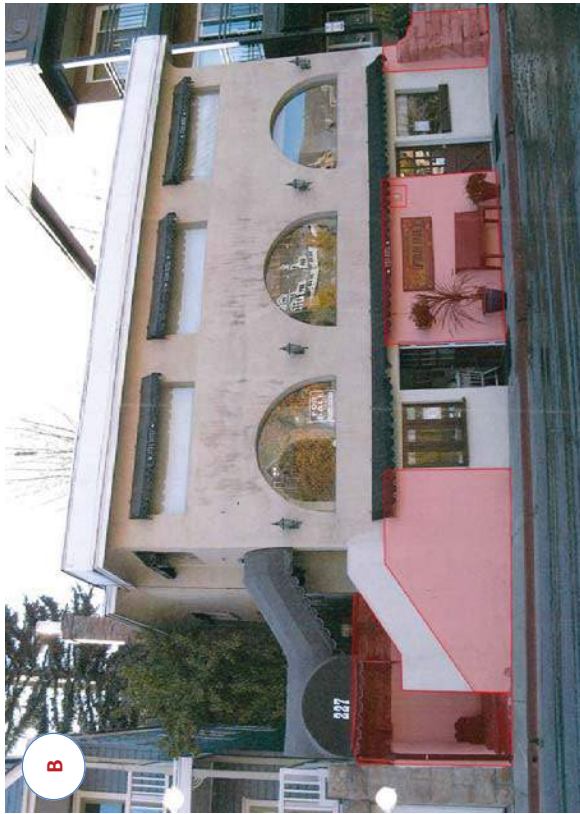
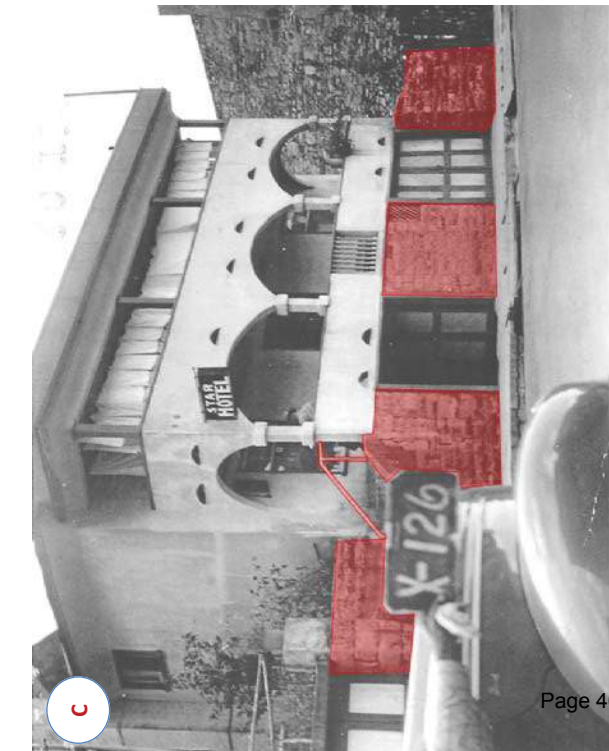
(A-E) The shaded red areas of the rendering and current photo represent the areas of the structure that staff finds are historic. (C) The red shaded areas of the ca. 1930s tax photograph show the original appearance of the basement/foundation. (D) While these areas were covered with stucco by the Rixies during the 1977 remodel, the stucco could be removed to expose the original stone foundation. (E) In addition, Senior Building Inspector Rich Novasio conducted a detailed inspection of the building on September 22, 2015. The inspection produced documentation of the stone foundation from the interior of the building and small window just left of the north garage entrance. Note the pipe penetrating the upper left pane of the historic window in Photo E and the pipe visible in Photo B (identified by a small red square) exiting the front (east) façade. (F) Also, staff has found evidence of the historic stair railing in the now solid stucco railing.

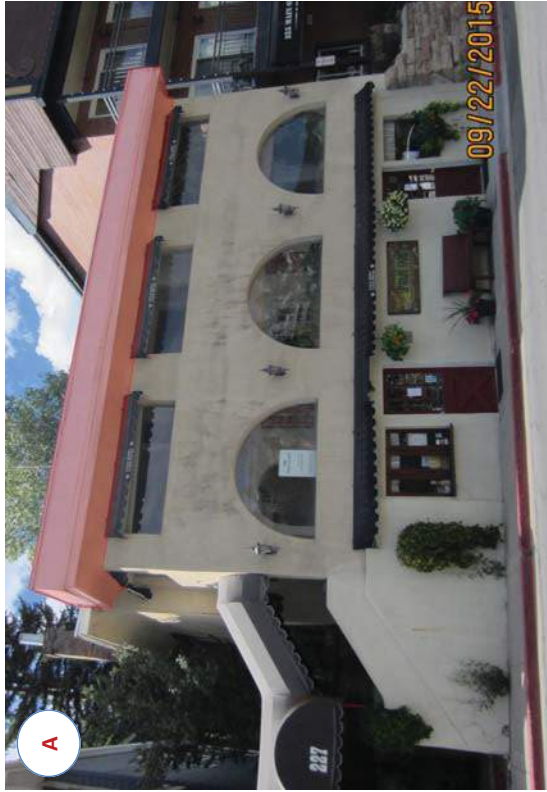
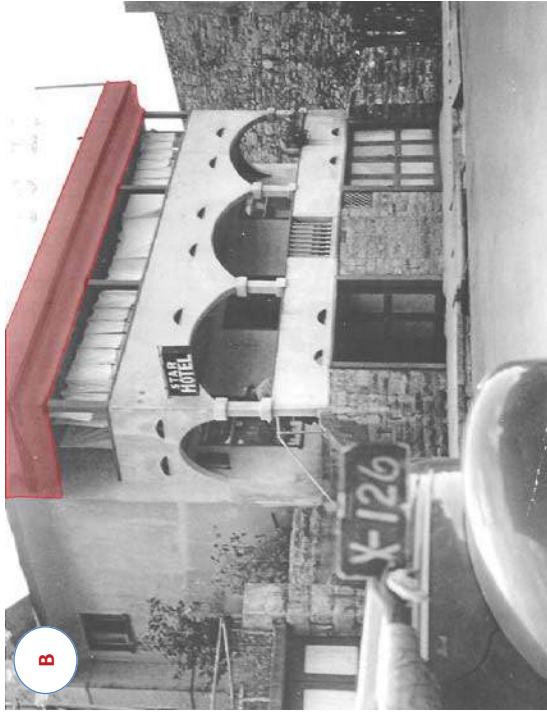
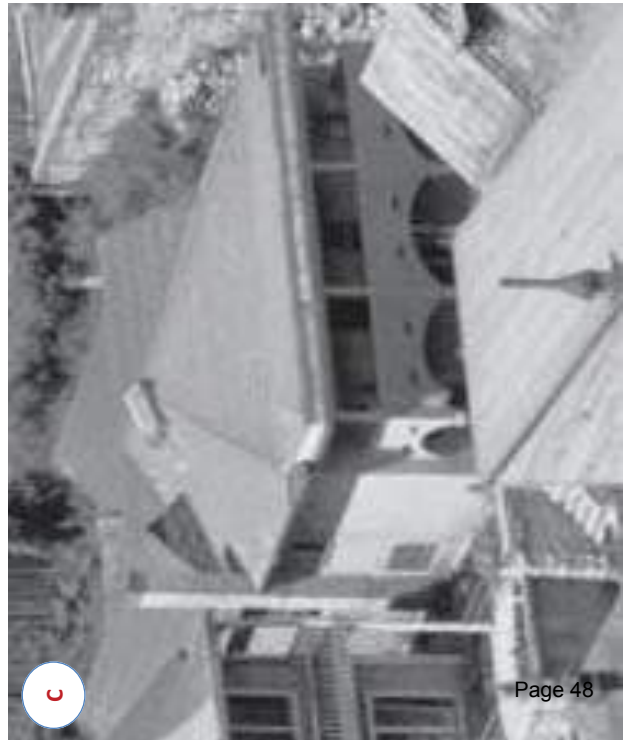
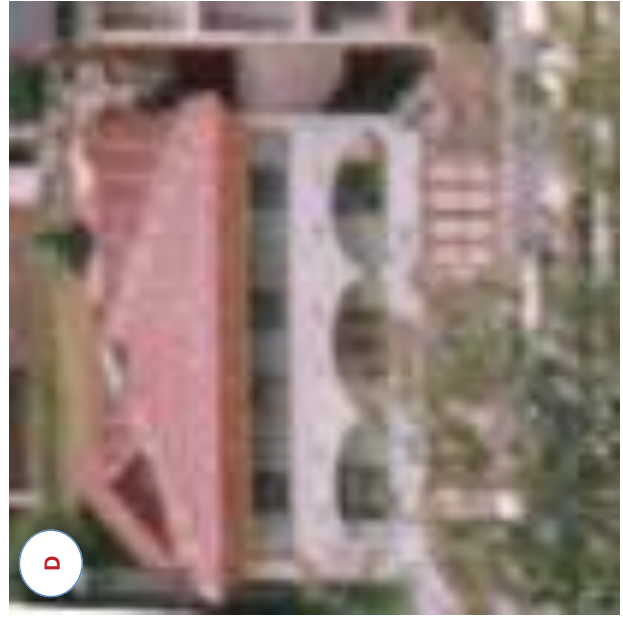
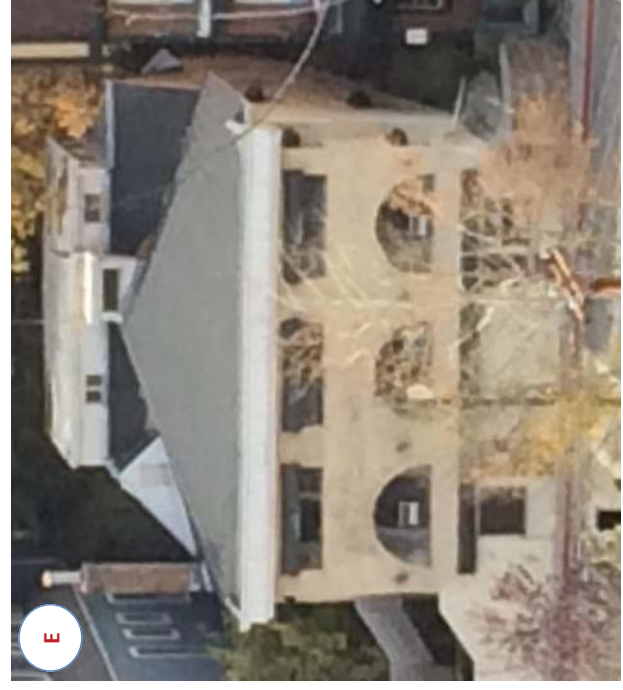
(A) The rendering provided by the applicant does not accurately represent the roof/cornice structure of the east elevation; therefore, a photograph taken by Rich Novasio on September 22, 2015 has been used to identify the areas (shaded red) of the historic cornice/roof structure on the east (front) elevation that stands are historic. (B) The red shaded areas of the ca. 1930s tax photograph show the original appearance of the roof/cornice. (C) A ca. 1930s cross-canyon view photograph (Park City Historical Society & Museum, Pop Jenks Collection) shows the original appearance of the entire roof form. (D) A pre-1976 cross-canyon view shows the roof form prior to the Rixie remodel. (E) A current cross-canyon view shows the current roof form (after the Rixie remodel). As is demonstrated by the exterior photographs, the original roof form has remained largely unchanged. The ca. 1889 Cross-wing cottage roof form is still visible as is the hipped roof form of the main structure and the flat roof form formed above the porch projection. *Continued on next page...*

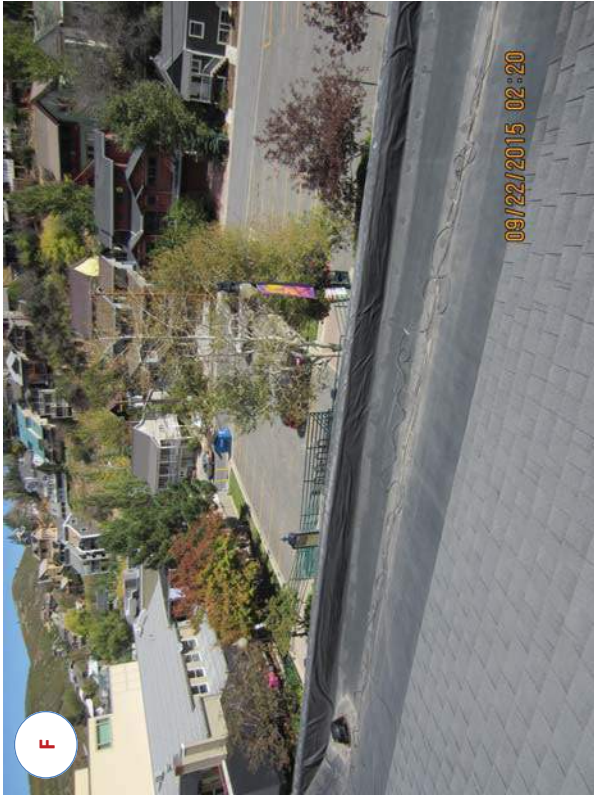
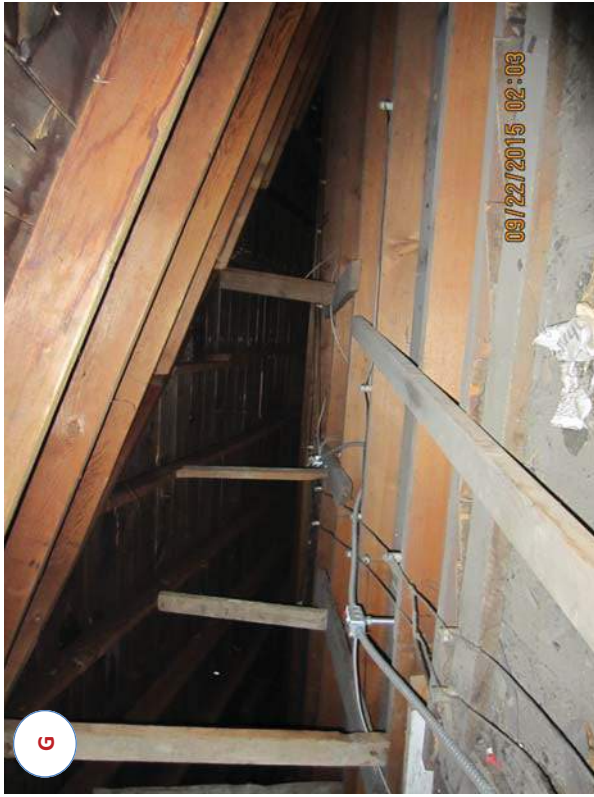
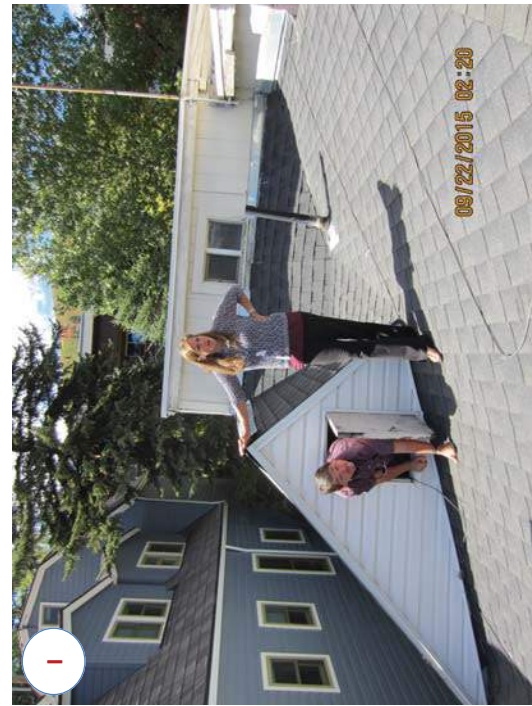
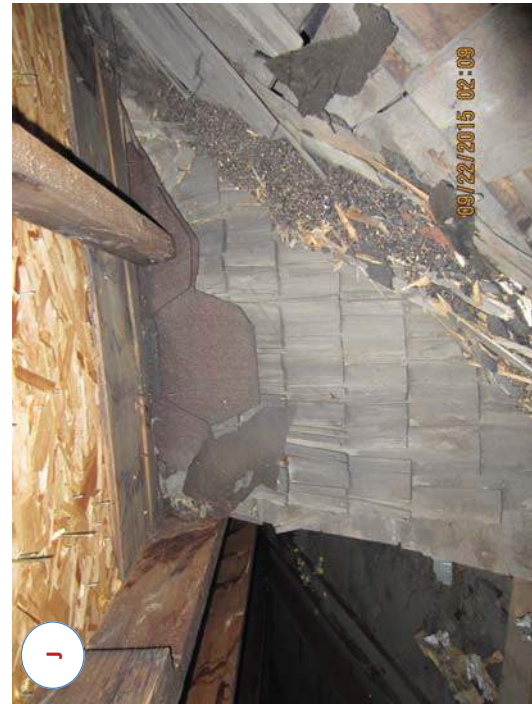
### Analysis 3: Roof Form and East Cornice Continued...

(F) Photo F (facing east) shows the flat roof form above the porch where it meets the hipped-roof form of the main building. (G) Staff has found physical evidence of the historic internal structure of the flat roof form above the porch and the hipped-roof form in the attic. Visible in Photo G (facing east) are the historic knob-and-peg wiring, historic structural members of the hipped-roof form where it meets the flat roof form above the porch, and non-historic vertical posts likely installed in an effort to add further structural support for the hipped-roof form. (H) Staff has also found physical evidence of the historic cornice structure and historic stucco on the interior of the Third Level enclosed porch. (I) The Cross-wing Cottage roof form is visible on the exterior of the structure. (J) In addition, visible in the attic space of the Star Hotel is further evidence of the Cross-wing cottage roof form.

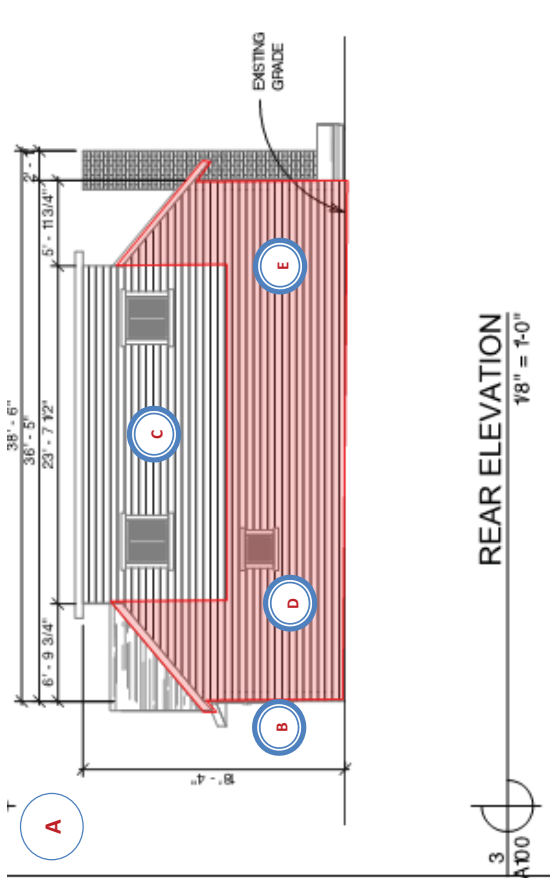
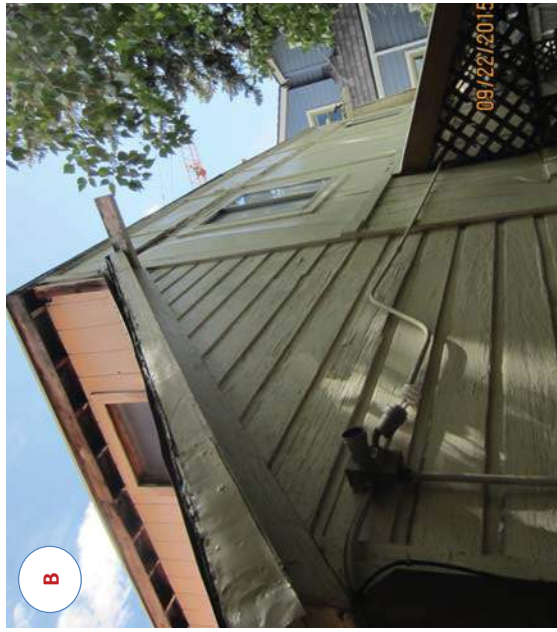
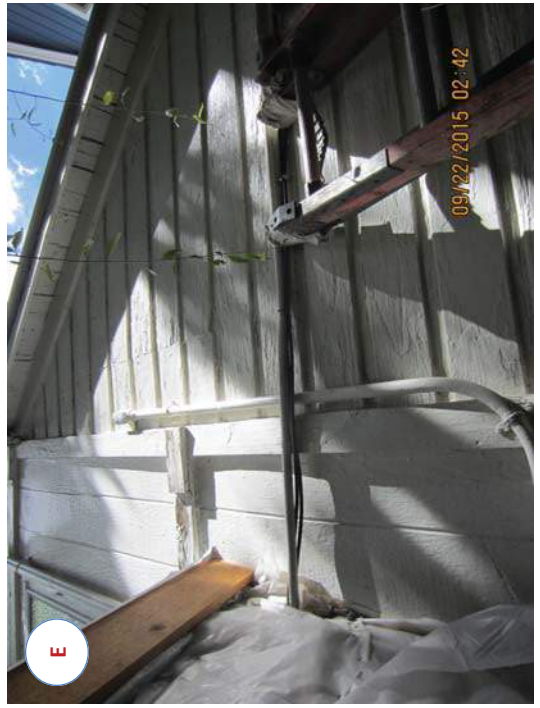
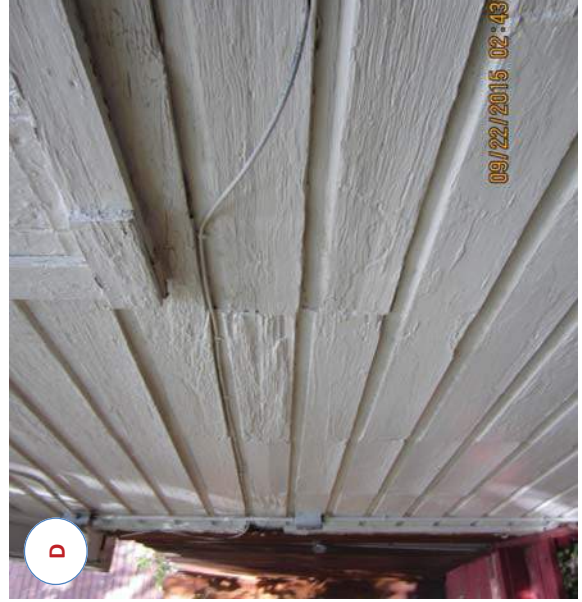
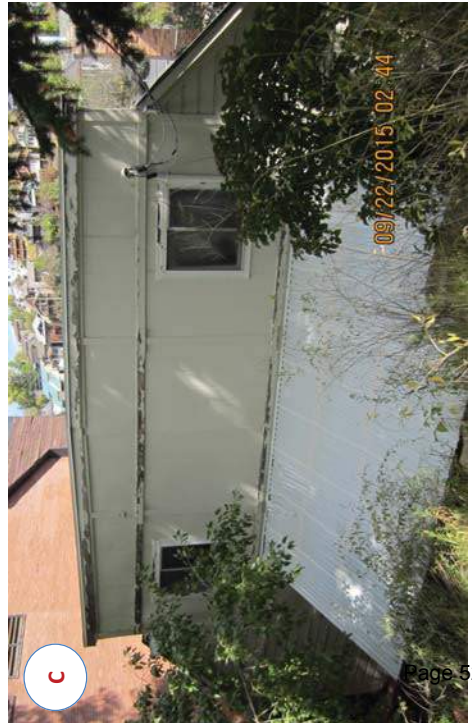
(A) The shaded red areas of the west (rear) elevation identify the areas of the elevation that staff finds are historic. Because the renderings provided by the applicant do not accurately represent all of the design details, such as the rear door, window openings, trim, material changes, etc., staff has provided additional photos—the circled letters on the rendering identify the Photo taken by staff of each design element (B) Photo B identifies the northern gabled-end of the ca. 1889 Cross-wing which was cut in half (vertically) to accommodate the 1976-1977 Rixie addition. (C) Photo C identifies the 1976-1977 Rixie addition and half-gabled-ends that still remain from the ca. 1889 Cross-wing cottage on the north and south ends of the west (rear) elevation. (D) Photo D identifies the historic siding of the ca. 1889 Cross-wing cottage. Note the window openings that were patched using historic siding from other areas of the ca. 1889 Cross-wing cottage. (E) Photo E identifies the southern gabled-end of the ca. 1889 Cross-wing which was cut in half (vertically) to accommodate the non-historic Rixie addition.

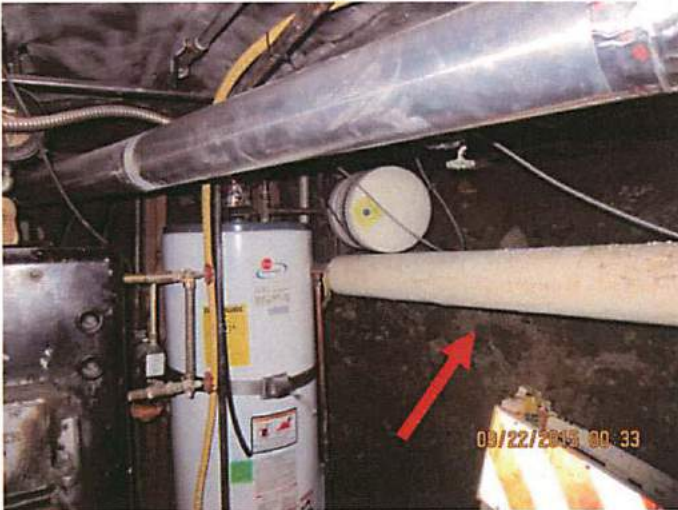
**Photo 1** The structure has no concrete or stable foundation. The foundation consists of rubble, dirt and lose stone matter.

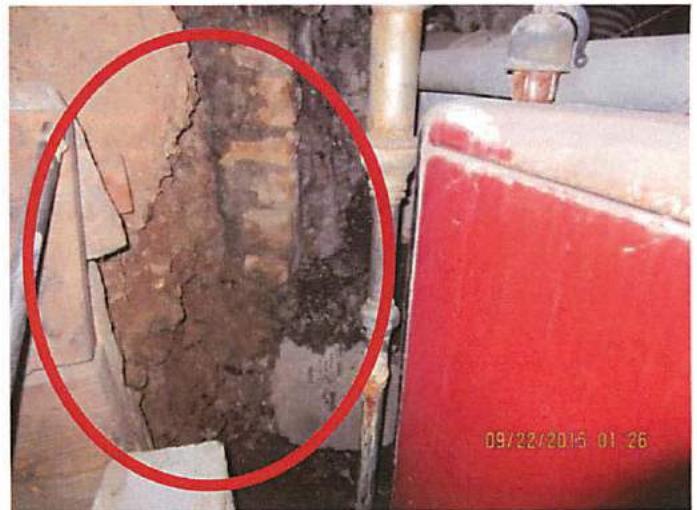
**Photo 2** Decay of the rubble foundation due to water infiltration

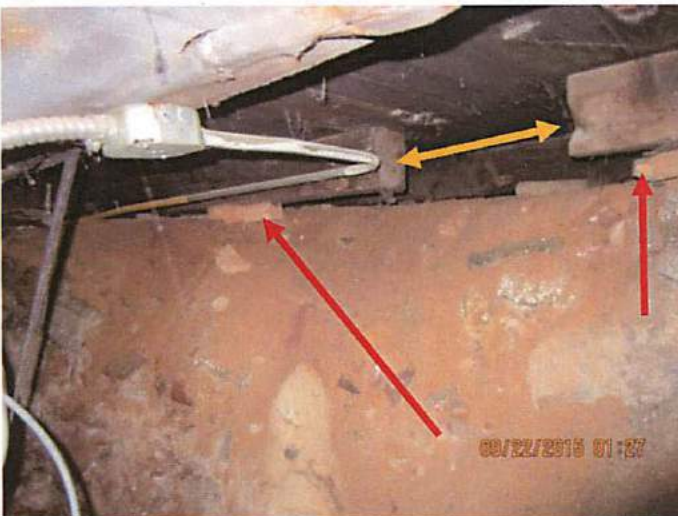
**Photo 3** The red arrows show improperly installed shims are blocking to level the floor above. Not permitted on dirt . The yellow arrow shows the removal of floor joist, this is consistent throughout the floor area

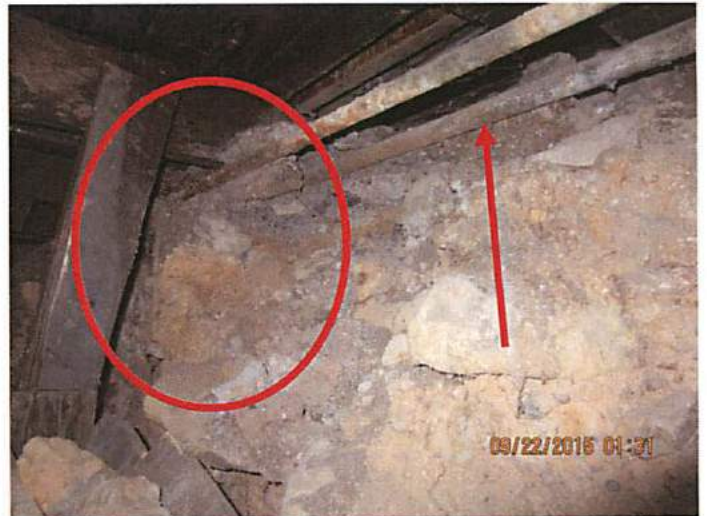
**Photo 4** The red circle shows movement of the rubble foundation and decay of the floor joist members resting directly on top of the rubble. The red arrow shows decay of water lines used to heat the structure

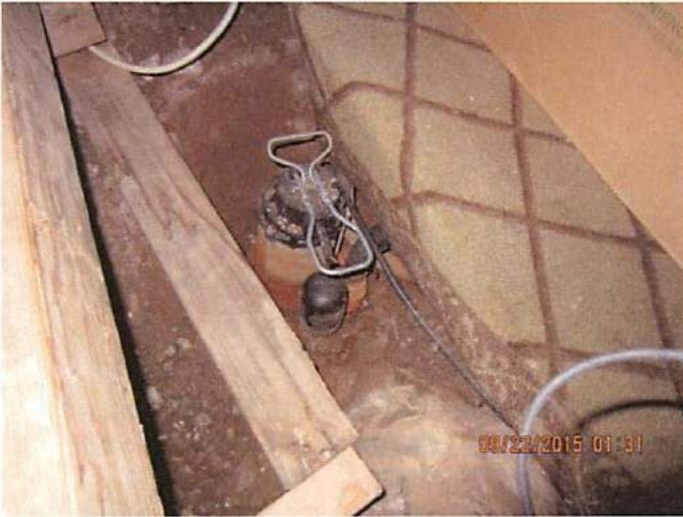
**Photo 5** A sump was installed to remove water from the area but was not properly maintained and currently is not in working condition

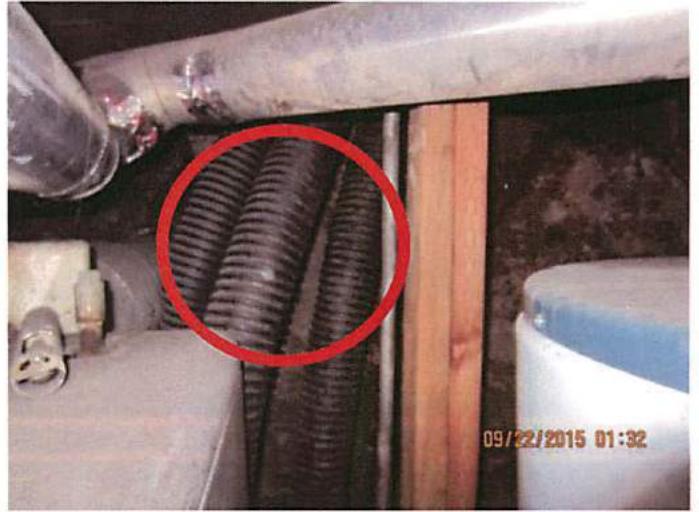
**Photo 6** A drainage system was improperly installed and permitted to drain directly on top of the dirt floor causing decay, mold and erosion

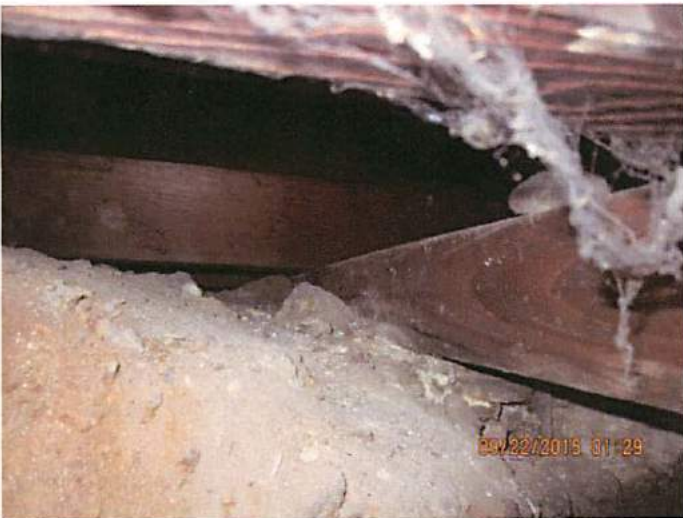
**Photo 7** The floor joist of the structure are resting directly on top of dirt and rubble. Not permitted under building codes

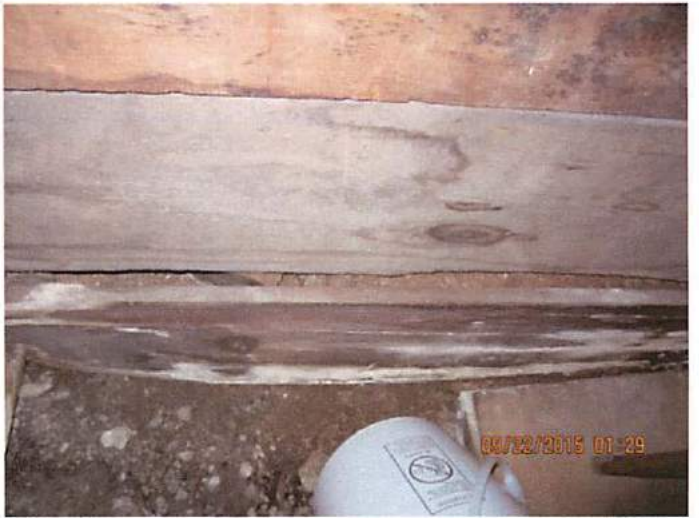
**Photo 8** Wood backing being used to prevent rubble from filling the storage area. Backing is failing and decayed. Serious mold and water concerns

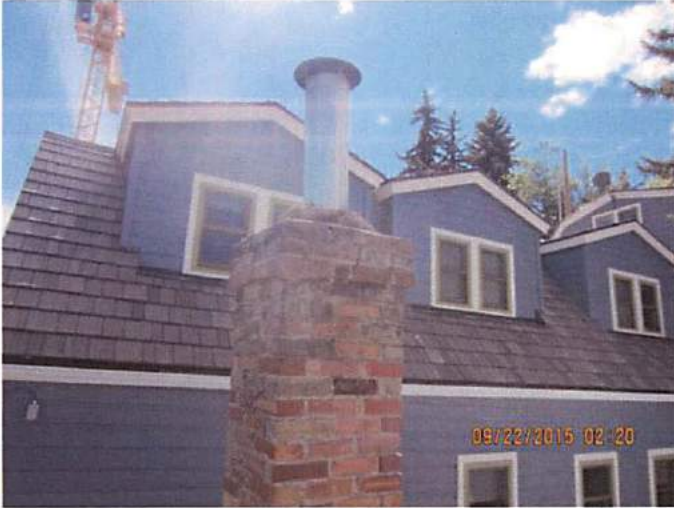
**Photo 1** The chimney shows signs of decay and instability. To be removed or evaluated by a structural engineer

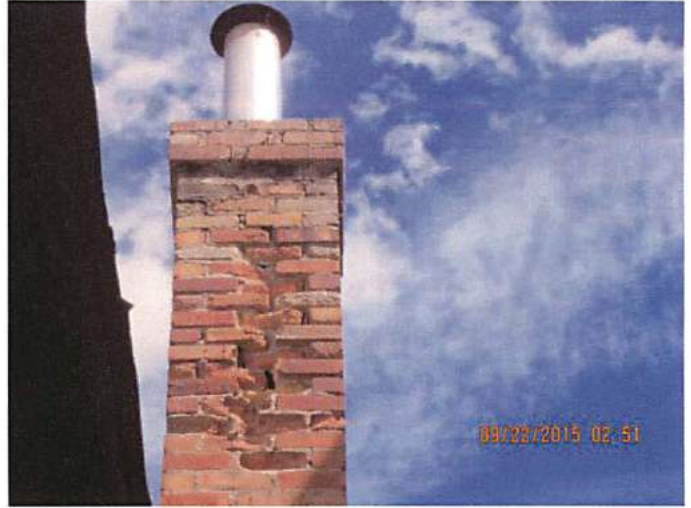
**Photo 2** Structural brick has decayed or is deteriorated in such a way is may fail

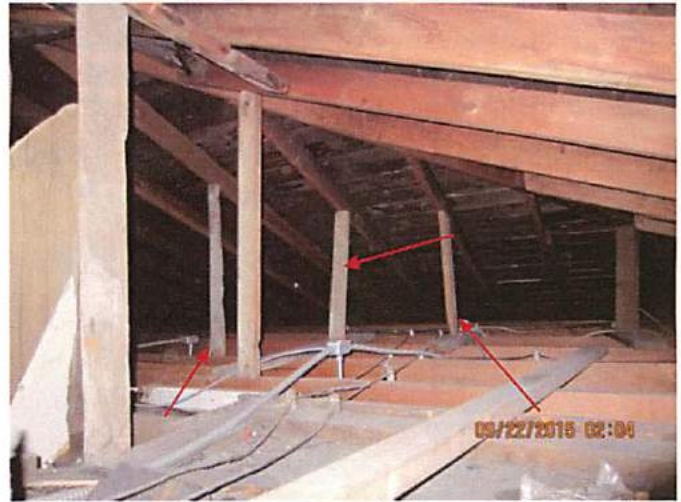
**Photo 2** Support members for roof are not adequate for the purpose being served. Engineer to justify

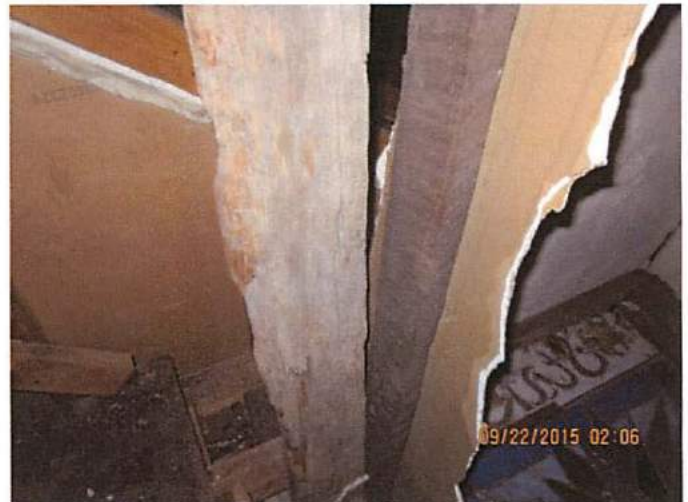
**Photo 4** Structural members not properly supported

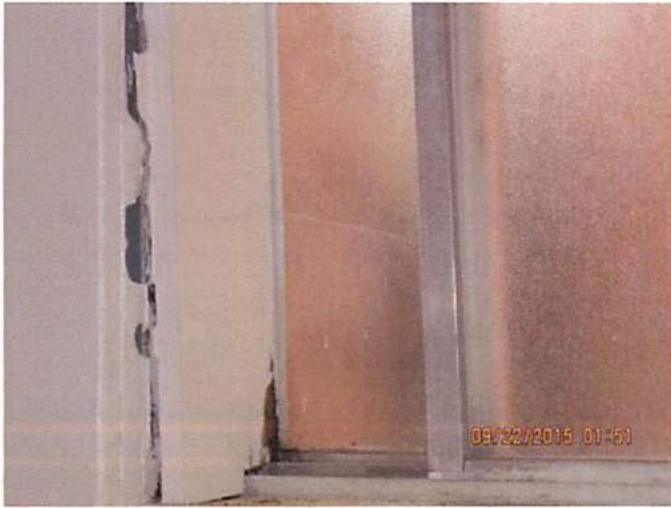
**Photo 11** Noted settling around the bathroom window on the second floor. Consistent with improperly installed support beam on third floor.

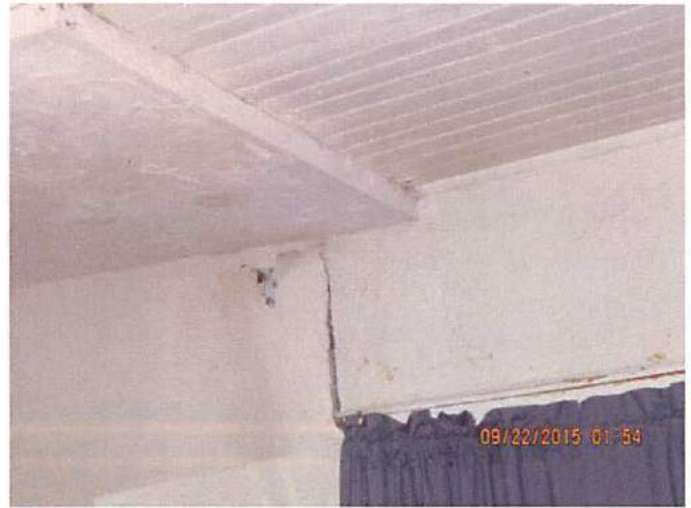
**Photo 12** Structural separation in second floor bedroom. Consistent with missing point loads and missing foundation

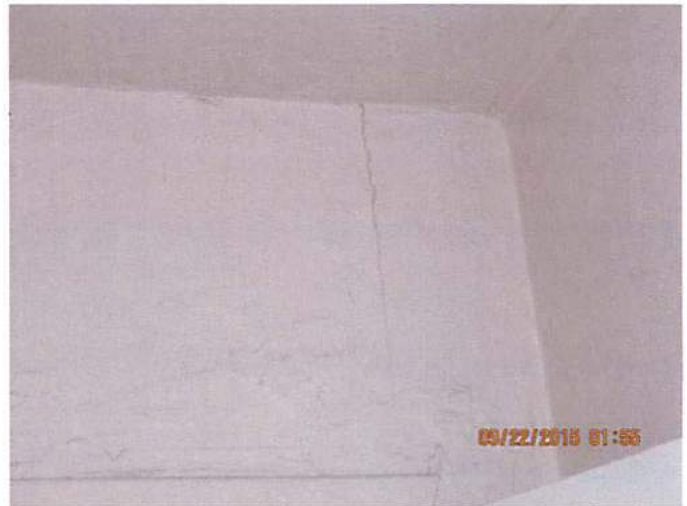
**Photo 14** Structural separation in second floor bedroom. Consistent with missing point loads and missing foundation

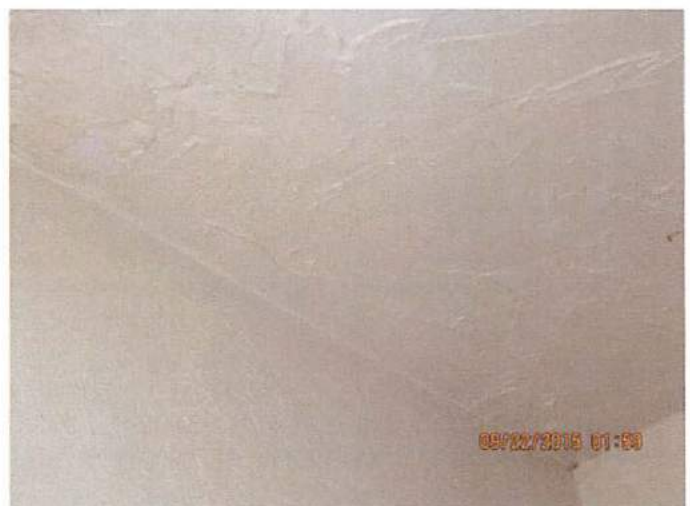
**Photo 16** Use of heavy texture was noted on recent repairs. Possibly being used to hide structural separation. Noted cracking and voids behind texture

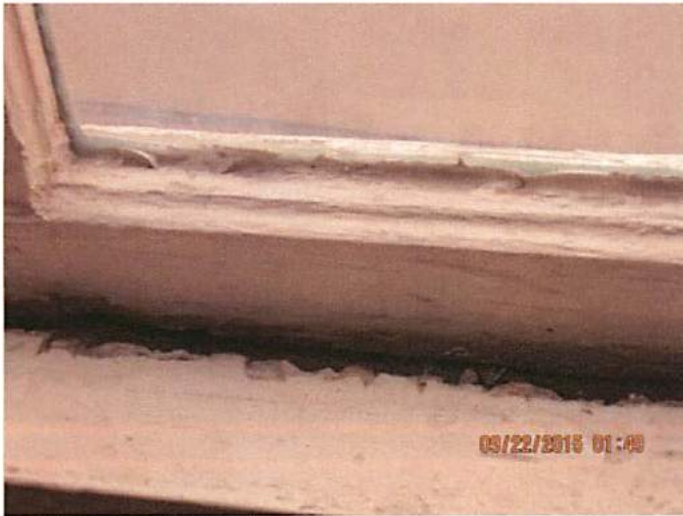
**Photo 17** Several windows on the second floor have separated and have been nailed shut. This is consistent with cracked and warped walls due to structural stability of the building

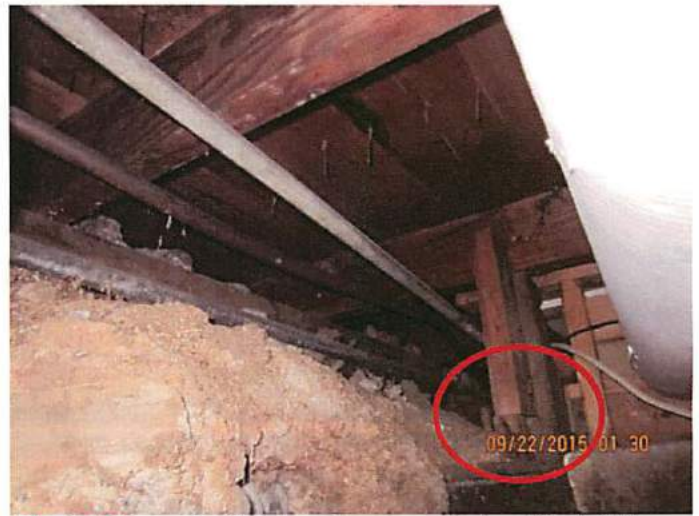
**Photo 18** Several shims have been used to level the building. These shims have not been properly installed

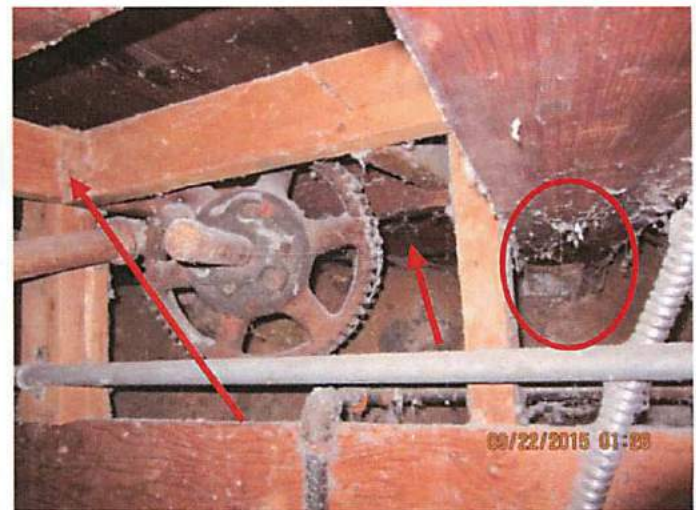
**Photo 22** Floor joist bearing directly on dirt. Shims and bracing added for support. Improperly installed

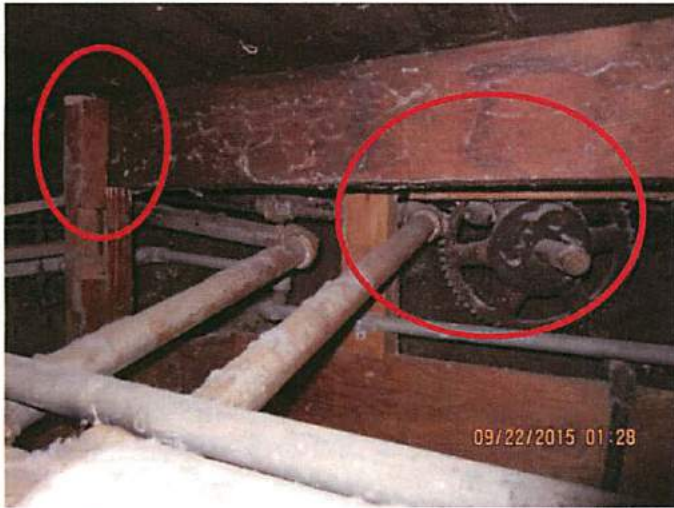
**Photo 23** The addition of bracing and shims to prevent settling of the building. Cannot have bearing directly on soils. All bearing is directly on soils. Engineer to justify

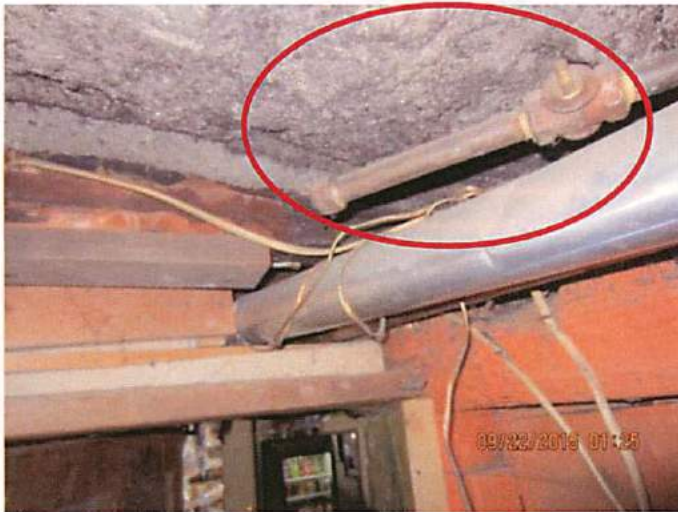
**Photo 1** Gas lines that have terminated in hidden rooms that are not properly secured. This room is located in the deli in the front area between entry doors

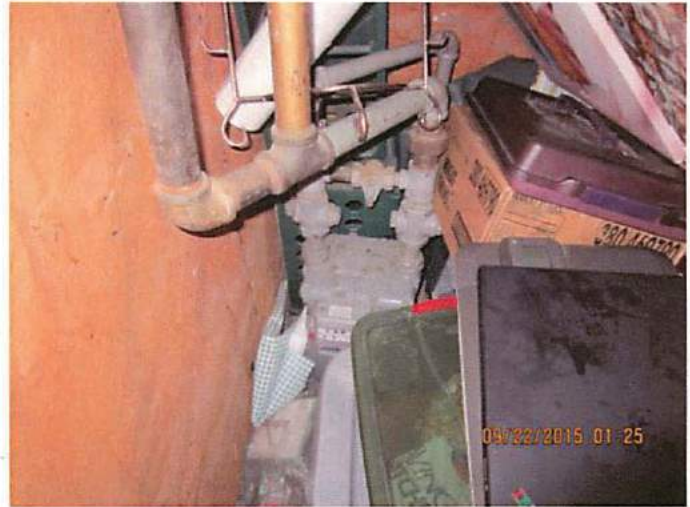
**Photo 2** Gas meter is located in a hidden room with possible improper connections to the building. The room is located in the front of the deli between the entry doors

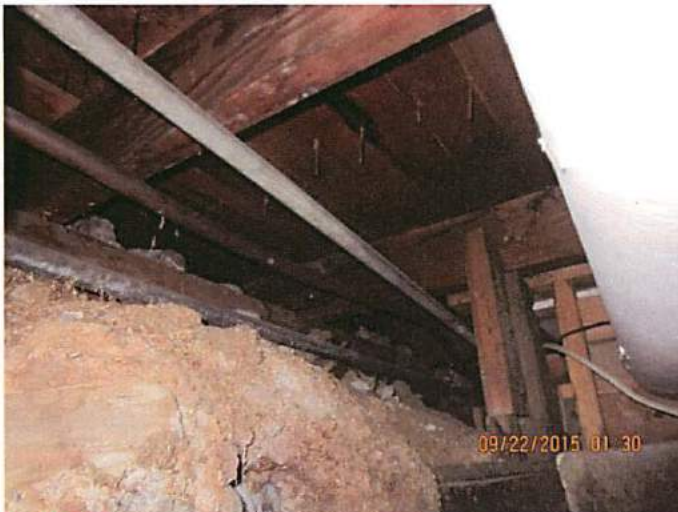
**Photo 3** There are numerous pipes consisting of potable water, heating water lines and gas lines that are in direct contact with soils and not properly secured. Decay and deterioration of piping is noted throughout the underground area

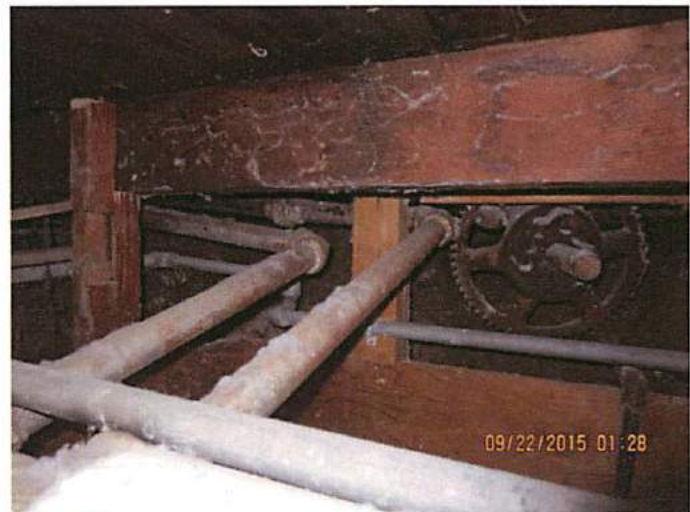
**Photo 4** Unsecured gas lines, unknown valves that are not properly maintained or marked

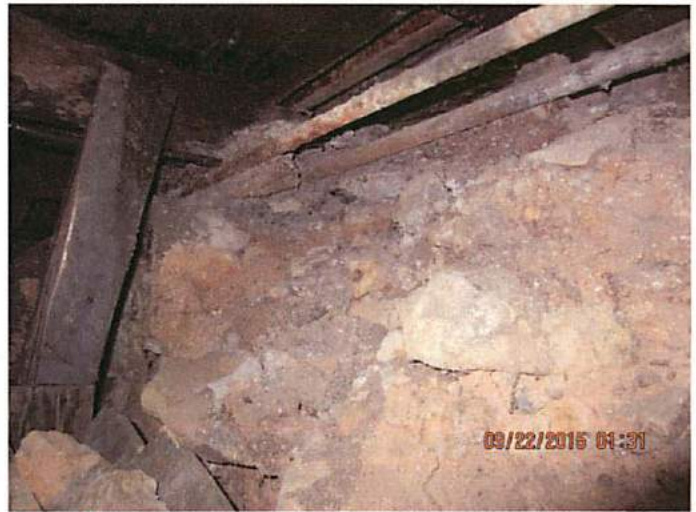
**Photo 6** Water lines used for the heating of the building are damaged by decay and deterioration. Erosion and sloughing of the rubble foundation. Severe stability concerns for the structure

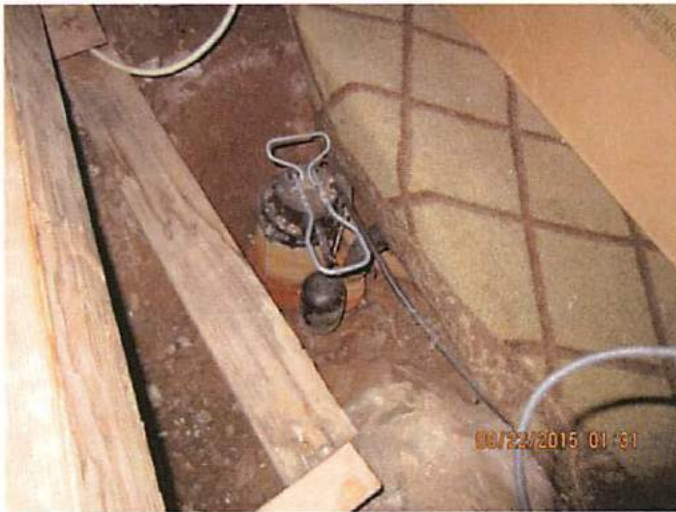
**Photo 7** A water/trash pump is located directly below photo 6, the pump is not in working condition

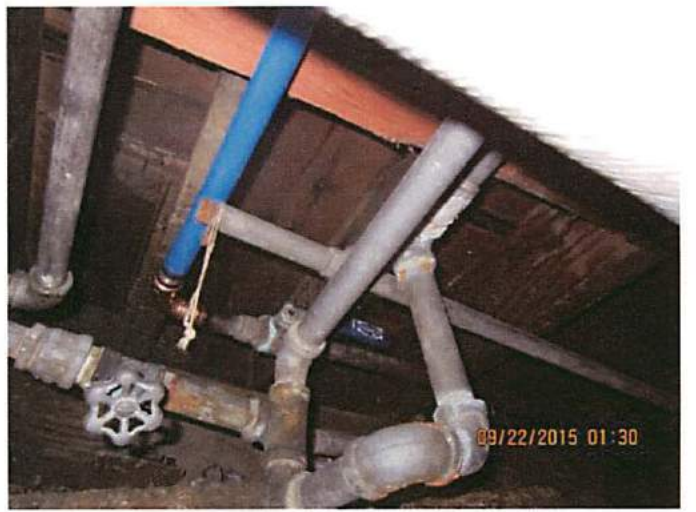
**Photo 8** Improperly installed plumbing repairs. Ends not properly capped. Copper to galvanized requires a brass coupler

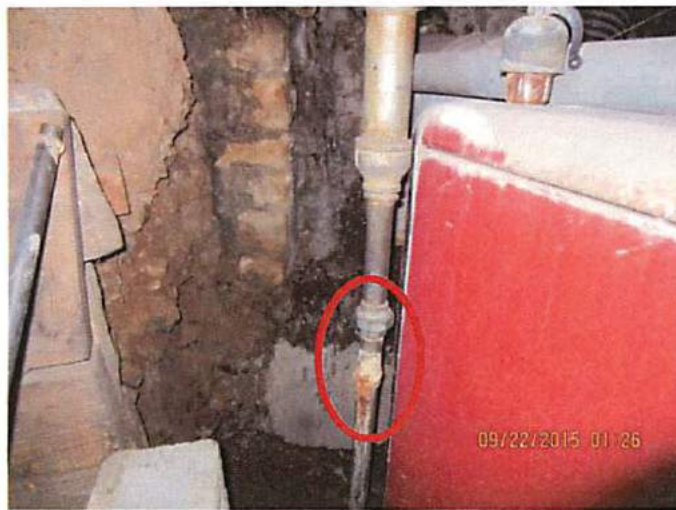
**Photo 9** Gas line shows decay and deterioration needs to be shut off ASAP

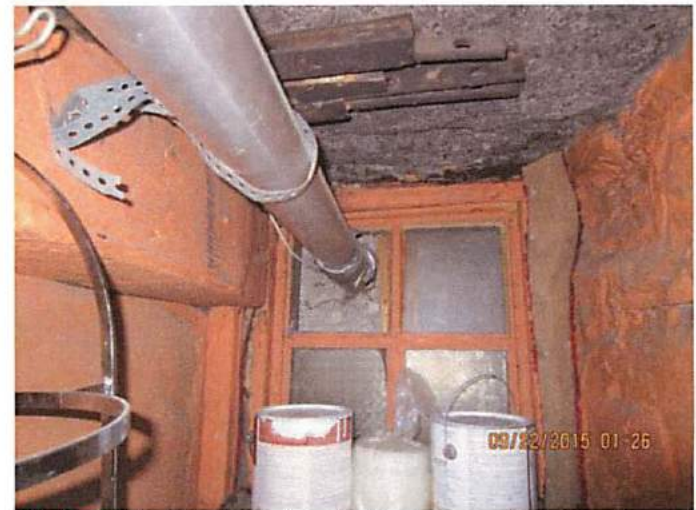
**Photo 10** Vent line for hot water heater exceeds the maximum length. Possible carbon dioxide (CO<sub>2</sub>) concerns. Located in deli

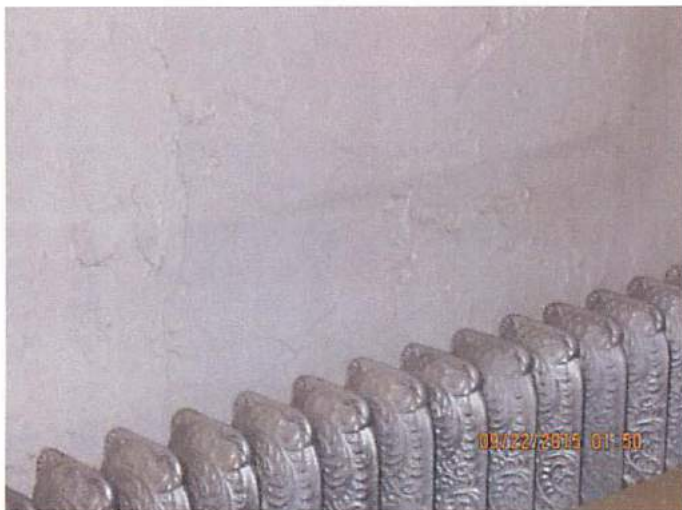
**Photo 12** Example of the radiator heating system that uses the boiler to heat the building

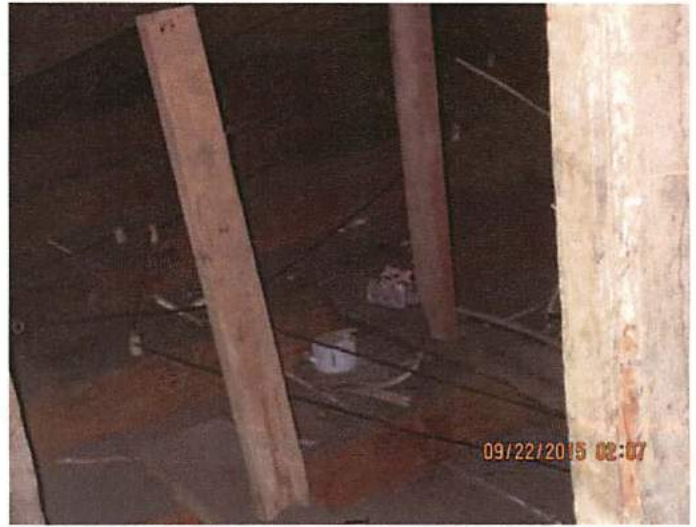
**Photo 18** General inspections noted that the knob and tube is most likely active

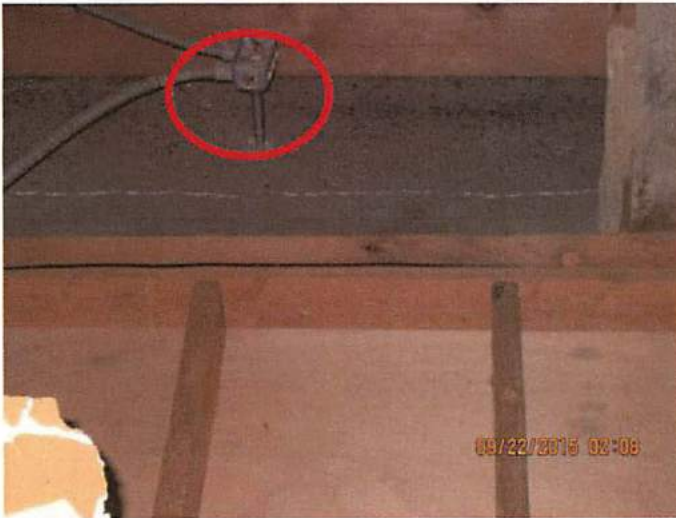
**Photo 18** Open electrical boxes noted throughout the building. Electrocutation hazard, fire hazard. Located in attic

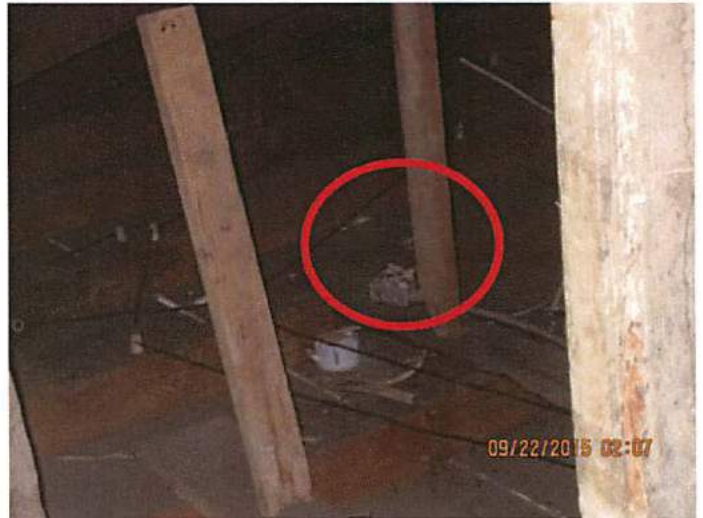
**Photo 19** Open electrical boxes noted throughout the building. Electrocutation hazard, fire hazard. Located in attic
