**PARK CITY MUNICIPAL CORPORATION  
 HISTORIC PRESERVATION BOARD  
 CITY COUNCIL CHAMBERS  
 November 2, 2016**

**Physical Conditions Report  
Internal Demolition Report  
227 Main Street - Star Hotel  
Submitted by Westlake Land, LLC**

**NOTICE AND ORDER TO REPAIR**

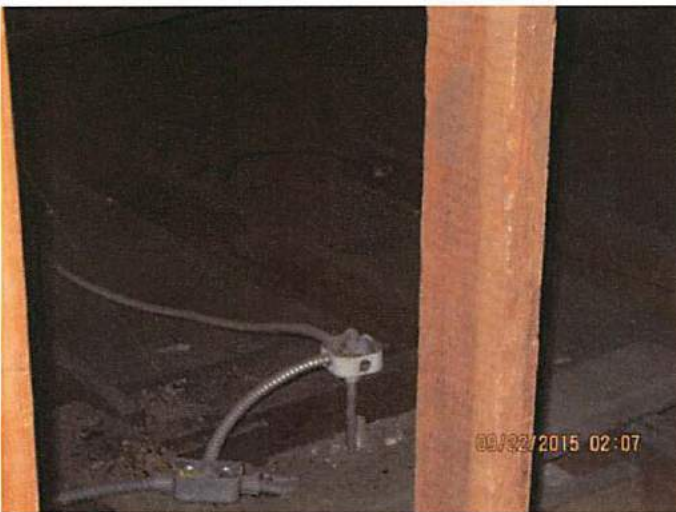
**Photo 20** Open electrical boxes noted throughout the building. Electrocutation hazard, fire hazard. Located in attic

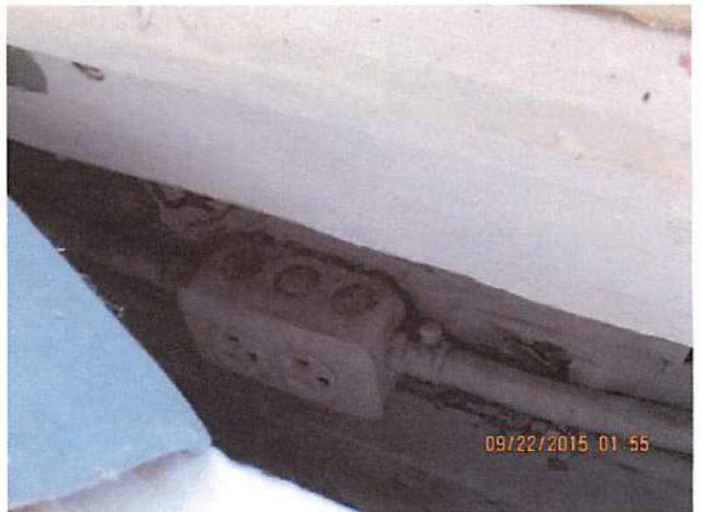
**Photo 21** Outlets located under windows that are damaged. Moisture and decay surrounds the electrical outlet

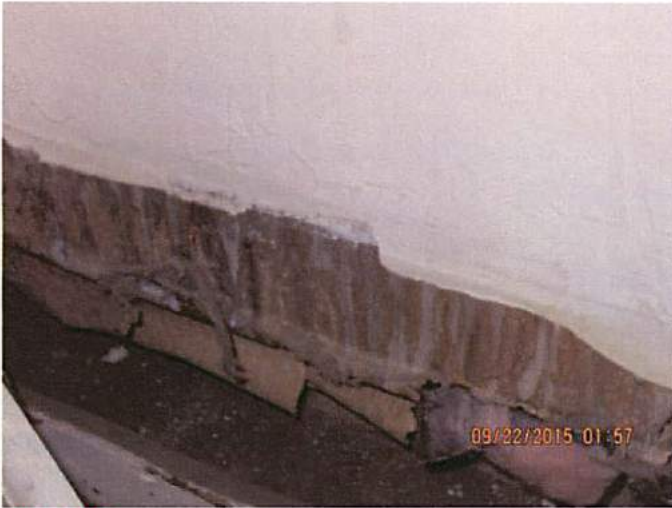
**Photo 22** Decay and deterioration noted throughout the building, cause appears to be lack of proper maintenance and infiltration of water from damaged roof

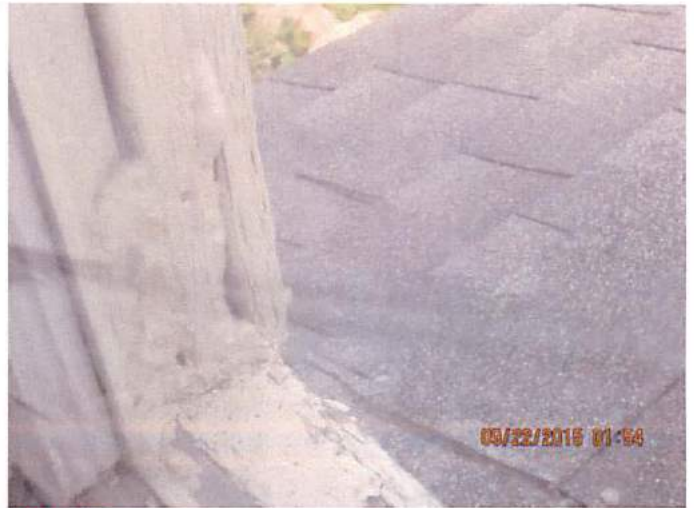
**Photo 23** Decay and deterioration noted throughout the building, cause appears to be lack of proper maintenance and infiltration of water from damaged roof

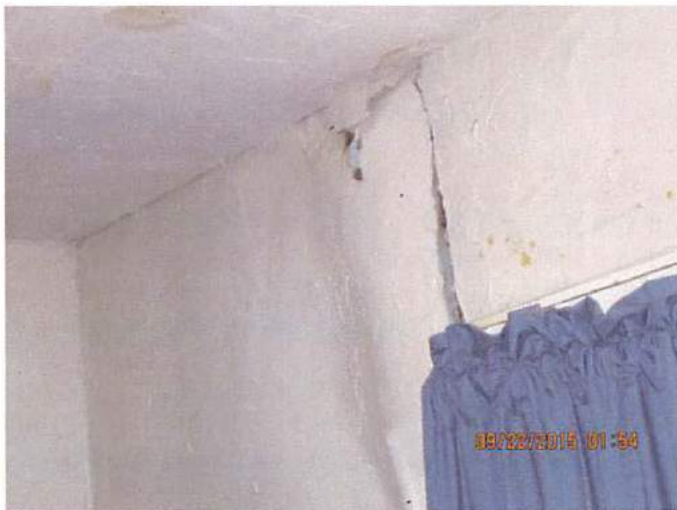
**Photo 24** Decay and deterioration noted throughout the building, cause appears to be lack of proper maintenance and infiltration of water from damaged roof

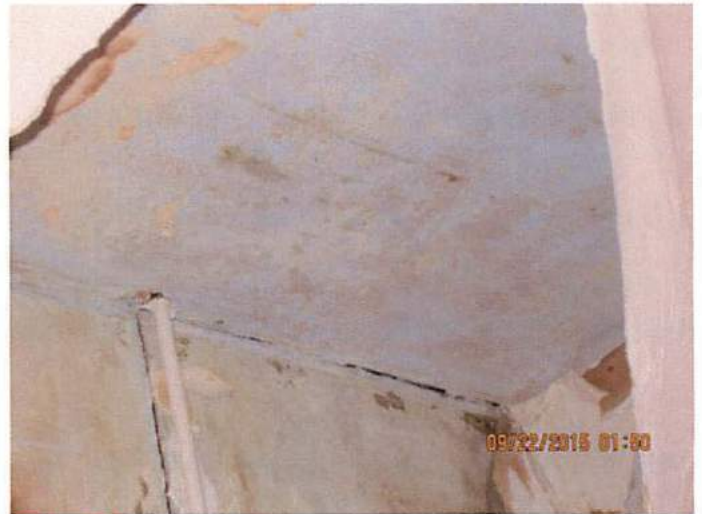
**Photo 25** Decay and deterioration noted throughout the building, cause appears to be lack of proper maintenance and infiltration of water from damaged roof

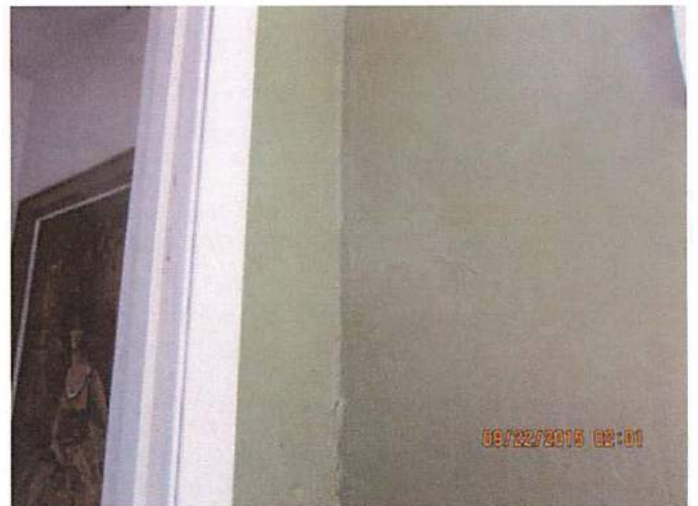
**Photo 27** Water damage and structural concern behind wall

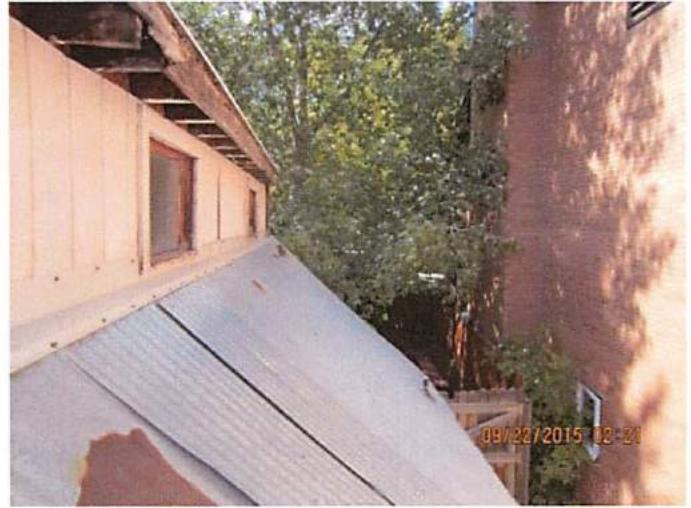
**Photo 31** Roof shows sign of decay and rot damage, soffit and fascia are missing, possible location of water infiltration

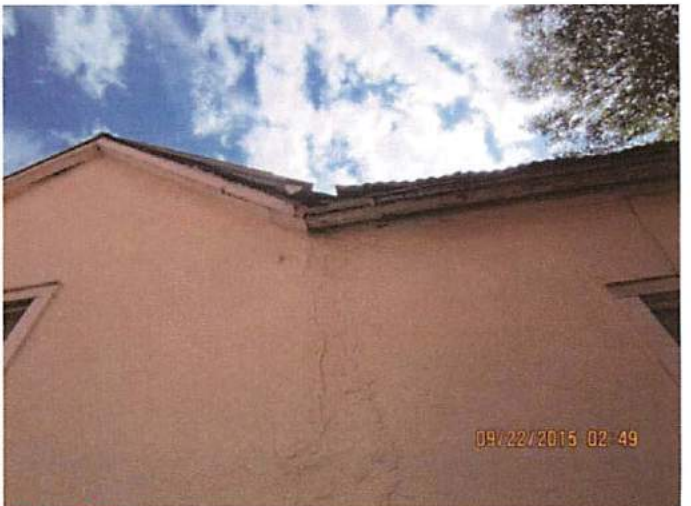
**Photo 33** Structural concerns possibly related to the drainage from the roof

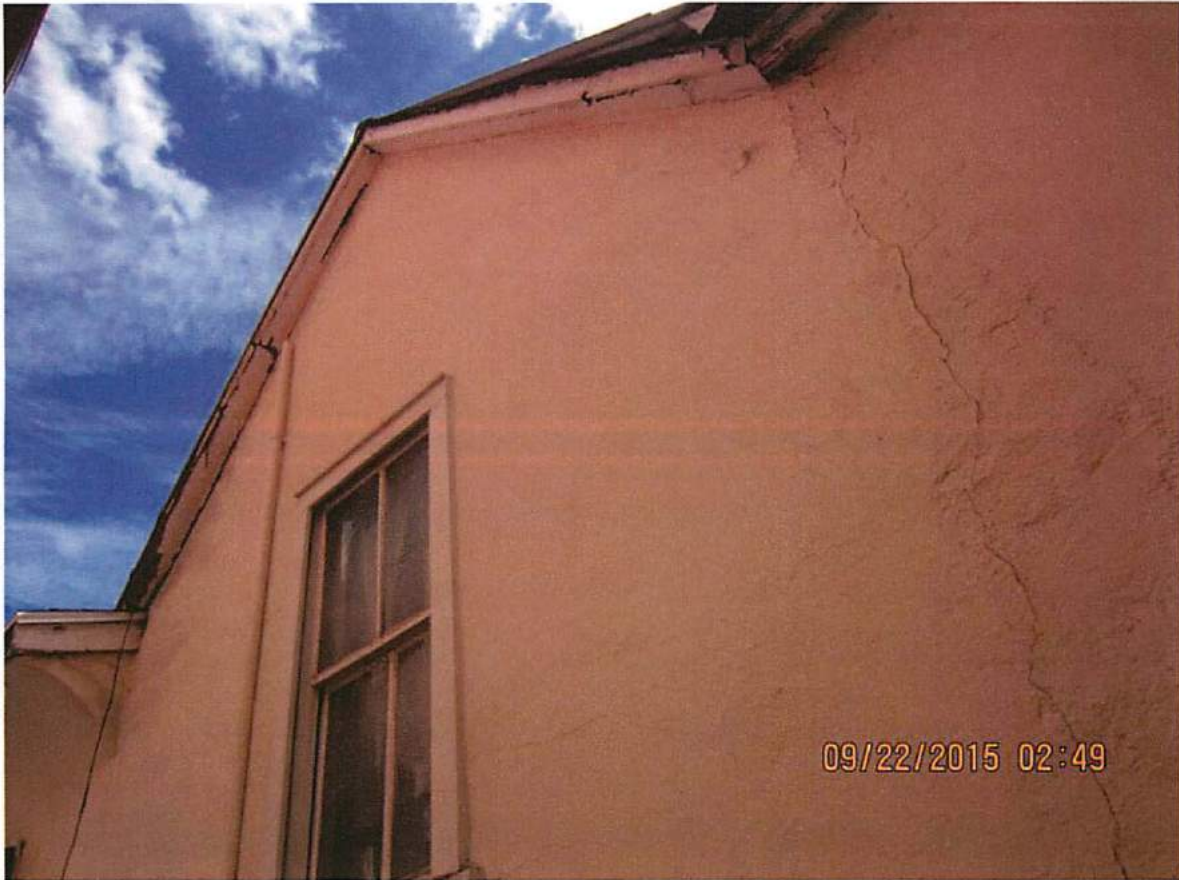
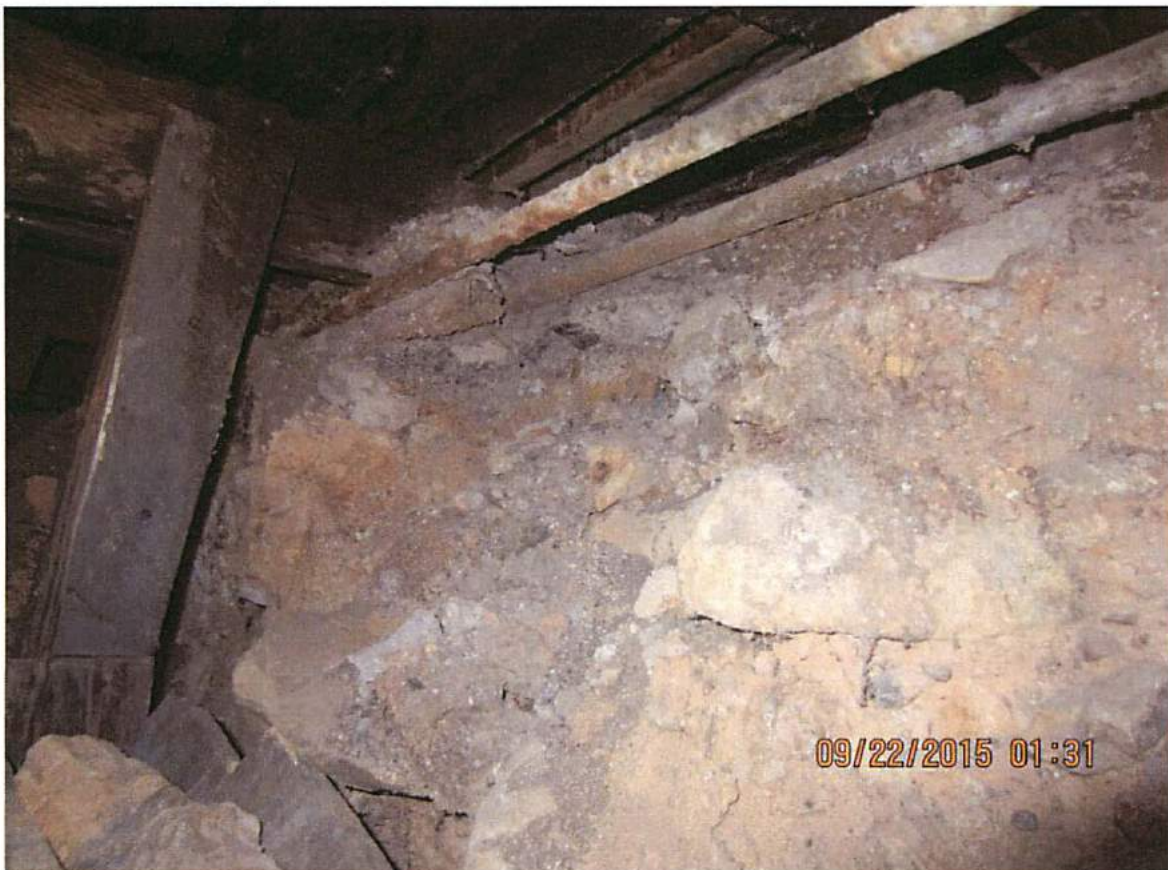
**Photo 34** The "above and "below" photos represent the continuation of a structural crack that is consistent with a rubble and dirt foundation. Structural deviations are difficult to see on wood framed construction. At least 30 of the building is wood framed

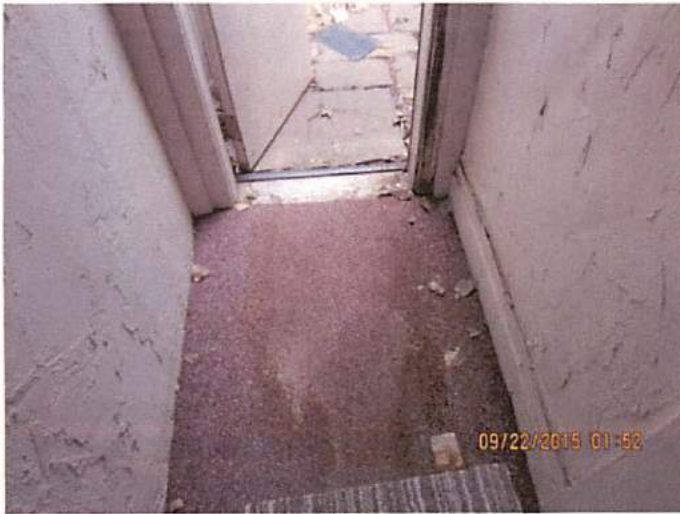
**Photo 35** Egress from the back of the dwelling serving 50% of 8 units or 22 occupants cannot be used. Gates are locked to prevent escape and no safe access to the front of the building is provided. Limited egress, direct violation of the fire code for egress requirements for type R-3 buildings and occupant load

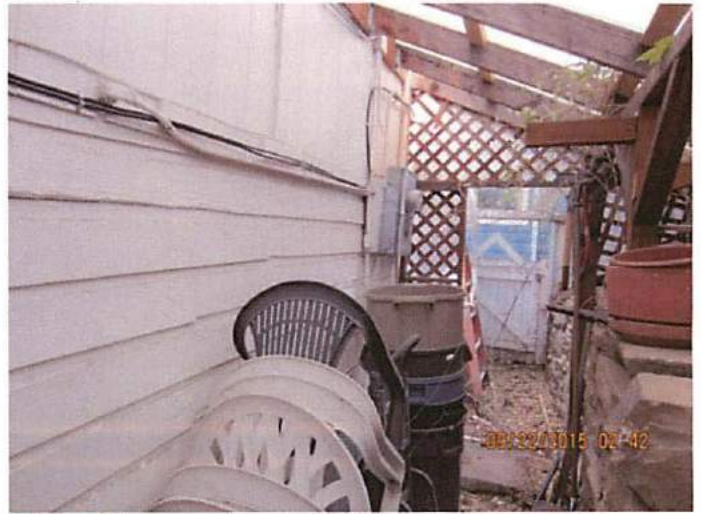
**Photo 36** Egress path rear of building. No access to safe location
