HISTORIC SITE FORM - HISTORIC SITES INVENTORY

Address: 45 King Road

Building Type and/or Style: Hall-Parlor / vernacular style

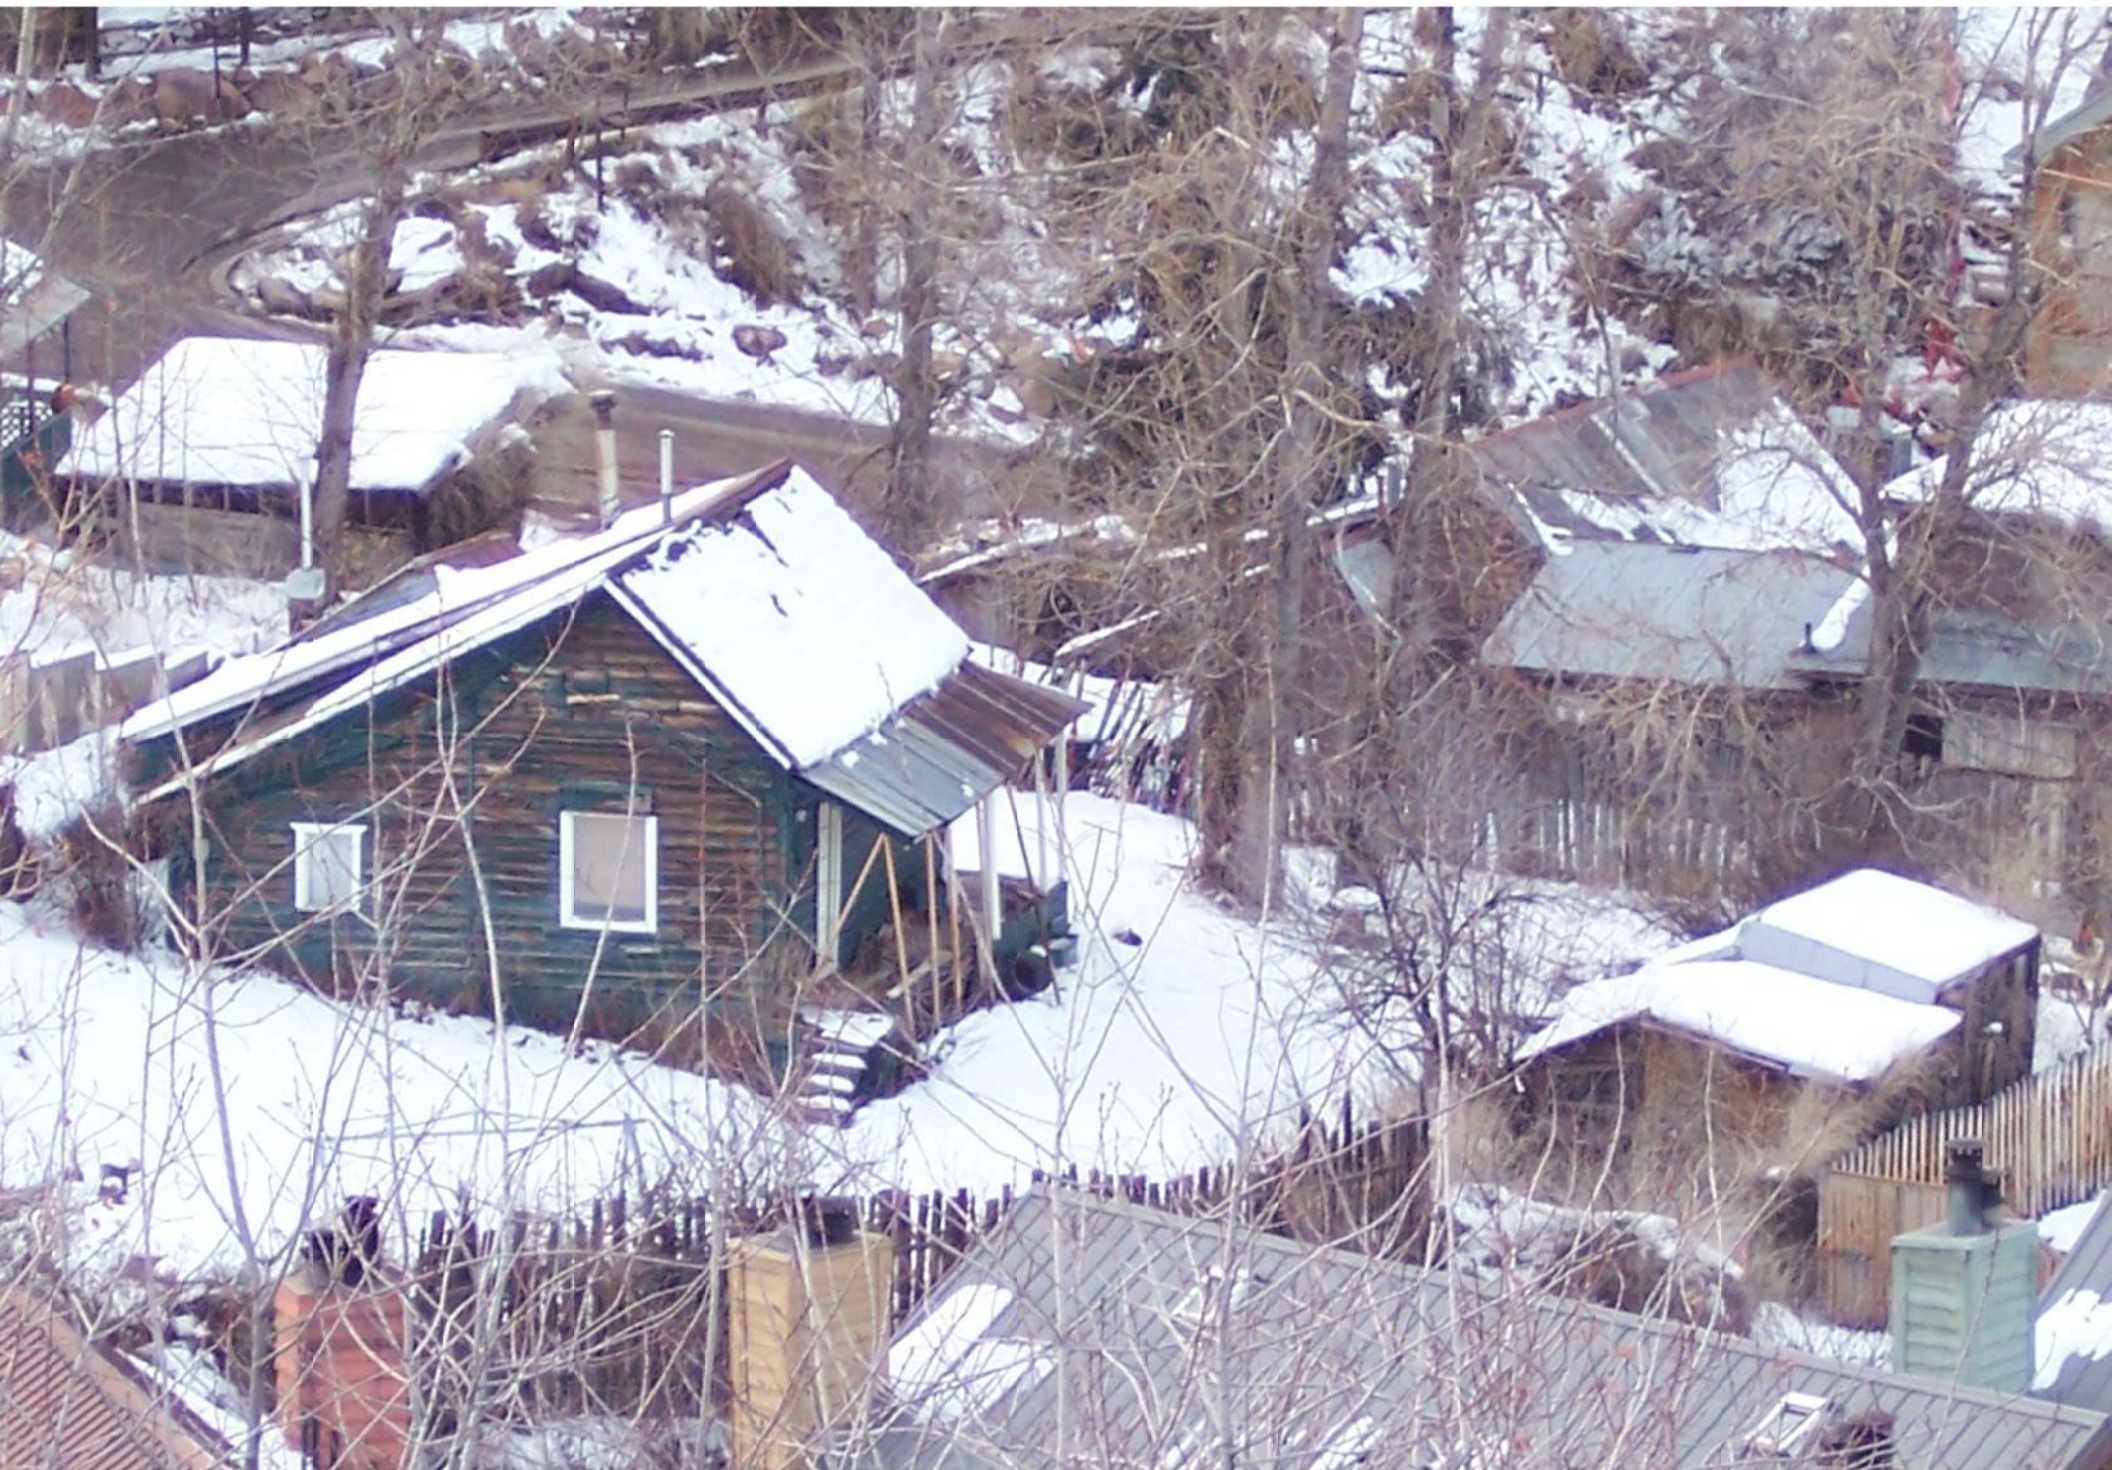
Photo No. 3: South elevation. Camera facing north from across canyon, 2006.

Walls: The exterior walls are clad in non-beveled (drop-novelty) wood siding and corner boards. Condition is poor and shows signs of severe weathering on south elevation.
