Historic Preservation Board Staff Report

Author: Katie Cattan
Subject: Historic Sites Inventory
Address: 811 Norfolk Accessory Structure
Project Number: PL-10-01021
Date: July 7, 2010
Type of Item: Administrative

Project Name: Park City Historic Sites Inventory
Applicant: Planning Department
Proposal: Remove Accessory Building at 811 Norfolk Avenue from the Historic Sites Inventory

HISTORIC SITE FORM - HISTORIC SITES INVENTORY

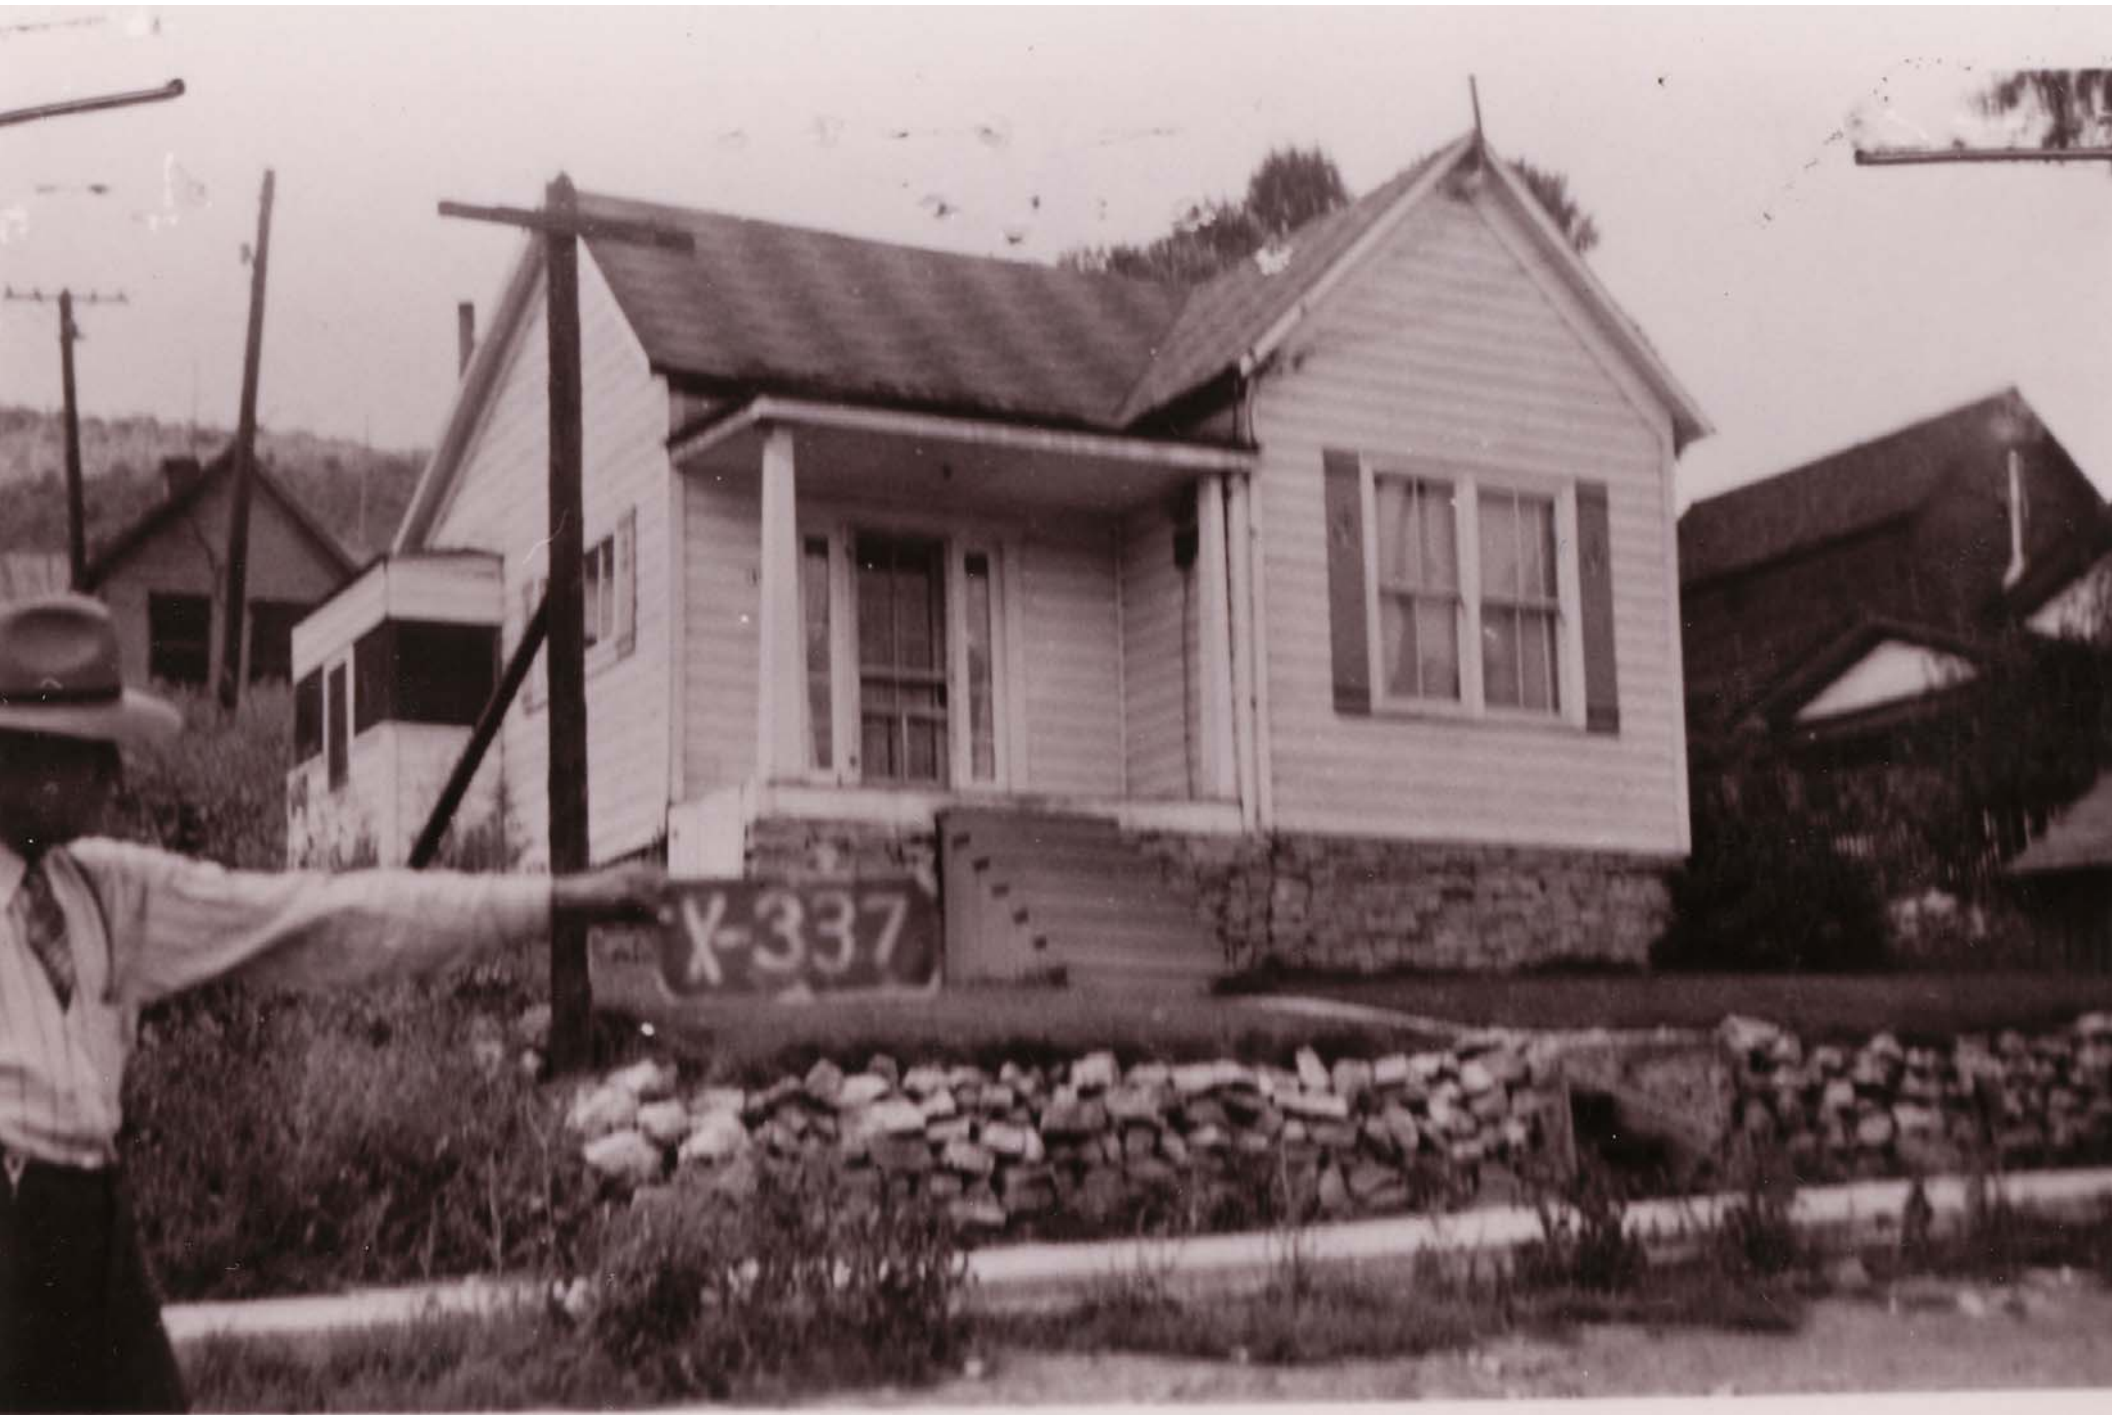
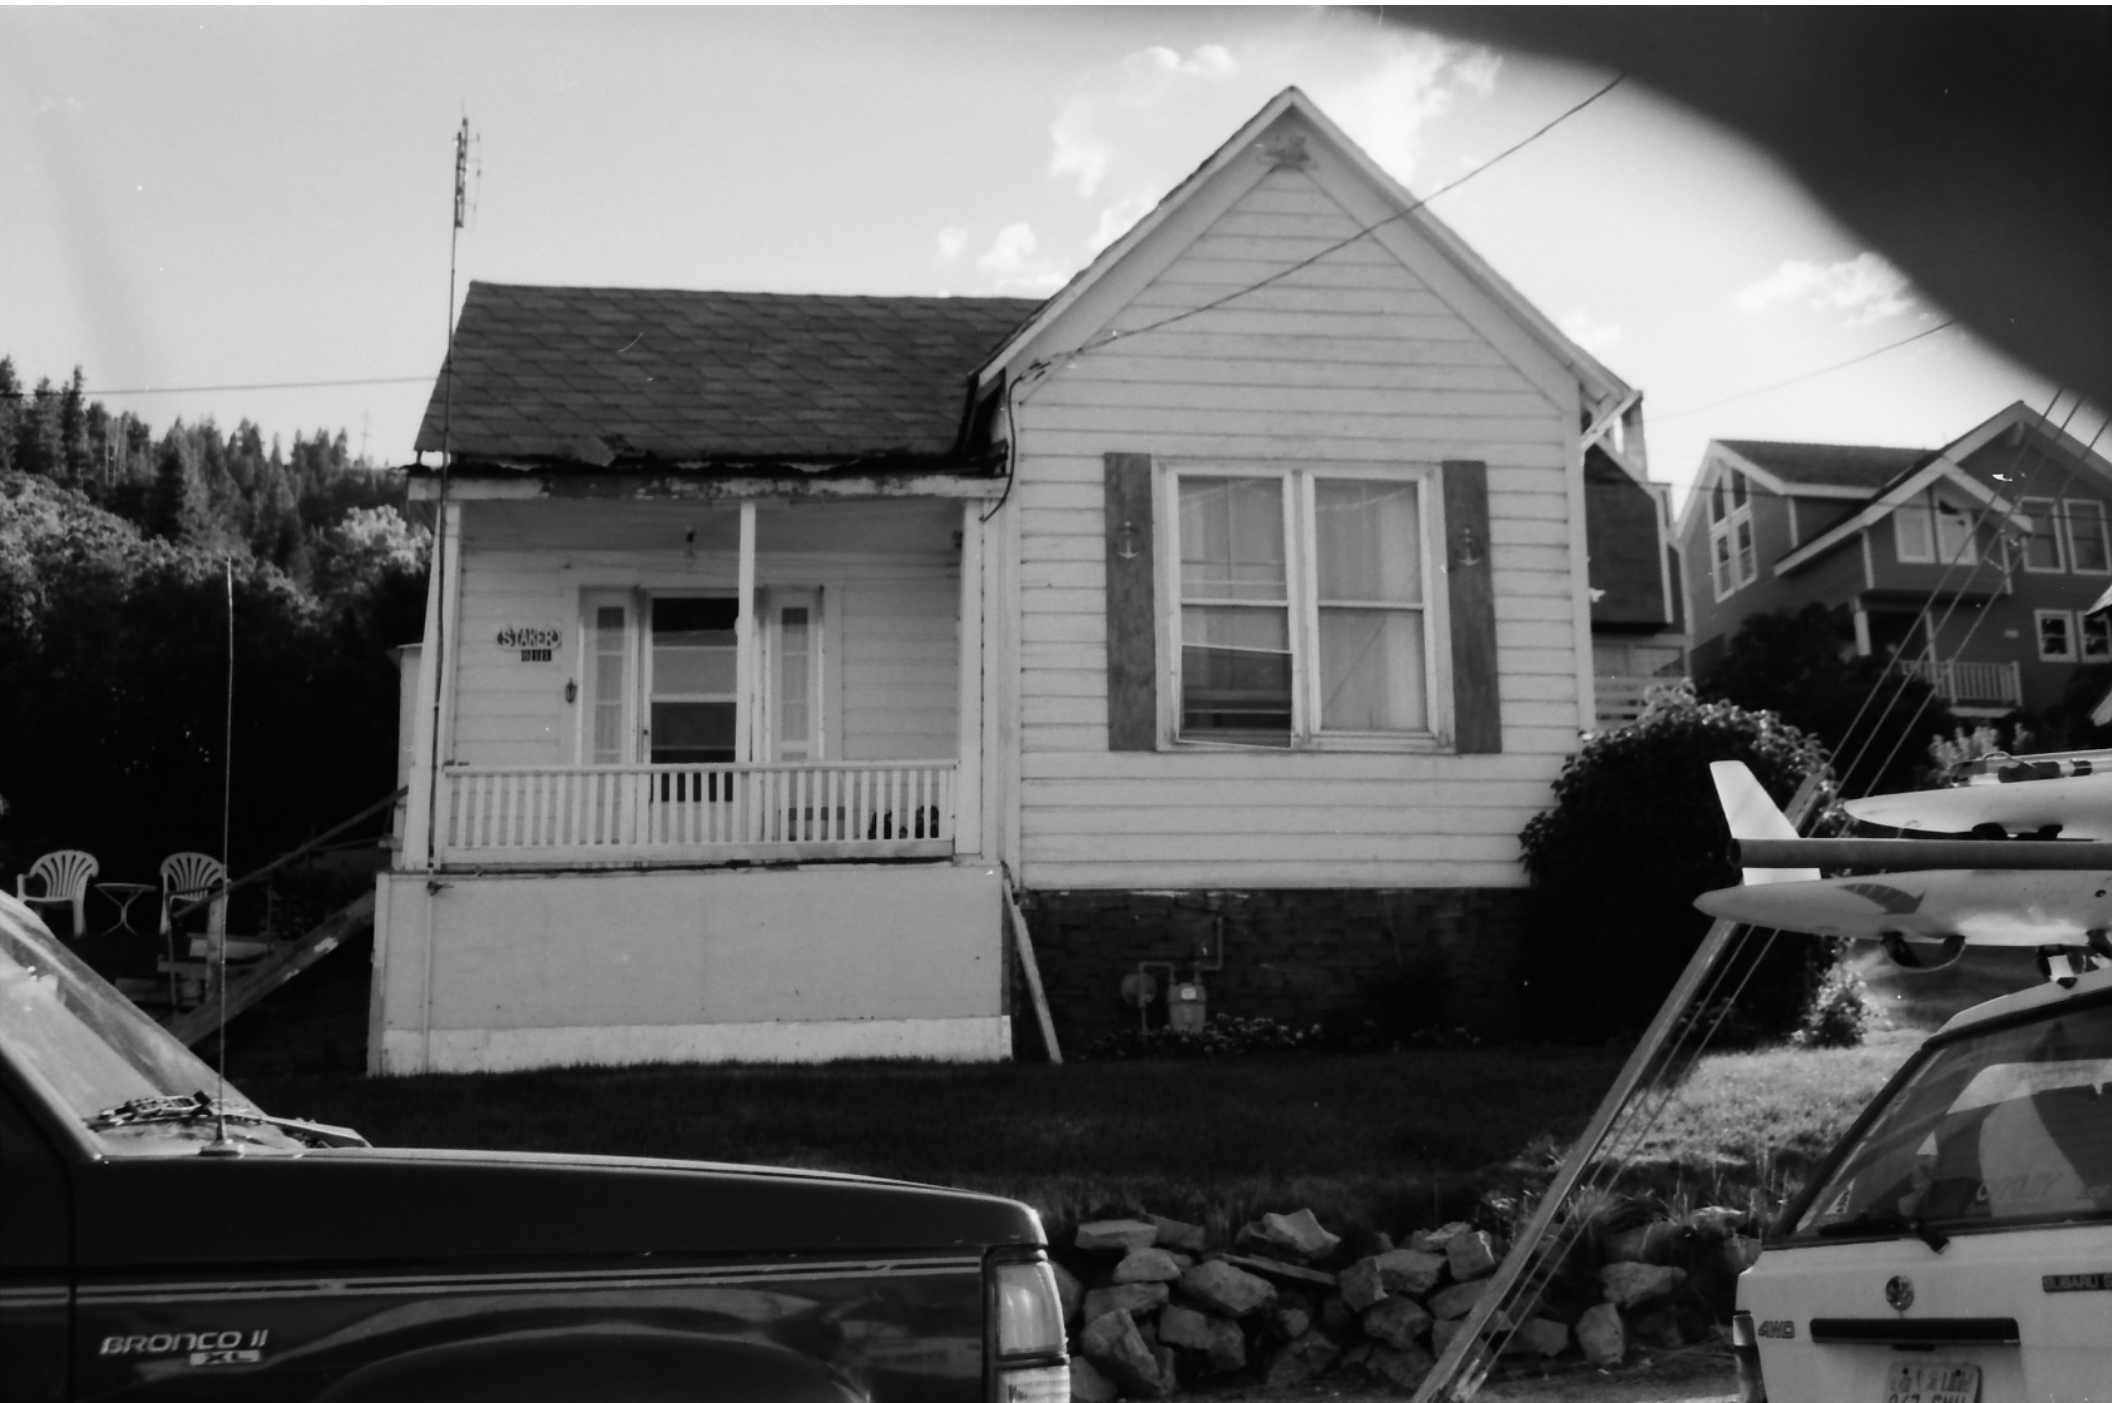
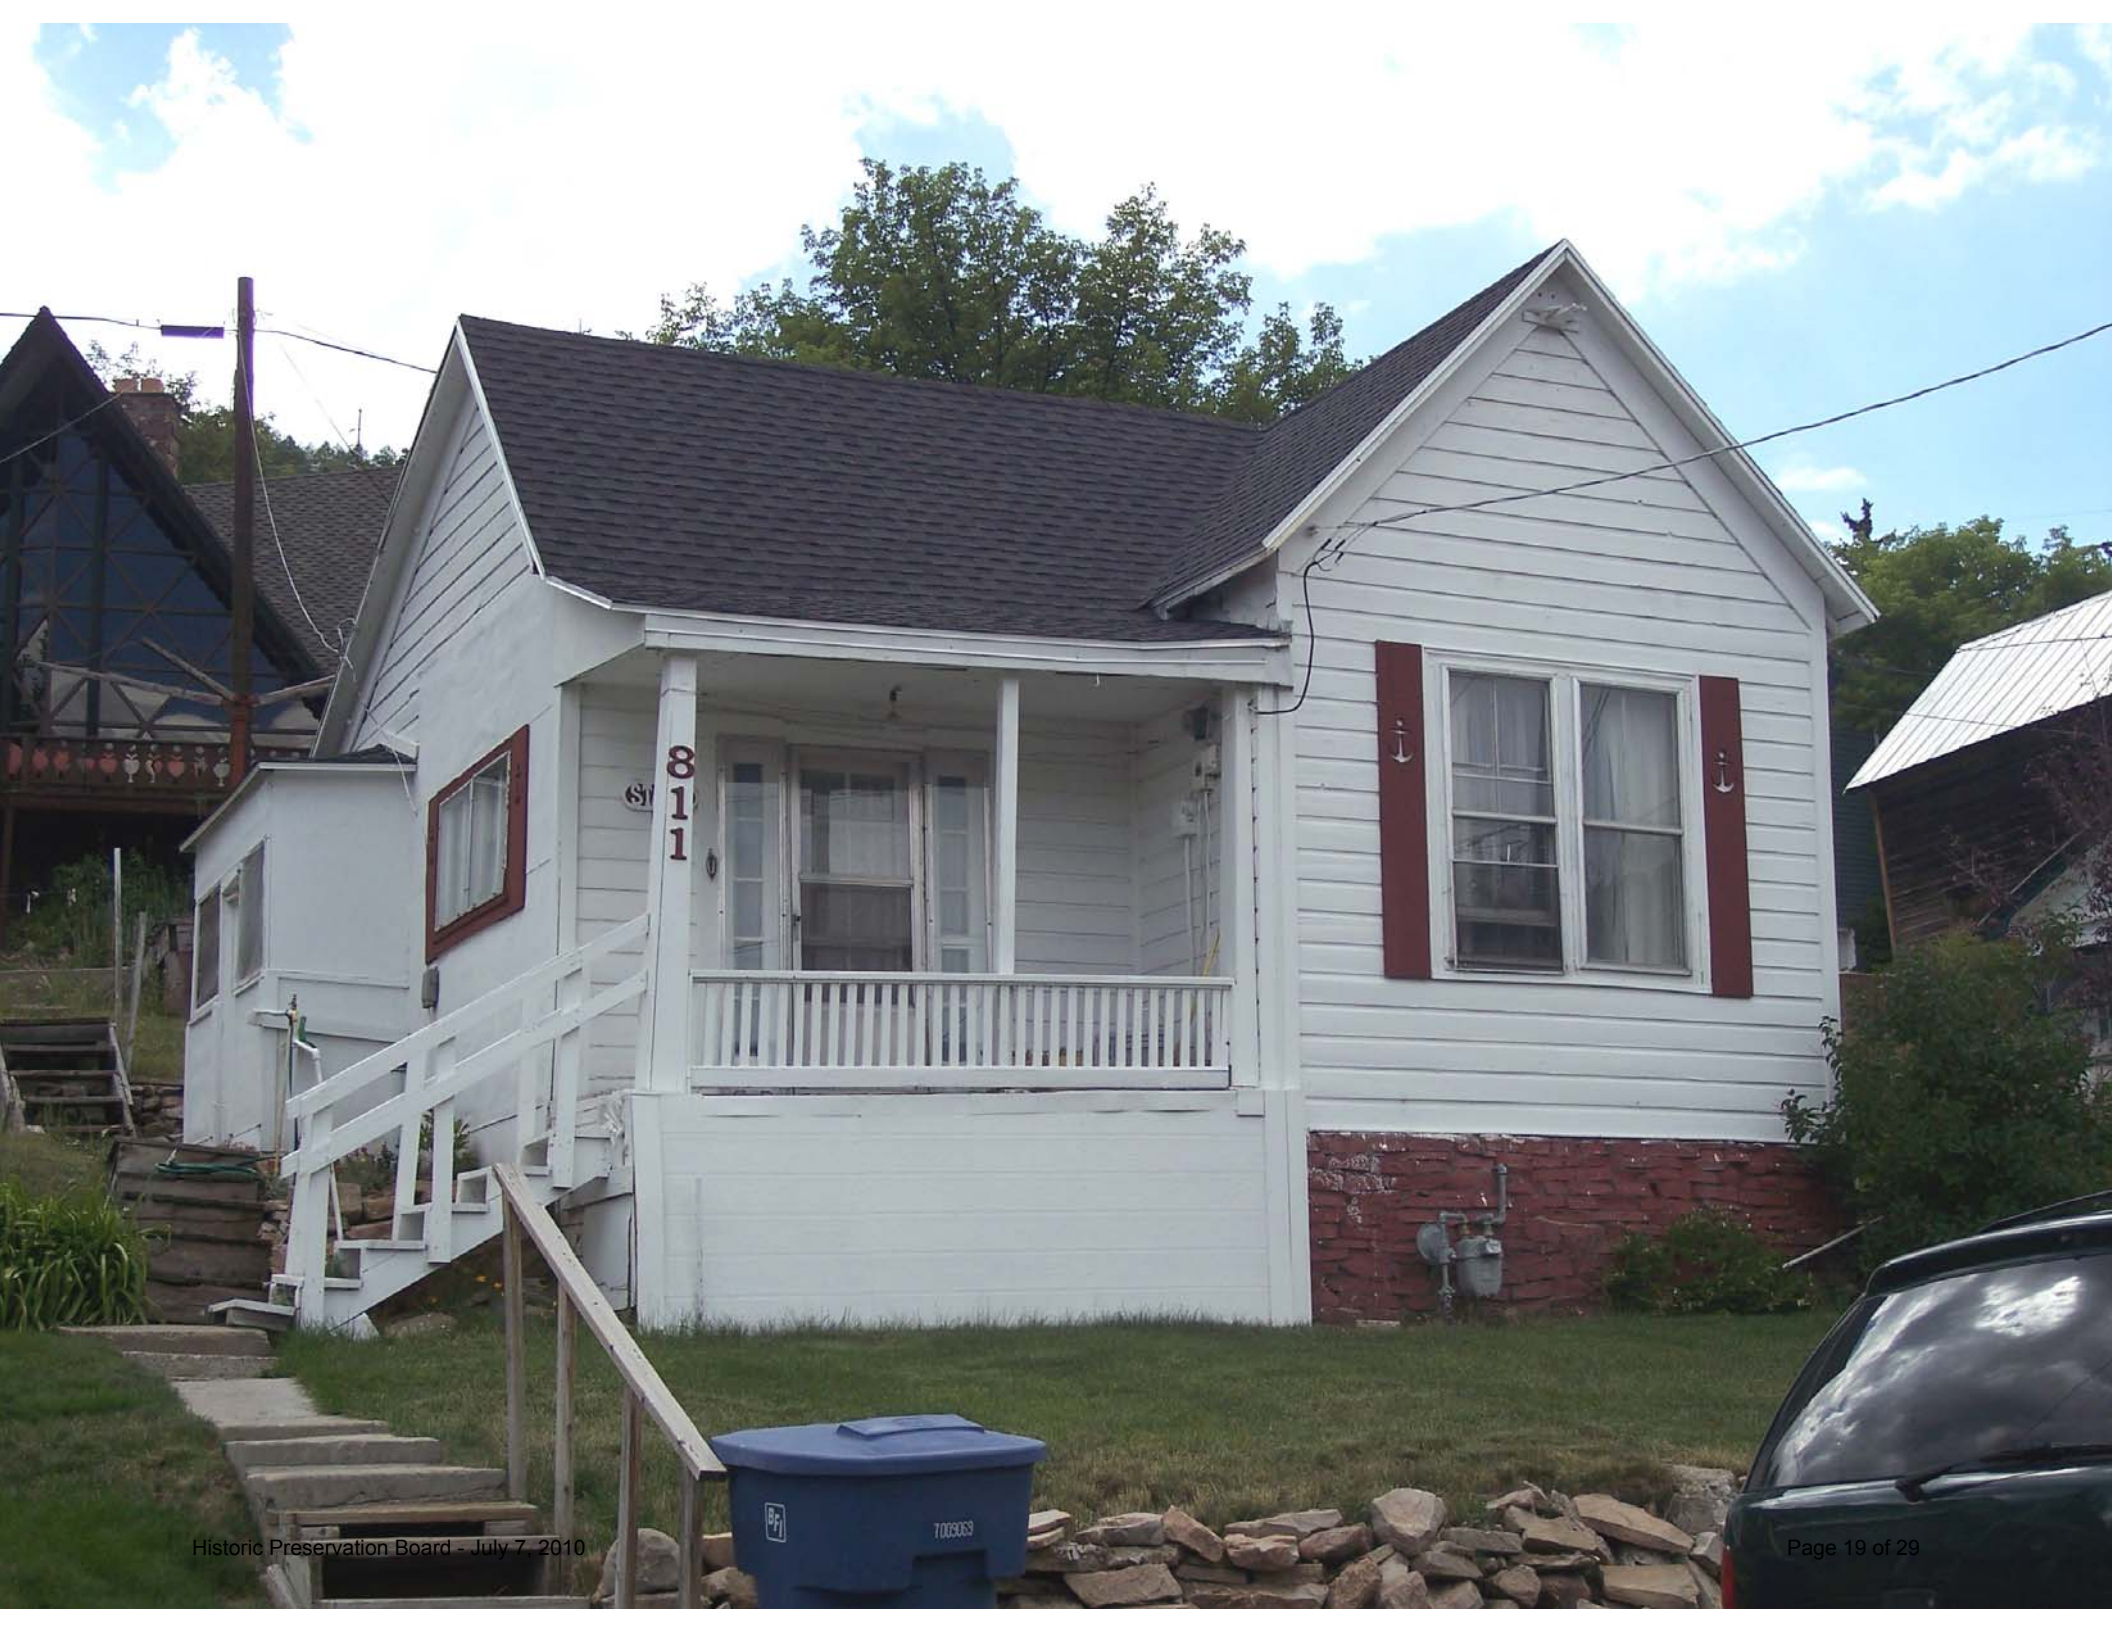
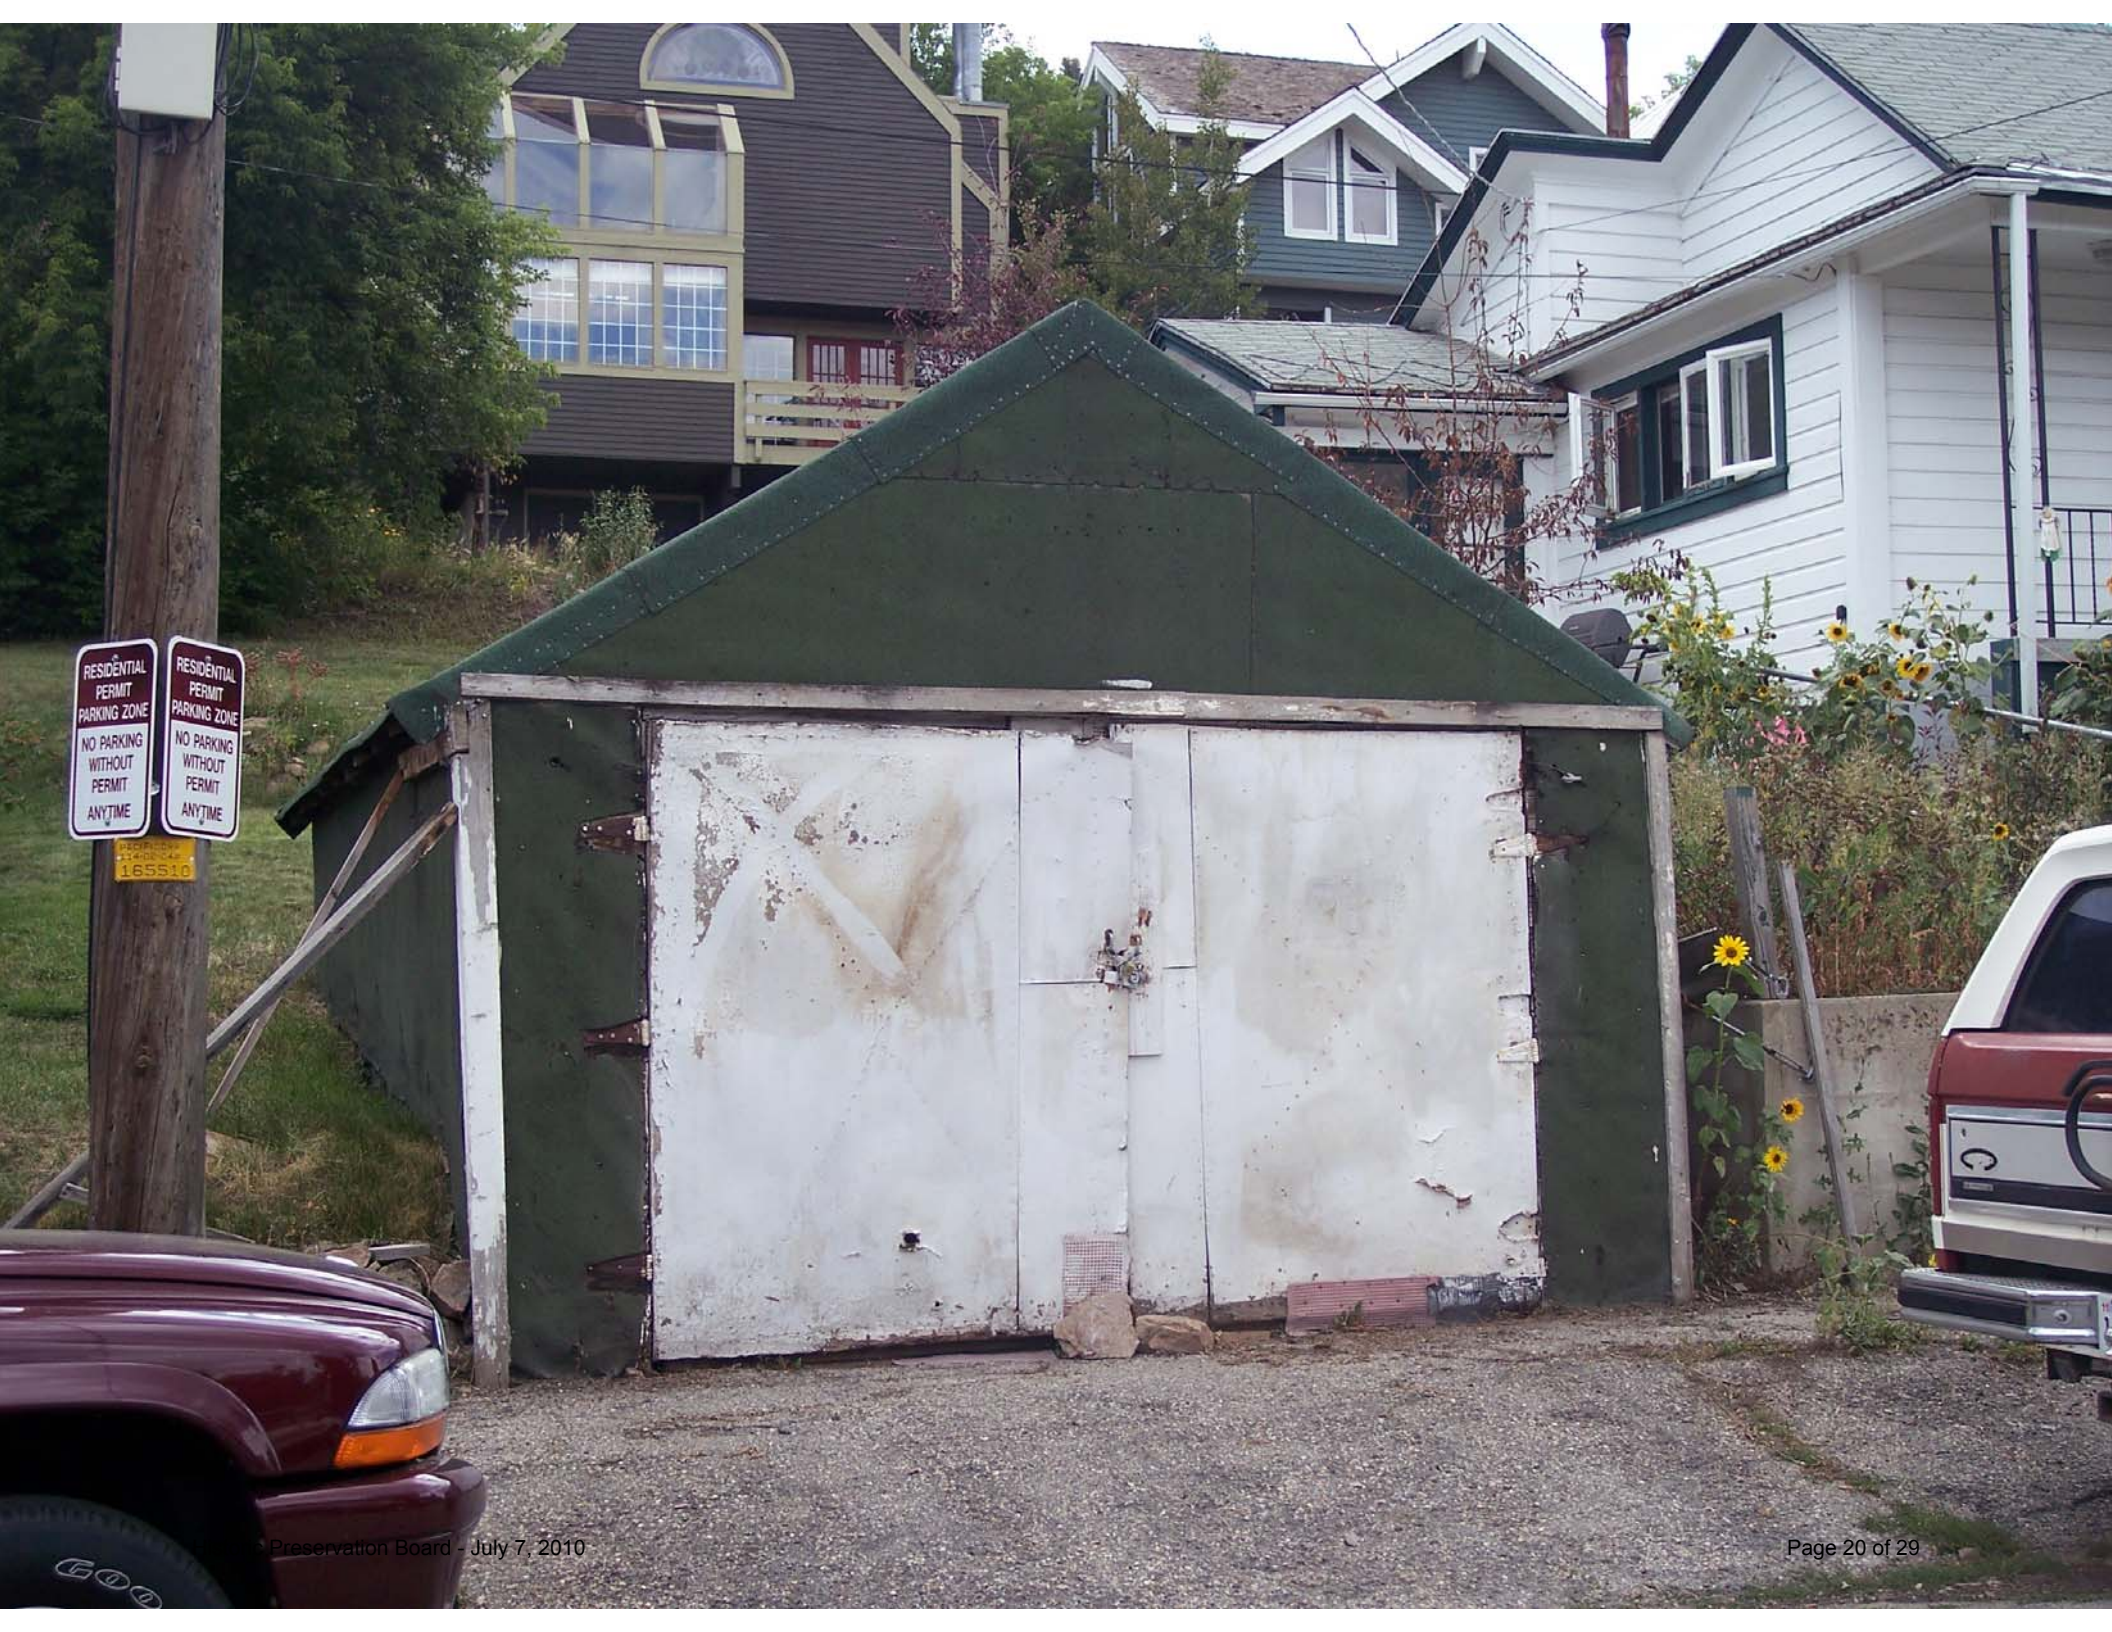
Photo No. 1: Southeast oblique. Camera facing northwest, 2006.

Photo No. 2: Accessory building. Camera facing west, 2006.

Photo No. 3: East elevation (primary façade). Camera facing west, 1995.

Photo No. 4: Southeast oblique. Camera facing northwest, tax photo.

Improvements: The frame garage dates from the historic period and is clad in a sheet material. It is mentioned on the 1959 tax card with the note that it is 15 years old although it does not appear on the 1949 tax card. 377 SF, Fair Quality
