Historic Preservation Board Staff Report

Author: Laura Newberry, Planning Technician
 Anya Grahn, Historic Preservation Planner
Subject: Material Deconstruction and Reconstruction Review
Address: 835 Empire Avenue
Project Number: PL-17-03556
Date: May 16, 2018
Type of Item: Administrative – Material Deconstruction and Reconstruction

Address: 835 Empire Avenue
Designation: Landmark
Applicant: Regis McHugh, represented by Architect Jonathan Degray
Proposal: Material Deconstruction on Landmark Site. The applicant is proposing to impact the following materials including the contemporary wood retaining wall; non-historic wood landscape steps; post-1941 rear additions; non-historic 1997 asphalt shingle and rolled asphalt roofing materials; non-historic concrete block foundation; pre-1983 wraparound porch; four (4) historic wood doors; and ten (10) historic wood windows.

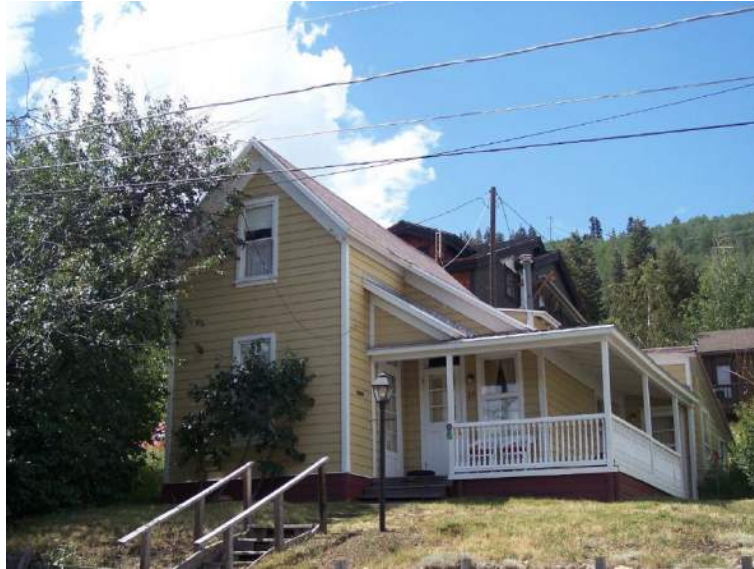
There is a non-historic wraparound porch on the northeast corner of the house, added sometime before 1983. While staff has not found evidence that this porch existed before 1983, it is a feature that would have been typical during the historic period. Further, it does not detract from the historical significance of the site. As noted in the National Register nomination for this house, "The porch is not original, but it was designed to complement the building and does not affect its original character."

The applicant is proposing to reconstruct the c.1983 porch to comply with building codes. Staff finds that the proposed reconstruction of the non-historic porch will mitigate any impacts that will occur to the historical significance of the house or any impact that will occur to the architectural integrity of the house.

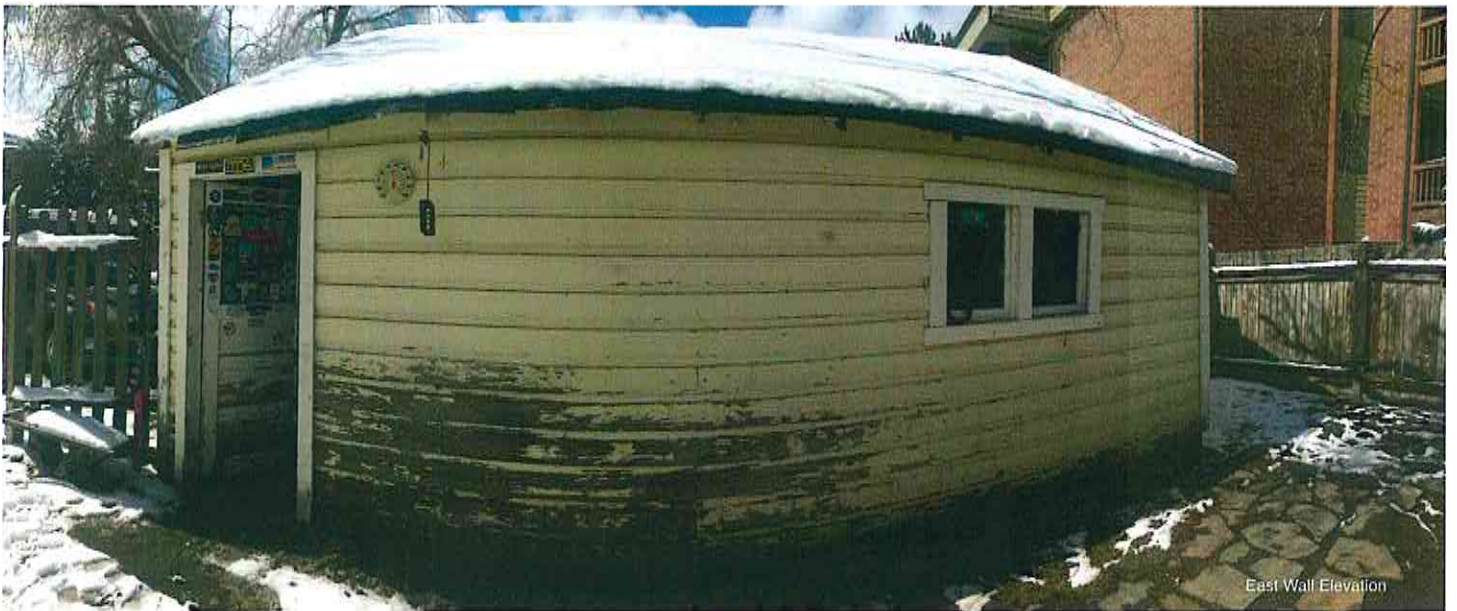
Contemporary 2x4 Wood Stud, Typical

Spacing 24" o.c., Typical

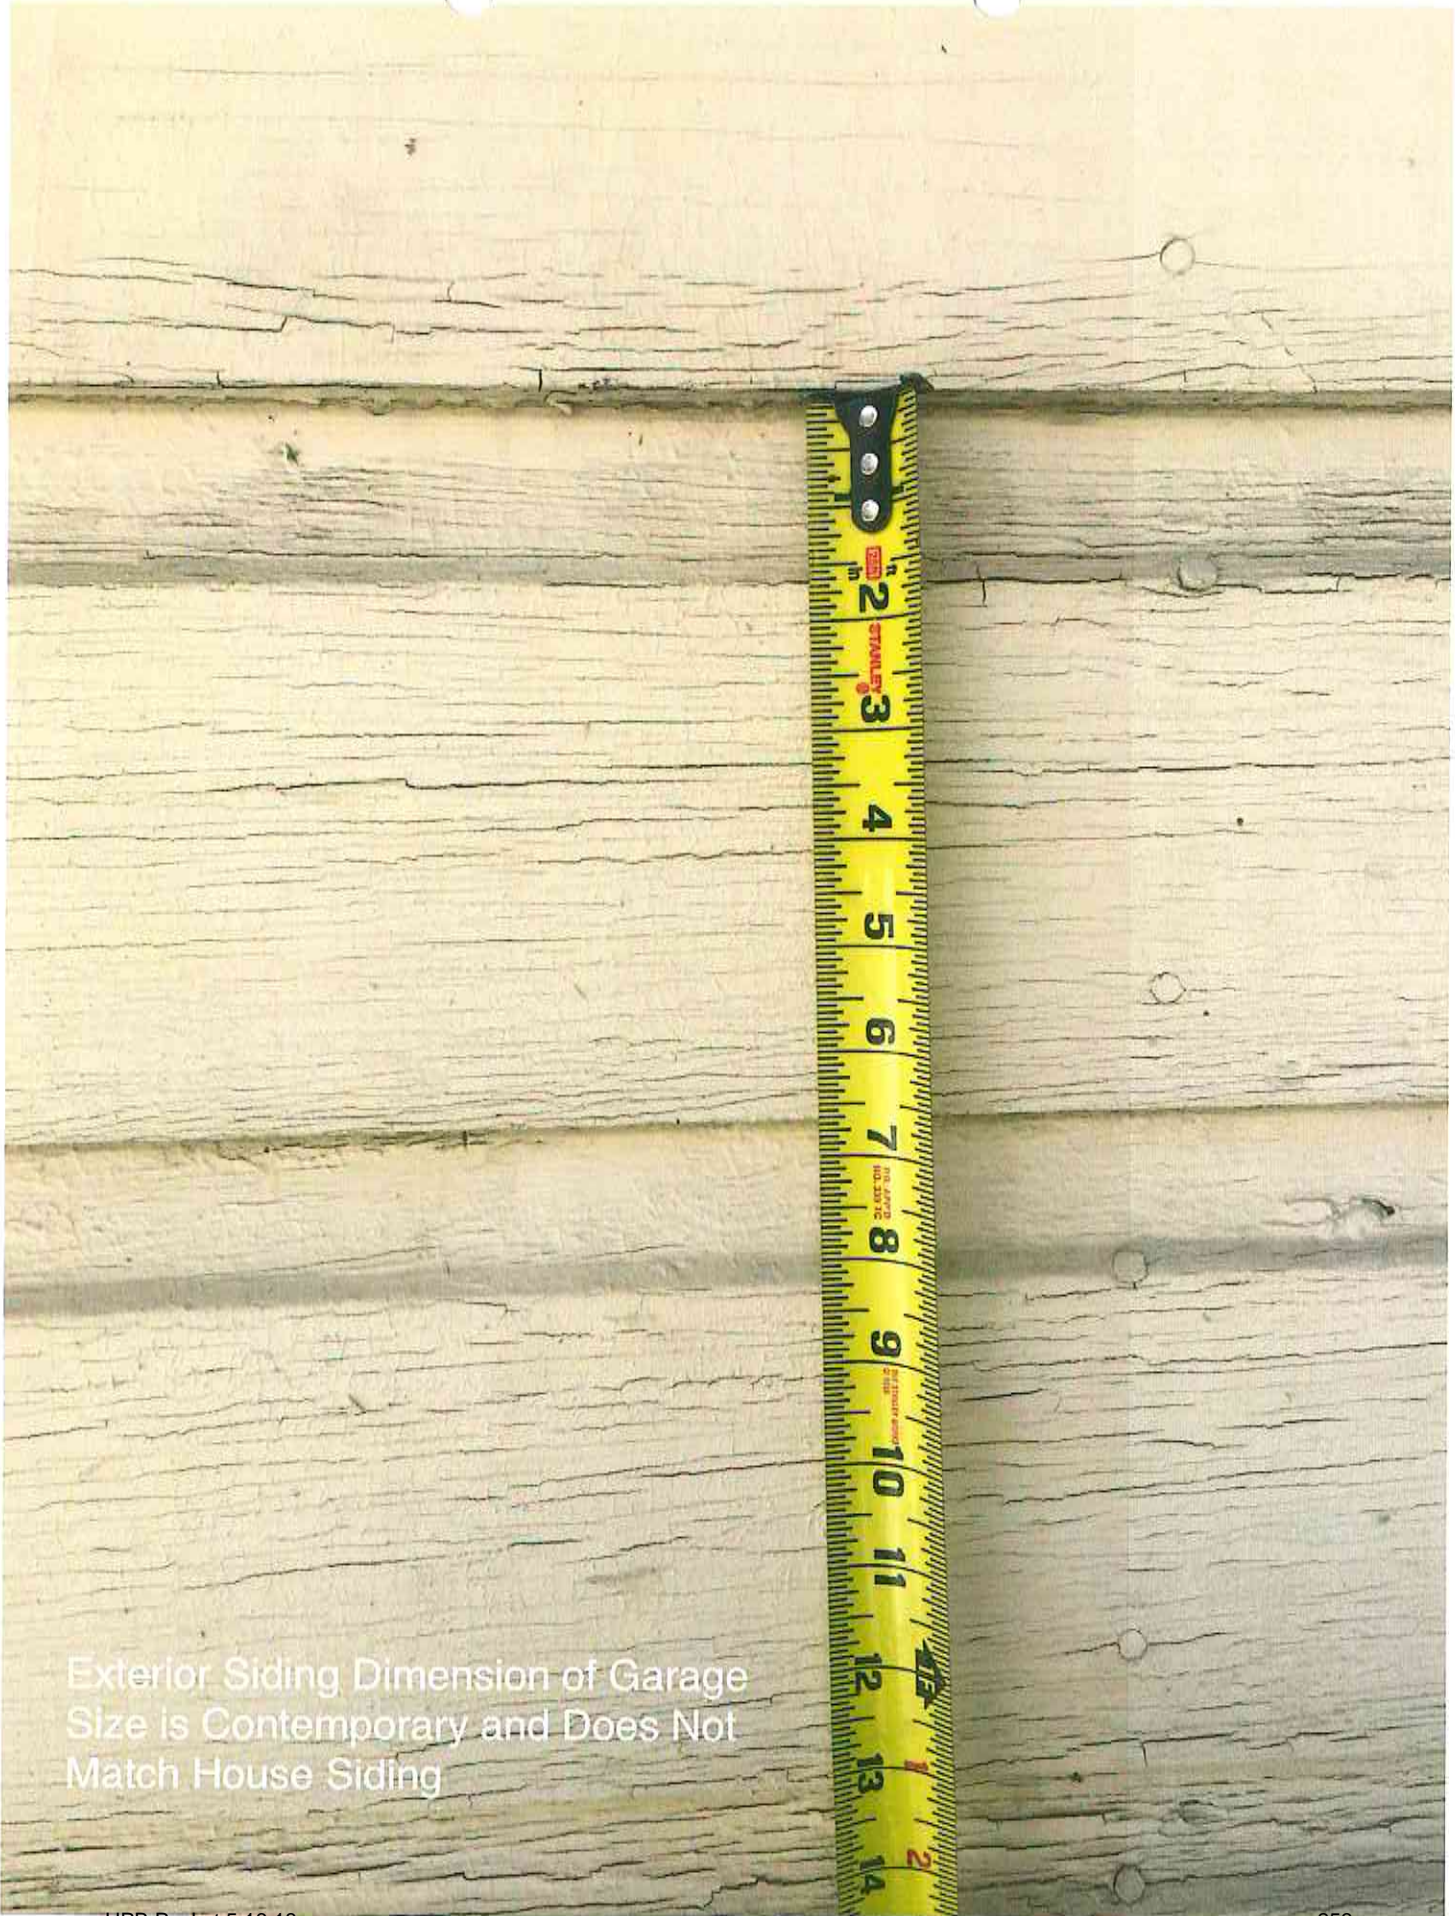
Exterior Siding Dimension of Garage
Size is Contemporary and Does Not
Match House Siding

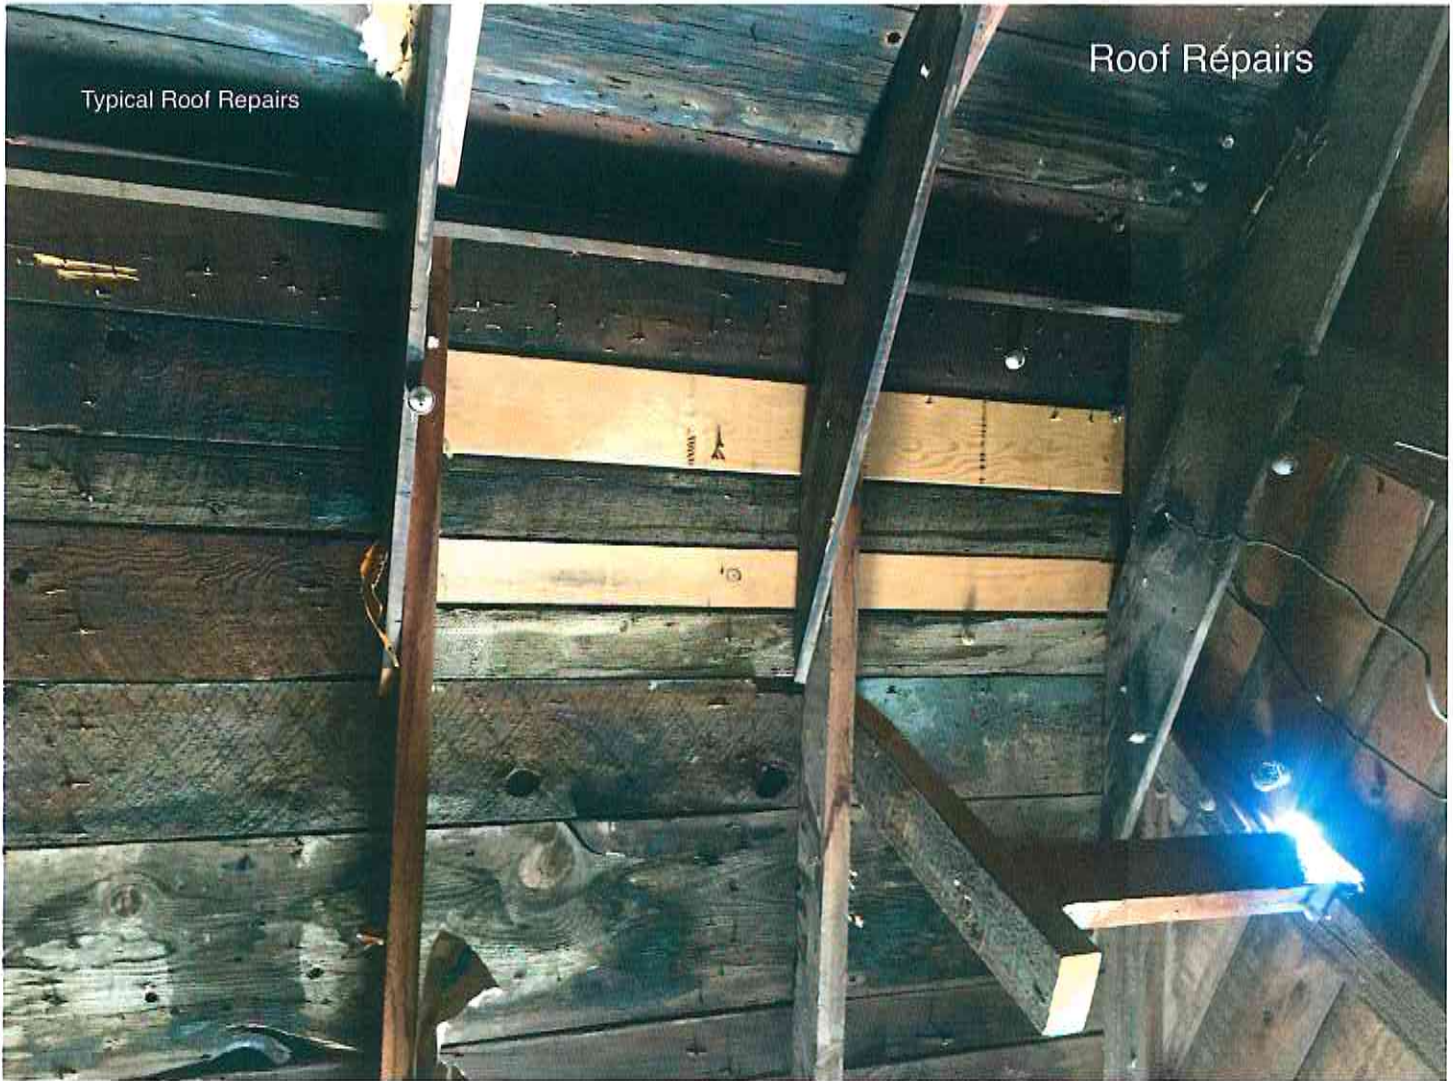
Typical Roof Repairs

Roof Répairs

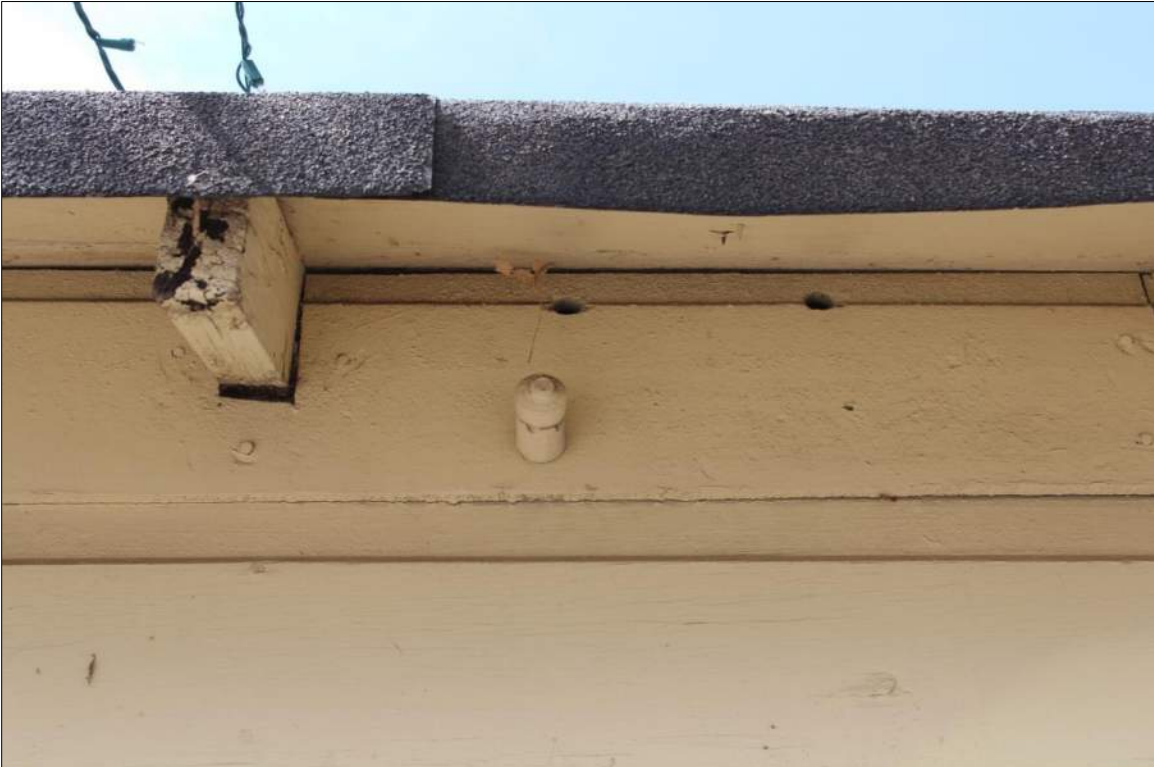
Figure 8. Porcelain knob under east eave of garage at 1503 Park Avenue, 2018, view facing west.

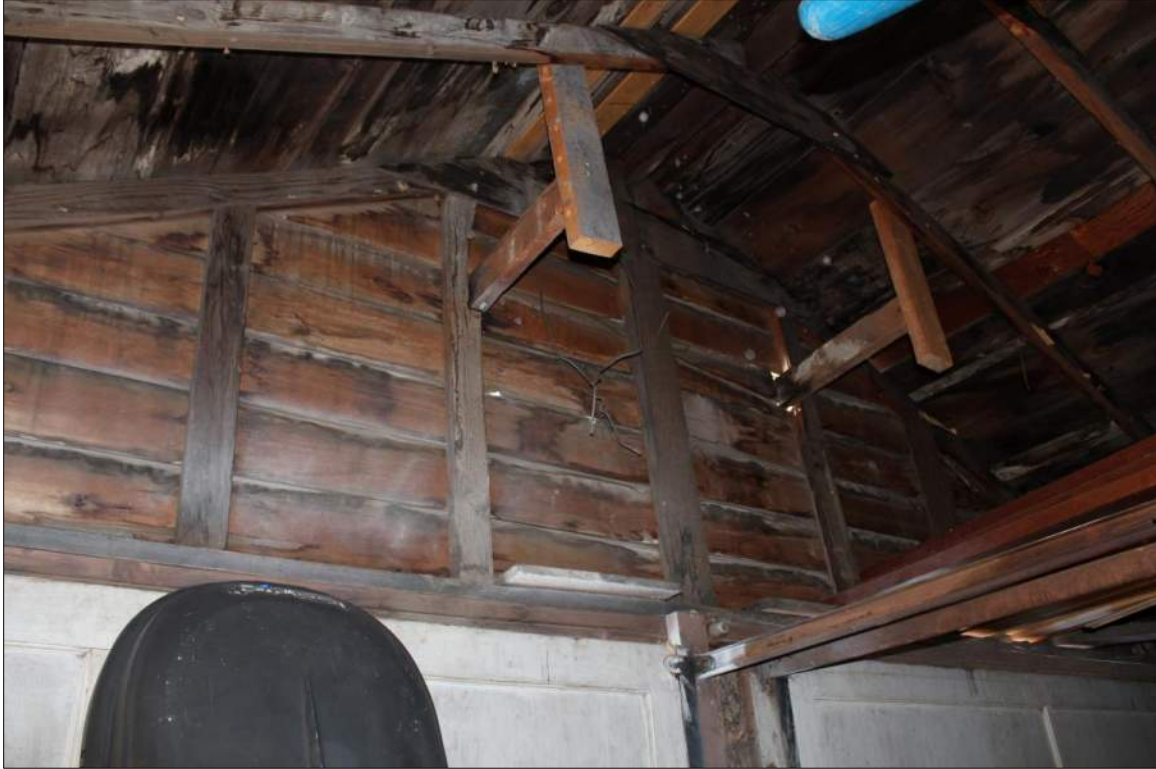
Figure 9. Interior of south gable end of garage at 1503 Park Avenue, 2018, view facing south.

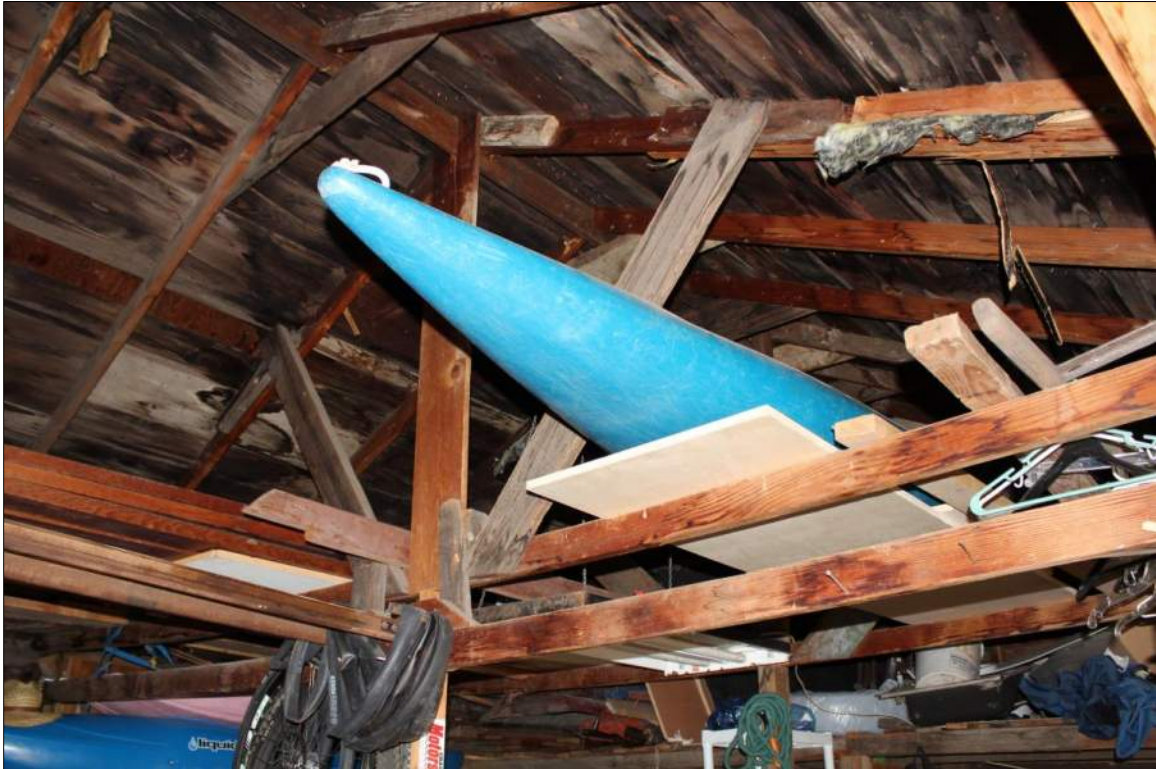
Figure 10. Roof framing system of garage at 1503 Park Avenue, 2018, view facing northwest.

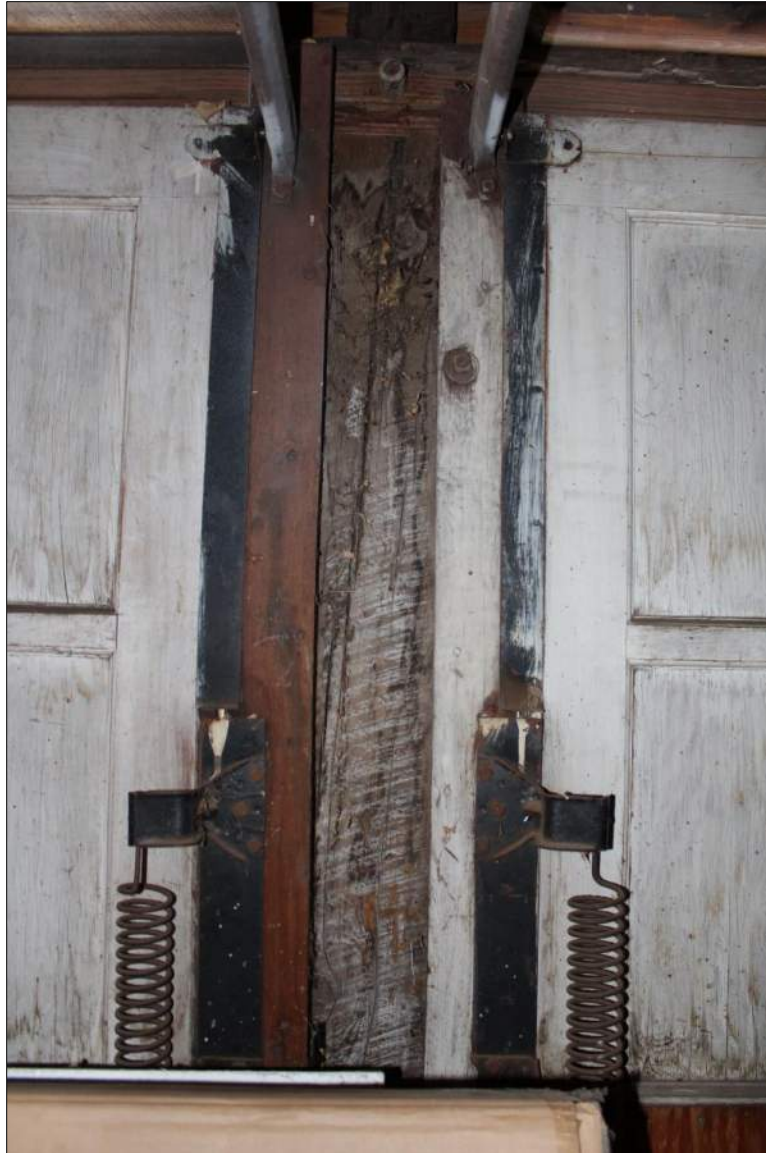
Figure 11. Door-opening and bracing hardware on original garage doors at 1503 Park Avenue, 2018, view facing south.
