HISTORIC SITE FORM - HISTORIC SITES INVENTORY

PARK CITY MUNICIPAL CORPORATION (10-08)

Name of Property: **George Murray House**

Address: 44 ONTARIO CANYON STREET

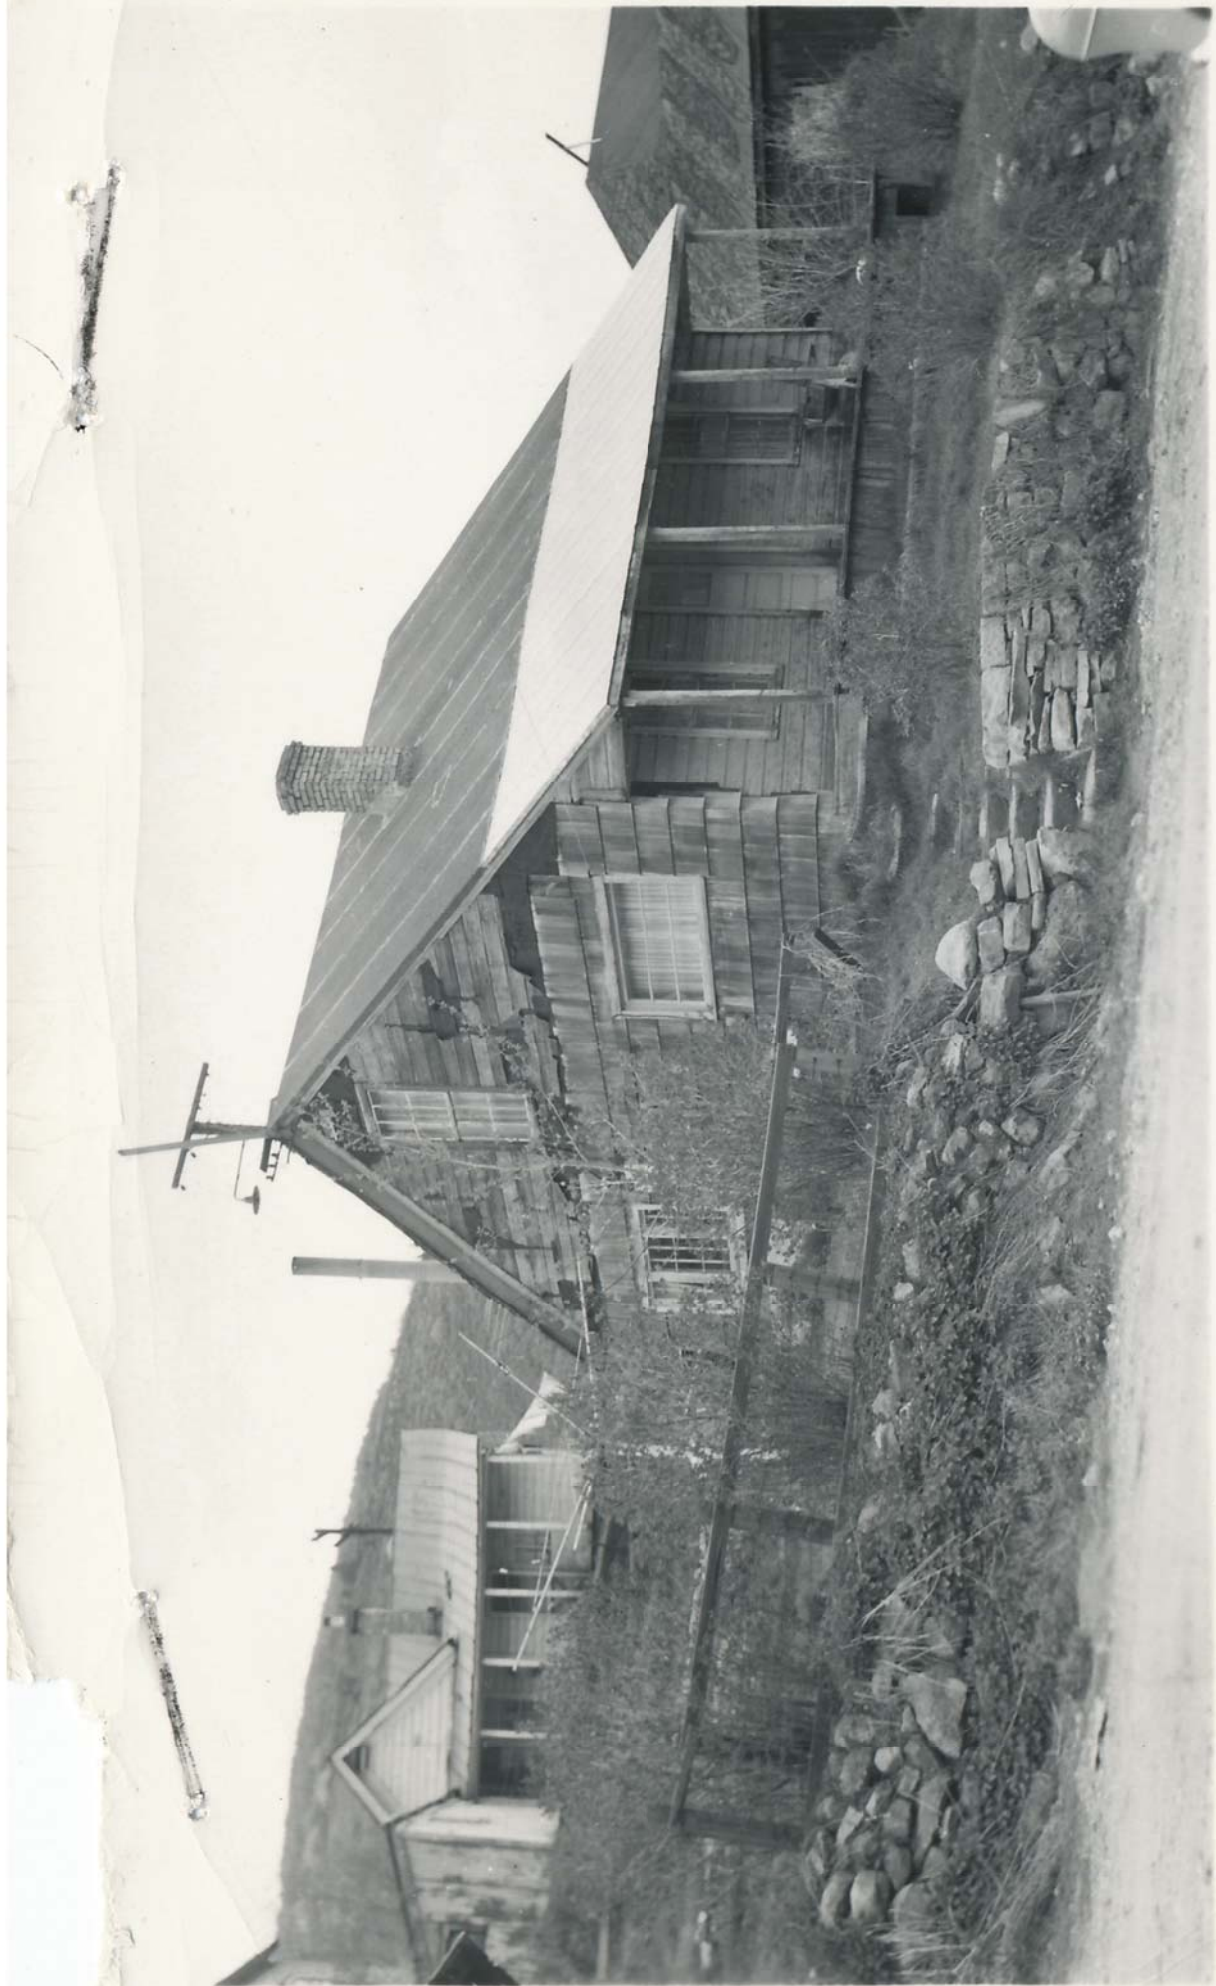
George Murray House
44 Chambers
Park City, Utah

East facade

Photo by Debbie Temme, October 1983
Negative: Utah State Historical Society
