HISTORIC SITE FORM - HISTORIC SITES INVENTORY

PARK CITY MUNICIPAL CORPORATION (10-08)

Name of Property: **St. John's Swedish Lutheran Church**

Address: 323 Park Ave

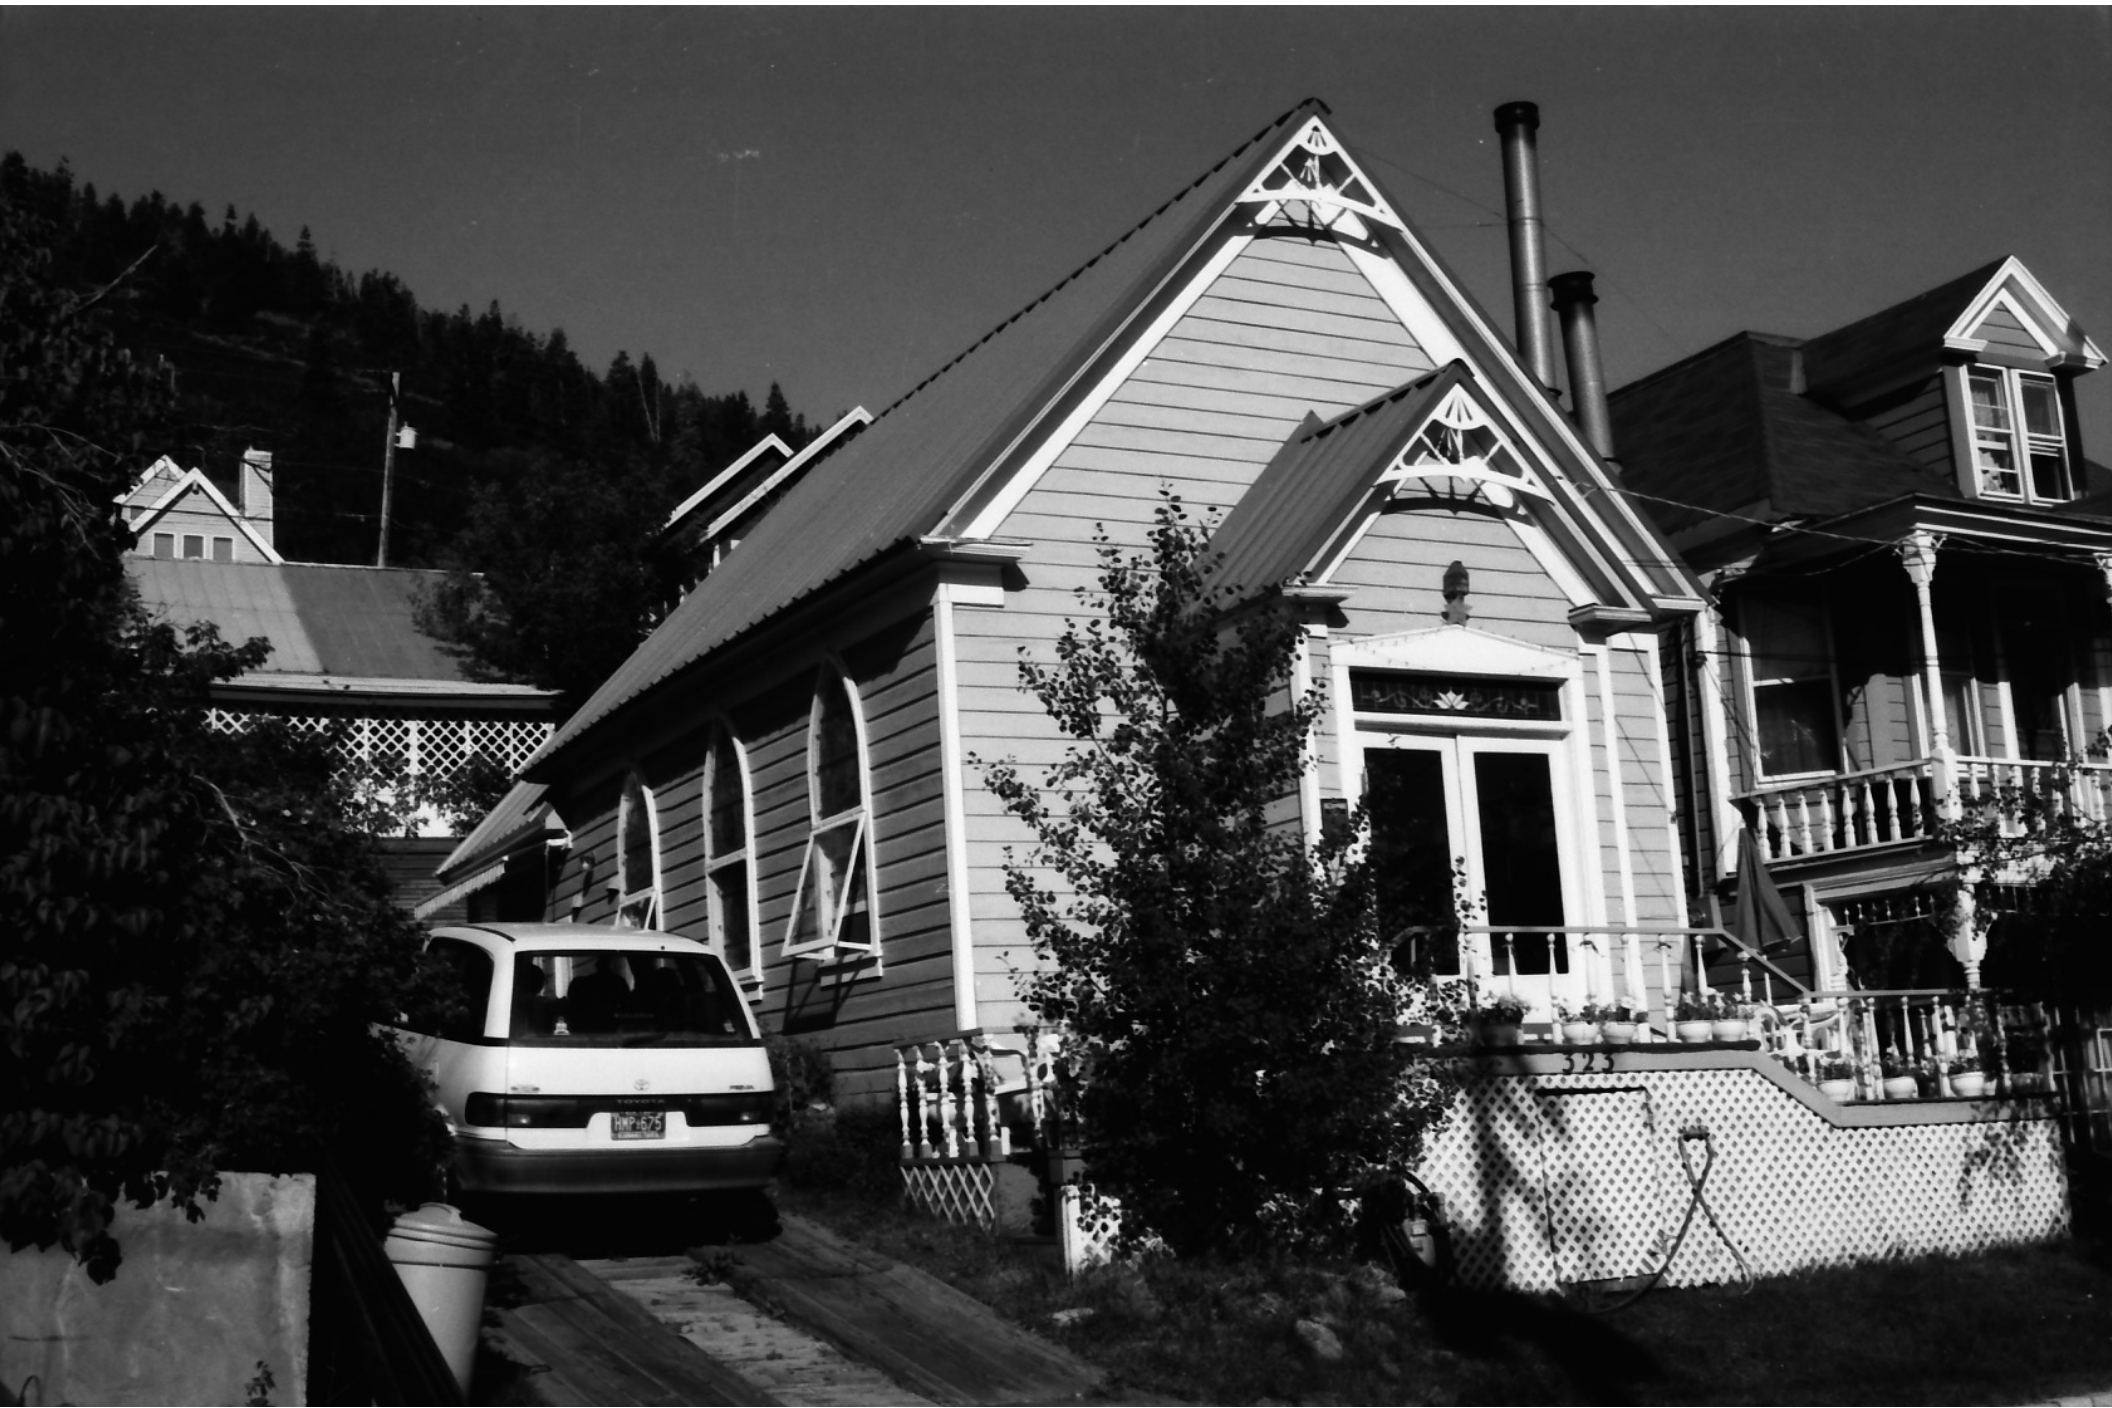
Photo No. 1: East elevation. Camera facing west, 2006.

Photo No. 2: Southeast oblique. Camera facing northwest, 1995.

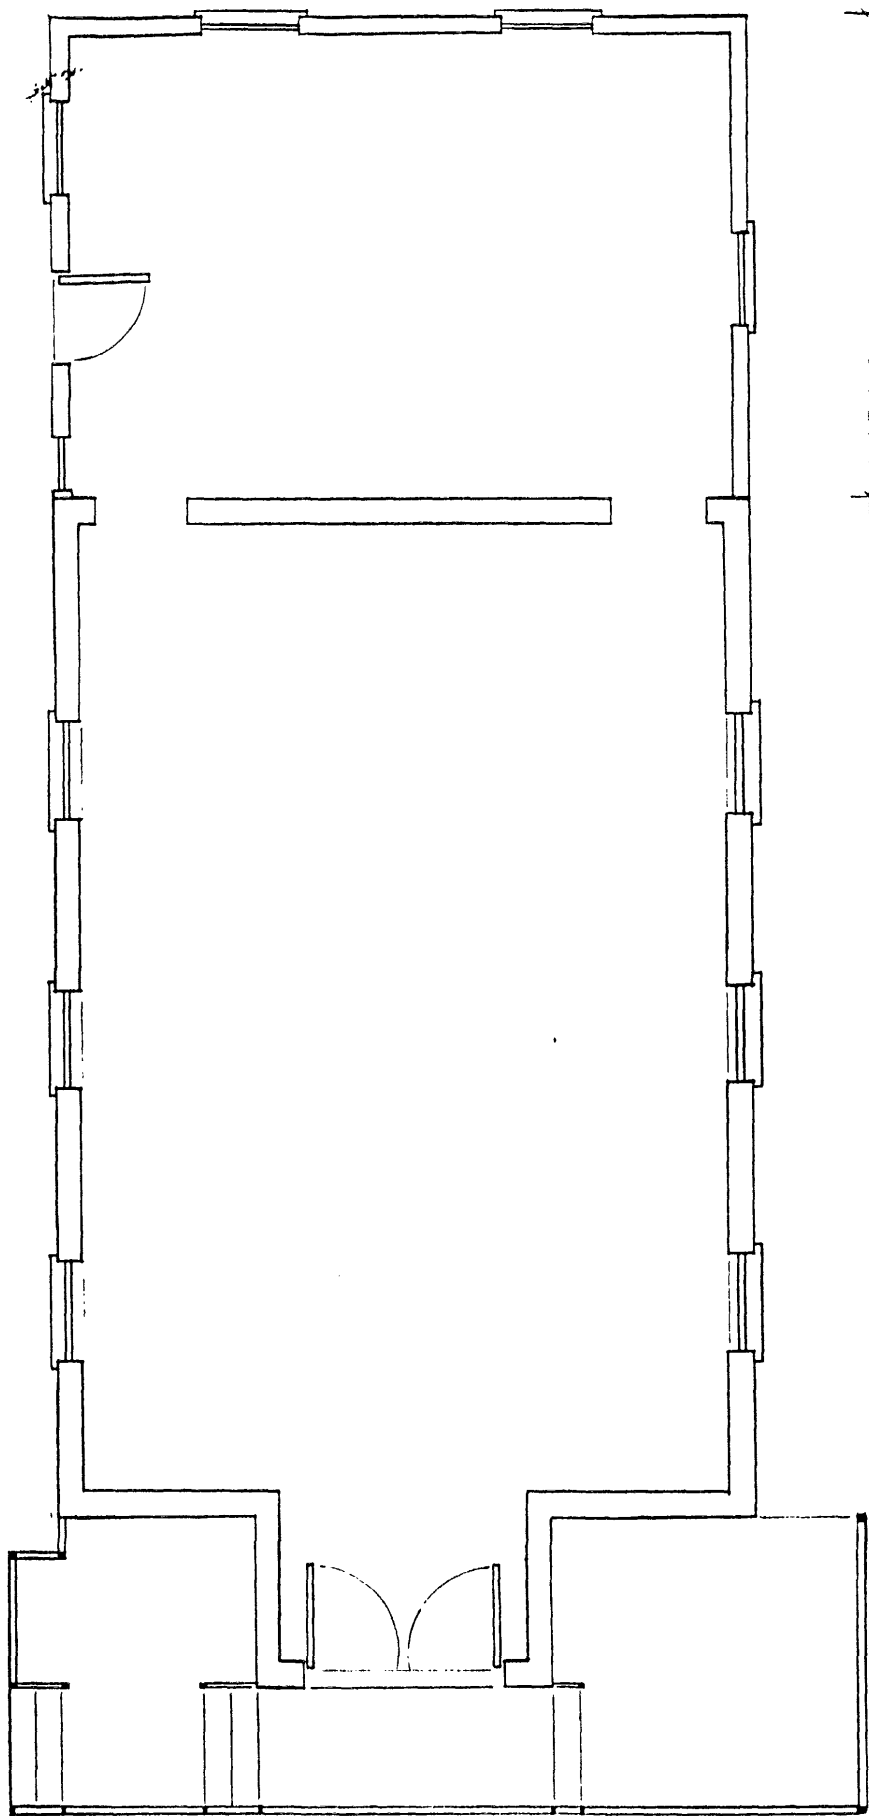
ST. JOHN'S SWEDISH LUTHERAN CHURCH
323 PARK AVENUE, PARK CITY, UTAH

The interior of the vestibule has floor to ceiling wood paneling, with a set of solid wood doors that open up into what was once the sanctuary, and is now the living room. No alterations have been made to this area, and it retains its openness. At the west end are stairs that lead up to a bedroom and a loft. Behind the stairs, on the main level, is the kitchen, a hall, a bath and two bedrooms.
