Planning Department

Historic Preservation Board Staff Report

Author: Hannah M. Tyler, Planner
Subject: Material Deconstruction Review
Address: 1333 Park Avenue
Project Number: PL-16-03378
Date: March 1, 2017
Type of Item: Administrative – Material Deconstruction

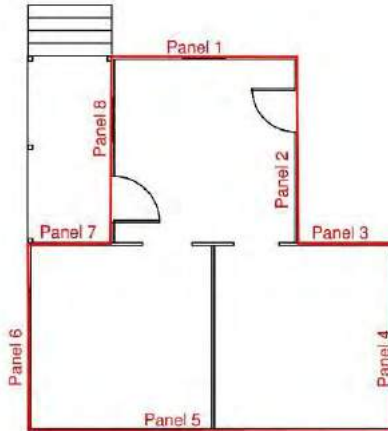
The applicant believes he can salvage all eight (8) of the original panels of the historic cross-wing house, as depicted in the image below:

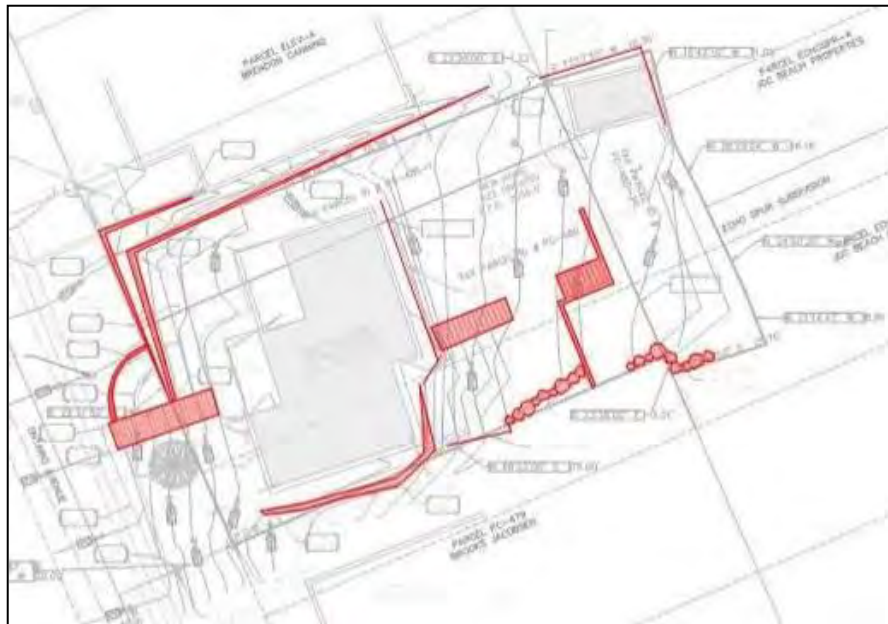
As existing, the historic c.1904 cross-wing house sits above Ontario Avenue on a flat portion of the uphill lot. The house is surrounded by mature trees, including a large evergreen tree in the Ontario Avenue right-of-way. There are also oak, apple, and plum trees in the rear yard of the property. There is currently an old stone retaining wall separating the historic house from its neighbor to the south as well as a c. 2009 concrete and boulder wall at the front of the lot that creates an unsanctioned parking pad parallel to Ontario Avenue. In the rear yard, there is an eight foot retaining wall consisting of steel pole and horizontal wood boards; the applicant believes this retaining wall was constructed when the addition was built (1941-1949) in an effort to retain the hillside directly behind the historic house. The backyard also features a solid wood fence along the south property line, and a barbed wire fence with steel and wood posts on the east and north sides of the property. There are also concrete steps leading from the front door down to Ontario Avenue. These improvements have been highlighted in the site plan below:

Close-up of survey showing site improvements.

Starting in the front yard, the applicant proposes to remove the non-historic c.2008 concrete retaining wall; this wall will be rebuilt as the front wall of an underground garage off of Ontario Avenue and clad in stacked stone. Staff finds that the wall is non-contributory to the historic integrity and significance of the site.

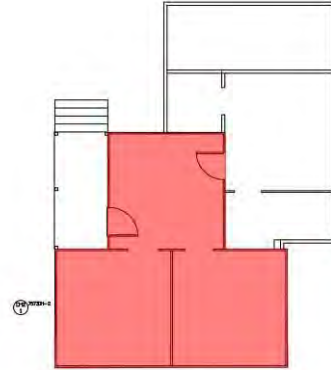
The area shaded in red is the original cross-wing house. The remainder of the building depicted in this floor plan was added between 1941-1949.

Staff finds that these additions do not contribute to the historic integrity or historic significance of the structure or site. The material deconstruction is necessary in order to restore the original c.1906 cross-wing form.

The applicant proposes to remove the non-historic additions to uncover and restore the original T-shaped cross wing. The diagram below shows the 1941 Sanborn Fire Insurance Map and the conditions that exist today:

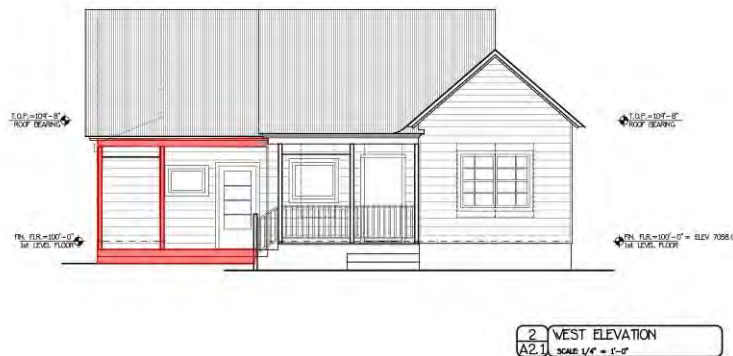
The applicant is proposing to remove the front porch as part of the demolition of the non-historic addition that was constructed between 1941 to 1949. The porch is not historic and staff finds that this proposed material deconstruction is acceptable as the porch does not contribute to the historic integrity or historical significance of the structure or site.

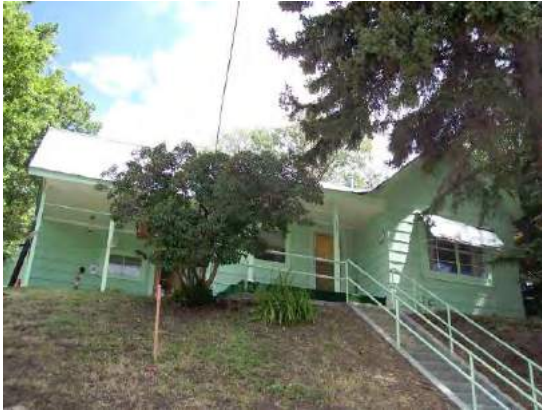
The second front porch is located on the c.1906 historic cross-wing house. The location of the front porch appears to be original; however, the materials are not historic. Staff finds that this porch was likely constructed at the same time as the porch on the 1941-1949 addition as it contains the same type of wood posts and concrete slab. The porch roof was also altered at this time as a new roof was constructed over the original cross-wing and over the front porch. The porch rails are contemporary and were added sometime after the 2009 reconnaissance survey photograph was taken for the Historic Site Form.

C.2009 reconnaissance survey photo of the house. Note the metal porch rails that match those on the concrete stairs.

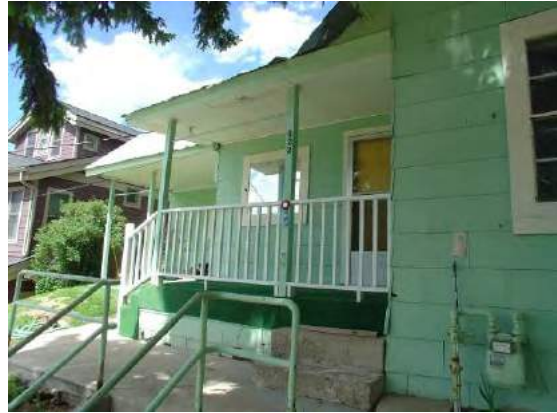
Current photograph of the house showing contemporary wood railing.

The applicant is proposing to reconstruct the historic front porch of the c.1906 cross-wing. In doing so, the applicant will reconstruct the original porch roof that sat beneath the eave of the north-south stem wing. They will also reconstruct a wood porch structure with new wood railings and wood decking materials. The new porch will be reconstructed using materials and details as close to the original design as possible.

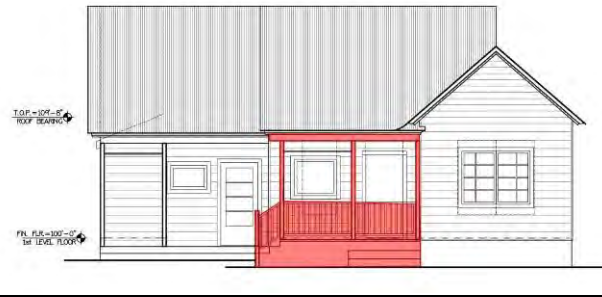
The image below highlights the removal of the non-historic porch on the front of the historic cross-wing house:

Staff finds that the proposed material deconstruction to remove the non-historic porch elements is appropriate as these materials do not contribute to the historic integrity or historical significance of the structure. Additionally, the material deconstruction is necessary to restore the front porch to its original c.1906 appearance.

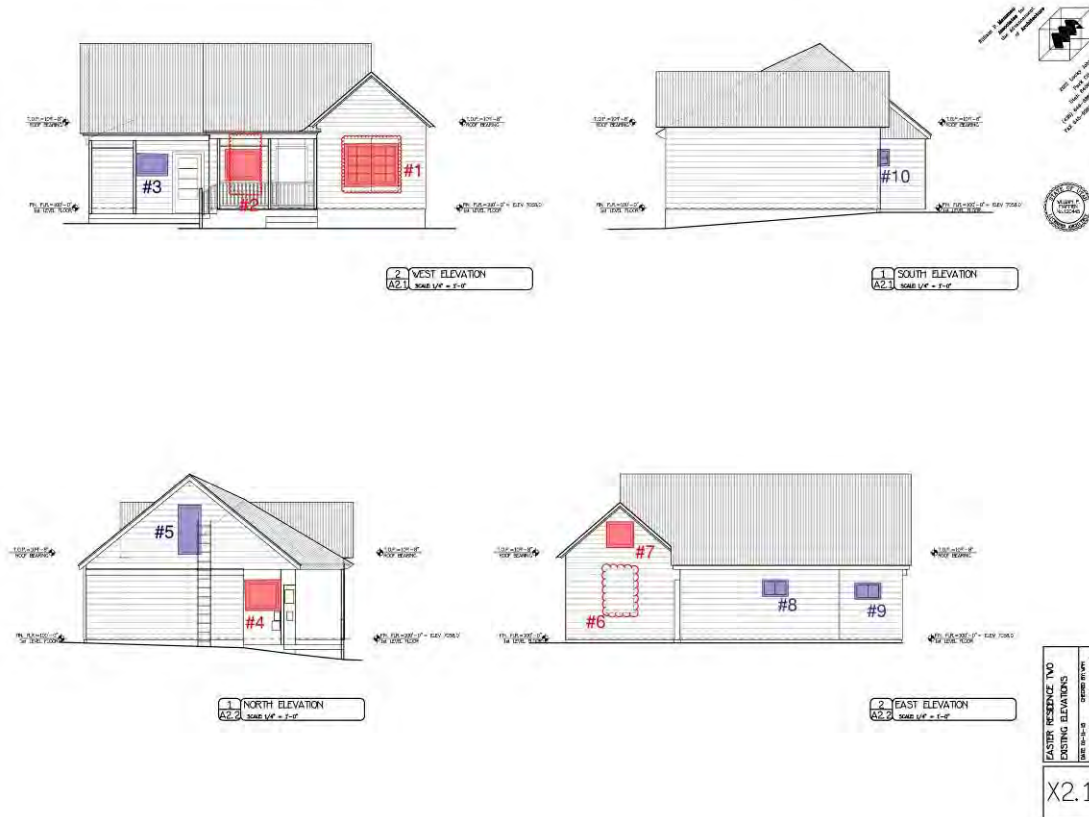
were likely added in the 1970s and 1980s. In some cases, the window openings have been modified.

Staff has highlighted windows on the original c.1906 T-shape cottage as red and clouded those window openings that have been filled in or modified. The blue shaded windows represent those that are on the non-historic additions.

The blue highlighted window forms represent the c.1941-1949 new addition/alterations. The red highlighted window forms represent those portions of the original c.1906 cross-wing that will need to be restored based on physical evidence.

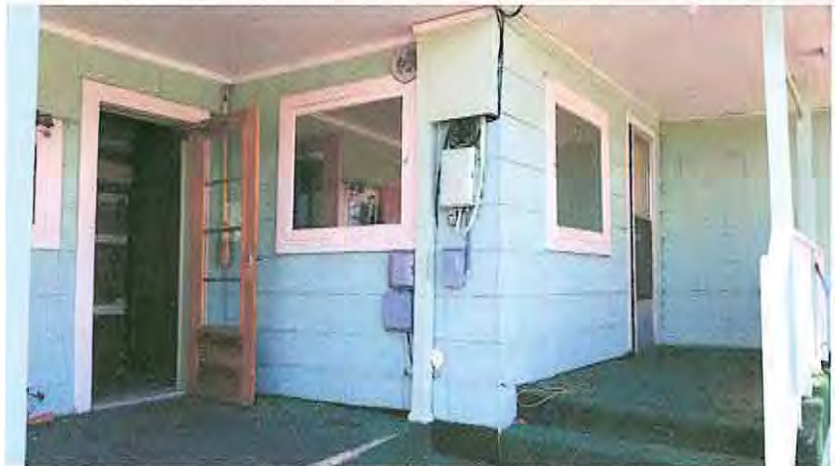
Photo #1

Existing front door in non-historic addition and original porch that has been reconstructed. Old front door does not fit original opening. All the existing windows do not fit the original openings.

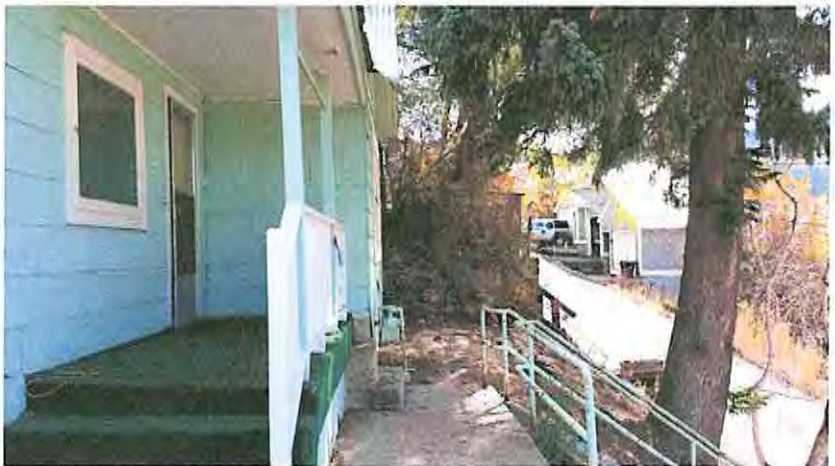
Photo #2

Location of original front door and porch. Front door does not fit original opening. The porch is a reconstruction that has not followed the historic detailing at all. Note the concrete steps in front of the door going nowhere.

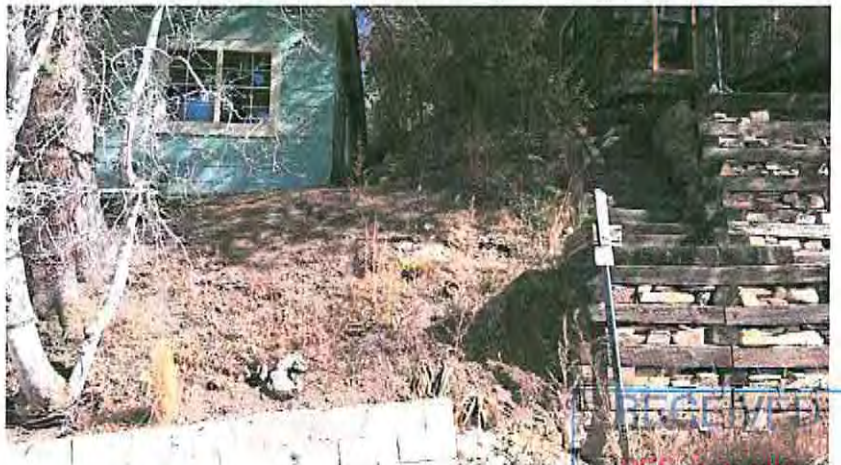
Photo #3

The original grade meets the street at the south end of the property. The retaining walls have all been built in the 1950's and in 2008.

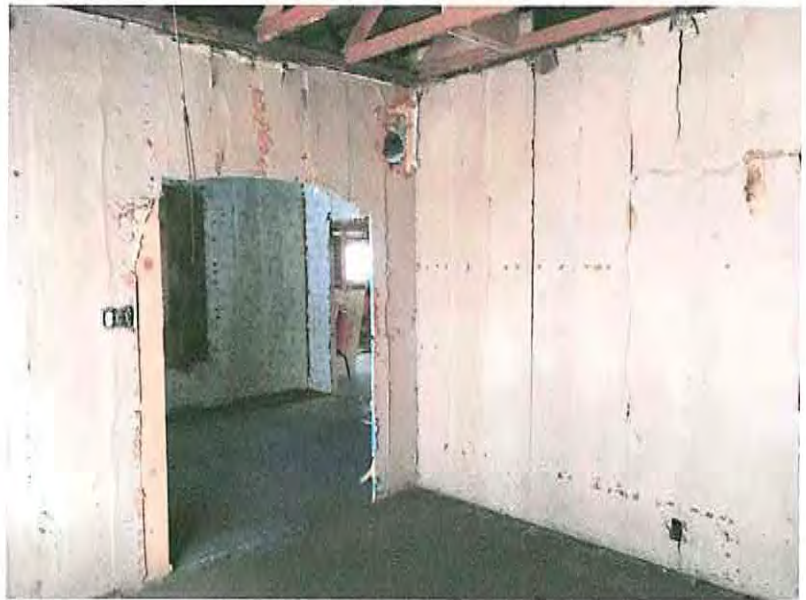
Photo #9

Opposite walls of Front room, West & North.

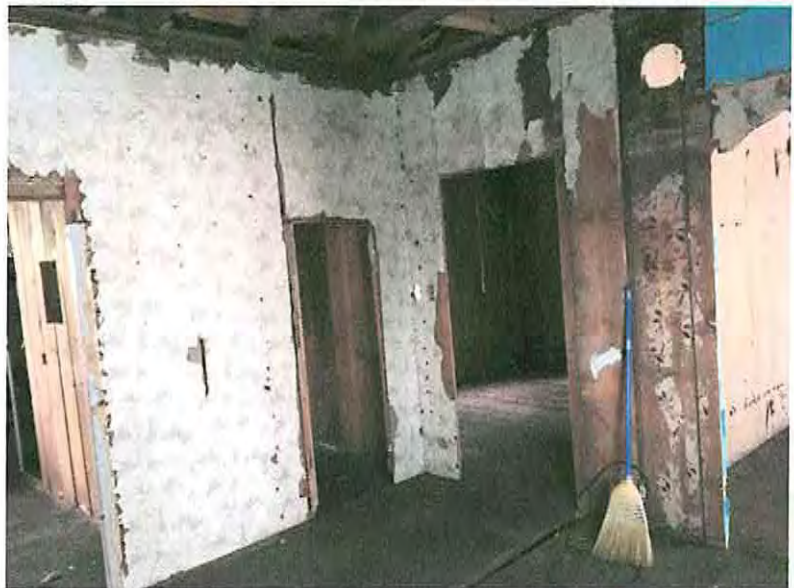
Photo #10

South & east walls of entry (Original kitchen)

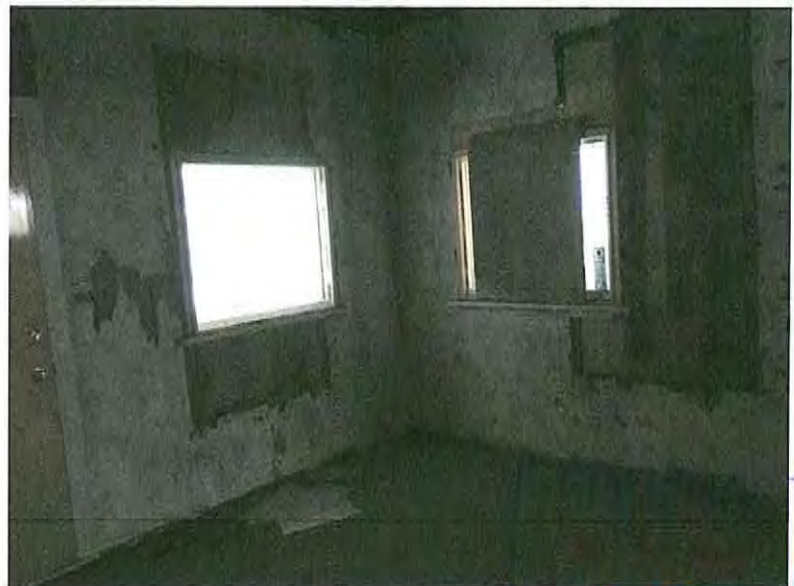
Photo #11

North & west walls of entry.

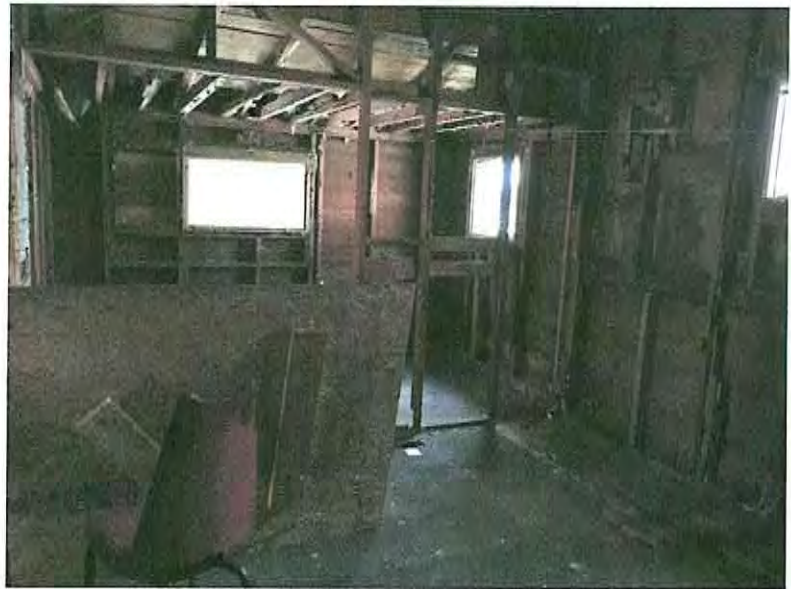
Photo #12

North & east walls of kitchen/dining.
(Not historic)

Photo 12 shows the East and North walls of the Non-historic additions
Photo 13 shows the South and West walls of the Non-historic addition and
Also the NE corner of the original Historic 'T'

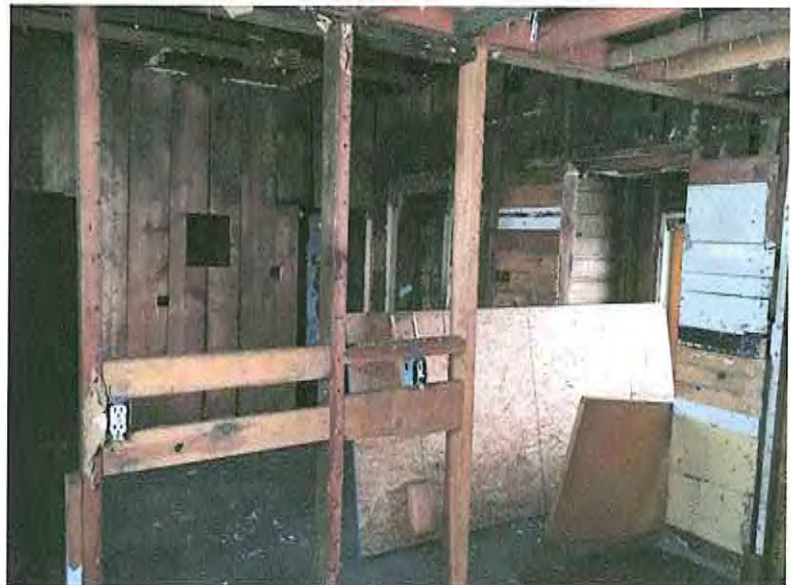
Photo #13

South and west wall of kitchen/dining.
(Not historic)

The doorway into the entry room is historic. The historic NE corner is visible.

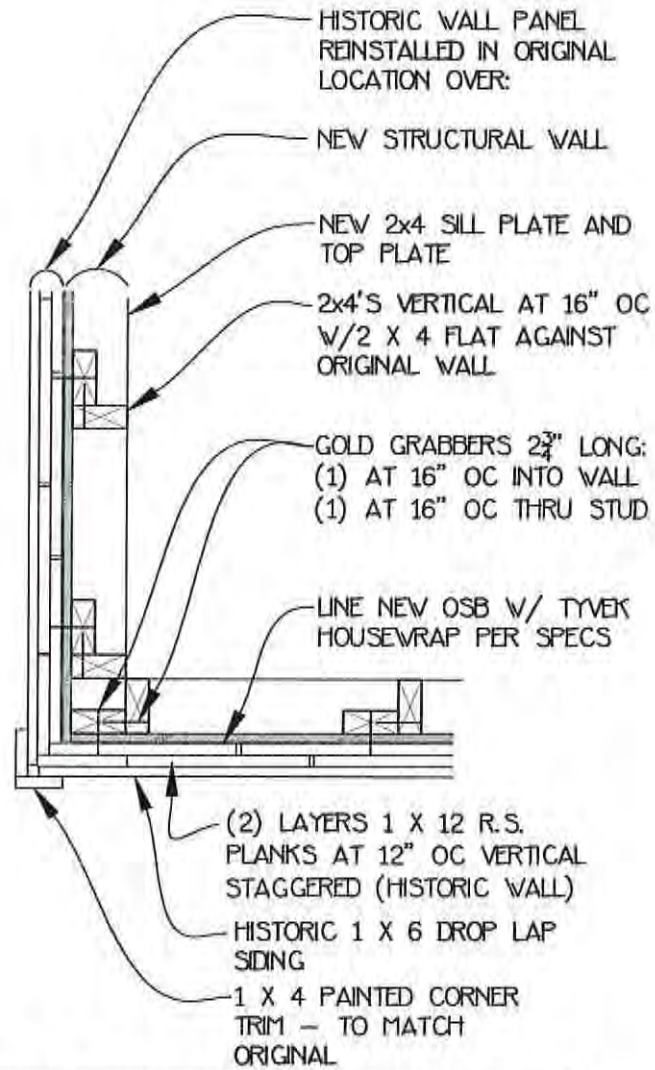
1	WALL CONSTRUCTION
X1.1

Detail 1/X1.1 (fig. 9) shows the condition at the wall corner. This detail shows how the existing walls currently sit in relation to one another. This detail also shows how the new structure will be built so the wall panels come back together as the exterior skin of the new structure. This will allow proper weather barrier to be constructed in the new wall. Shear will be provided as well as insulation. This will help preserve the existing historic walls. They will no longer be subject to the deteriorating effects of mold and mildew.
