**PARK CITY PLANNING DEPARTMENT  
STAFF REPORT**

TO: HISTORIC DISTRICT COMMISSION  
FROM: PLANNING STAFF  
DATE: MAY 20, 1996  
RE: 332 DALY AVENUE - CERTIFICATE FOR APPROPRIATENESS FOR  
DEMOLITION

# PHYSICAL CONDITIONS REPORT

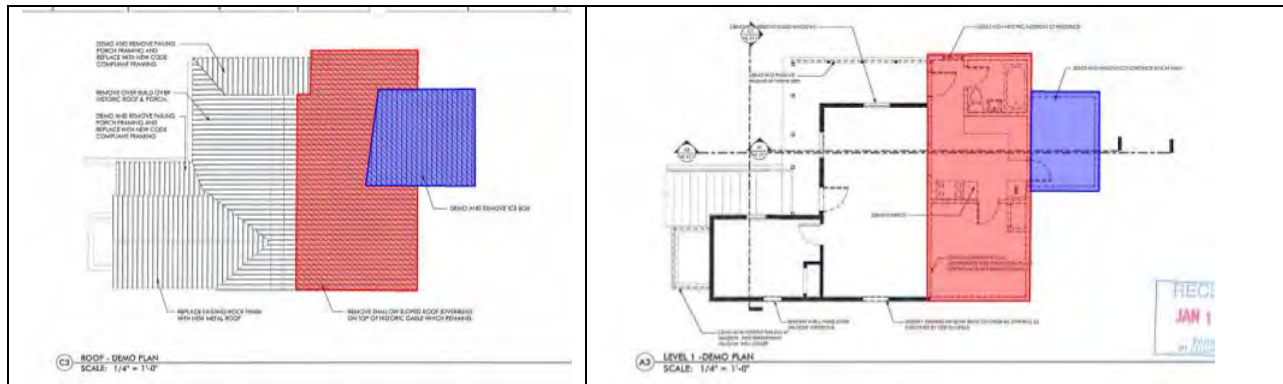
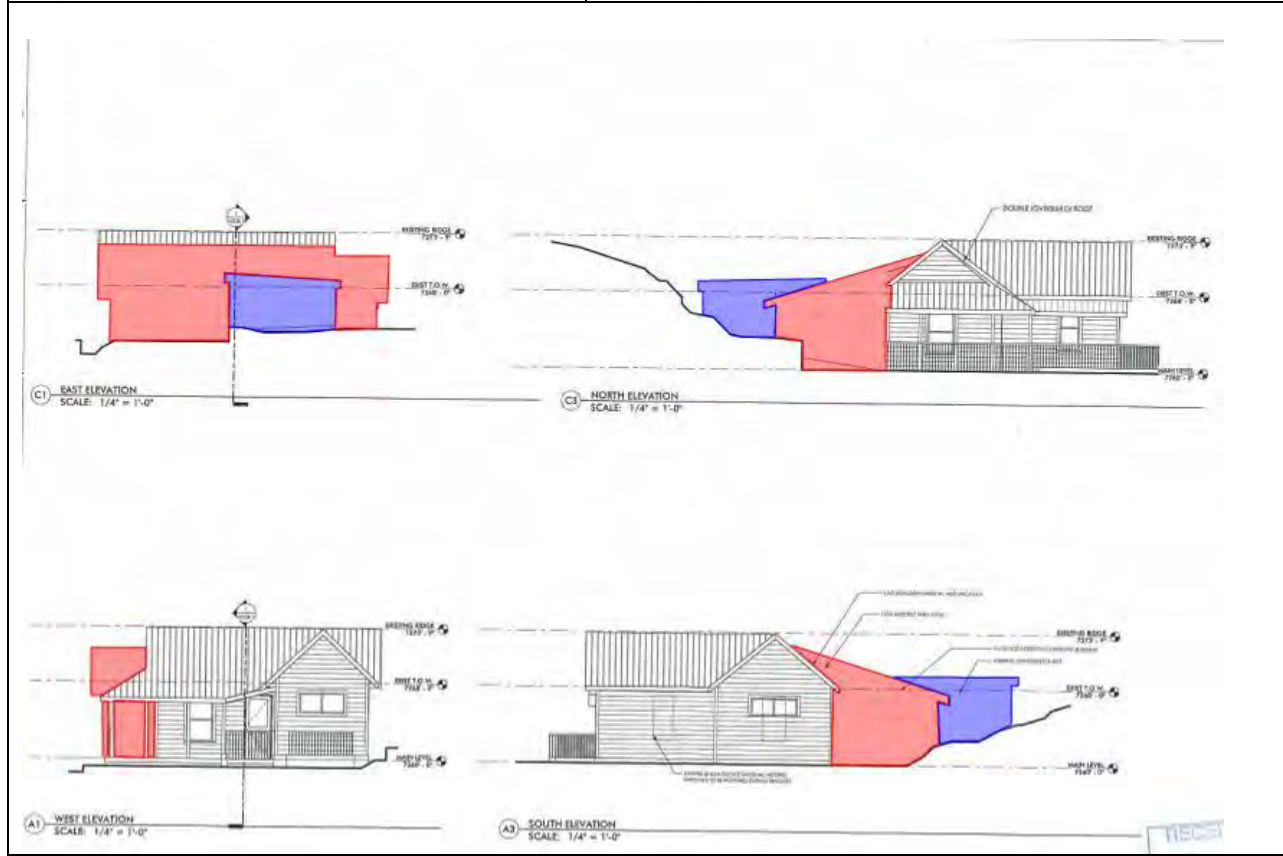
*In these plan and elevation drawings, the first addition is shaded in red. The second addition—the concrete ice box/mechanical room—is shaded in blue.*

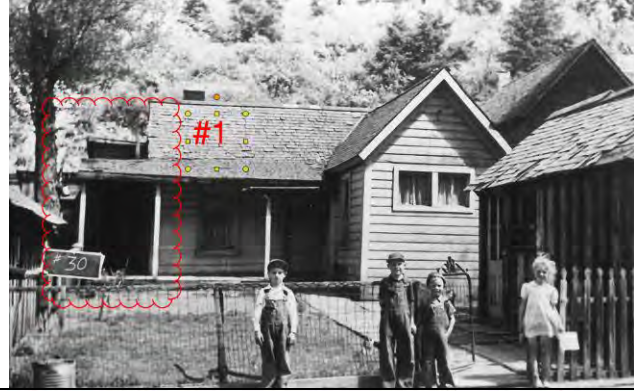
*This c.1941 historic photograph shows a shed-roof addition that extends from the rear (east) elevation of the house to the north. It appears in this photograph that the wrap-around porch terminates at this addition on the north side.*

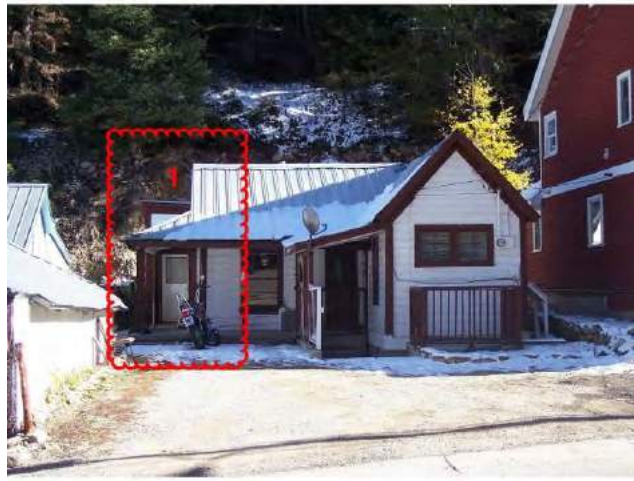
This addition has wood siding on the west (façade) and south (side) elevations; however, the back of the addition is clad in horizontal, corrugated metal panels. The hillside has settled and the wall is partially buried underground. The roof over this area has been built over, typical of Park City construction, indicating that there may have had a shallower roof pitch at one point and the new roof was constructed to eliminate two different roof pitches.

*This photograph shows the location of Addition 1. On the west (façade) elevation, it is clad in wood siding and appears largely identical to the addition shown in the c.1941 tax photograph.*

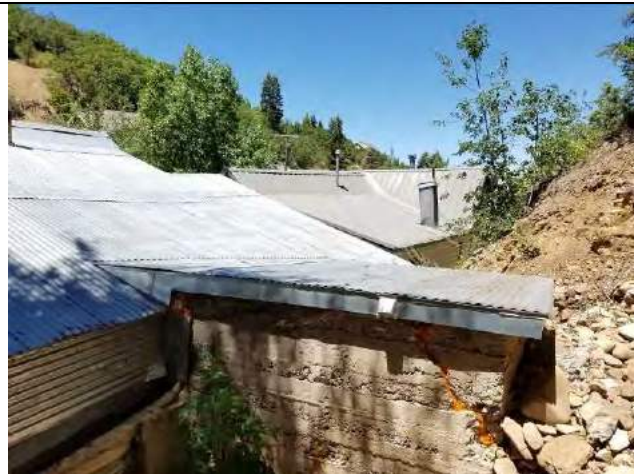
Addition #2 (shaded in blue) is a rough-poured concrete box that sits directly on a wood floor on the ground. This may have initially been constructed as an ice box and/or used as mechanical space. The shed roof ties into the first addition on the house. Staff finds that this addition was probably constructed before 1930 when root cellars were popular. In the past, the HPB has determined that root cellars are not historically significant.

*This photograph taken from the southeast corner of the site shows the rough-poured concrete root cellar/mechanical room (Addition #2). Also note the corrugated metal siding on the east (rear) wall of Addition #1.*

The HPB may also find that the additions to the Historic Building are historically significant and may not be removed. If that is the case, the HPB should condition this material deconstruction to require that the applicant maintain and reconstruct the shed-roof addition and/or concrete root cellar as necessary.

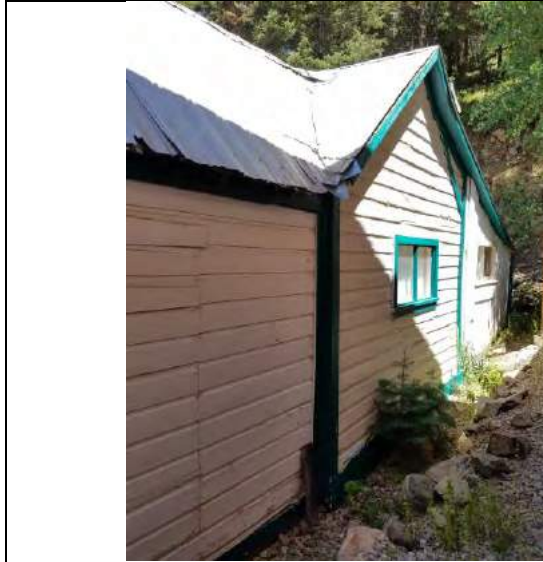
*This photograph of the south (side) elevation shows the transition from historic drop-novelty wood siding to plywood. The gable is original to the cross-wing house and the projecting ell is nearest to photographer. Note the plywood material on the shed addition to the rear.*

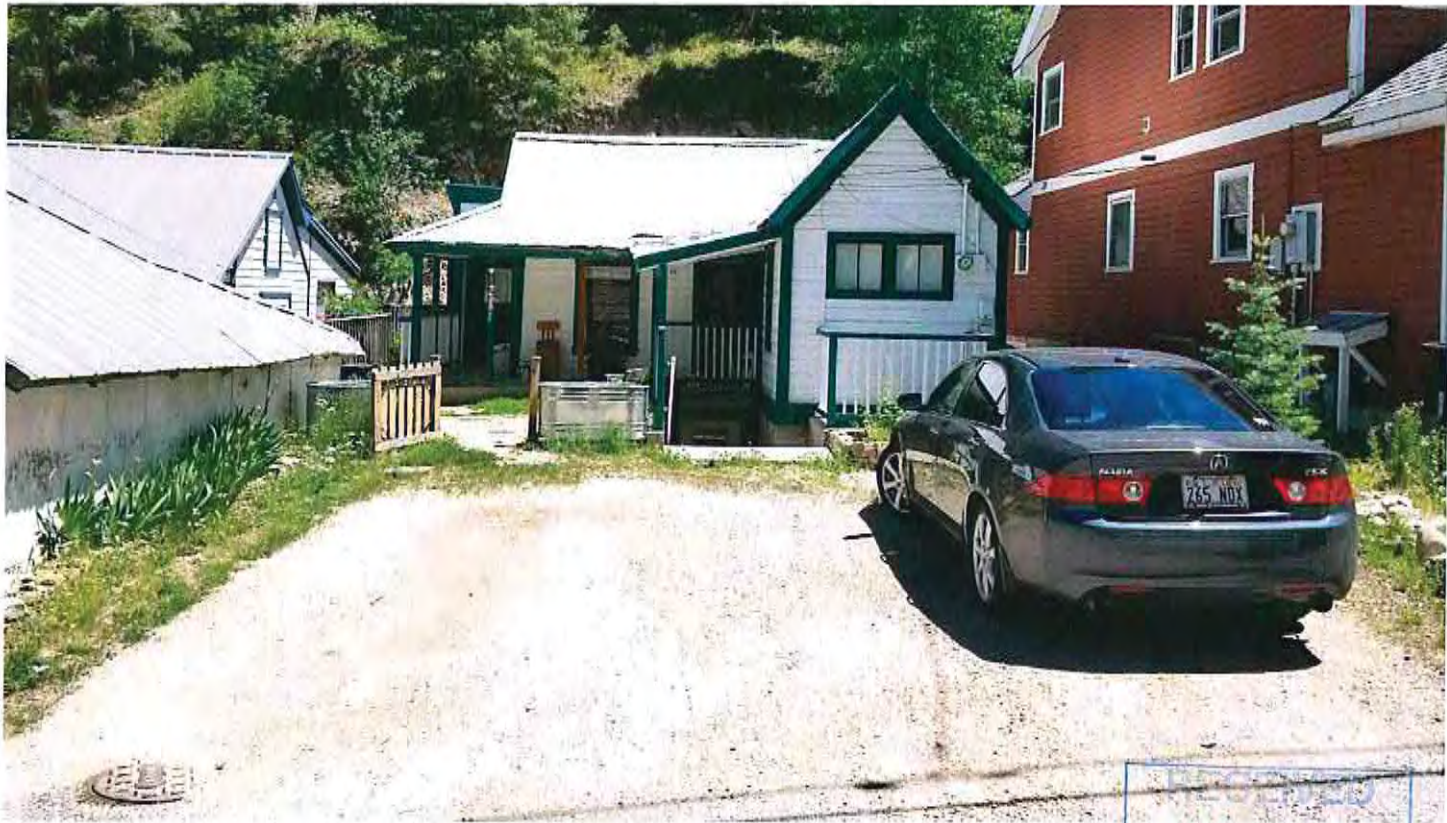
Photo #1: West Elevation

The majority of the existing walls are in acceptable/good form, however, the soffits and fascias are deficient at all the areas of the porch as well as the connections to the earlier addition.

The applicant is proposing to make minor repairs to the exterior walls. Maintenance is required to address damaged wood siding on the north and west walls. The south wall is in overall good shape. The east wall is currently an interior wall of the house. It will be returned to an exterior wall if the additions are removed and the exterior will be resided with wood siding milled to match the historic drop novelty siding.

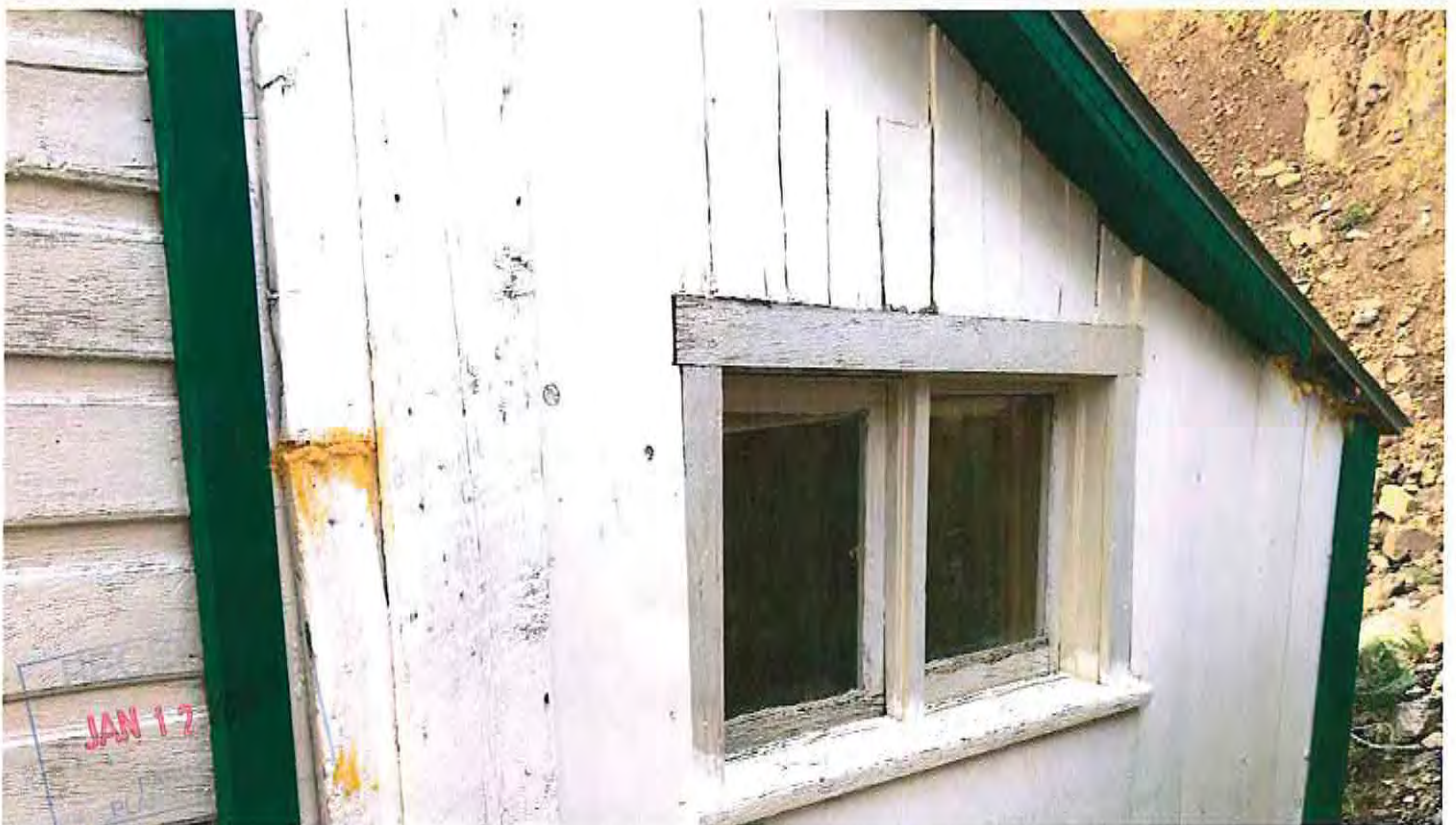
Photo #8: Rear Addition

The entire addition is non historic and in poor shape.

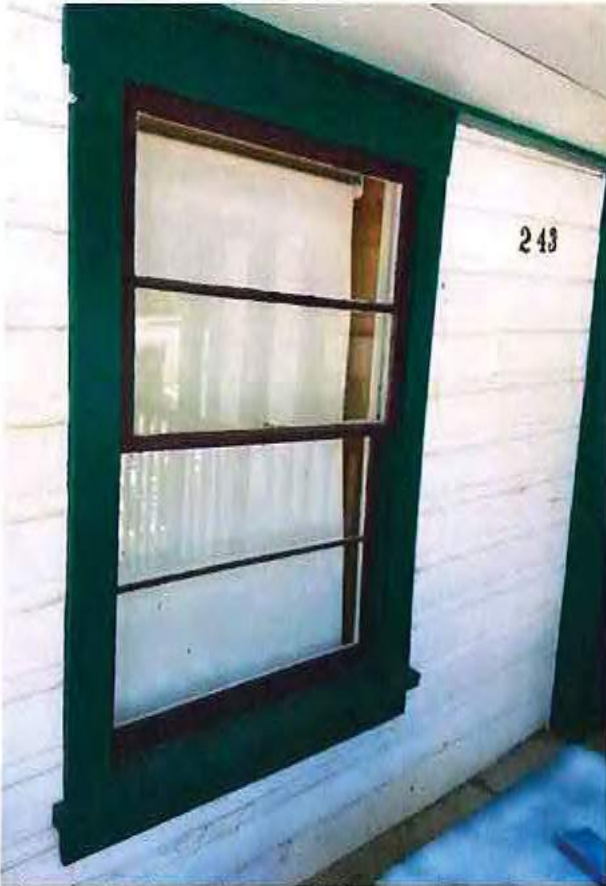
Photo #15: Existing Window

Window #:	Existing Condition (Excellent, Good, Fair, Poor):	Describe any deficiencies:	Photo #:	Historic (50 years or older):
1	Poor	Window frame is warped, track doesn't allow for operation, falling hardware and poor insulation	15	Y
2	Poor	Window frame is warped, track doesn't allow for operation, falling hardware and poor insulation, broken glass	36	Y
3	Poor	Window frame is warped, track doesn't allow for operation, falling hardware and poor insulation	37	Y
4	Poor	Window frame is warped, track doesn't allow for operation, falling hardware and poor insulation, rotting wood	40	Y
5	Poor	non existent - framed and filled in	6	Y
6	Poor	non historic window (original window size apparent by siding infill)	25	N
7	Poor	Window frame is warped, track doesn't allow for operation, falling hardware and poor insulation	8	N
8	Poor		10	N
9	Poor		10	N
10	Excellent		39	N
	Fair			
	Fair			
	Fair

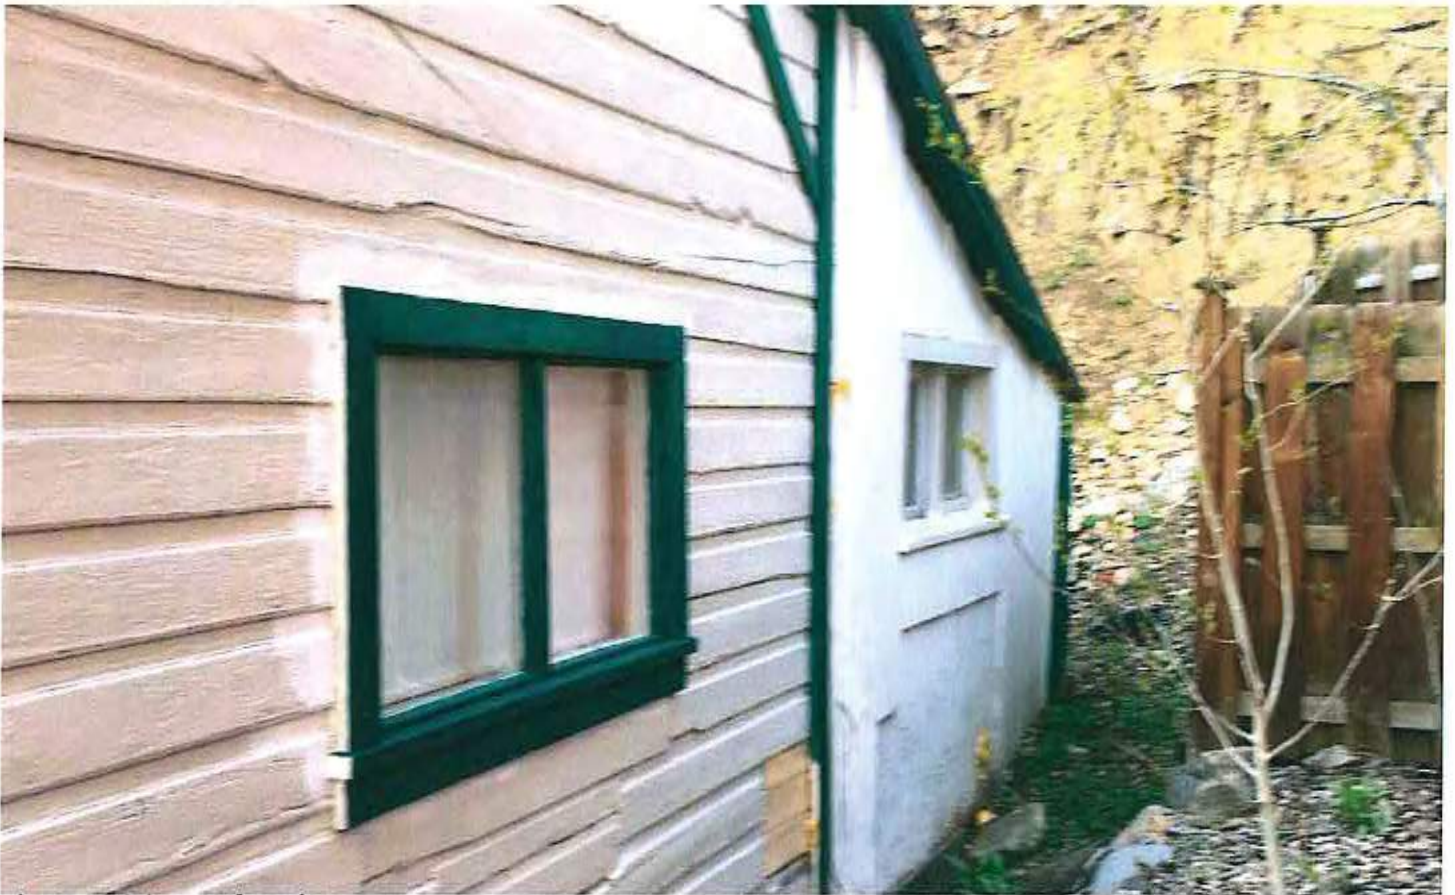
Photo #25: South Elevation

The majority of the South wall is in good shape, however, there is a non historic window which exists that will be removed and replaced with a new window to match the historic size. Additionally, another historic window which is now sided over will be cut back in to the wall. Both of the windows described above can clearly be seen on the wall as the siding transitions at clear cut lines.

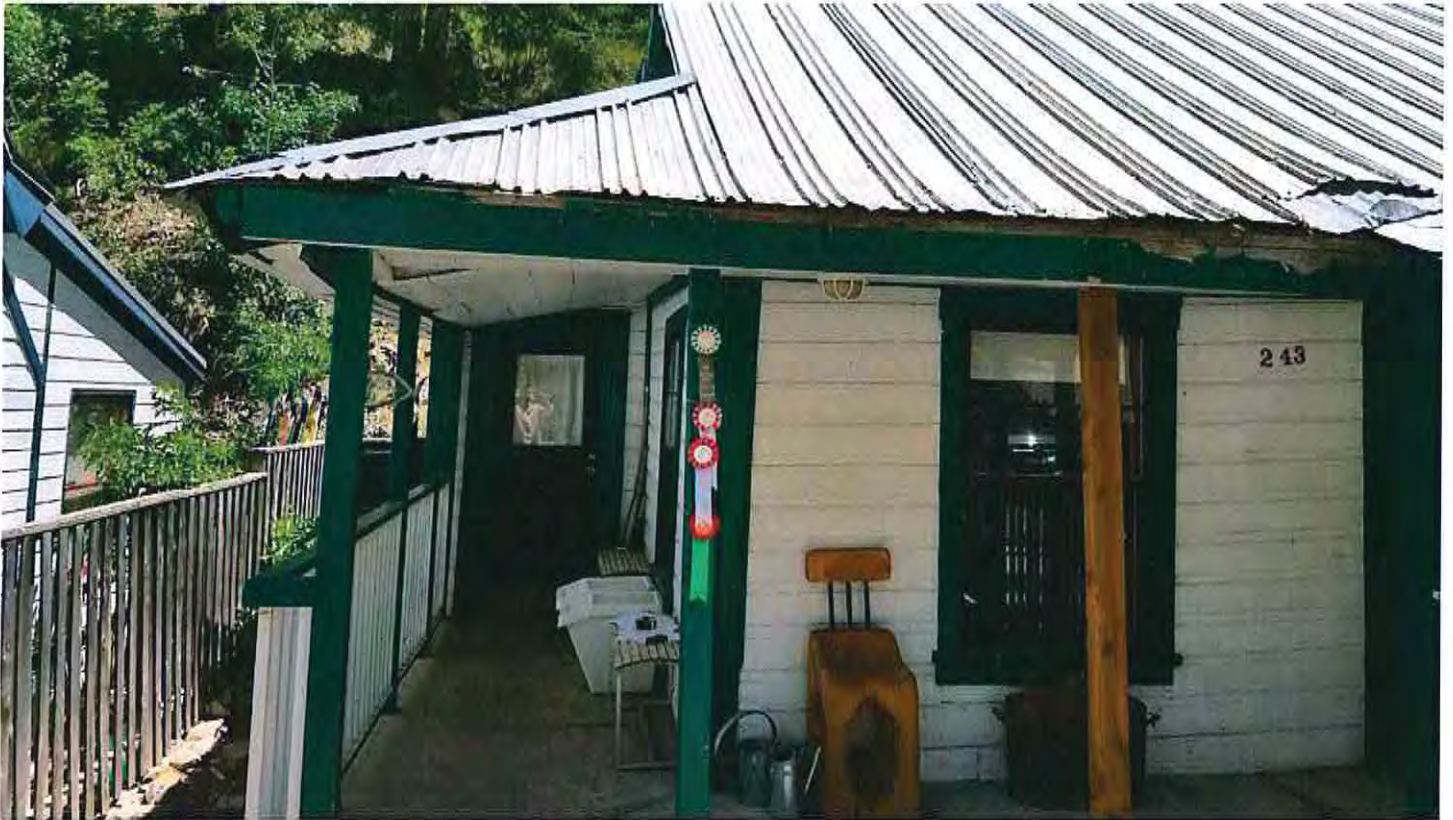
Photo #31: West Roof Elevation

Door #:	Existing Condition (Excellent, Good, Fair, Poor):	Describe any deficiencies:	Photo #:	Historic (50 years or older):
1	Poor	Not code compliant (not tall enough) and the frame is warped.	31	n
2	Fair	Not code compliant (not tall enough) and the frame is warped.	16	y
	Fair			
	Fair			
	Fair			
	Fair			
	Fair			
	Fair			
	Fair			
	Fair			
	Fair			
	Fair			
	Fair			
	Fair

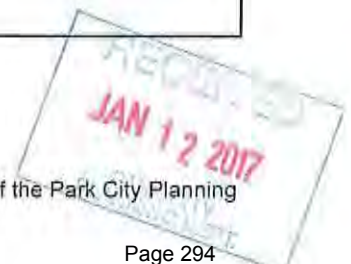
The majority of the exterior wall structure appears to be intact and structurally sound because it was upgraded when the basement foundation was constructed. See below for roof scope of work.

The non historic additions at the rear of the building will be removed.
