PARK CITY MUNICIPAL CORPORATION
HISTORIC PRESERVATION BOARD
CITY COUNCIL CHAMBERS
August 2, 2017

632 Deer Valley Loop —Disassembly/Reassembly (Panelization) and Material Deconstruction—Significant House. The applicant is proposing to disassemble and reassemble the north, east, and west walls of the existing historic house on its lot. In addition, the applicant will be removing non-historic broken wood stairs and overgrown landscaping; historic c.1918 floor structure; c.1941 enclosed porch addition; c.1969 rear addition; c.1918 fire-damaged roof structure; c.1918 brick chimney; non-historic c.1969 concrete block chimney; c.1969 T-11 siding; 18 linear feet of the historic c.1918 west wall; historic c.1918 front porch and c.1969 ornamental porch posts; c.1930 exterior door on north façade; non-historic service door on west elevation; 9 non-historic single-pane, replacement windows.

PARK CITY MUNICIPAL CORPORATION
HISTORIC PRESERVATION BOARD
MINUTES OF JUNE 7, 2017

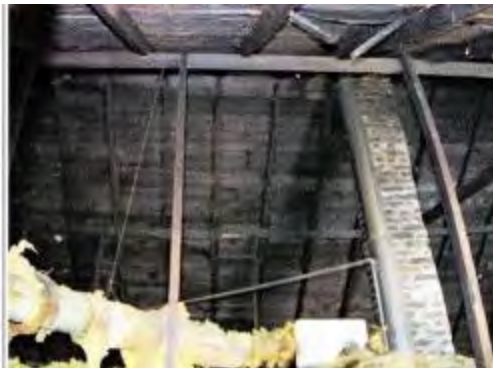
As previously described, the house currently has a framed wall system with 1x12 horizontal planks covering the framing. The south wall of the historic house (interior wall between the historic house and c.1969 addition) was severely damaged by the 1999 fire and is beyond repair. The fire also damaged the roof structure. Because there is no foundation, the floor framing sits directly on the dirt. As the structure settled, individual structural members have become deformed.

Charred roof construction with brick chimney.

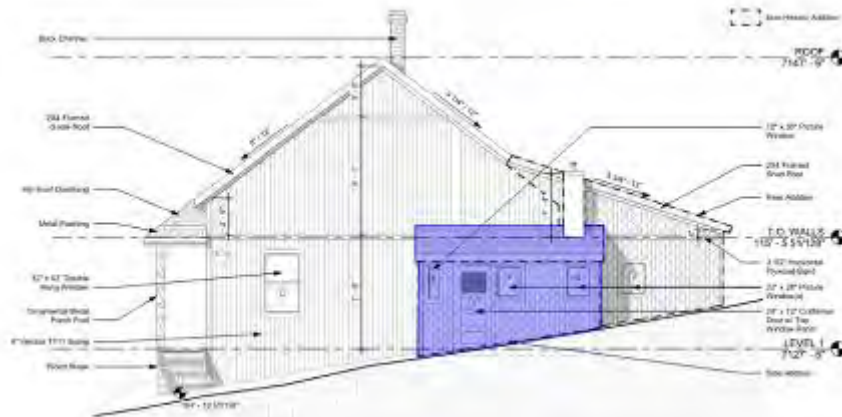
Staff finds that this addition no longer maintains its integrity. The design of this addition has been modified from an open porch with a square footprint to an enclosed mudroom with a rectangular footprint. The exterior is now clad in T-11 siding and the original porch structure is no longer visible. It does not reflect the

workmanship, feeling, and association with the Mature Mining Era (1894-1930) in which the historic house has been designated as significant. Further, the enclosed porch is located beyond the midpoint of the historic structure, and is secondary to the primary façade. Staff finds that this addition is non-contributory to the historic integrity and historical significance of the structure and can be demolished.

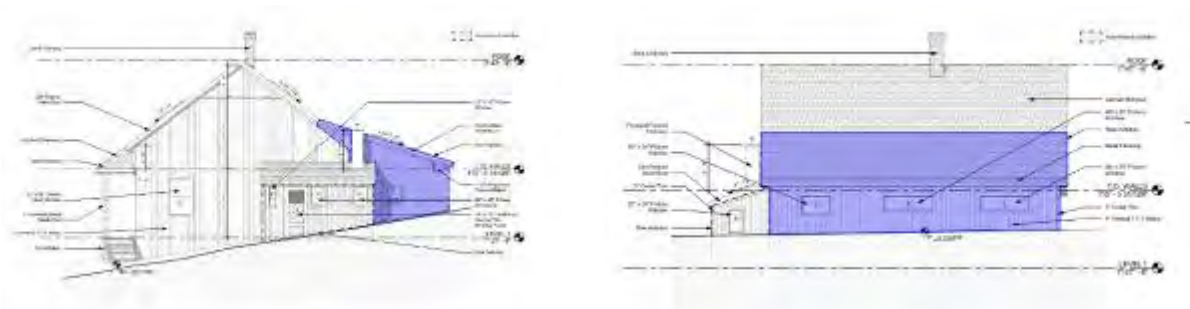
West Elevation

A second addition was constructed across the south elevation of the historic house in c.1969. The applicant has proposed to remove this addition in order to restore the original side-gable appearance of the historic house. The addition consists of a framed structure and is clad in T-11 siding and 3 inch vertical wood trim. The windows on this addition are oriented horizontally and further speak to its construction date of c.1969.

Staff finds that this addition is non-contributory to the historic integrity and historical significance of the structure and can be demolished.

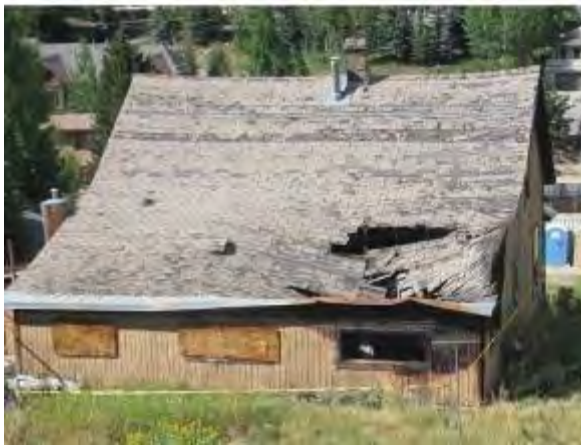
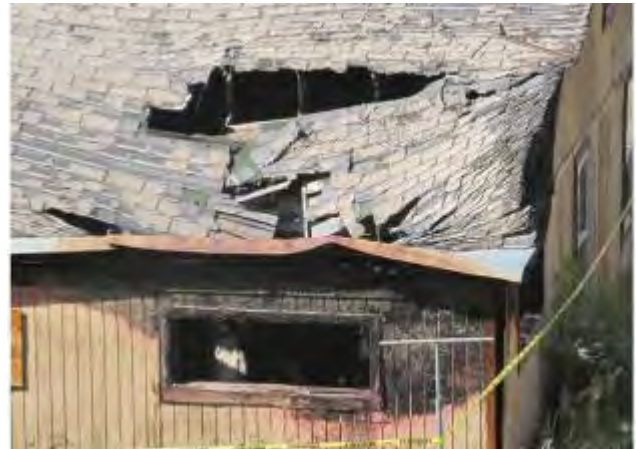
As previously described, the applicant's structural engineer has found that the roof has been jeopardized due to the 1999 fire. In addition to destroying the structural members of the roof above the historic house and c.1969 addition, the fire also caused the roof of the c.1969 addition to collapse. The addition as well as the attic of the historic house have been exposed to the elements for almost two decades, leading to further deterioration.

The historic gable roof structure has a 9:12 pitch. It was constructed of 2x6 dimensional framing with 1x10 planking. The original shingles were replaced with asphalt shingles. The eaves of the historic gables are plumb cut.

The applicant proposes to demolish the roof assembly entirely.

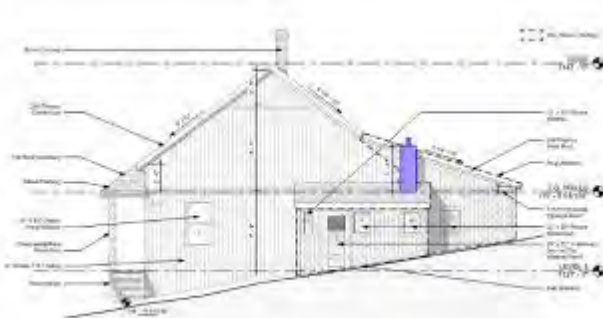
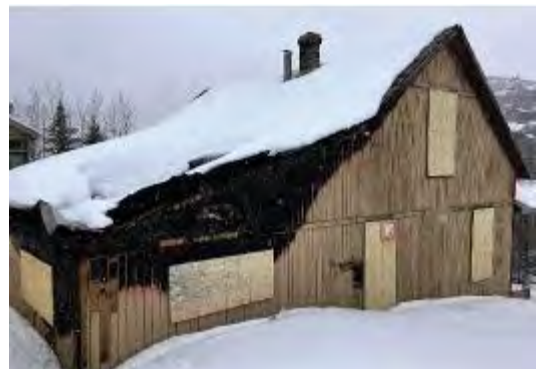
On the west elevation, there is a concrete block chimney that runs through the roof of the c.1969 roof of the enclosed porch addition. There are also a metal chimney flues on the south (rear) elevation of the house. Staff finds that the concrete block chimney and metal flue do not contribute to the historic integrity and historical significance of the structure.

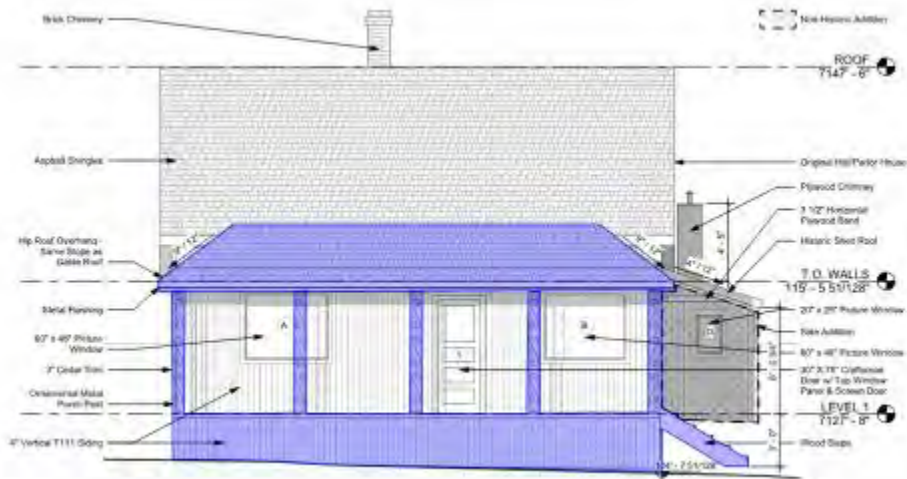
The existing porch is constructed of contemporary building materials, and staff believes it may not be the original porch. The current floor framing has settled as it rests on 6x6 wood piers that are in fair to poor condition, and the wood stairs leading from the porch to the ground are severely rotted. The hip roof of the porch is supported by ornamental metal posts, likely introduced in the c.1969 remodel.

The applicant is proposing to reconstruct the porch. Physical evidence and the historic c.1940 tax photograph will be used to replicate the turned posts and horizontal railing of the historic porch. A new hip roof will be constructed to comply with structural codes.

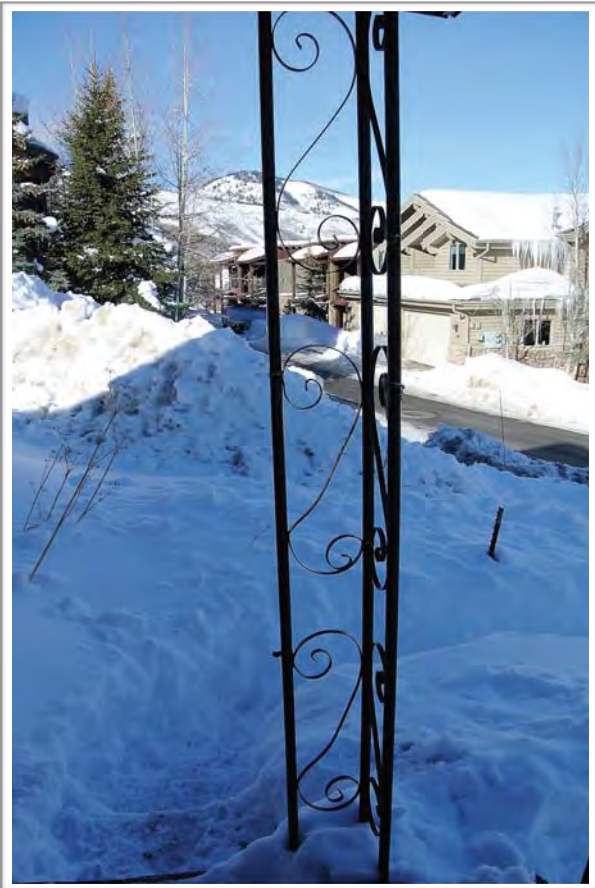
Photo #6: Ornamental Metal Porch Post

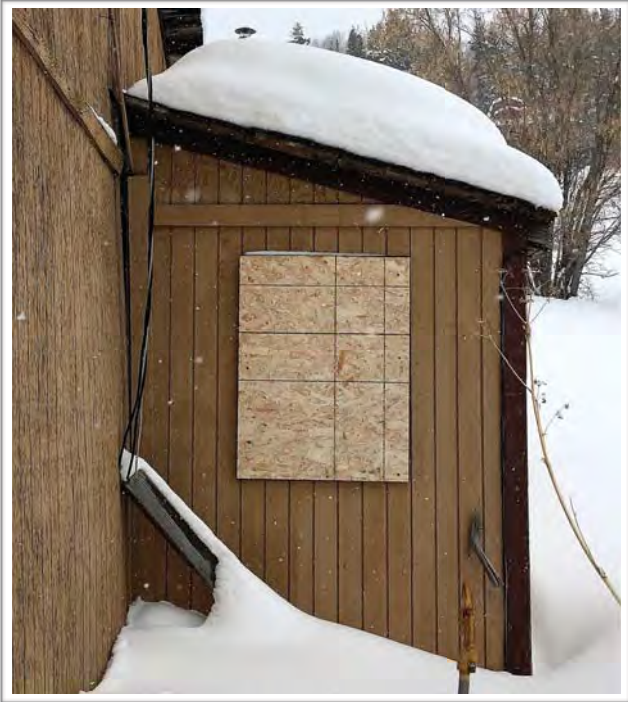
Photo #7: Side Addition (Non-Historic) w/ Historic (?) Roof

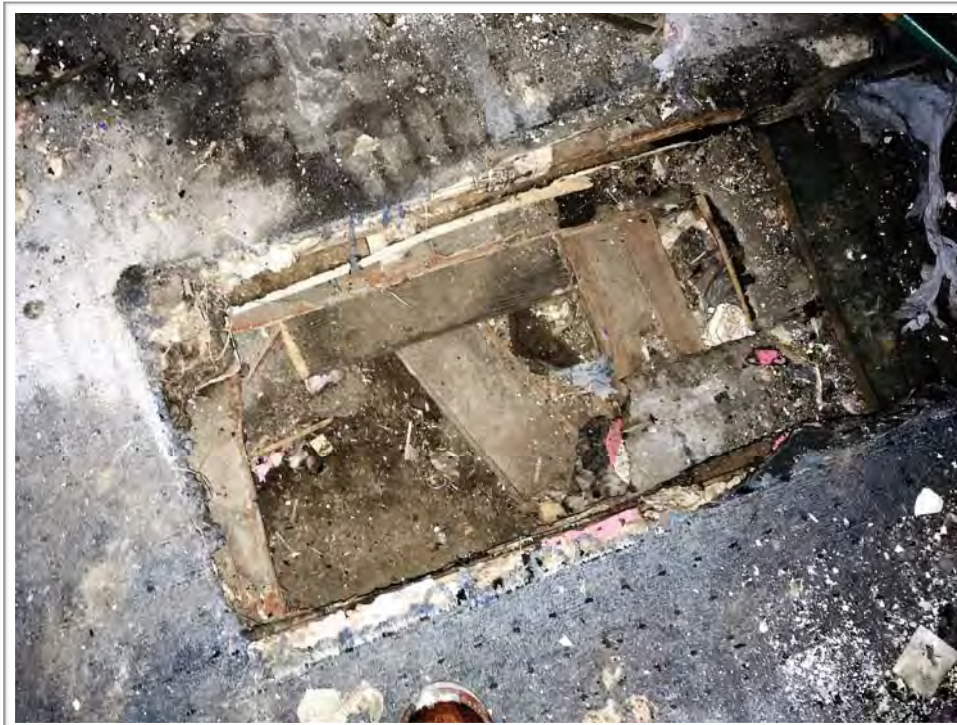
Photo #10: Floor Construction on Grade

In the past, the owners removed portions of the floor structure in the historic house to determine whether or not a foundation was present. At this time, it appears that there is no existing foundation. This is further supported by the way in which the house has settled, specifically the shifting of floors and skewed door frames. The applicant believes the house was built on planks that rested directly on the ground.

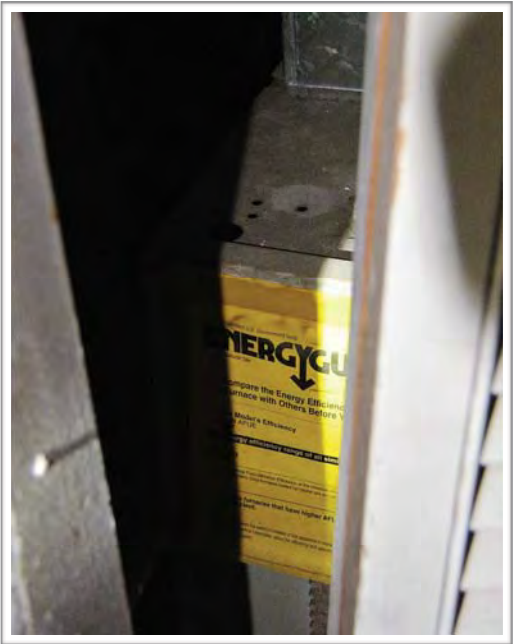
Photo #18: Gas Furnace

All utility systems have been likely updated from the original house.
The electric meter is located in the West addition.
Telephone lines are observed entering the house at the West elevation.
There is evidence of a gas furnace, but the location of the gas meter is unknown.

Electricity has been disconnected from the house. The furnace is missing as well.

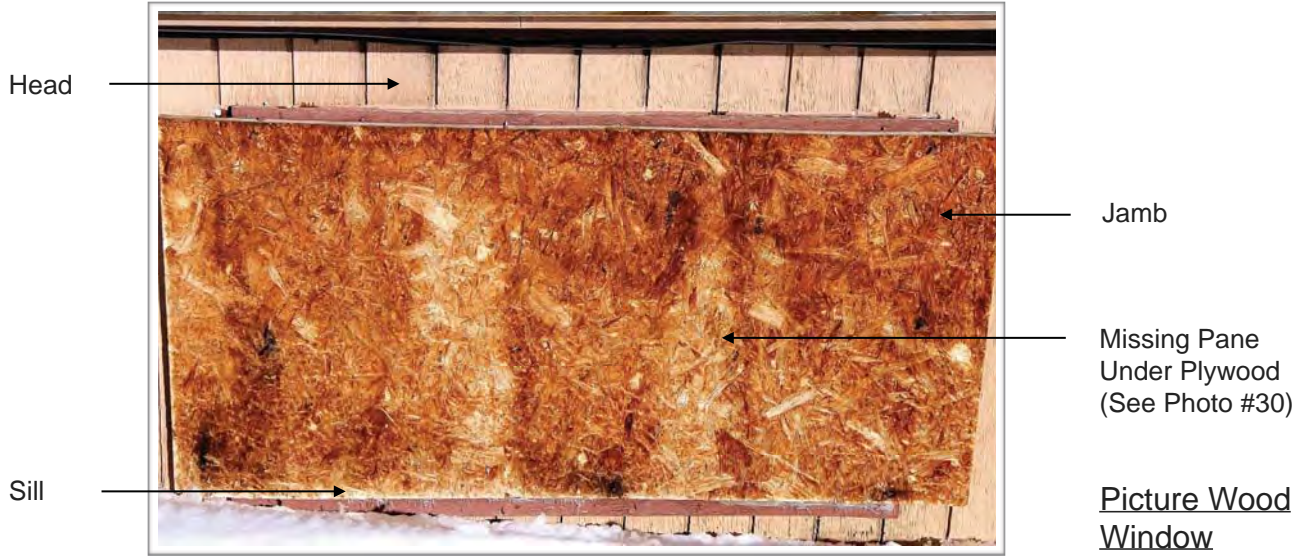
Photo #29: Back Window J

* Site Conditions Do Not Allow For Plywood Removal

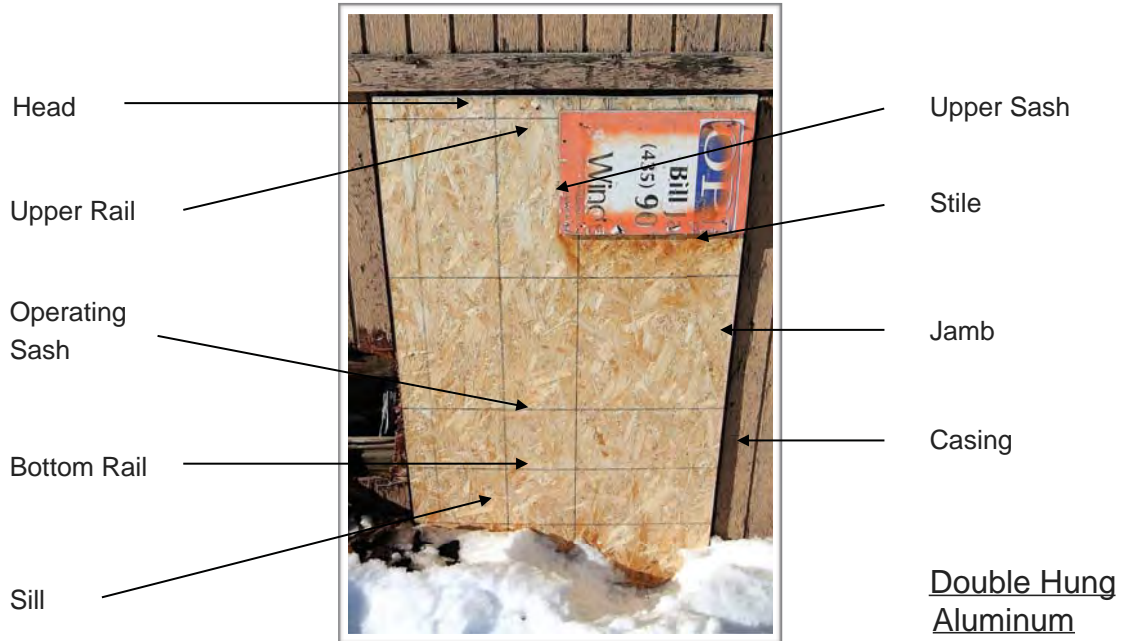
Photo #31: Side Window N

* Site Conditions Do Not Allow For Plywood Removal

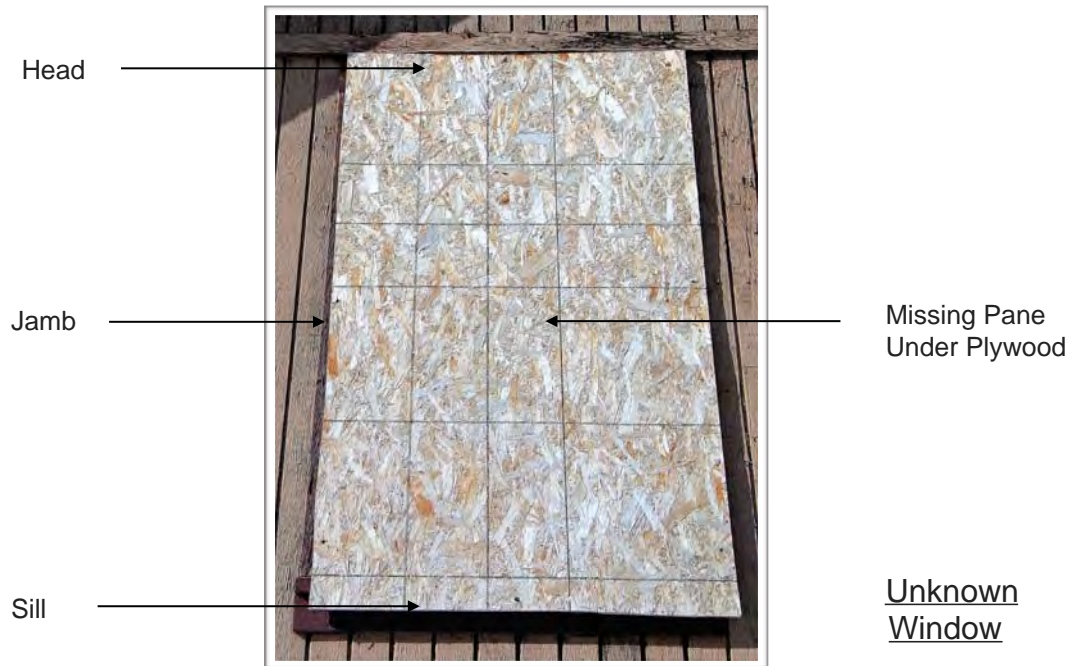
Photo #32: Side Window O

* Site Conditions Do Not Allow For Plywood Removal
