**PARK CITY MUNICIPAL CORPORATION
HISTORIC PRESERVATION BOARD
CITY COUNCIL CHAMBERS
November 1, 2017**

632 Deer Valley Loop —Reconstruction—Significant House. The applicant is proposing to reconstruct the north, east, and west walls of the existing historic house. PL-17-03512 17
Planner Grahn

Staff recommends the Historic Preservation Board review and discuss the application, conduct a public hearing, and approve the reconstruction of the historic house at 632 Deer Valley Loop pursuant to the following findings of fact, conclusions of law, and conditions of approval. This site is listed as Significant on the City's Historic Sites Inventory (HSI).

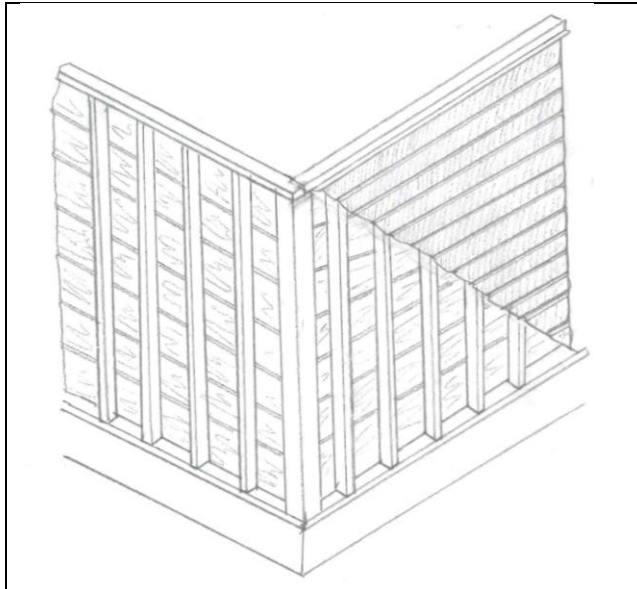
Framed Wall Construction. 632 Deer Valley Loop has framed wall construction. On exterior, the horizontal wood siding is nailed to the studs. On the interior, horizontal wood planks cover the studs. This creates a cavity that was then filled with insulation, containing asbestos.

Because the individual siding pieces are nailed to the studs on the exterior and the wall structure is in such poor condition, the applicant cannot salvage an entire wall panel the way that they could have if the structure had been built using single-wall construction.

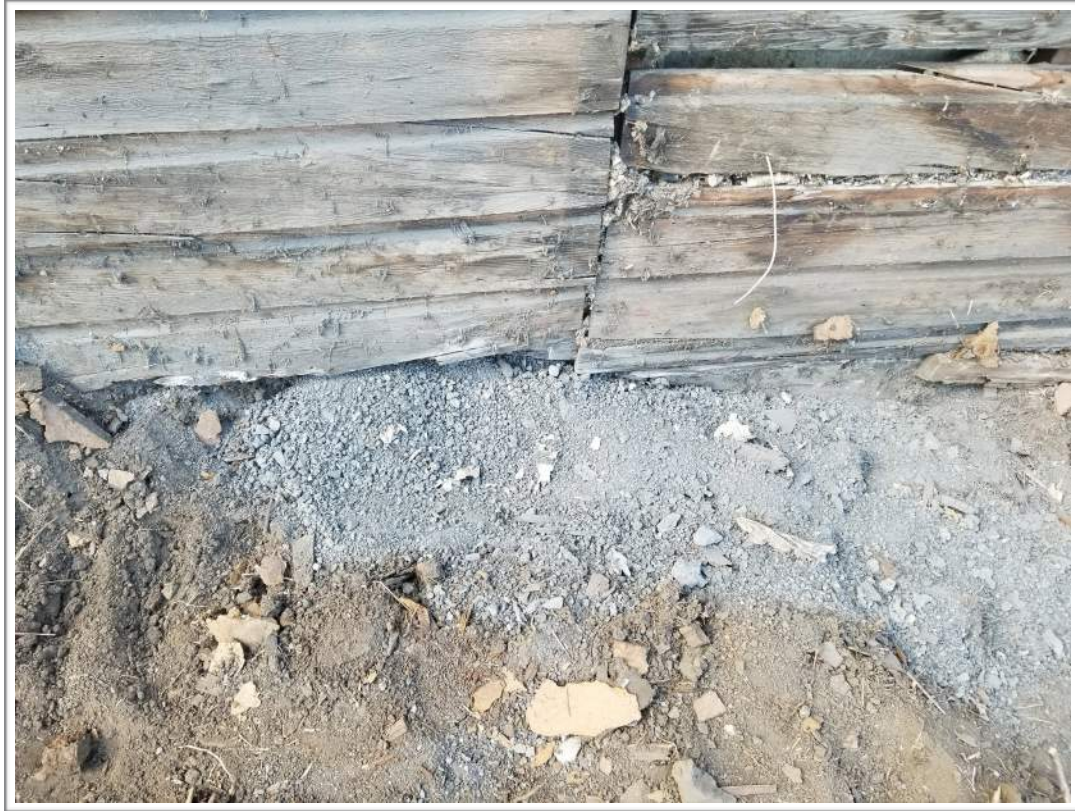
Photo #13: Deteriorated Foundation and Ash Mixture

As outlined in the applicant’s analysis (Exhibit A), the foundation was ~~hobbled~~ “hobbled together” at best. On the east and west sides of the house, a [single wythe foundation](#) – a wall consisting of a single layer of stacked bricks—was haphazardly added as the grade falls away from the main floor level of the house. The north façade is held up by a post and beam foundation that sags some six inches (6”) across the length of the house. The

beam under the north wall of the house consists of two large timbers connected by a dovetail rabbet joint; the joint has failed and contributes to the sagging structure. On the south half of the house (original hall-parlor), the wood floor structure sits directly on the dirt. This floor structure is held up by a combination of dirt, rotted wood posts and beams that sit directly on the ground. It is in failing condition.

- In poor condition due to fire
- Will need to be replaced
