**PARK CITY MUNICIPAL CORPORATION  
HISTORIC PRESERVATION BOARD  
CITY COUNCIL CHAMBERS  
May 16, 2018**

115 Sampson Avenue – HDDR Material Deconstruction and Reconstruction – The applicant is proposing to reconstruct the historic house designated as “Significant” on the City’s Historic Sites Inventory. In addition the applicant will be removing existing non-historic parking pad along with its associated wood staircases and railroad tie retaining wall; non-historic stacked stone retaining walls and 1990s wood slat fences; post-1947 addition on the west elevation and an underground root cellar; rebuilding the historic pyramid roof and dormers; reconstructing the existing masonry chimney; raising the house 2 feet to pour a new foundation; reconstructing the historic ca.1900 wraparound porch on the east and south elevations; replacing two non-historic doors; and removing non-historic aluminum windows and restoring 11 window openings.

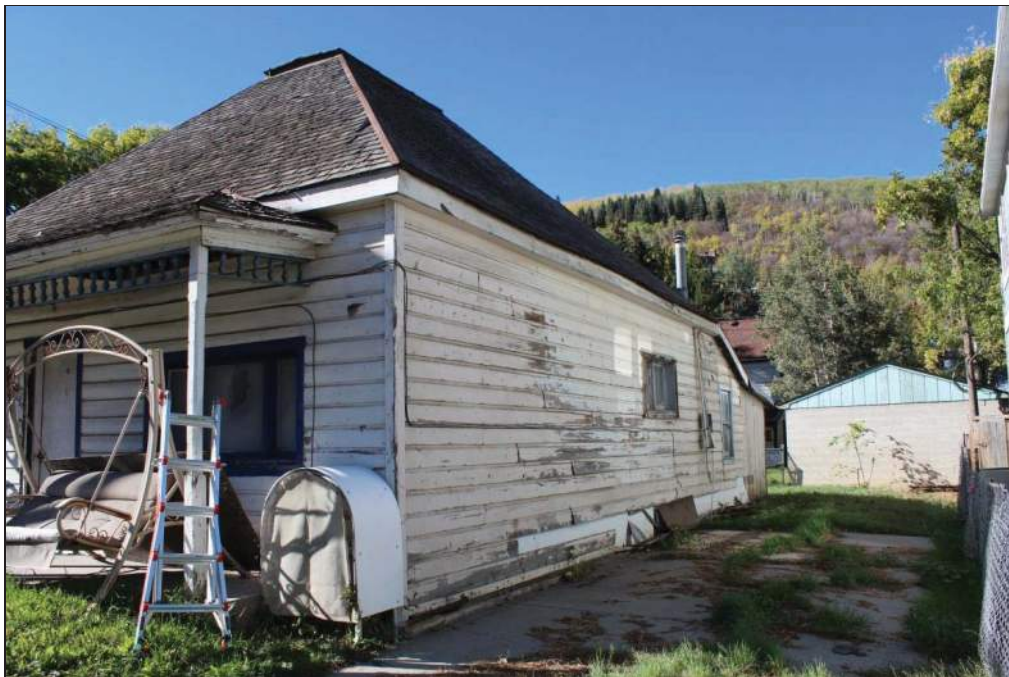
**A.2. LANDSCAPING:** Concrete parking pad on north side, facing southwest
